Title	Guam Waterworks Authority (VP0989)
Subject	Northern System
Latitude	██████████
Longitude	██████████
Photo Direction	██████
Elevation	████
Date Time Stamp	4/27/2012 9:37:55 AM
Photographer	K. Sable
Comment	Y 15 Well
Description	Overview of Y 15 well

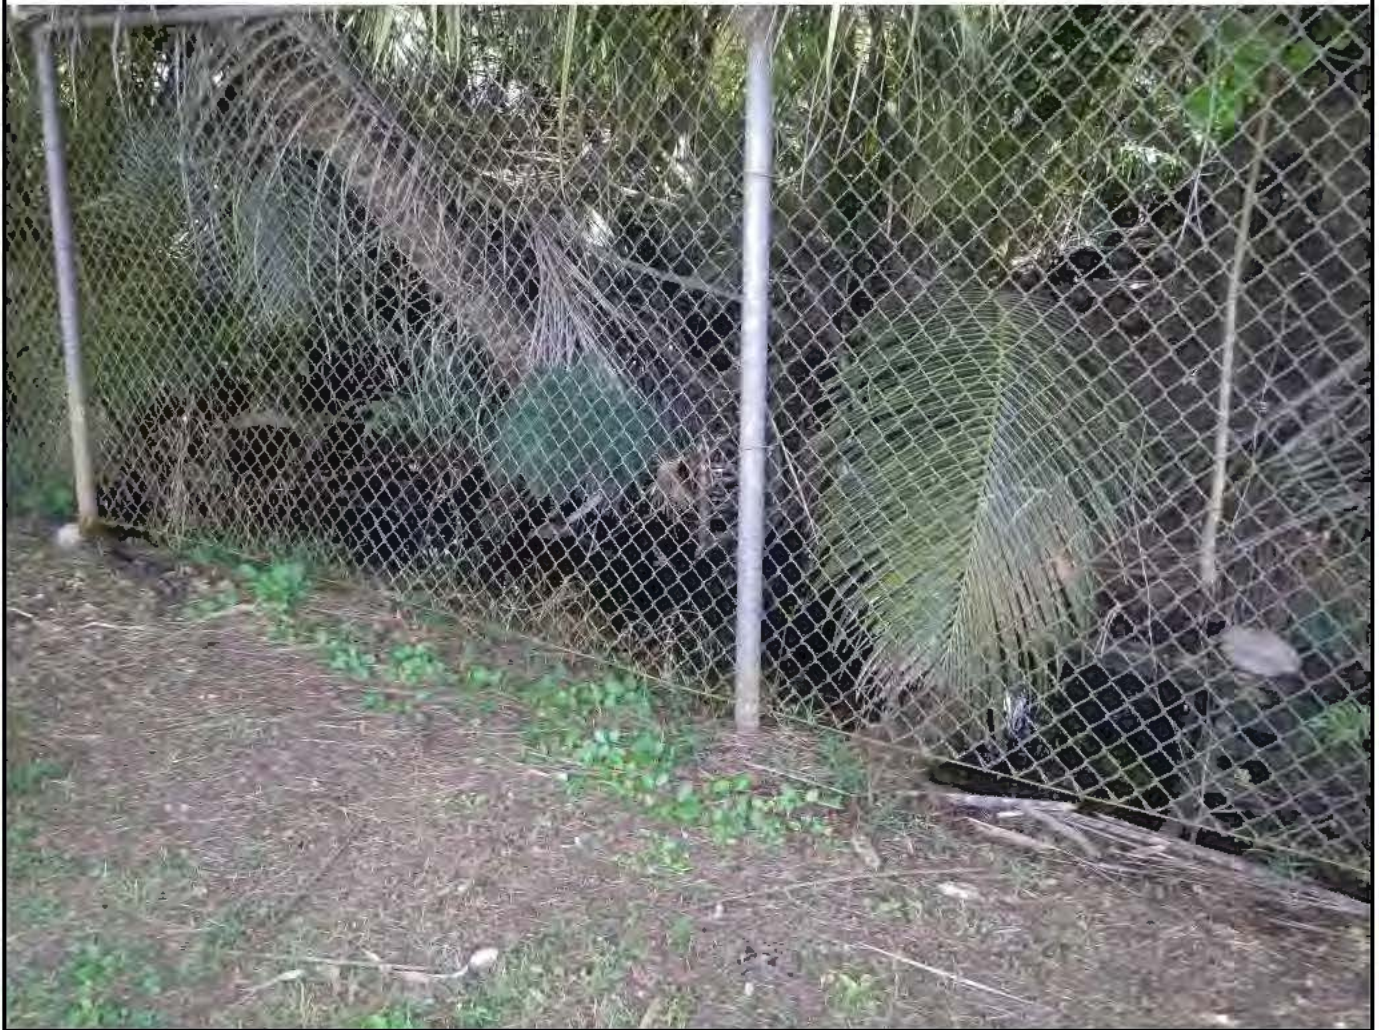
Title	Guam Waterworks Authority (VP0989)
Subject	Northern System
Latitude	██████████
Longitude	██████████
Photo Direction	██████████
Elevation	██████
Date Time Stamp	4/27/2012 9:47:15 AM
Photographer	K. Sable
Comment	Y 15 Well
Description	Bypass location

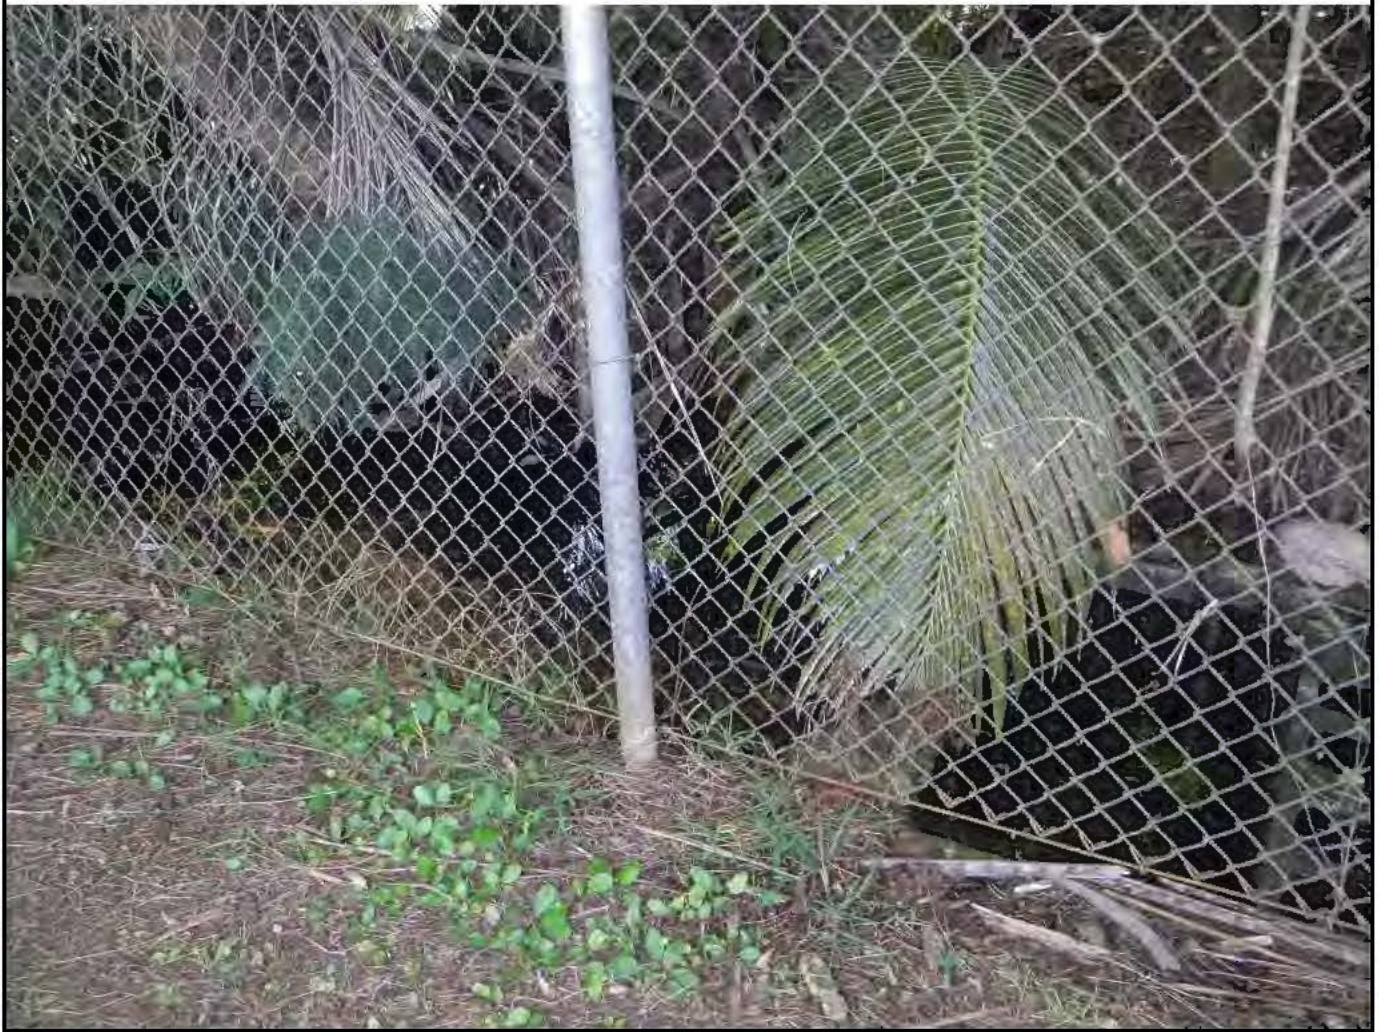
Title	Guam Waterworks Authority (VP0989)
Subject	Northern System
Latitude	██████████
Longitude	██████████
Photo Direction	██████████
Elevation	██████
Date Time Stamp	4/27/2012 9:47:26 AM
Photographer	K. Sable
Comment	Y 15 Well
Description	Close-up of bypass location

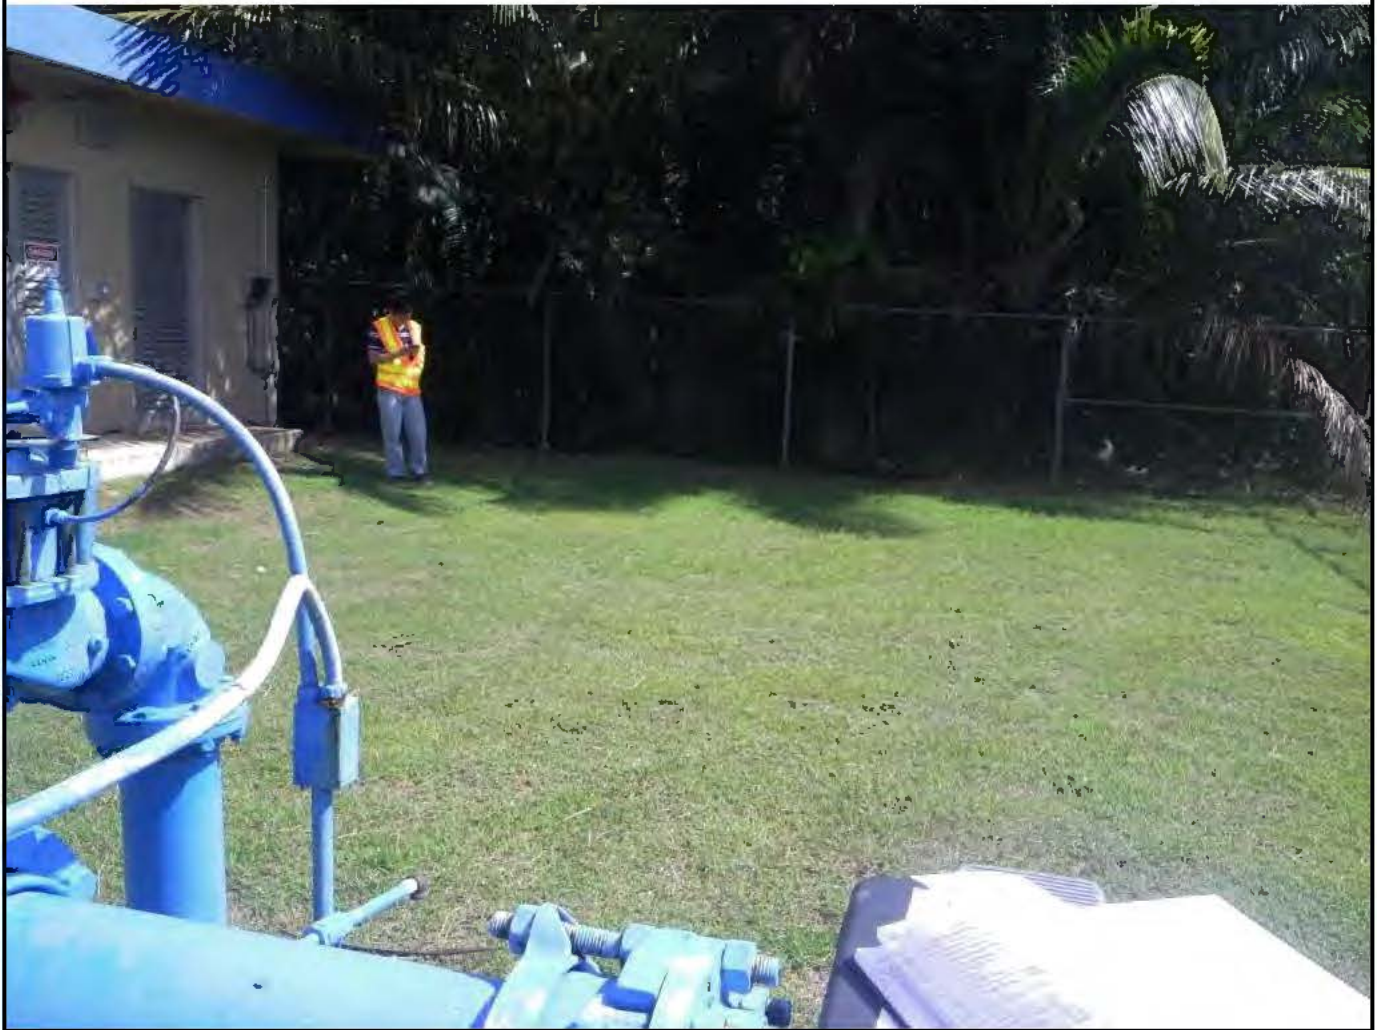
Title	Guam Waterworks Authority (VP0989)
Subject	Northern System
Latitude	██████████
Longitude	██████████
Photo Direction	██████
Elevation	██████
Date Time Stamp	4/27/2012 9:48:24 AM
Photographer	K. Sable
Comment	Y 15 Well
Description	From bypass pipe toward bypass location

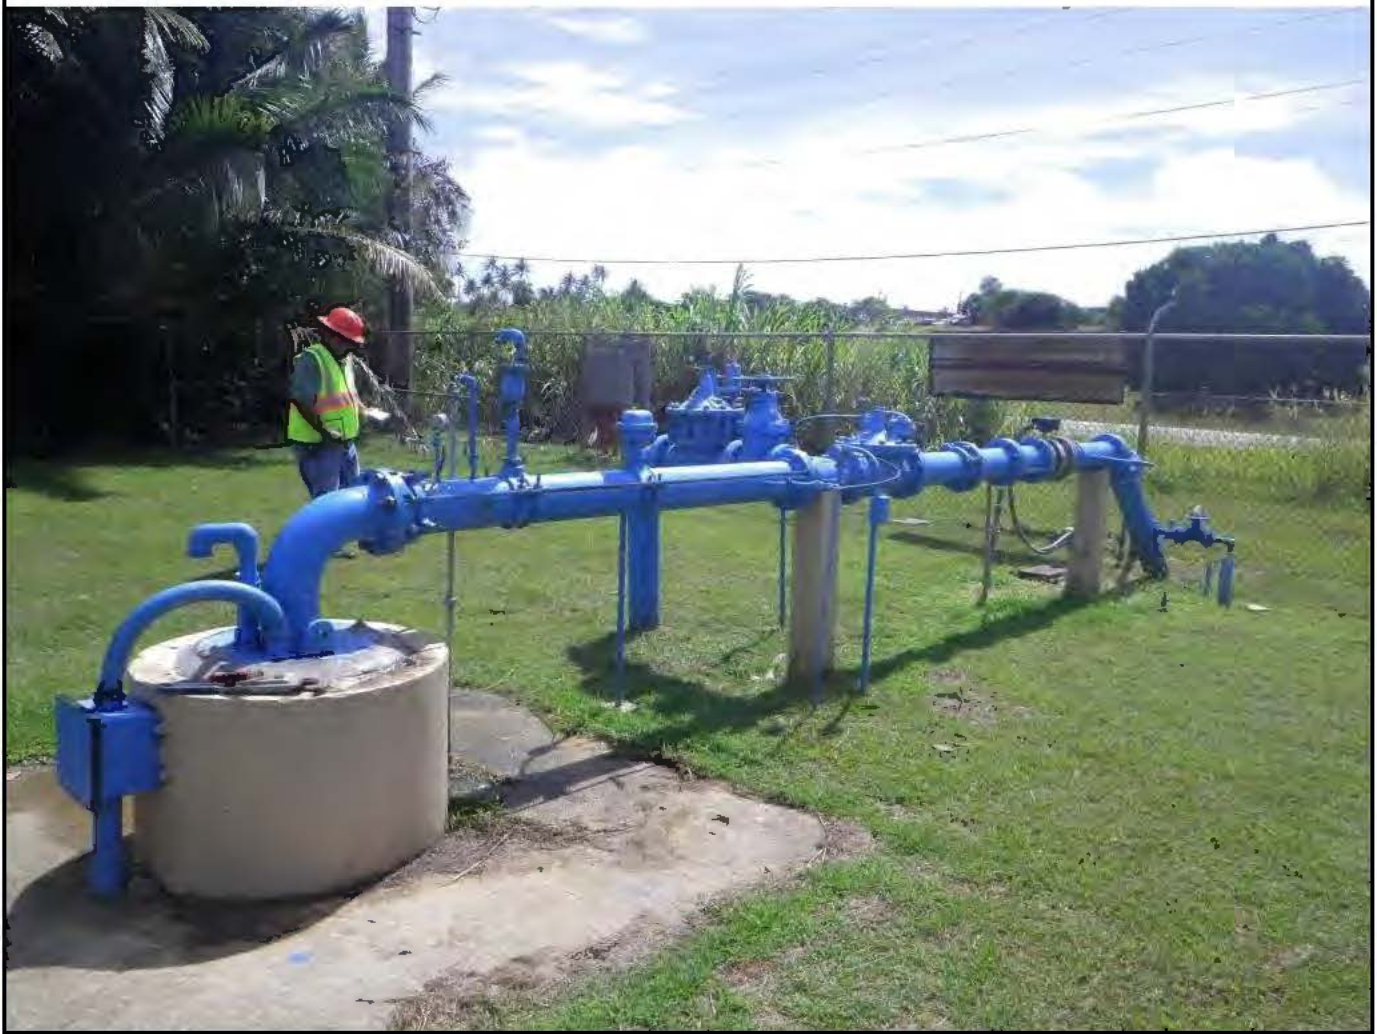
Title	Guam Waterworks Authority (VP0989)
Subject	Northern System
Latitude	██████████
Longitude	██████████
Photo Direction	██████████
Elevation	██████████
Date Time Stamp	4/27/2012 9:54:13 AM
Photographer	K. Sable
Comment	Y 15 Well
Description	Well assembly

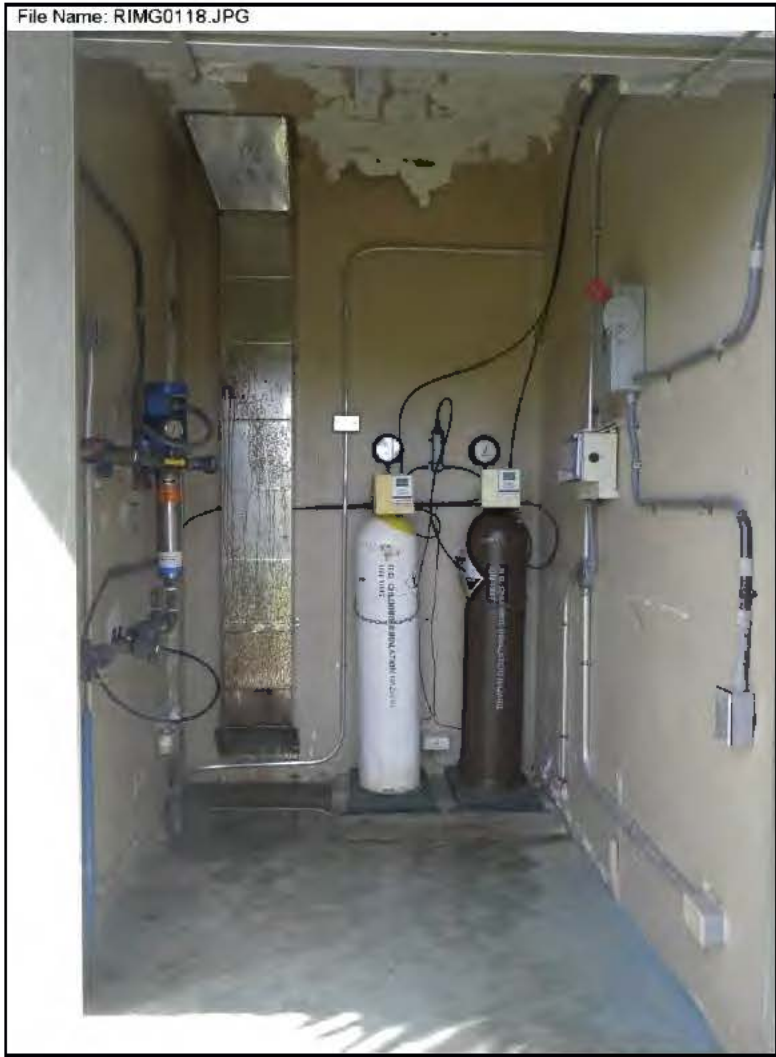
Attributes	
Title	Guam Waterworks Authority (VP0989)
Subject	Northern System
Latitude	[REDACTED]
Longitude	[REDACTED]
Photo Direction	[REDACTED]
Elevation	[REDACTED]
Date Time Stamp	4/27/2012 10:11:23 AM
Photographer	K. Sable
Comment	Y 15 Well
Description	Chlorine room

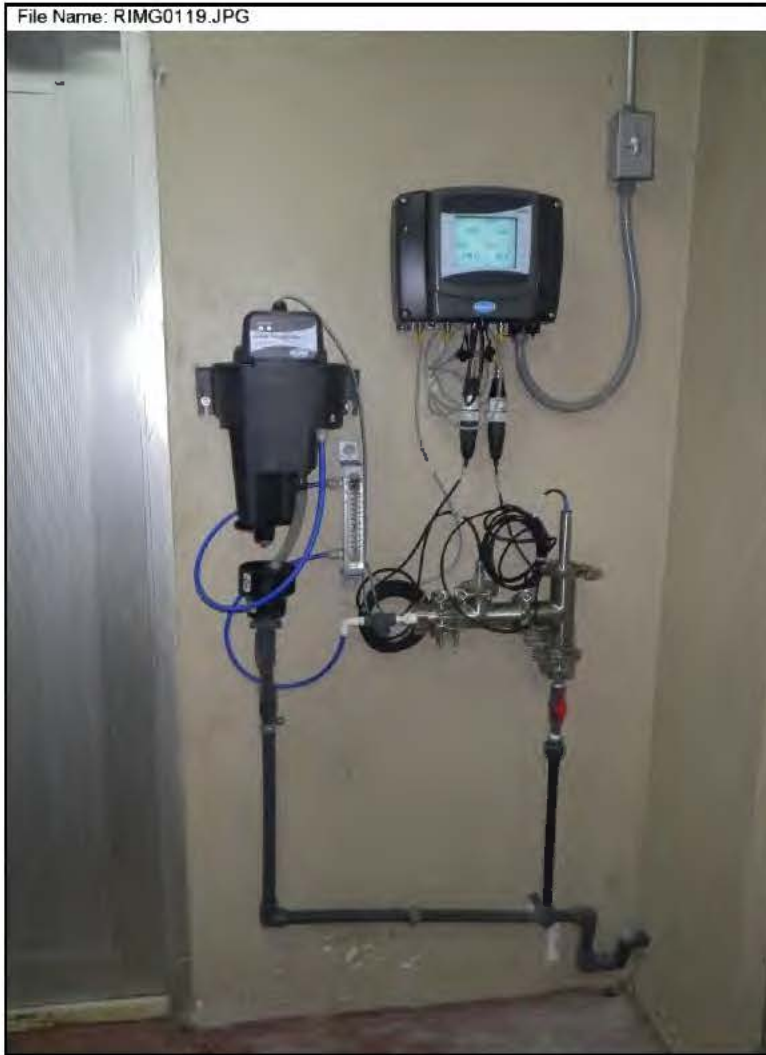
Attributes	
Title	Guam Waterworks Authority (VP0989)
Subject	Northern System
Latitude	[REDACTED]
Longitude	[REDACTED]
Photo Direction	[REDACTED]
[REDACTED]	[REDACTED]
Date Time Stamp	4/27/2012 10:12:55 AM
Photographer	K. Sable
Comment	Y 15 Well
Description	Turbidimeter

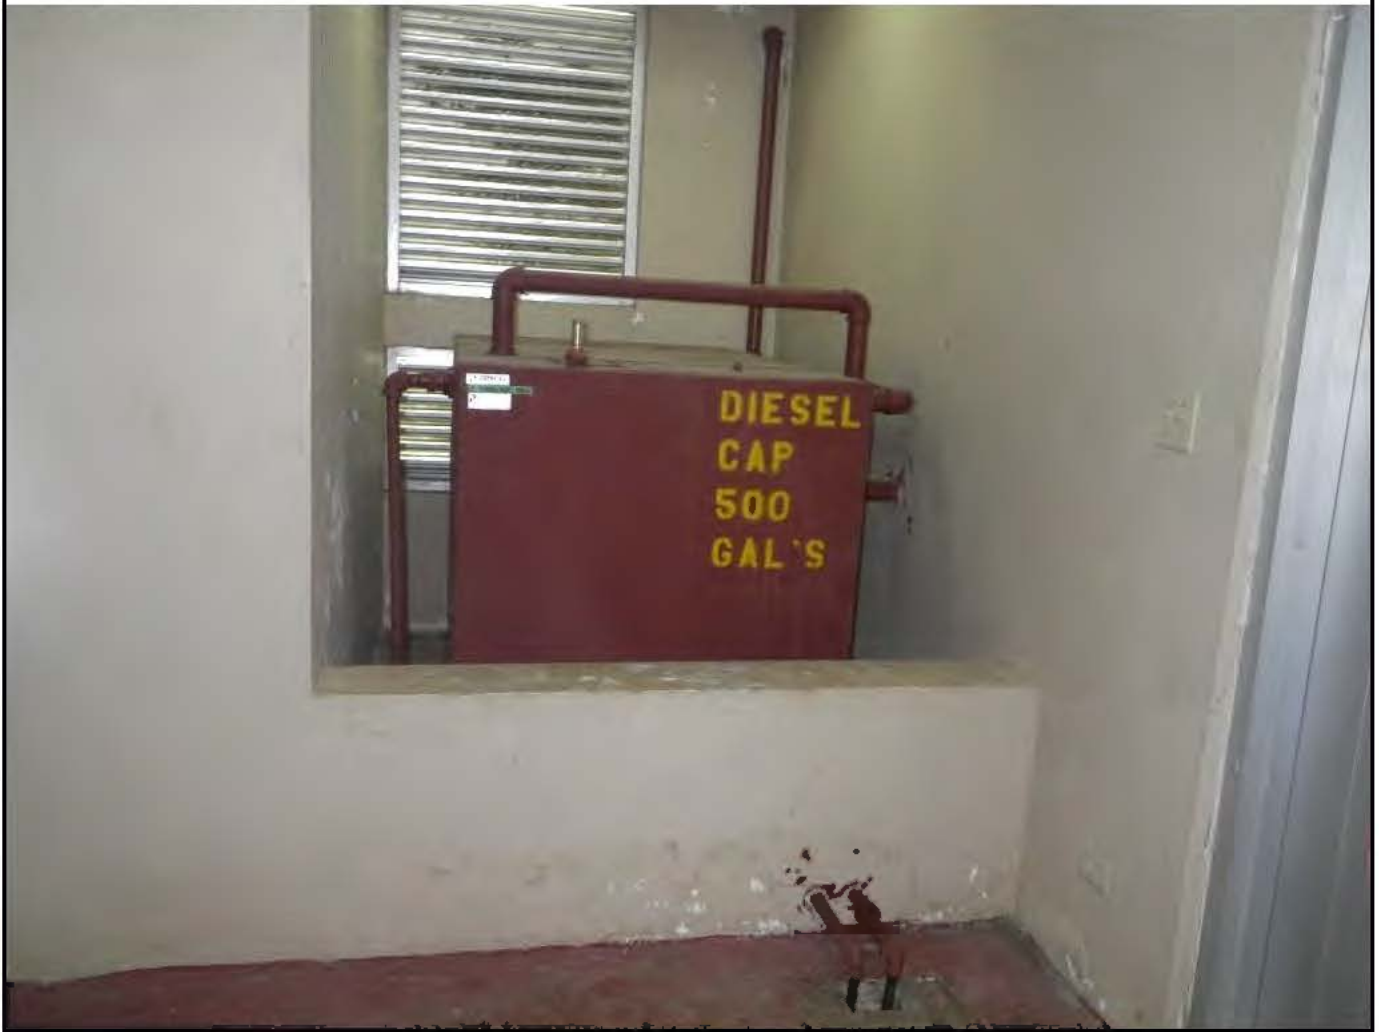
Title	Guam Waterworks Authority (VP0989)
Subject	Northern System
Latitude	██████████
Longitude	██████████
Photo Direction	██████
Elevation	████
Date Time Stamp	4/27/2012 10:15:52 AM
Photographer	K. Sable
Comment	Y 15 Well
Description	Generator diesel fuel tank

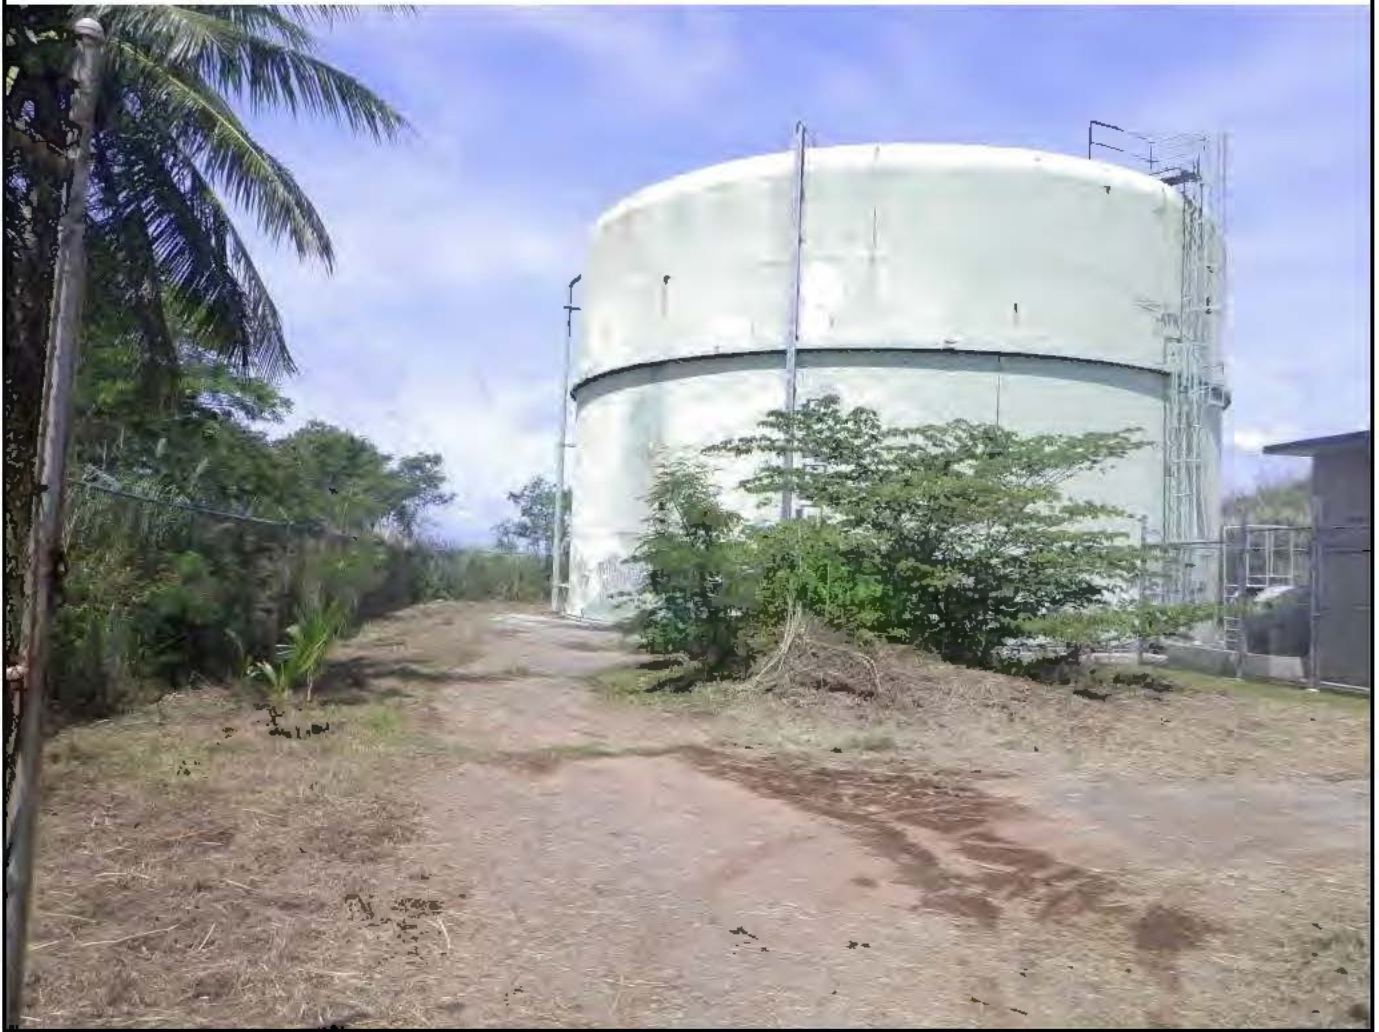
Title	Guam Waterworks Authority (VP0989)
Subject	Northern System
Latitude	██████████
Longitude	██████████
Photo Direction	██████████
Elevation	██████
Date Time Stamp	4/27/2012 10:28:00 AM
Photographer	K. Sable
Comment	Santa Rosa Tank
Description	Overview of tank

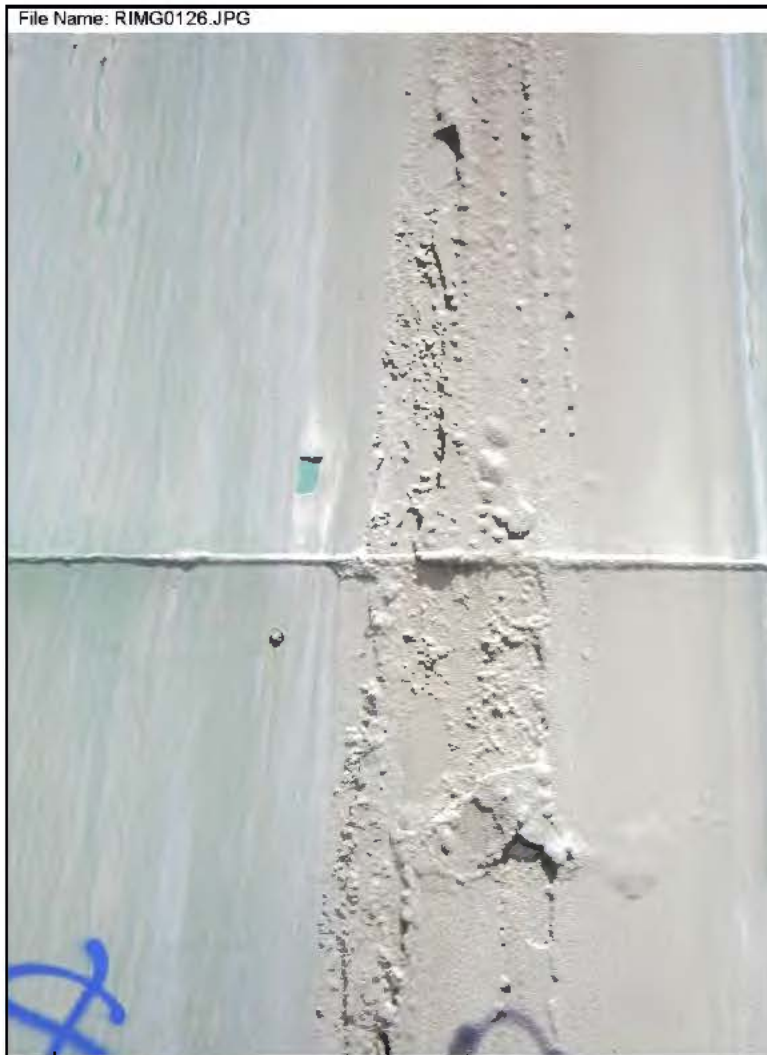
Attributes	
Title	Guam Waterworks Authority (VP0989)
Subject	Northern System
Latitude	[REDACTED]
Longitude	[REDACTED]
Photo Direction	[REDACTED]
Elevation	[REDACTED]
Date Time Stamp	4/27/2012 10:39:46 AM
Photographer	K. Sable
Comment	Santa Rosa Tank
Description	Close-up of previously patched area with build-up of precipitate

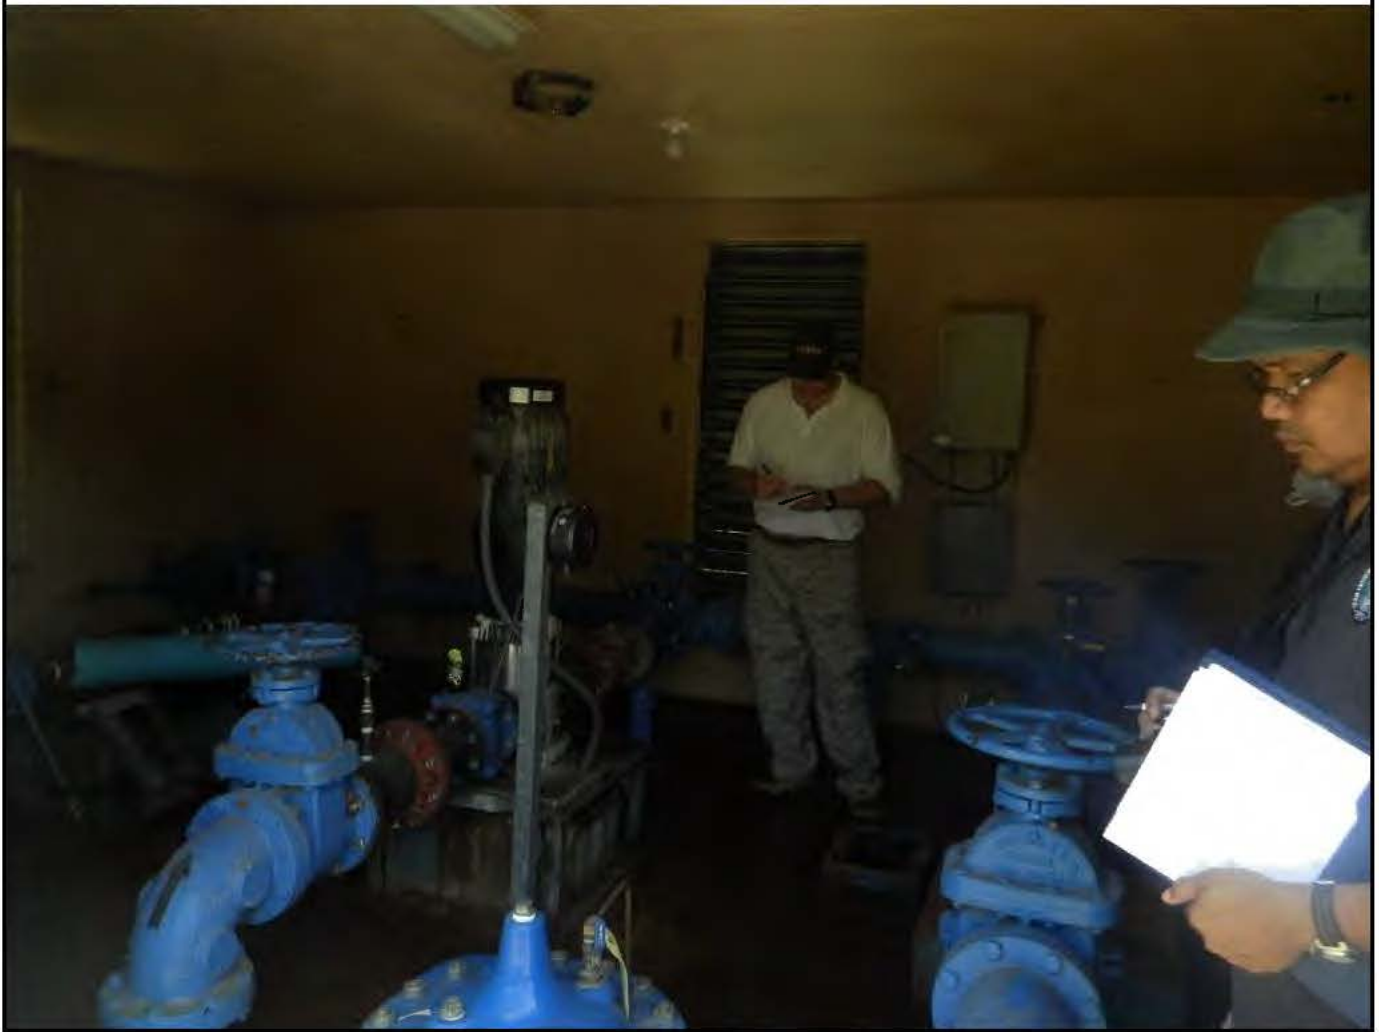
Title	Guam Waterworks Authority (VP0989)
Subject	Northern System
Latitude	██████████
Longitude	██████████
Photo Direction	██████
Elevation	████
Date Time Stamp	4/27/2012 10:52:59 AM
Photographer	K. Sable
Comment	Santa Rosa Pump Station
Description	Overview of pump station

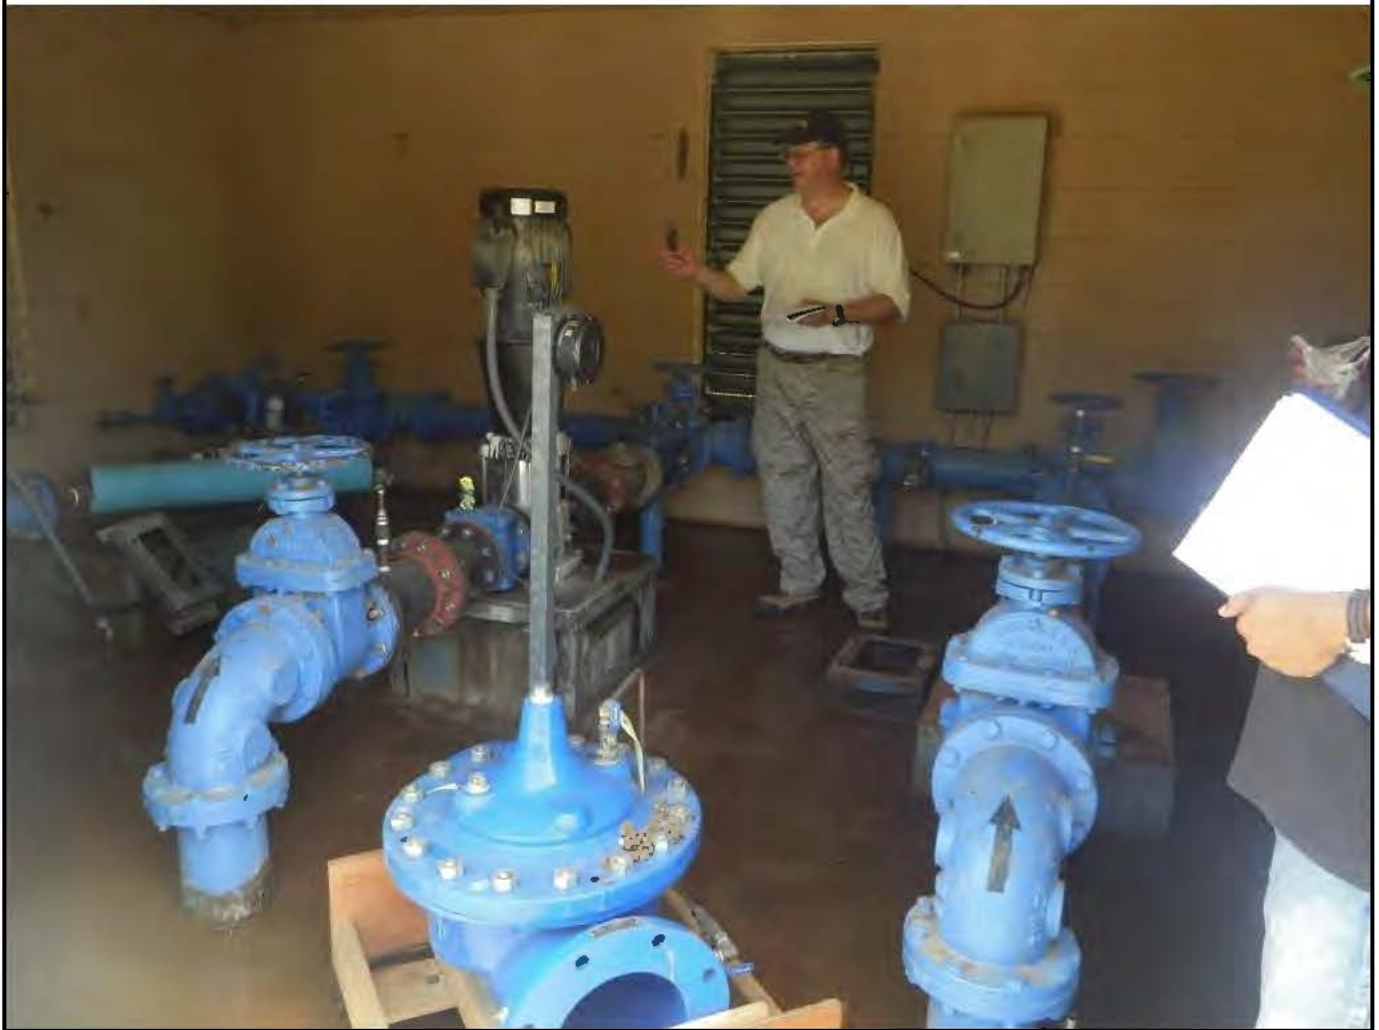
Title	Guam Waterworks Authority (VP0989)
Subject	Northern System
Latitude	██████████
Longitude	██████████
Photo Direction	██████████
Elevation	██████
Date Time Stamp	4/27/2012 10:53:05 AM
Photographer	K. Sable
Comment	Santa Rosa Pump Station
Description	Overview of pump station

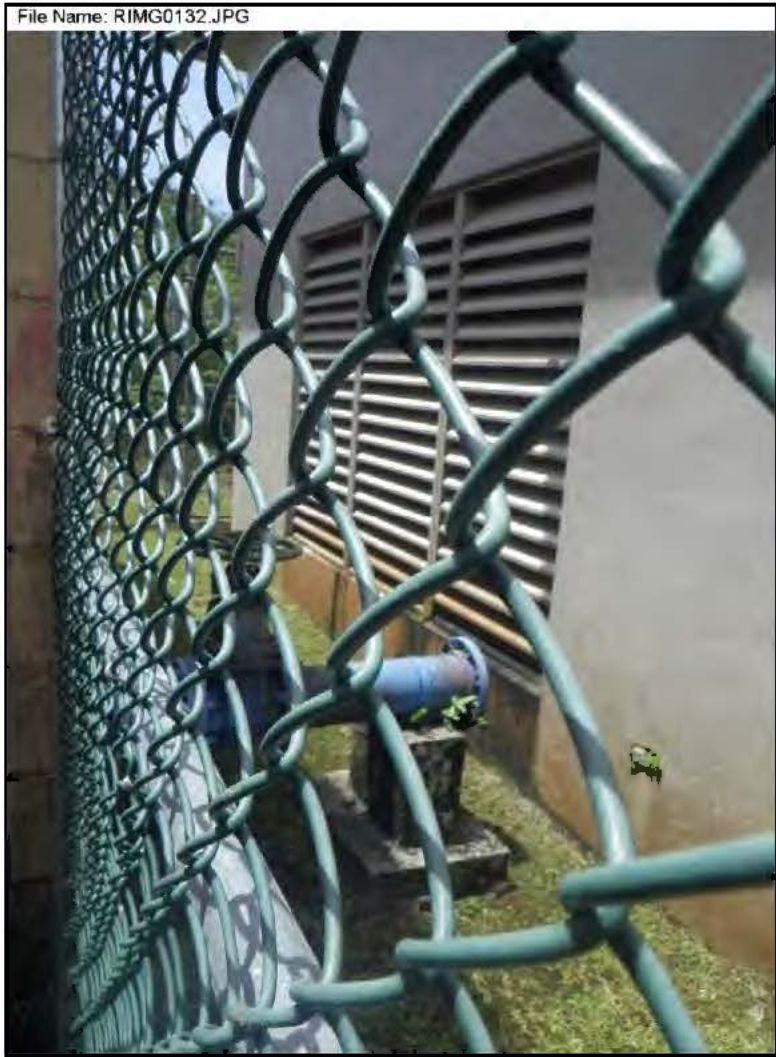
Attributes	
Title	Guam Waterworks Authority (VP0989)
Subject	Northern System
Latitude	[REDACTED]
Longitude	[REDACTED]
Photo Direction	[REDACTED]
Elevation	[REDACTED]
Date Time Stamp	4/27/2012 11:03:31 AM
Photographer	K. Sable
Comment	Santa Rosa Pump Station
Description	Bypass pipe facing power station

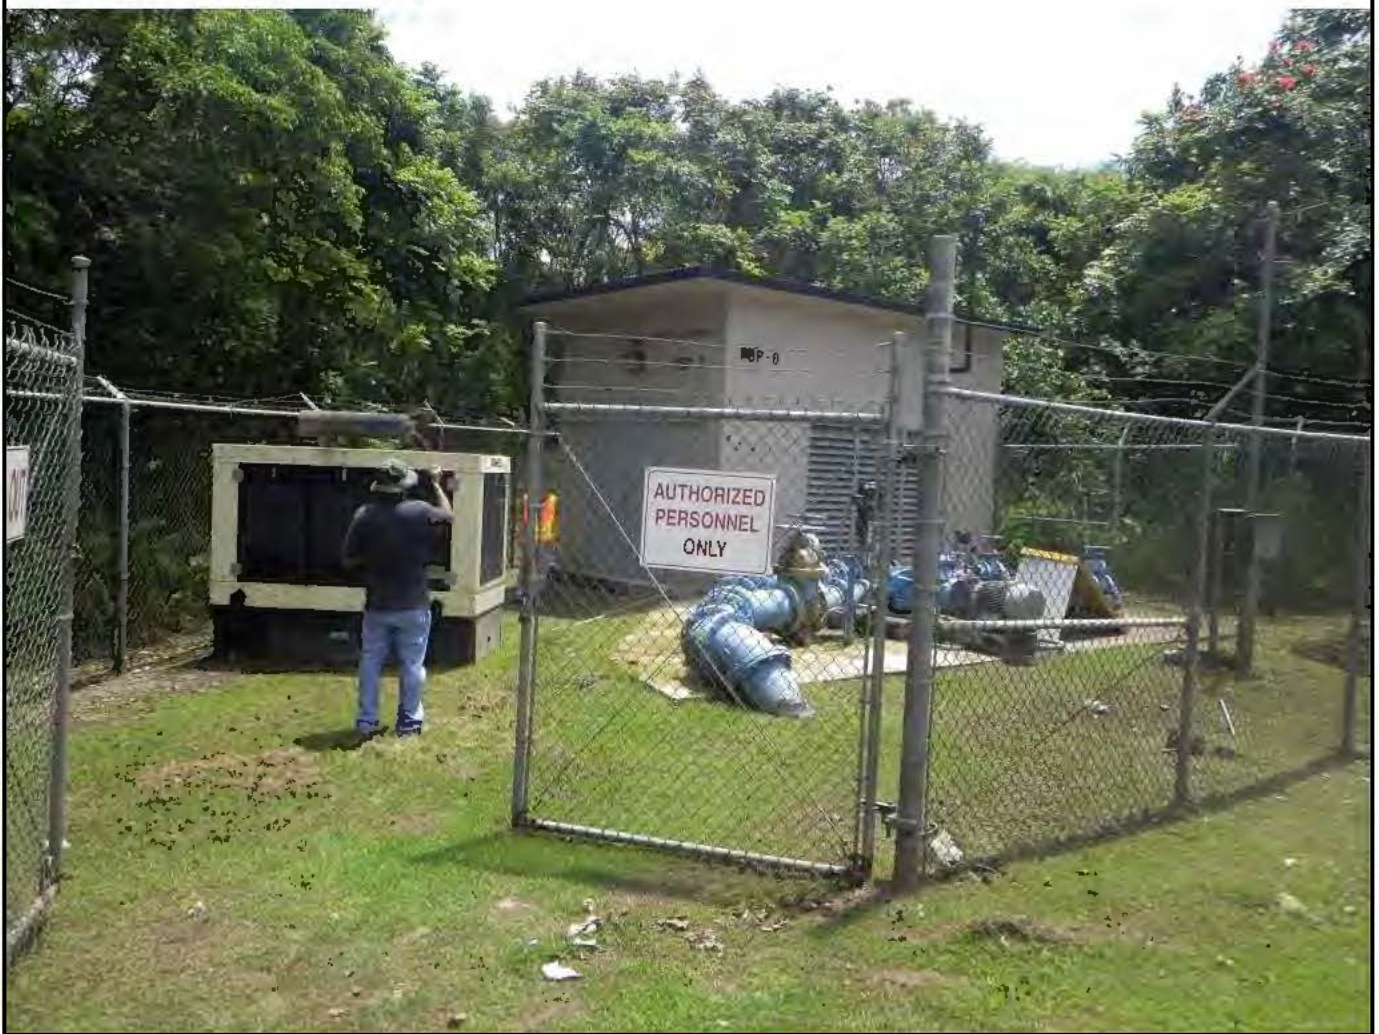
Title	Guam Waterworks Authority (VP0989)
Subject	Northern System
Latitude	[REDACTED]
Longitude	[REDACTED]
Photo Direction	[REDACTED]
Elevation	[REDACTED]
Date Time Stamp	4/27/2012 11:13:34 AM
Photographer	K. Sable
Comment	Gayinero Pump Station
Description	Overview of pump station

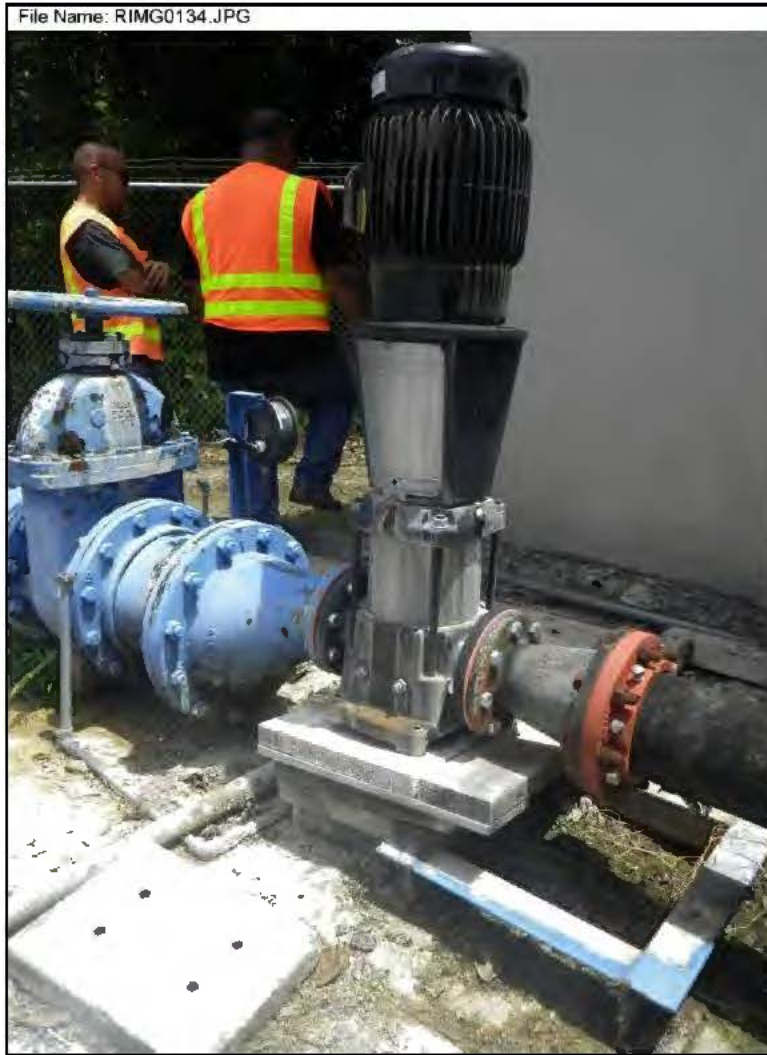
Attributes	
Title	Guam Waterworks Authority (VP0989)
Subject	Northern System
Latitude	██████████
Longitude	██████████
Photo Direction	██████████
Elevation	██████
Date Time Stamp	4/27/2012 11:17:56 AM
Photographer	K. Sable
Comment	Gayinero Pump Station
Description	Pump # 1

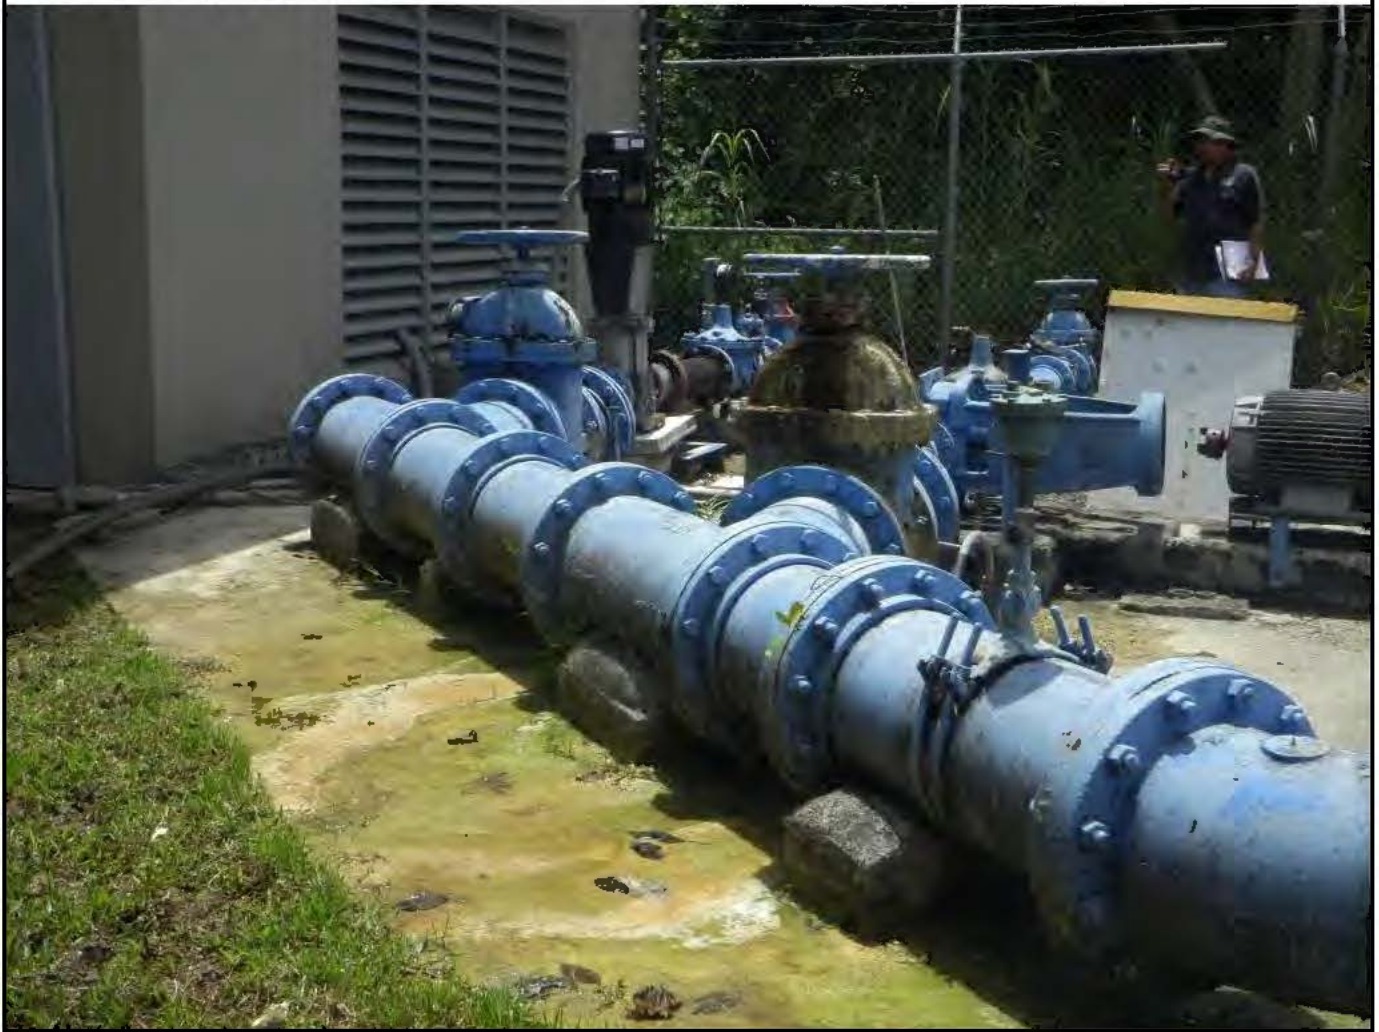
Title	Guam Waterworks Authority (VP0989)
Subject	Northern System
Latitude	██████████
Longitude	██████████
Photo Direction	████
Elevation	████
Date Time Stamp	4/27/2012 11:22:17 AM
Photographer	K. Sable
Comment	Gayinero Pump Station
Description	Assembly overview

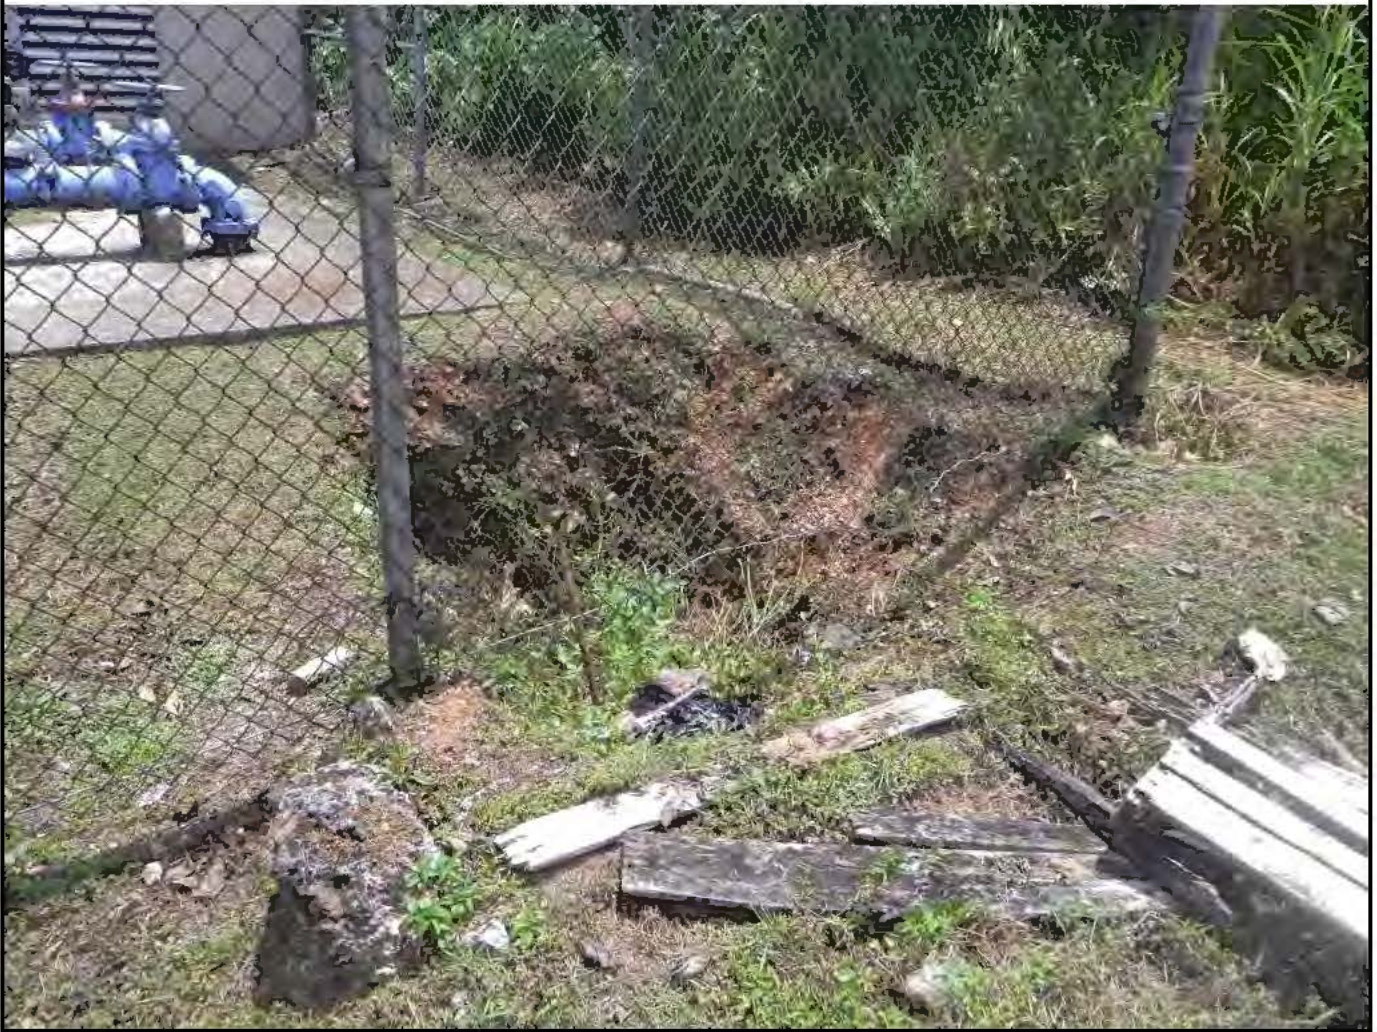
Title	Guam Waterworks Authority (VP0989)
Subject	Northern System
Latitude	██████████
Longitude	██████████
Photo Direction	██████
Elevation	██████
Date Time Stamp	4/27/2012 11:27:48 AM
Photographer	K. Sable
Comment	Gayinero Pump Station
Description	Hole under fence

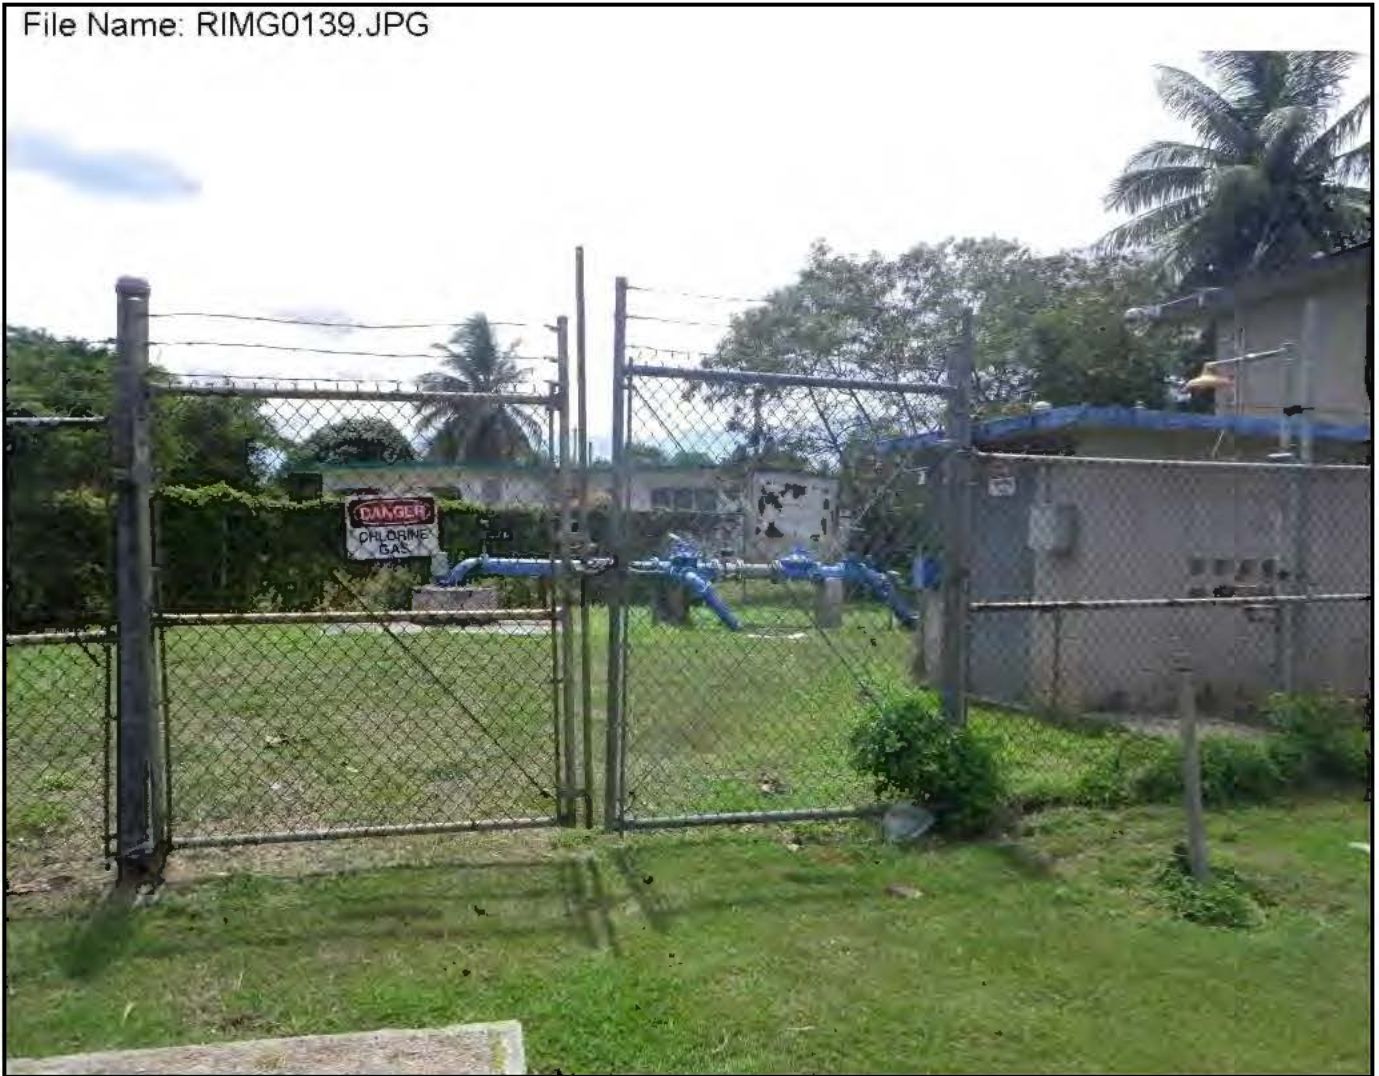
Title	Guam Waterworks Authority (VP0989)
Subject	Northern System
Latitude	[REDACTED]
Longitude	[REDACTED]
Photo Direction	[REDACTED]
Elevation	[REDACTED]
Date Time Stamp	4/27/2012 1:36:30 PM
Photographer	K. Sable
Comment	Y 9 Well
Description	Overview of well
