Title	Guam Waterworks Authority (VP0989)
Subject	Northern System
Latitude	██████████
Longitude	██████████
Photo Direction	██████
Elevation	████
Date Time Stamp	4/27/2012 9:37:55 AM
Photographer	K. Sable
Comment	Y 15 Well
Description	Overview of Y 15 well

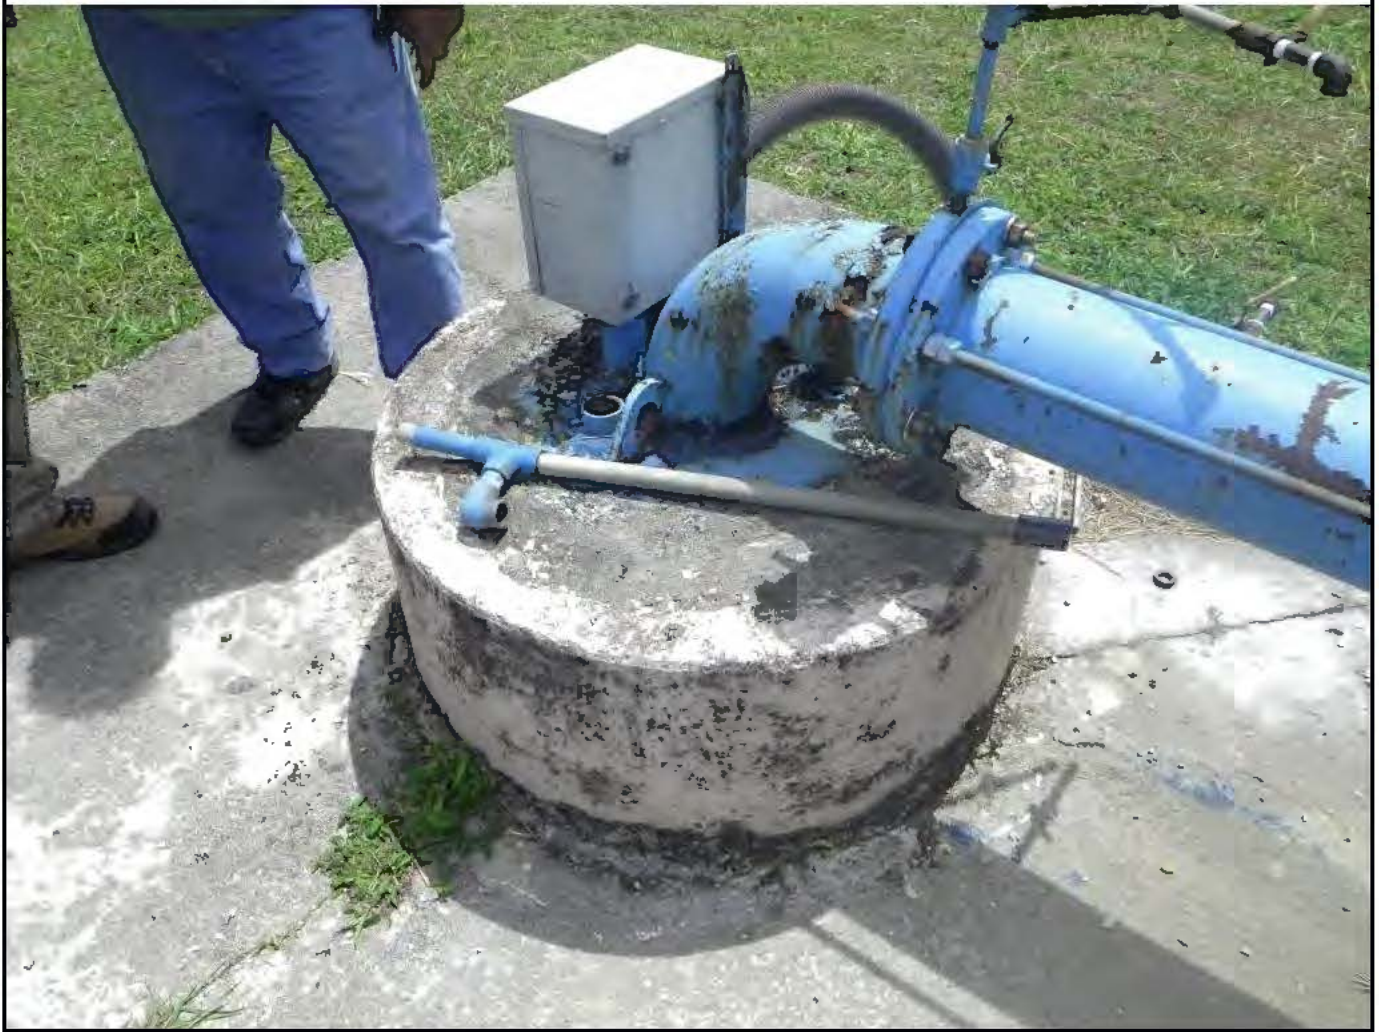
Title	Guam Waterworks Authority (VP0989)
Subject	Northern System
Latitude	██████████
Longitude	██████████
Photo Direction	██████████
Elevation	██████
Date Time Stamp	4/27/2012 1:38:57 PM
Photographer	K. Sable
Comment	Y 9 Well
Description	Air vent

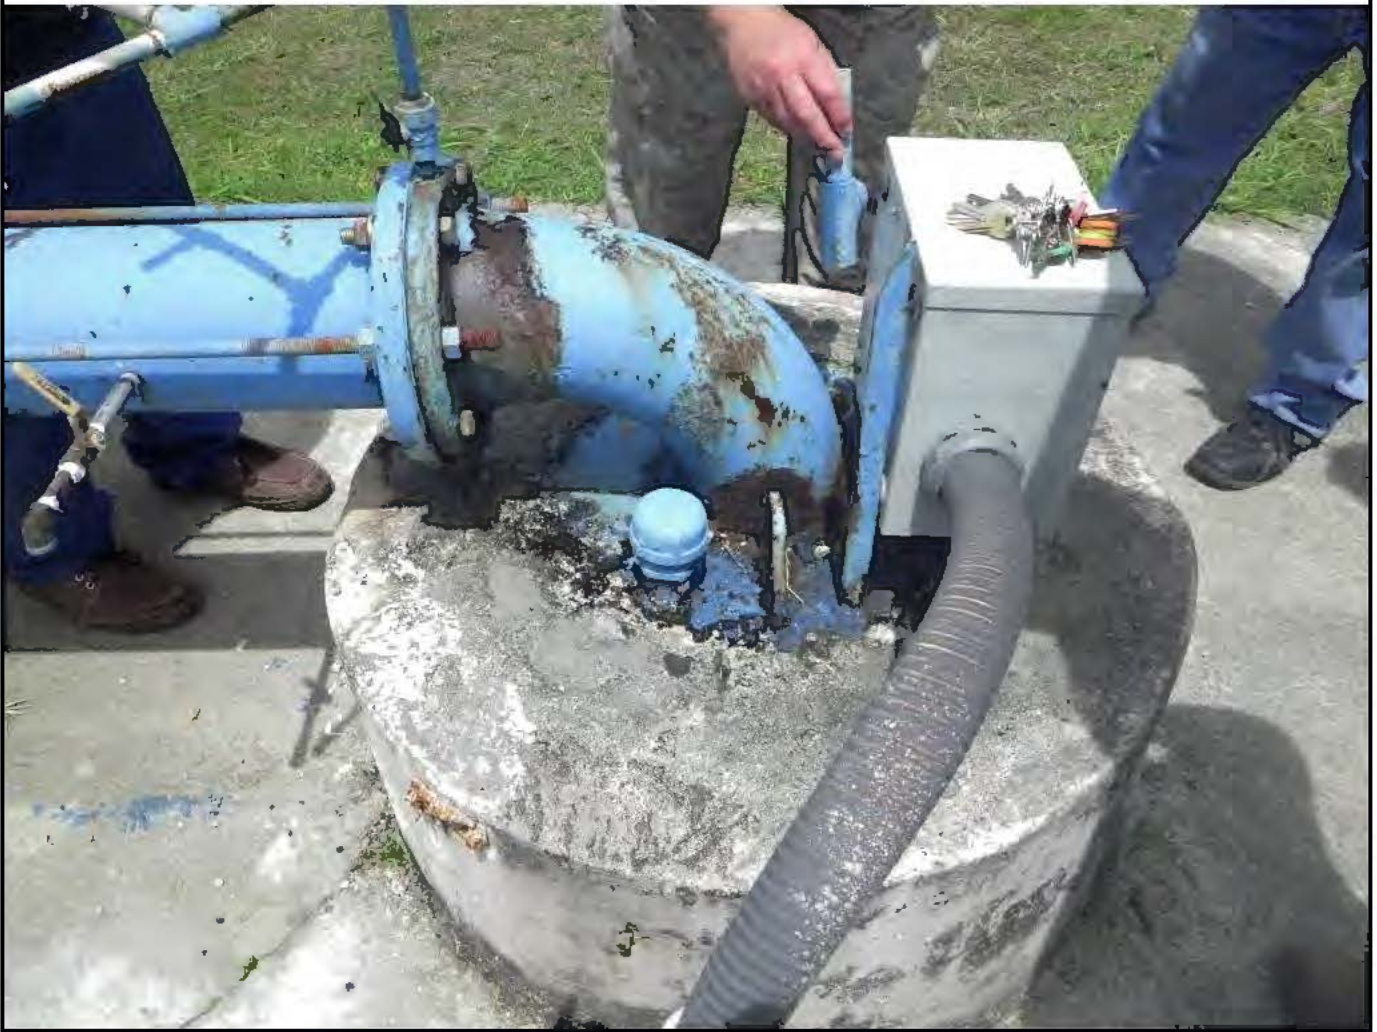
Title	Guam Waterworks Authority (VP0989)
Subject	Northern System
Latitude	██████████
Longitude	██████████
Photo Direction	████
Elevation	████
Date Time Stamp	4/27/2012 1:39:52 PM
Photographer	K. Sable
Comment	Y 9 Well
Description	Sounding tube

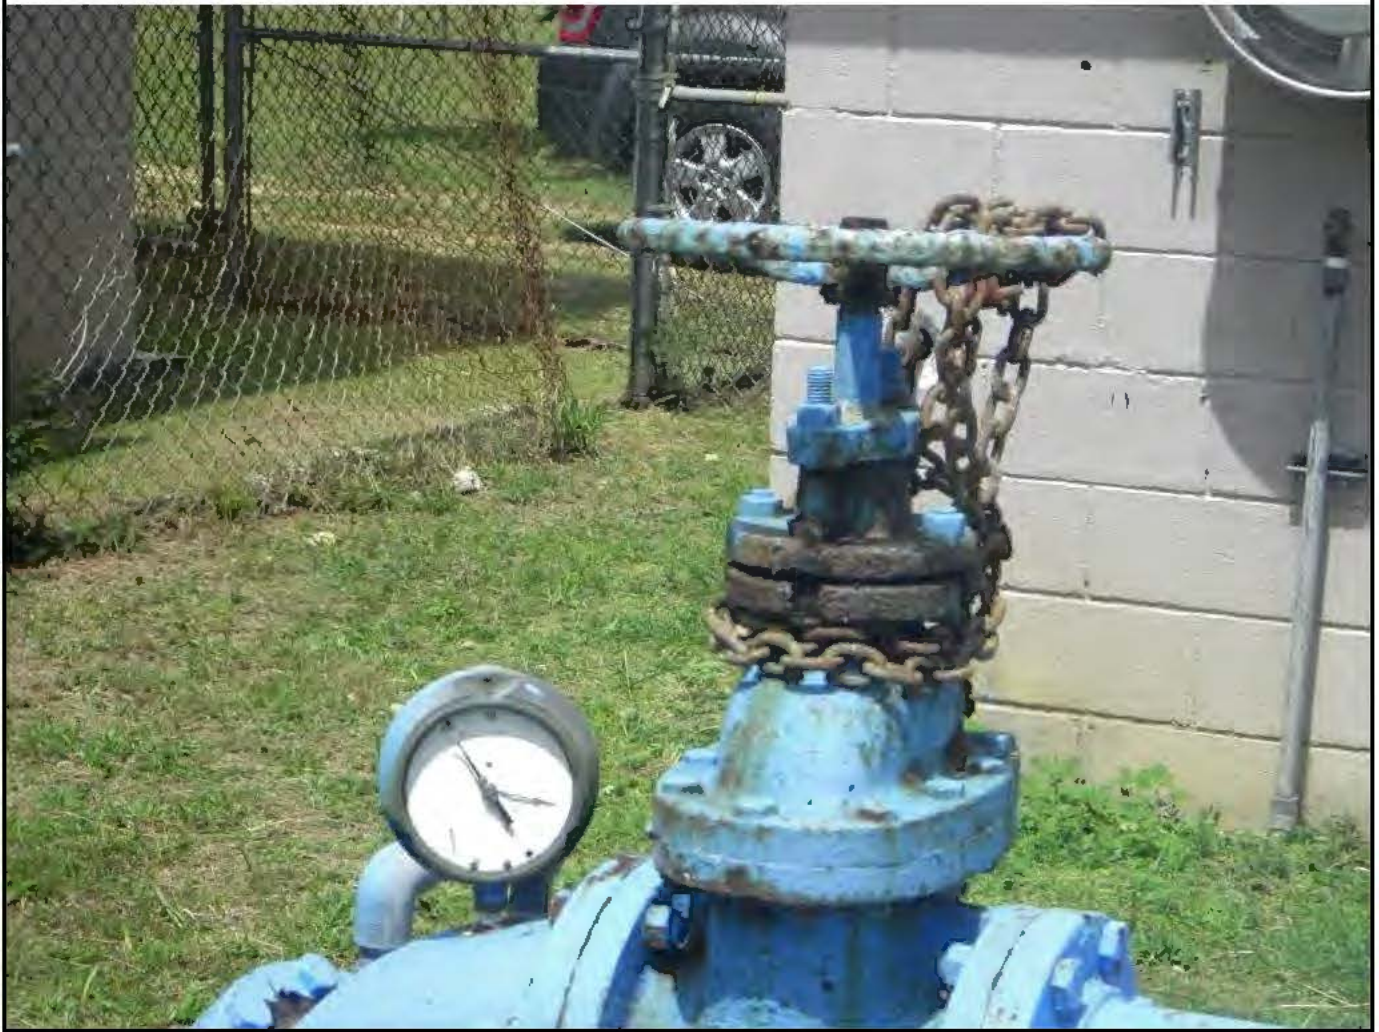
Title	Guam Waterworks Authority (VP0989)
Subject	Northern System
Latitude	██████████
Longitude	██████████
Photo Direction	██████
Elevation	████
Date Time Stamp	4/27/2012 1:53:08 PM
Photographer	K. Sable
Comment	Y 9 Well
Description	Discharge line locked open

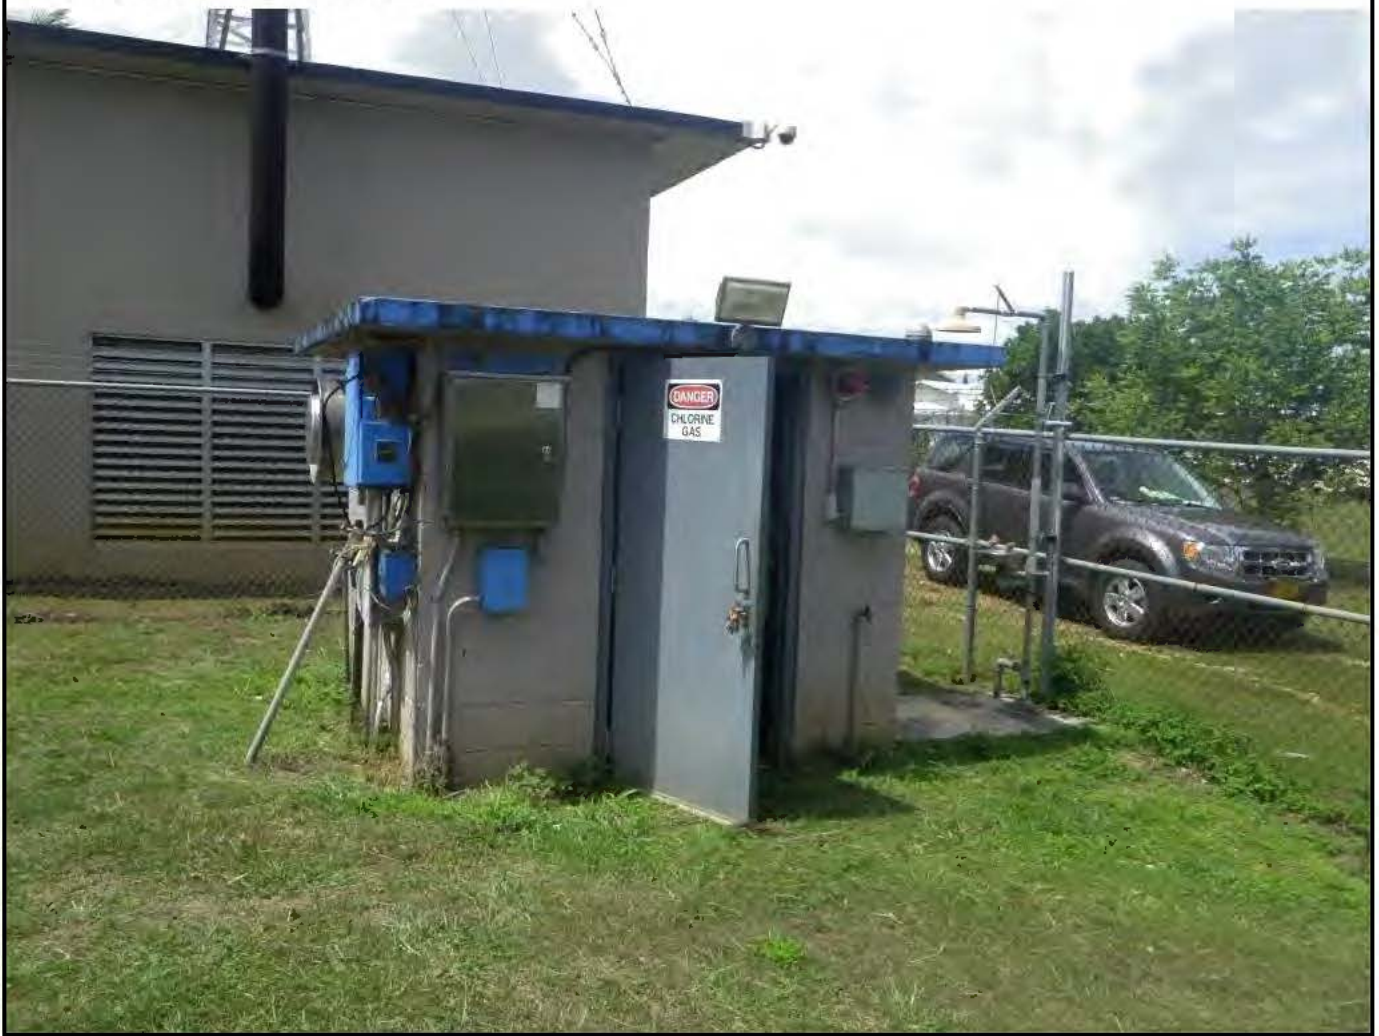
Title	Guam Waterworks Authority (VP0989)
Subject	Northern System
Latitude	[REDACTED]
Longitude	[REDACTED]
Photo Direction	[REDACTED]
Elevation	[REDACTED]
Date Time Stamp	4/27/2012 1:56:30 PM
Photographer	K. Sable
Comment	Y 9 Well
Description	Chlorine building

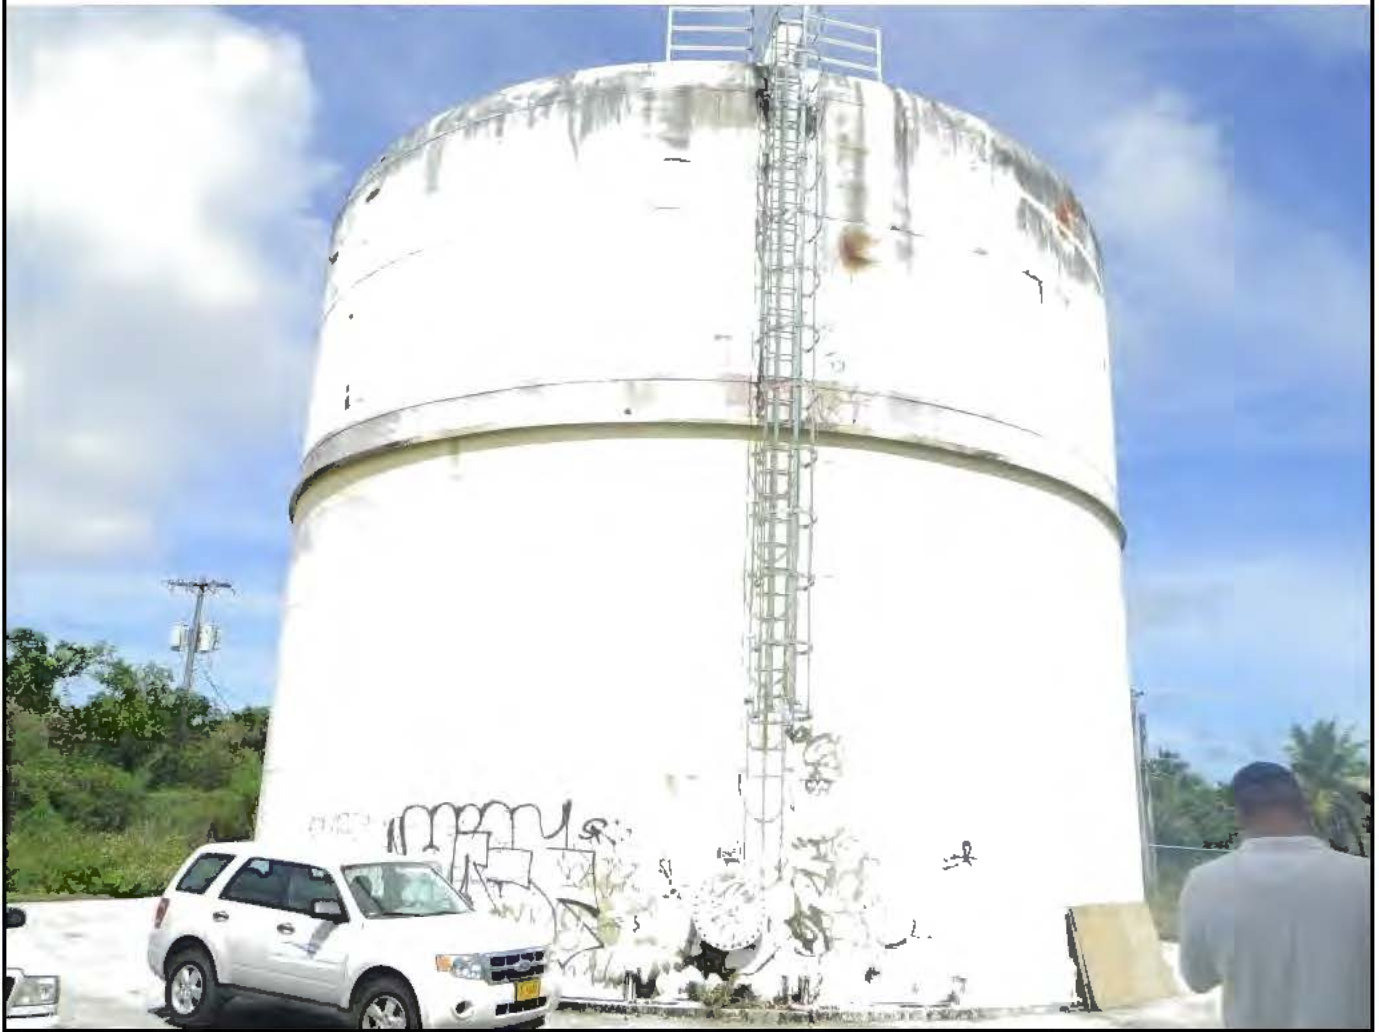
Title	Guam Waterworks Authority (VP0989)
Subject	Northern System
Latitude	██████████
Longitude	██████████
Photo Direction	██████████
Elevation	██████████
Date Time Stamp	4/27/2012 2:17:53 PM
Photographer	K. Sable
Comment	Yigo # 1 Tank
Description	Overview of tank

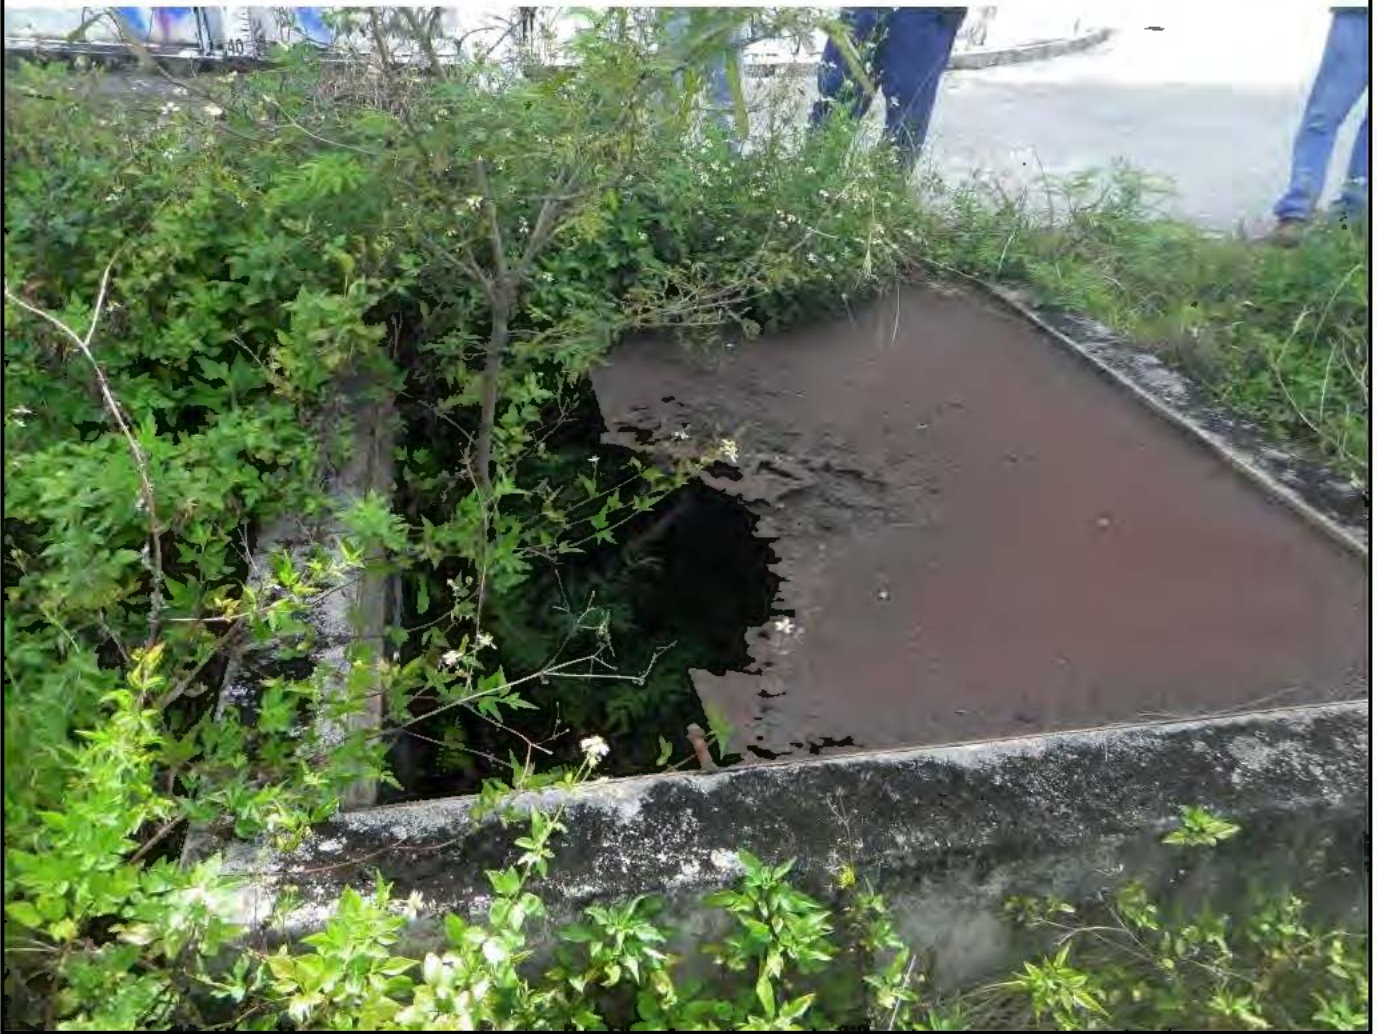
Title	Guam Waterworks Authority (VP0989)
Subject	Northern System
Latitude	[REDACTED]
Longitude	[REDACTED]
Photo Direction	[REDACTED]
Elevation	[REDACTED]
Date Time Stamp	4/27/2012 2:21:25 PM
Photographer	K. Sable
Comment	Yigo # 1 Tank
Description	Valve pit

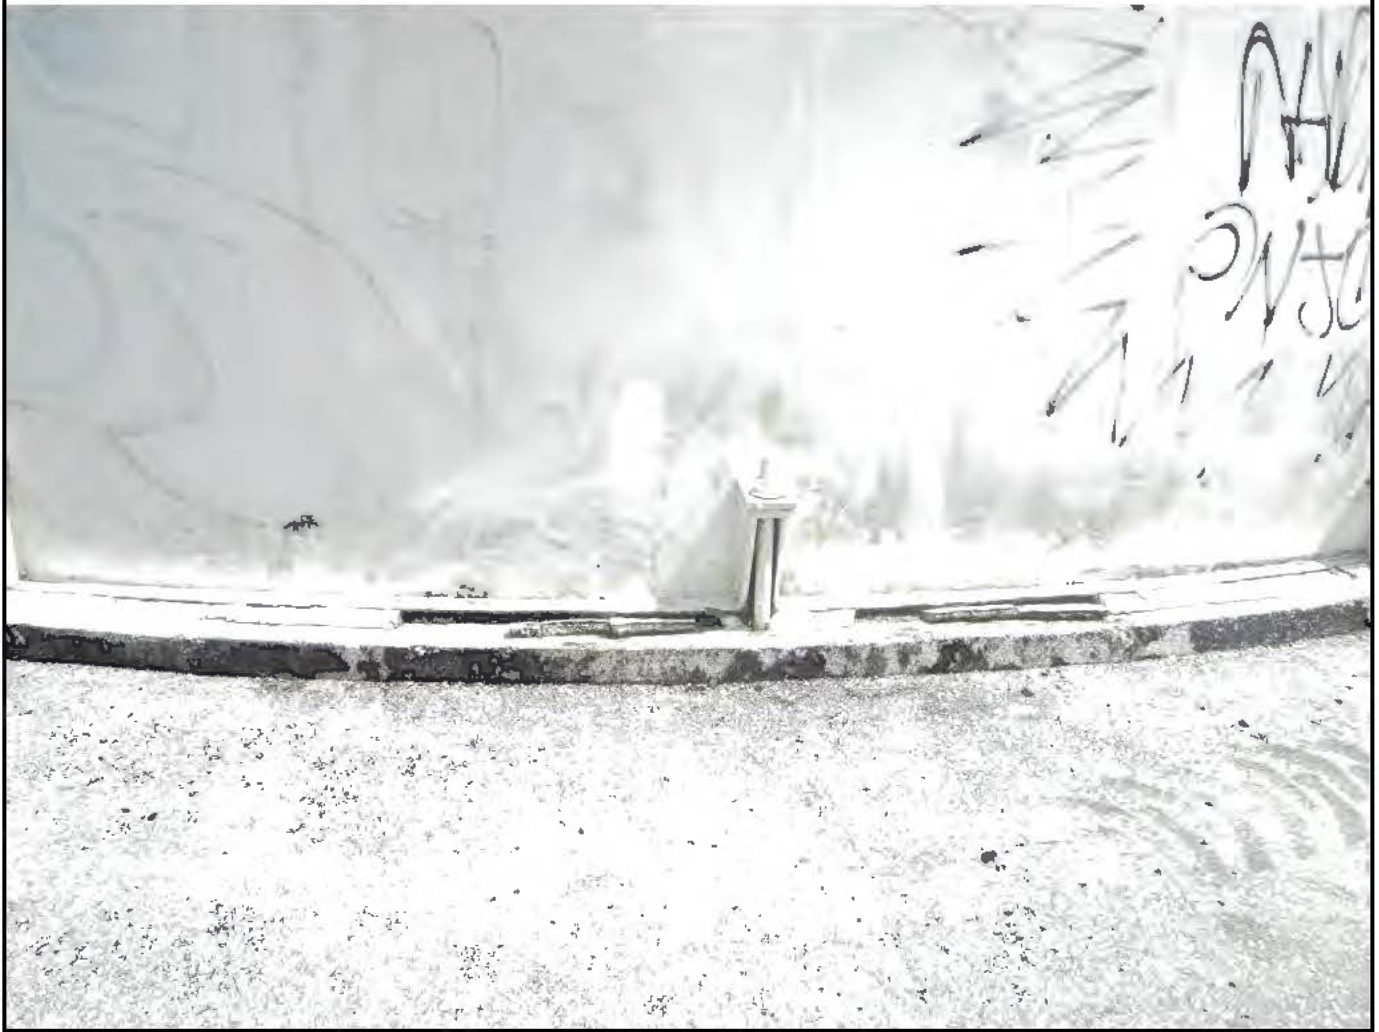
Title	Guam Waterworks Authority (VP0989)
Subject	Northern System
Latitude	[REDACTED]
Longitude	[REDACTED]
Photo Direction	[REDACTED]
Elevation	[REDACTED]
Date Time Stamp	4/27/2012 2:23:04 PM
Photographer	K. Sable
Comment	Yigo # 1 Tank
Description	Concrete base on tank

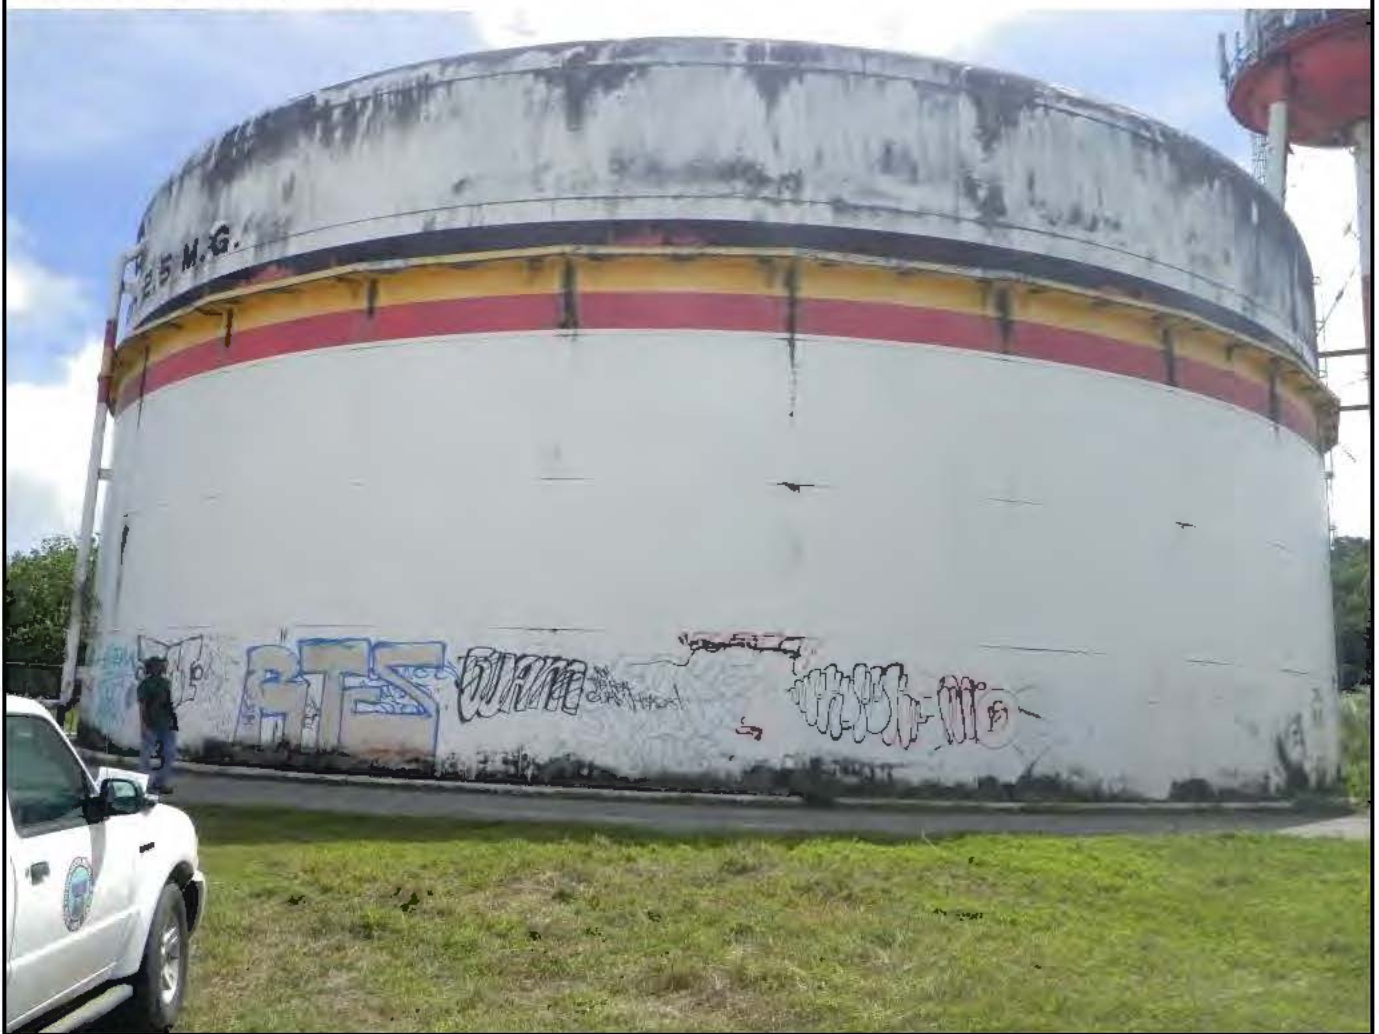
Title	Guam Waterworks Authority (VP0989)
Subject	Northern System
Latitude	██████████
Longitude	██████████
Photo Direction	██████████
Elevation	██████
Date Time Stamp	4/27/2012 2:24:56 PM
Photographer	K. Sable
Comment	Yigo # 2 Tank
Description	Overview of tank

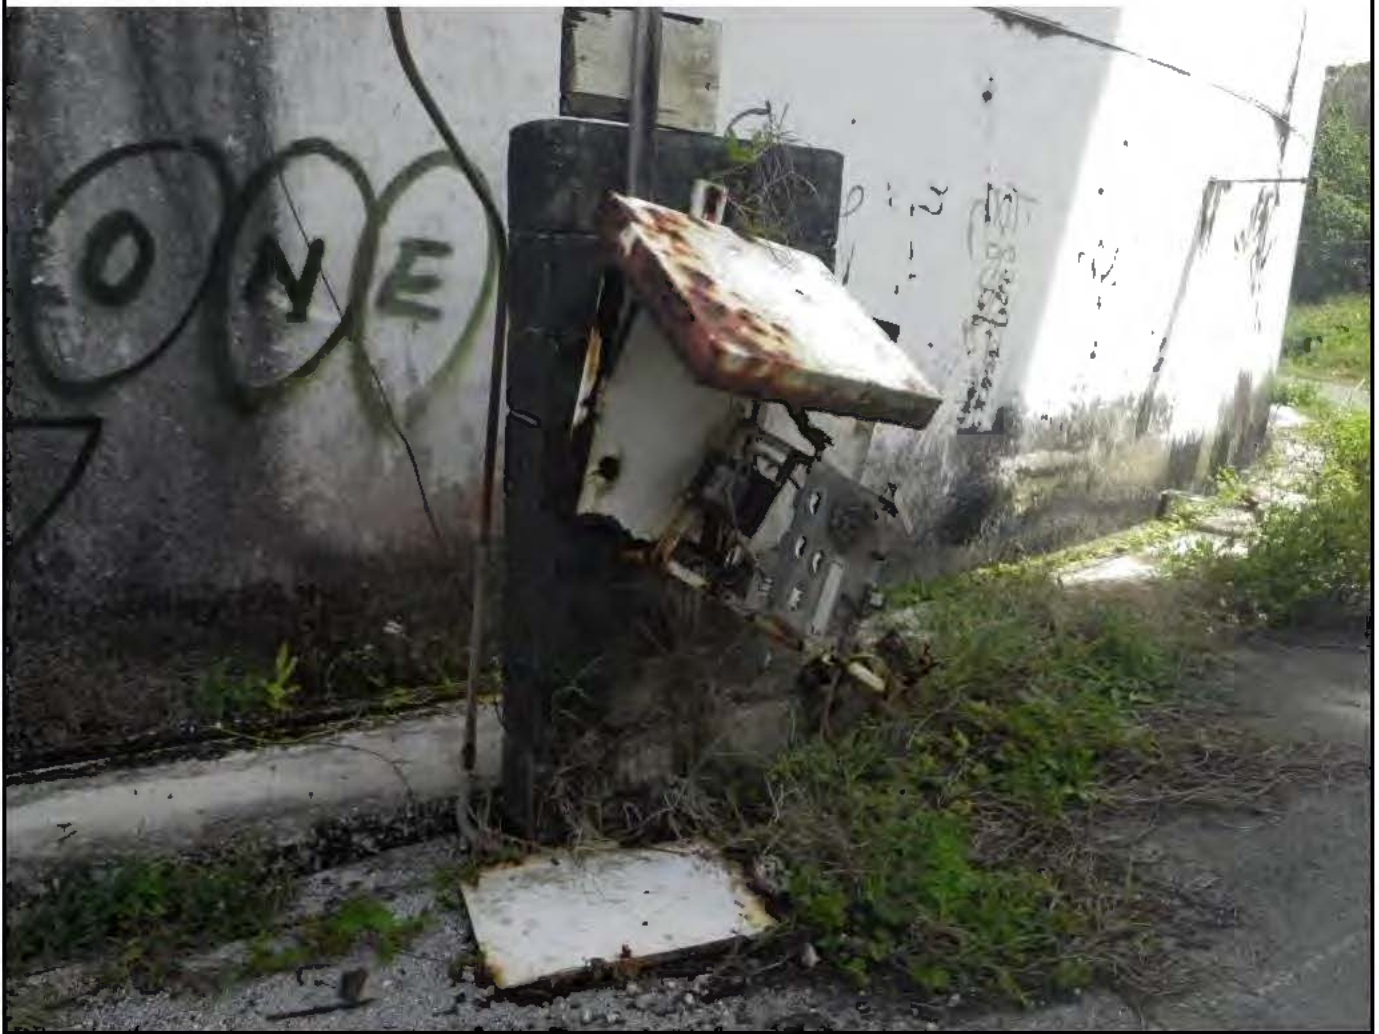
Title	Guam Waterworks Authority (VP0989)
Subject	Northern System
Latitude	[REDACTED]
Longitude	[REDACTED]
Photo Direction	[REDACTED]
Elevation	[REDACTED]
Date Time Stamp	4/27/2012 2:28:06 PM
Photographer	K. Sable
Comment	Yigo # 2 Tank
Description	Cathodic protection

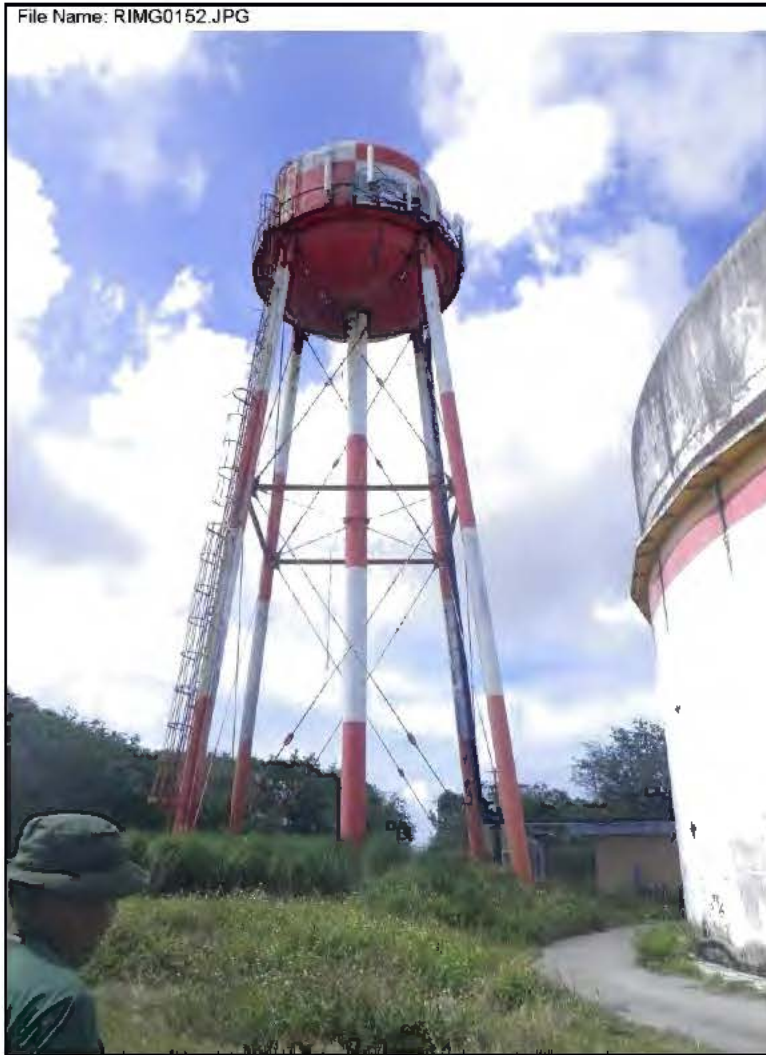
Attributes	
Title	Guam Waterworks Authority (VP0989)
Subject	Northern System
Latitude	██████████
Longitude	██████████
Photo Direction	██████
Elevation	██████
Date Time Stamp	4/27/2012 2:36:25 PM
Photographer	K. Sable
Comment	Yigo # 3 Elevated Tank
Description	Overview of tank

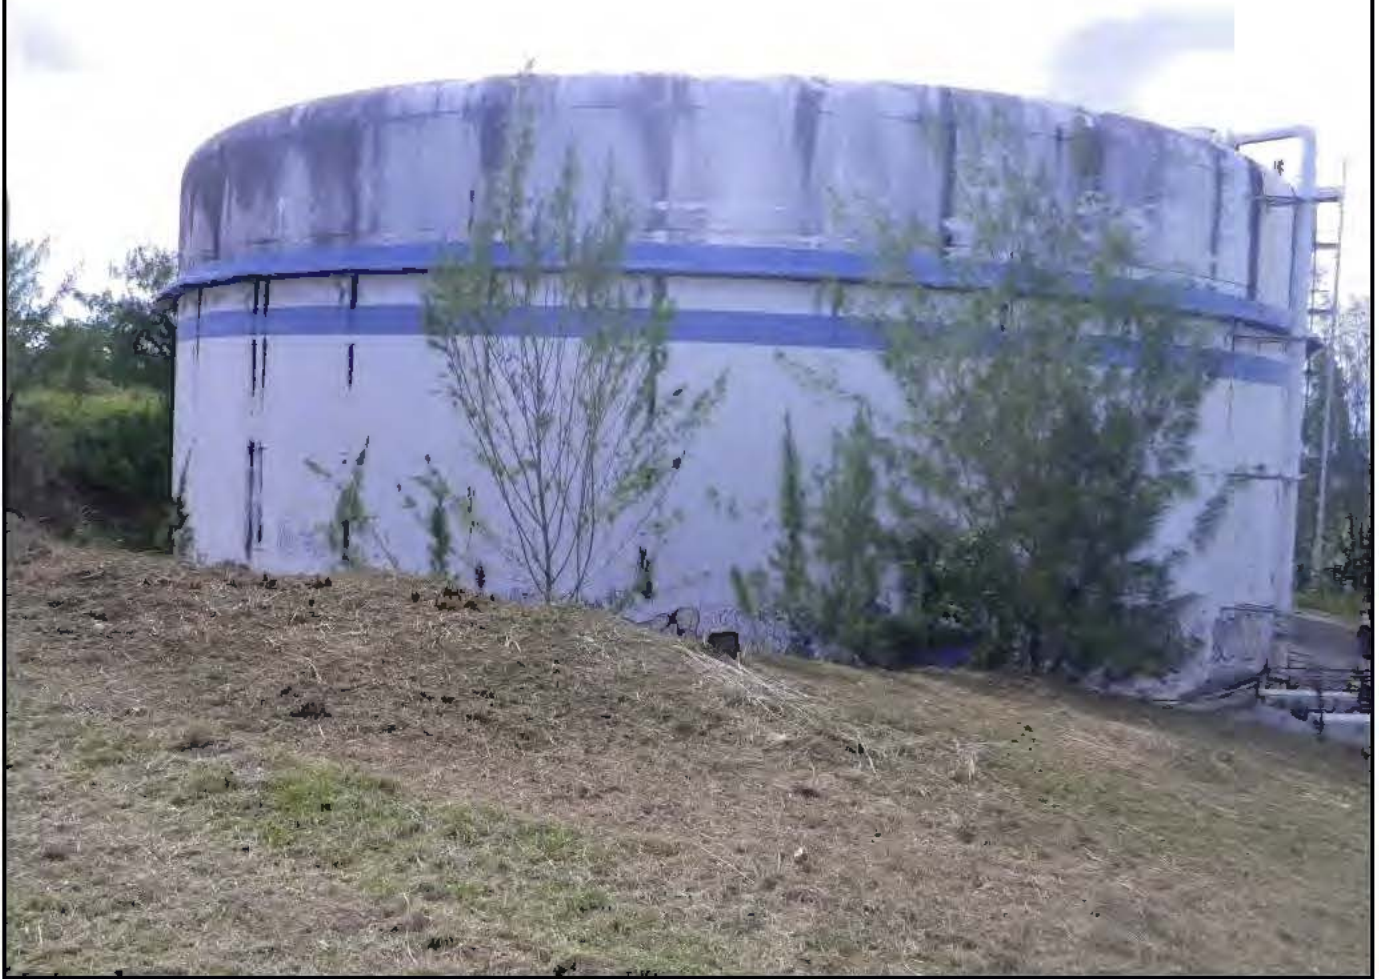
Title	Guam Waterworks Authority (VP0989)
Subject	Northern System
Latitude	██████████
Longitude	██████████
Photo Direction	██████████
Elevation	██████
Date Time Stamp	4/27/2012 3:17:04 PM
Photographer	K. Sable
Comment	Barrigada # 3 Tank
Description	Overview of tank

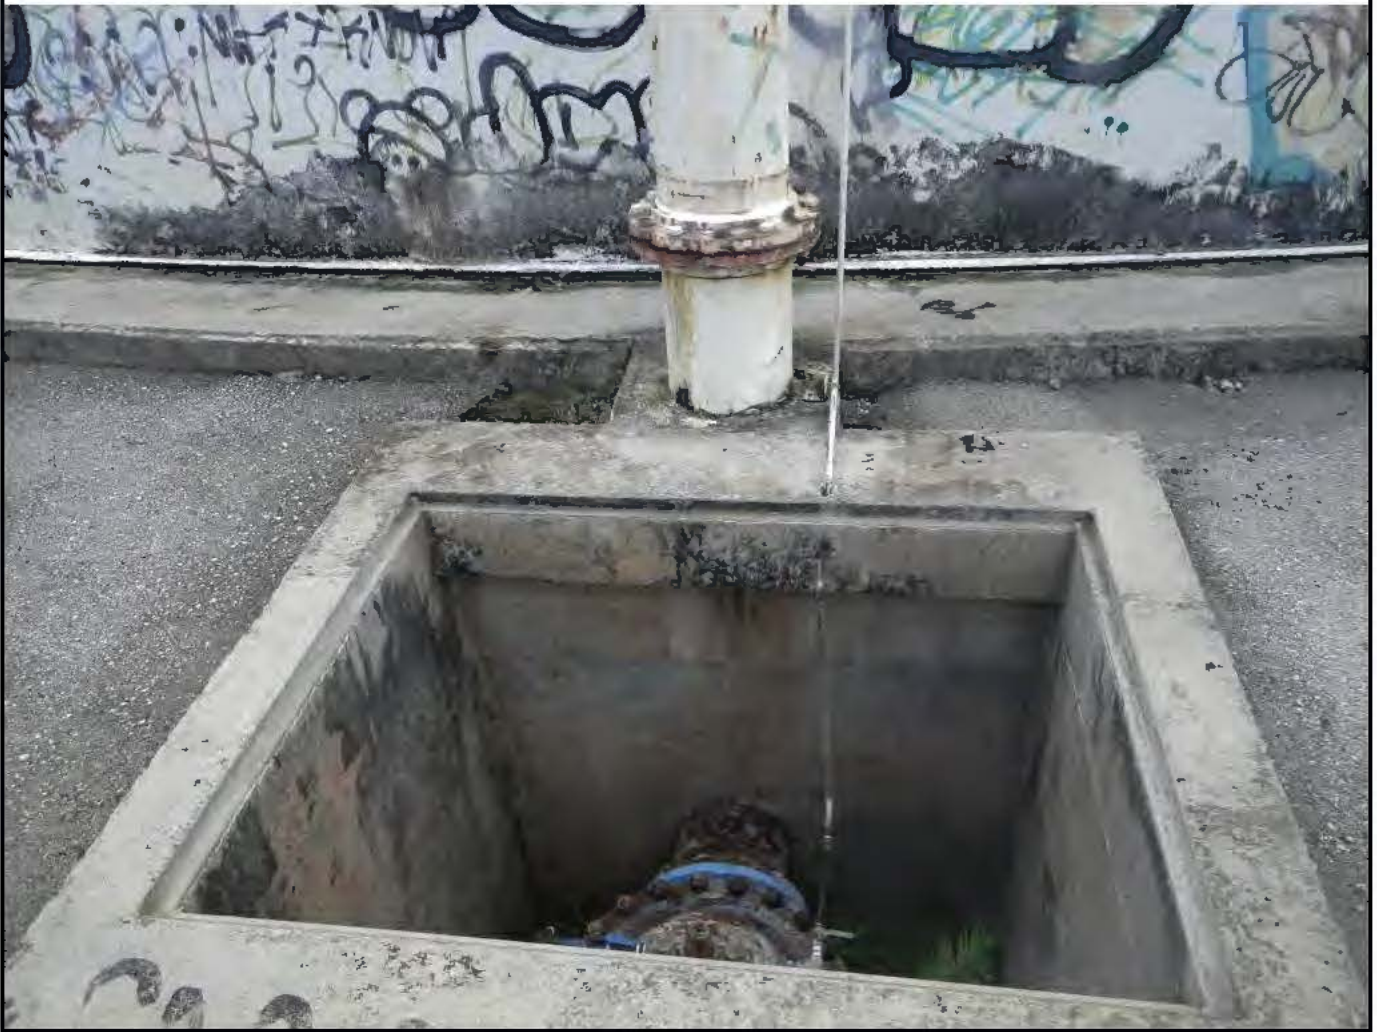
Title	Guam Waterworks Authority (VP0989)
Subject	Northern System
Latitude	██████████
Longitude	██████████
Photo Direction	██████
Elevation	████
Date Time Stamp	4/27/2012 3:19:47 PM
Photographer	K. Sable
Comment	Barrigada # 3 Tank
Description	Inlet box

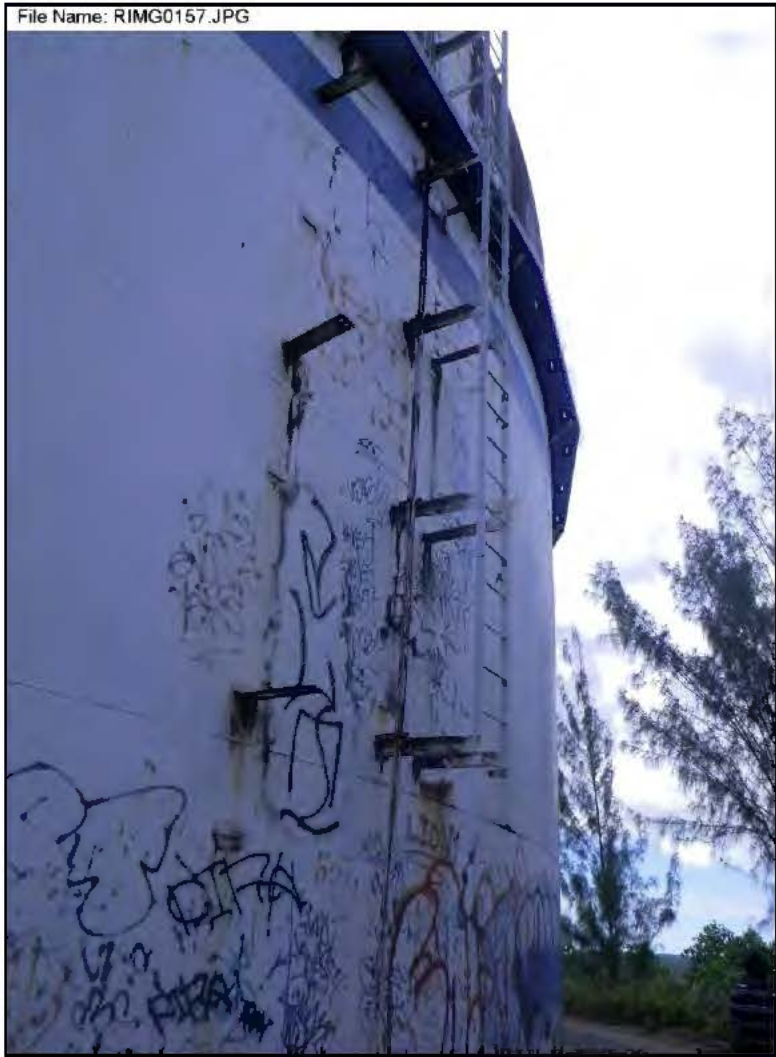
Attributes	
Title	Guam Waterworks Authority (VP0989)
Subject	Northern System
Latitude	[REDACTED]
Longitude	[REDACTED]
Photo Direction	[REDACTED]
Elevation	[REDACTED]
Date Time Stamp	4/27/2012 3:20:28 PM
Photographer	K. Sable
Comment	Barrigada # 3 Tank
Description	Ladder with no cage

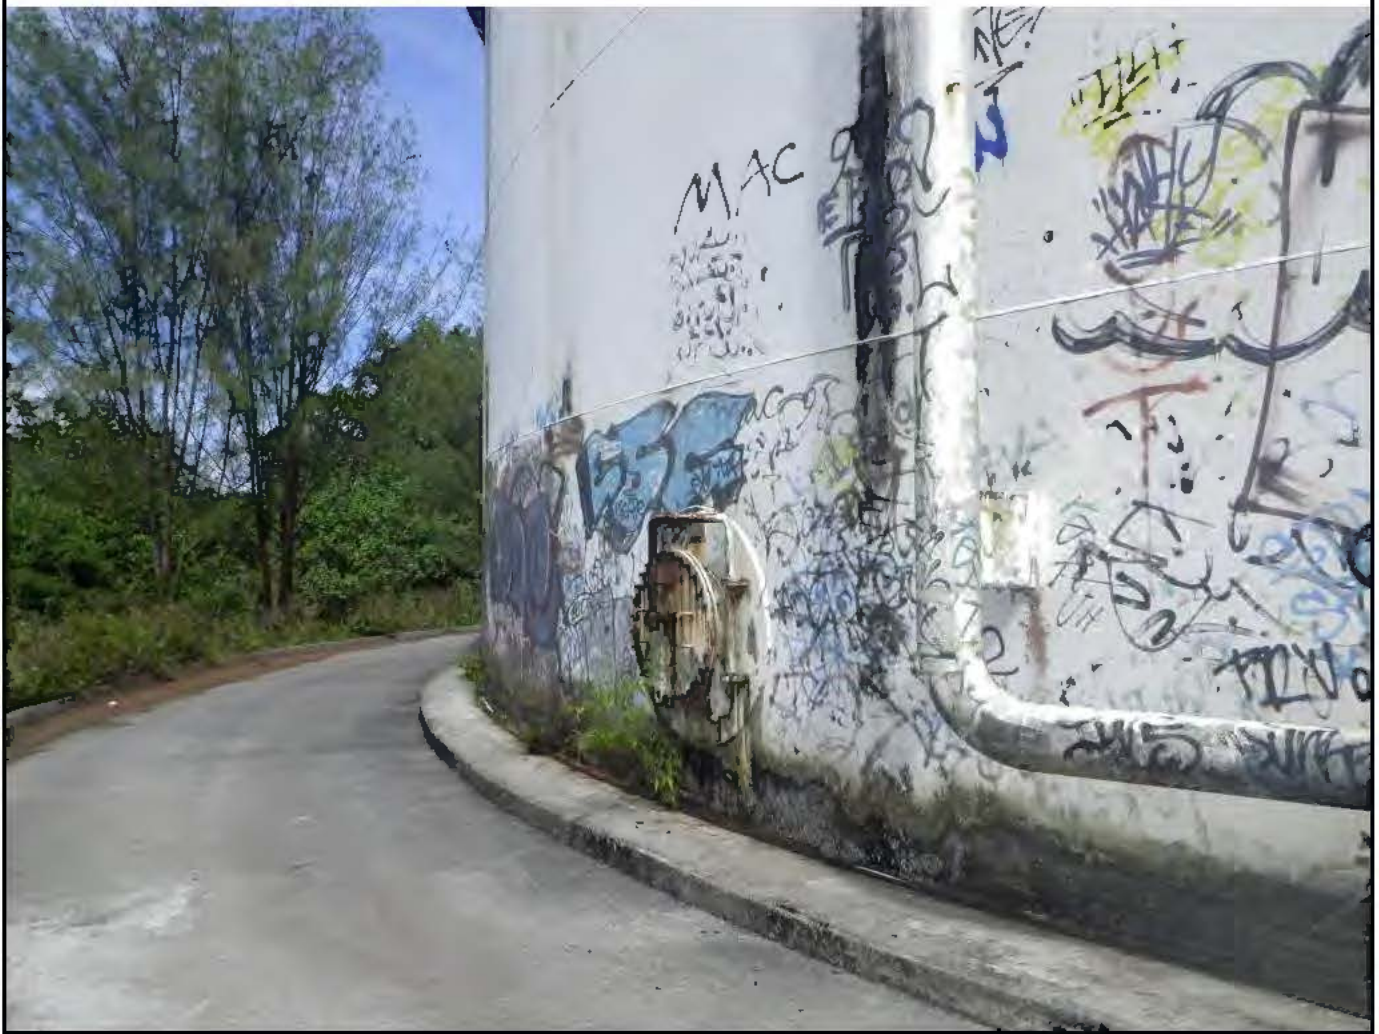
Title	Guam Waterworks Authority (VP0989)
Subject	Northern System
Latitude	██████████
Longitude	██████████
Photo Direction	██████
Elevation	████
Date Time Stamp	4/27/2012 3:21:50 PM
Photographer	K. Sable
Comment	Barrigada # 3 Tank
Description	Side of tank

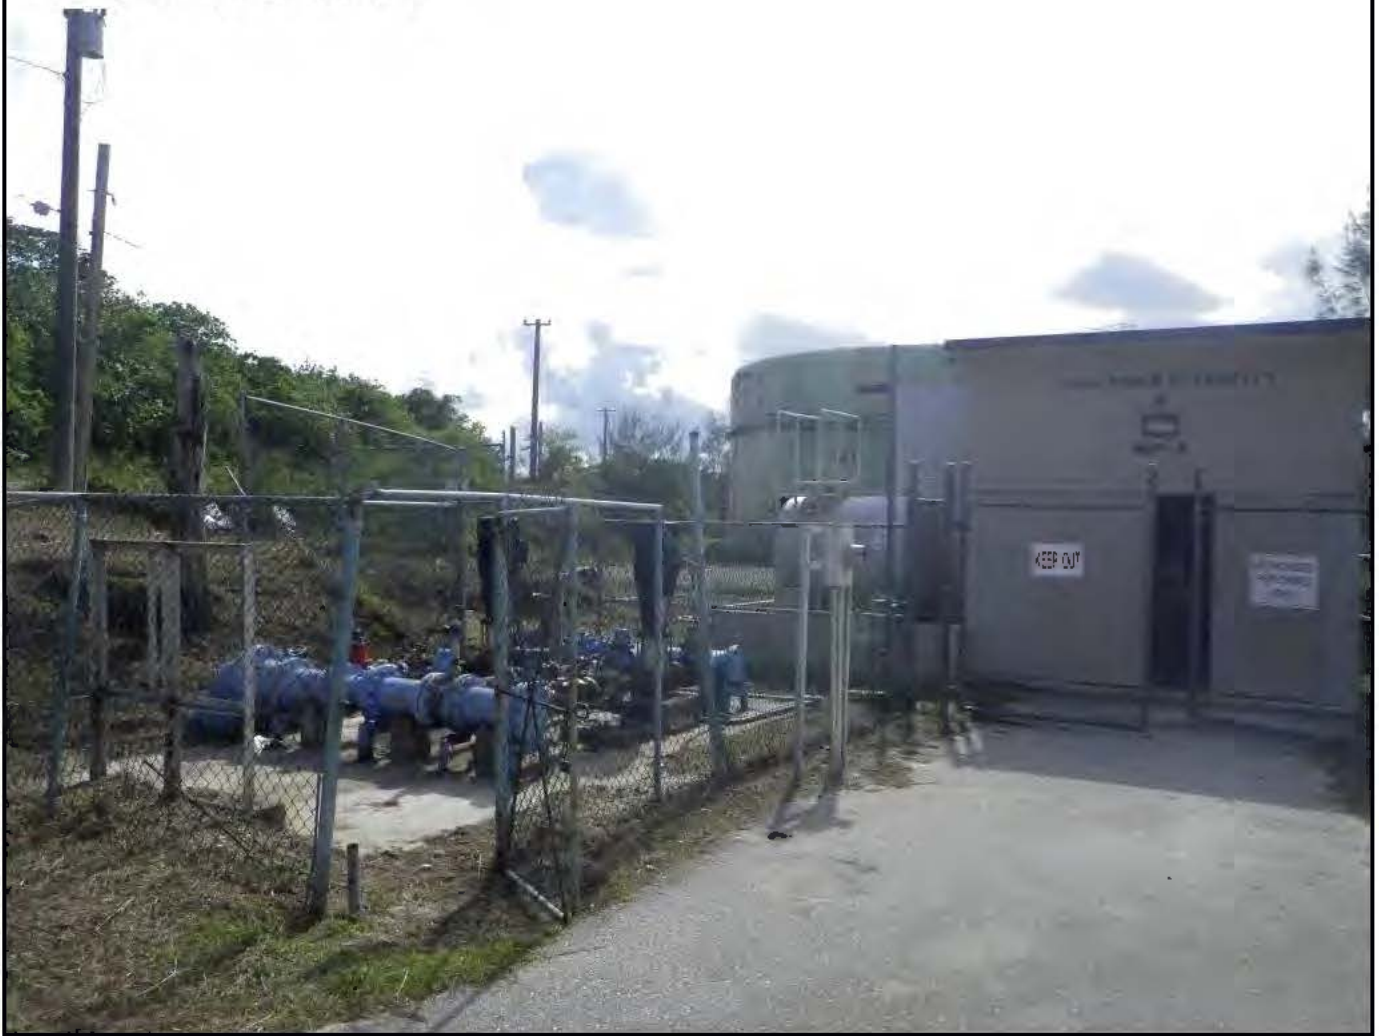
Title	Guam Waterworks Authority (VP0989)
Subject	Northern System
Latitude	██████████
Longitude	██████████
Photo Direction	██████████
Elevation	██████
Date Time Stamp	4/27/2012 3:32:08 PM
Photographer	K. Sable
Comment	Hyundai Pump Station
Description	Overview of pump station

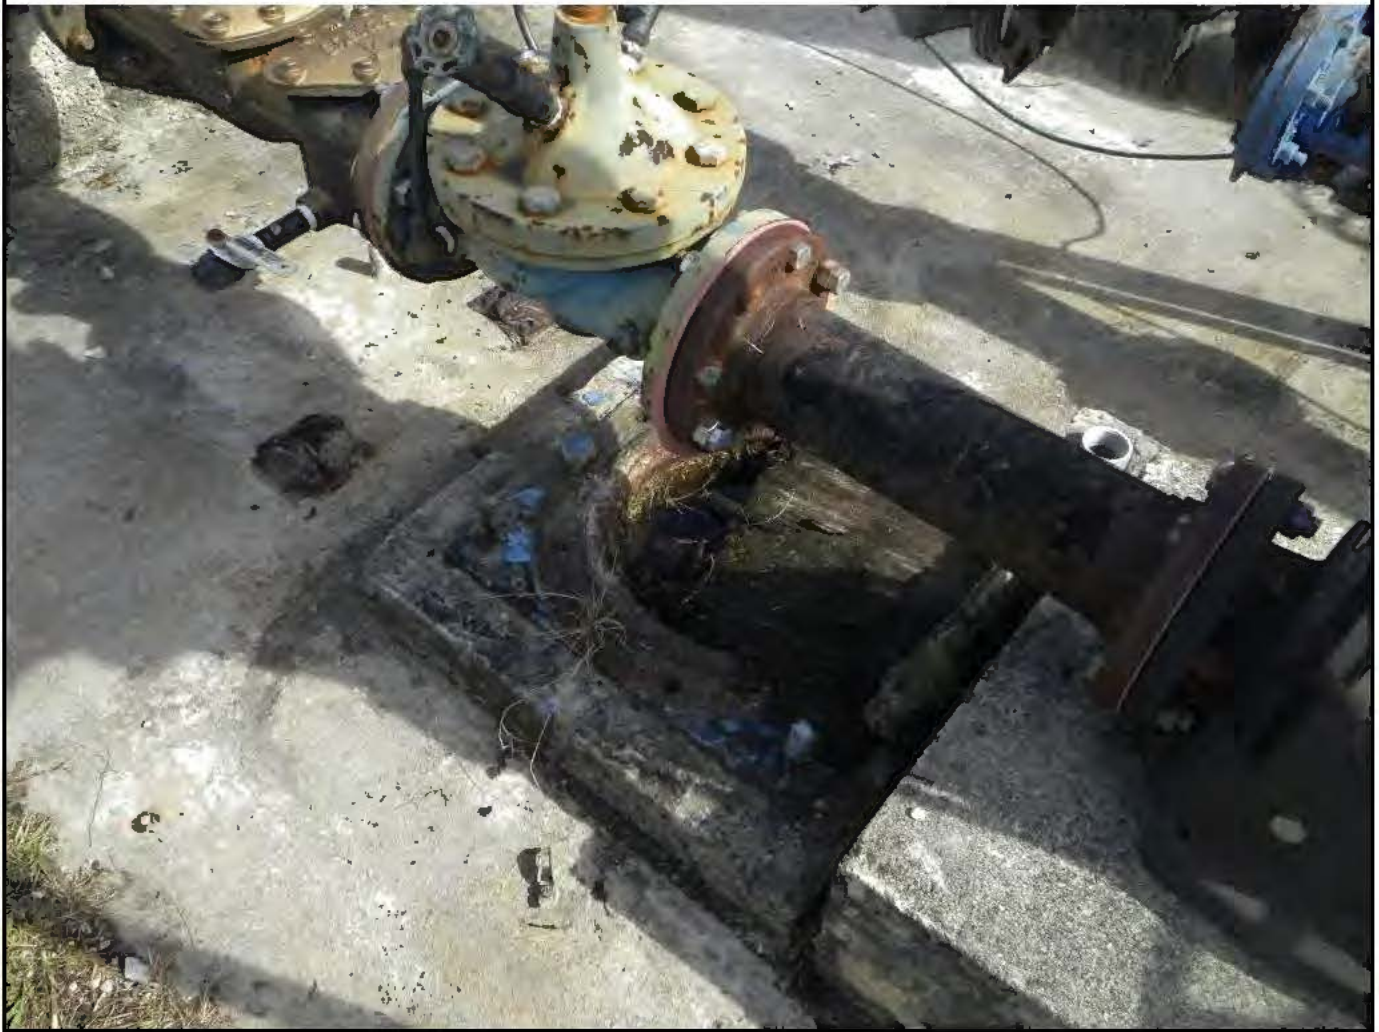
Title	Guam Waterworks Authority (VP0989)
Subject	Northern System
Latitude	██████████
Longitude	██████████
Photo Direction	██████
Elevation	████
Date Time Stamp	4/27/2012 3:37:32 PM
Photographer	K. Sable
Comment	Hyundai Pump Station
Description	Hole where old pump was located
