Title	Guam Waterworks Authority (VP0989)
Subject	Northern System
Latitude	██████████
Longitude	██████████
Photo Direction	██████
Elevation	████
Date Time Stamp	4/27/2012 9:37:55 AM
Photographer	K. Sable
Comment	Y 15 Well
Description	Overview of Y 15 well

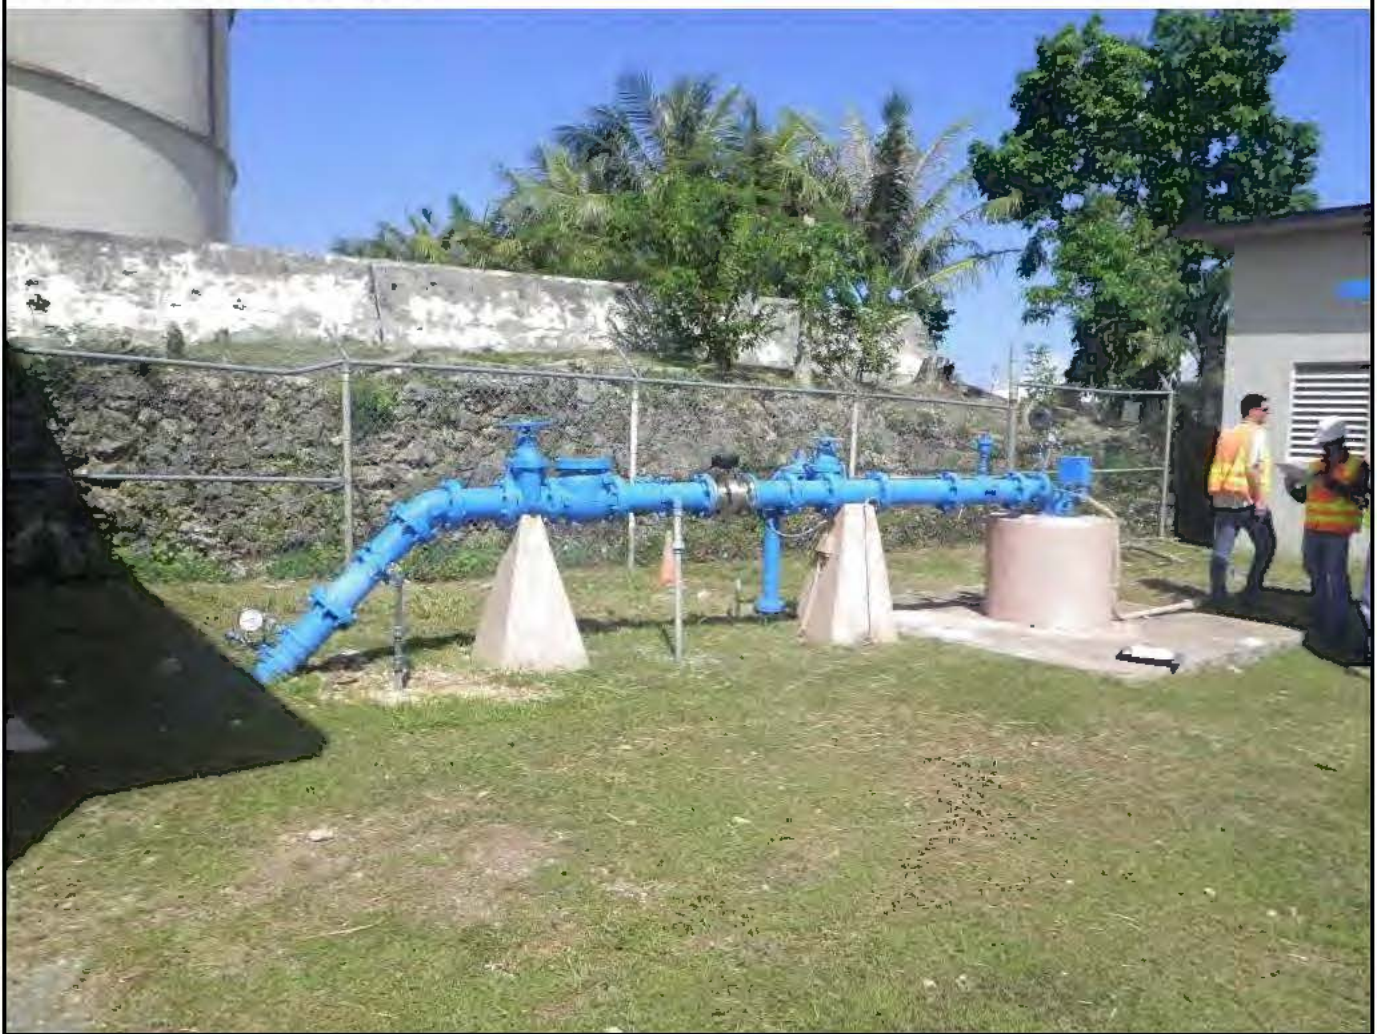
File Name: RIMG0164.JPG

Title	Guam Waterworks Authority (VP0989)
Subject	Northern System
Latitude	██████████
Longitude	██████████
Photo Direction	██████ /
Elevation	██████
Date Time Stamp	4/30/2012 9:30:01 AM
Photographer	K. Sable
Comment	A 31 Well
Description	Well assembly

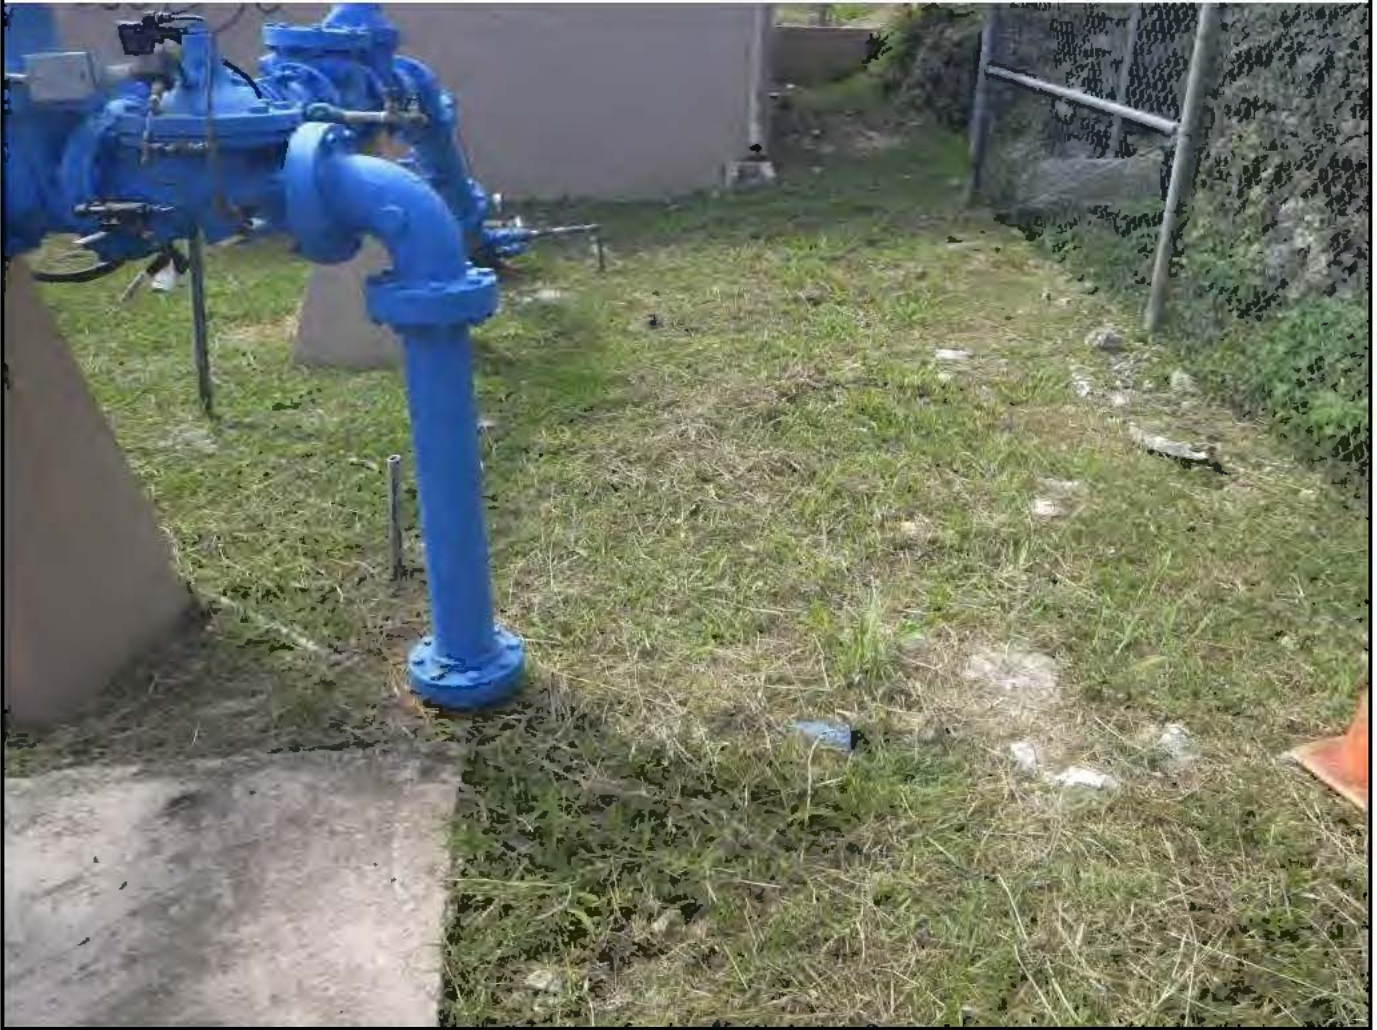
File Name: RIMG0166.JPG

Title	Guam Waterworks Authority (VP0989)
Subject	Northern System
Latitude	██████████
Longitude	██████████
Photo Direction	██████
██████	██████
Date Time Stamp	4/30/2012 9:34:58 AM
Photographer	K. Sable
Comment	A 31 Well
Description	Bypass valve to ground

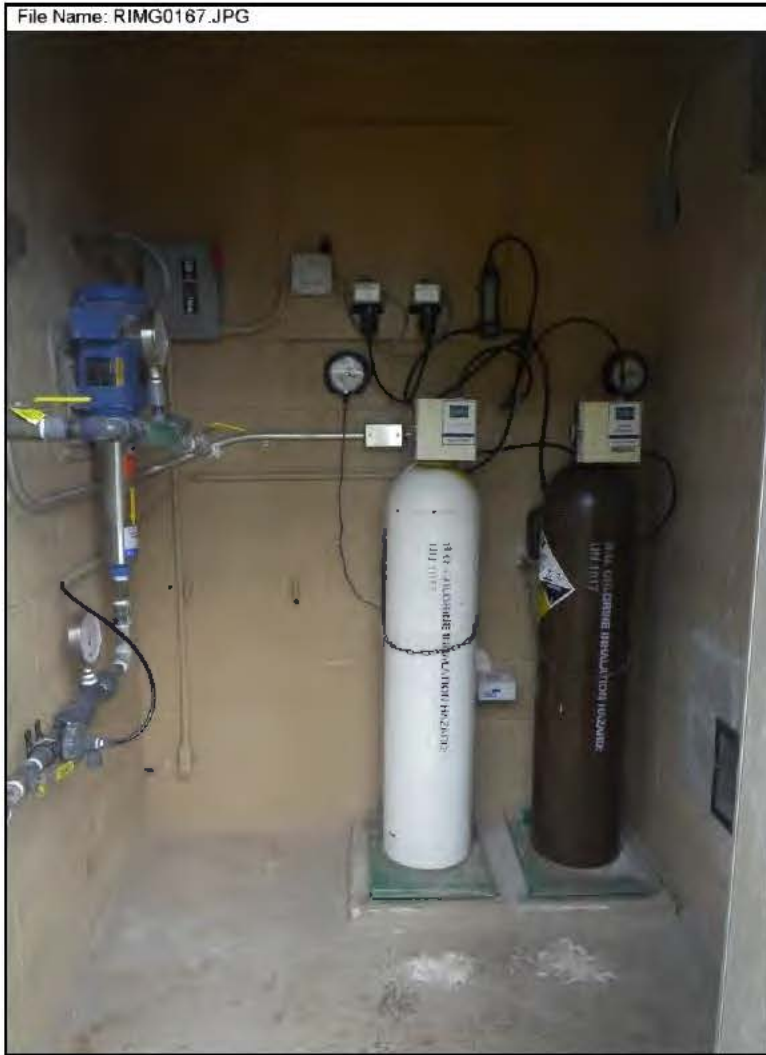
Attributes	
Title	Guam Waterworks Authority (VP0989)
Subject	Northern System
Latitude	[REDACTED]
Longitude	[REDACTED]
Photo Direction	[REDACTED]
Elevation	[REDACTED]
Date Time Stamp	4/30/2012 9:42:43 AM
Photographer	K. Sable
Comment	A 31 Well
Description	Chlorine room

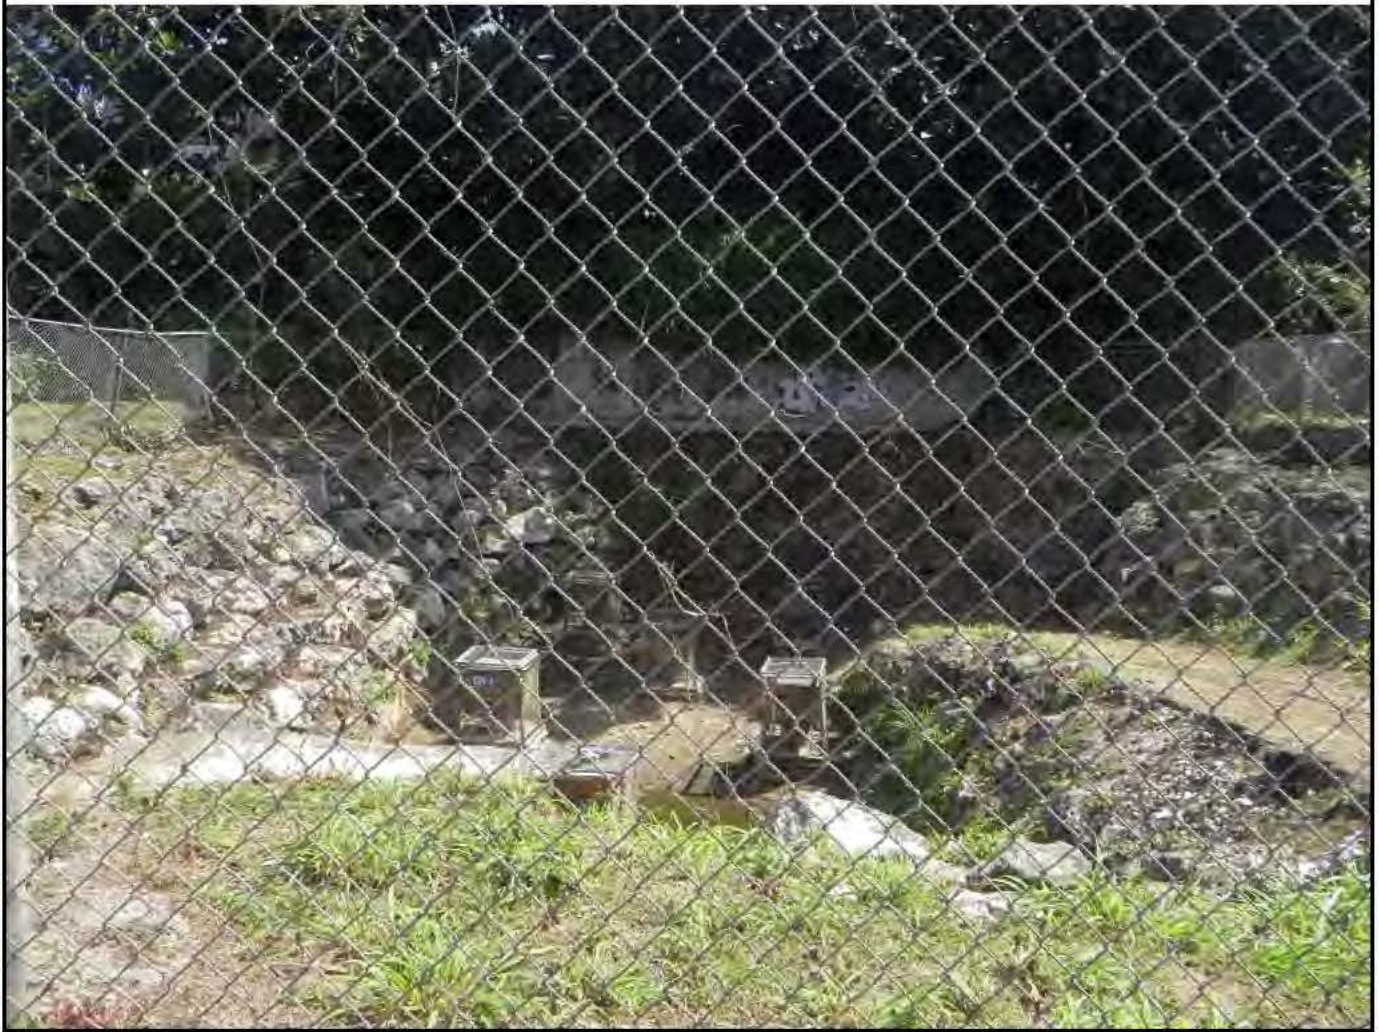
File Name: RIMG0169.JPG

Title	Guam Waterworks Authority (VP0989)
Subject	Northern System
Latitude	[REDACTED]
Longitude	[REDACTED]
Photo Direction	[REDACTED]
Elevation	[REDACTED]
Date Time Stamp	4/30/2012 9:55:10 AM
Photographer	K. Sable
Comment	UIC Ponding Basin
Description	Overview

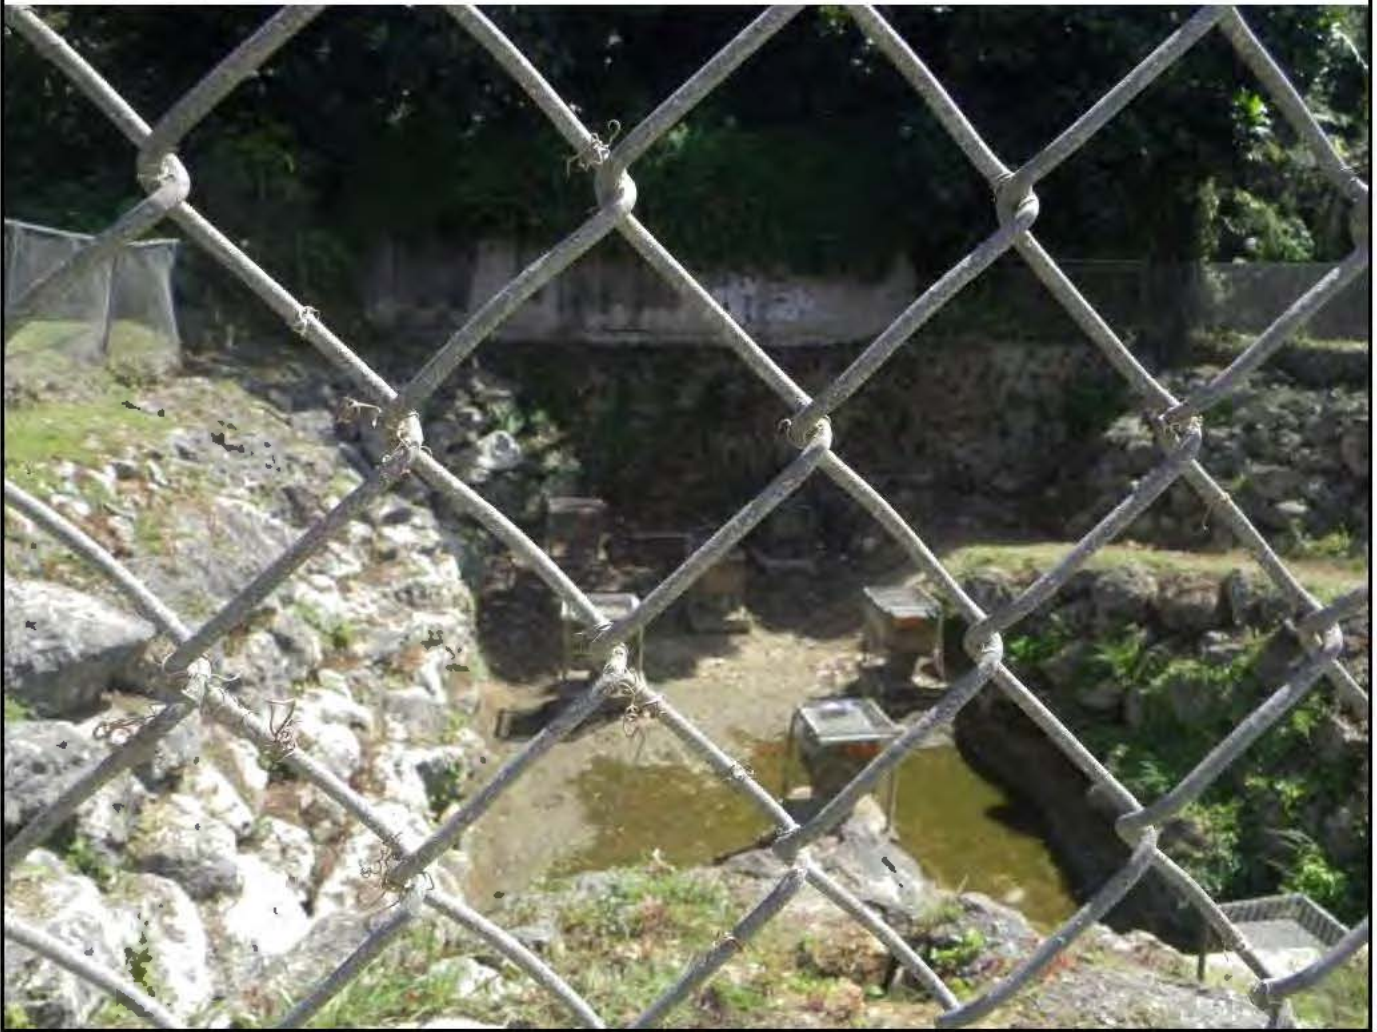
File Name: RIMG0170.JPG

Title	Guam Waterworks Authority (VP0989)
Subject	Northern System
Latitude	██████████
Longitude	██████████
Photo Direction	██████████
██████████	██████████
Date Time Stamp	4/30/2012 9:58:18 AM
Photographer	K. Sable
Comment	UIC Ponding Basin
Description	Overview

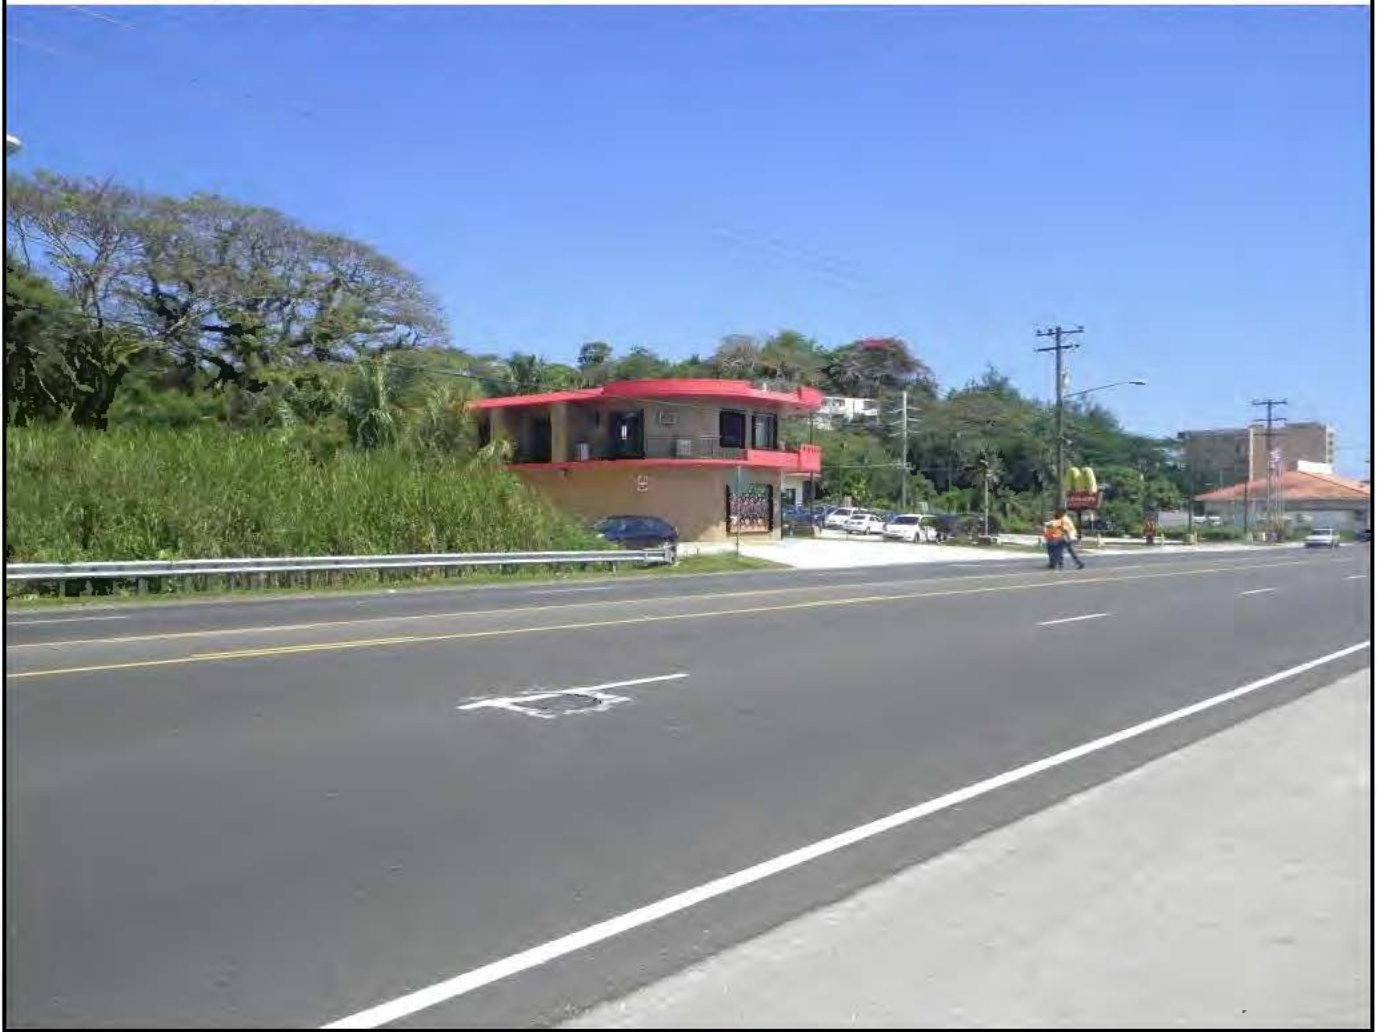
File Name: RIMG0172.JPG

Title	Guam Waterworks Authority (VP0989)
Subject	Northern System
Latitude	██████████
Longitude	██████████
Photo Direction	██████████
Elevation	████
Date Time Stamp	4/30/2012 10:19:17 AM
Photographer	K. Sable
Comment	Previous SSO Manhole Location
Description	Manhole on Route 4 near McDonalds

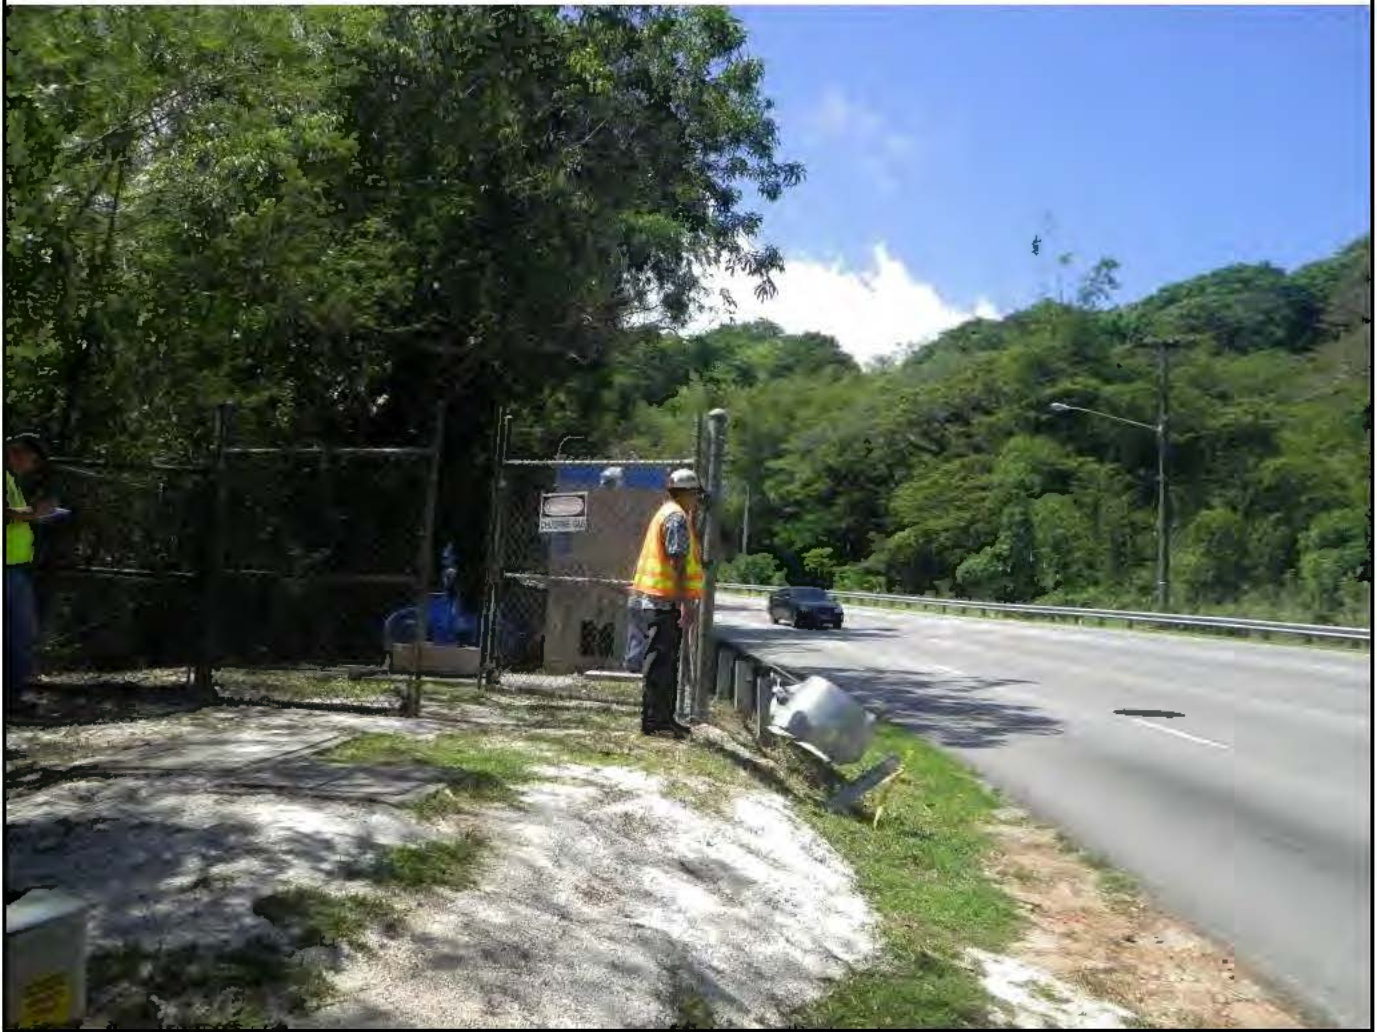
File Name: RIMG0173.JPG

Title	Guam Waterworks Authority (VP0989)
Subject	Northern System
Latitude	██████████
Longitude	██████████
Photo Direction	██████████
Elevation	██████████
Date Time Stamp	4/30/2012 10:28:52 AM
Photographer	K. Sable
Comment	A 23 Well
Description	Well with nearby manhole along Route 4

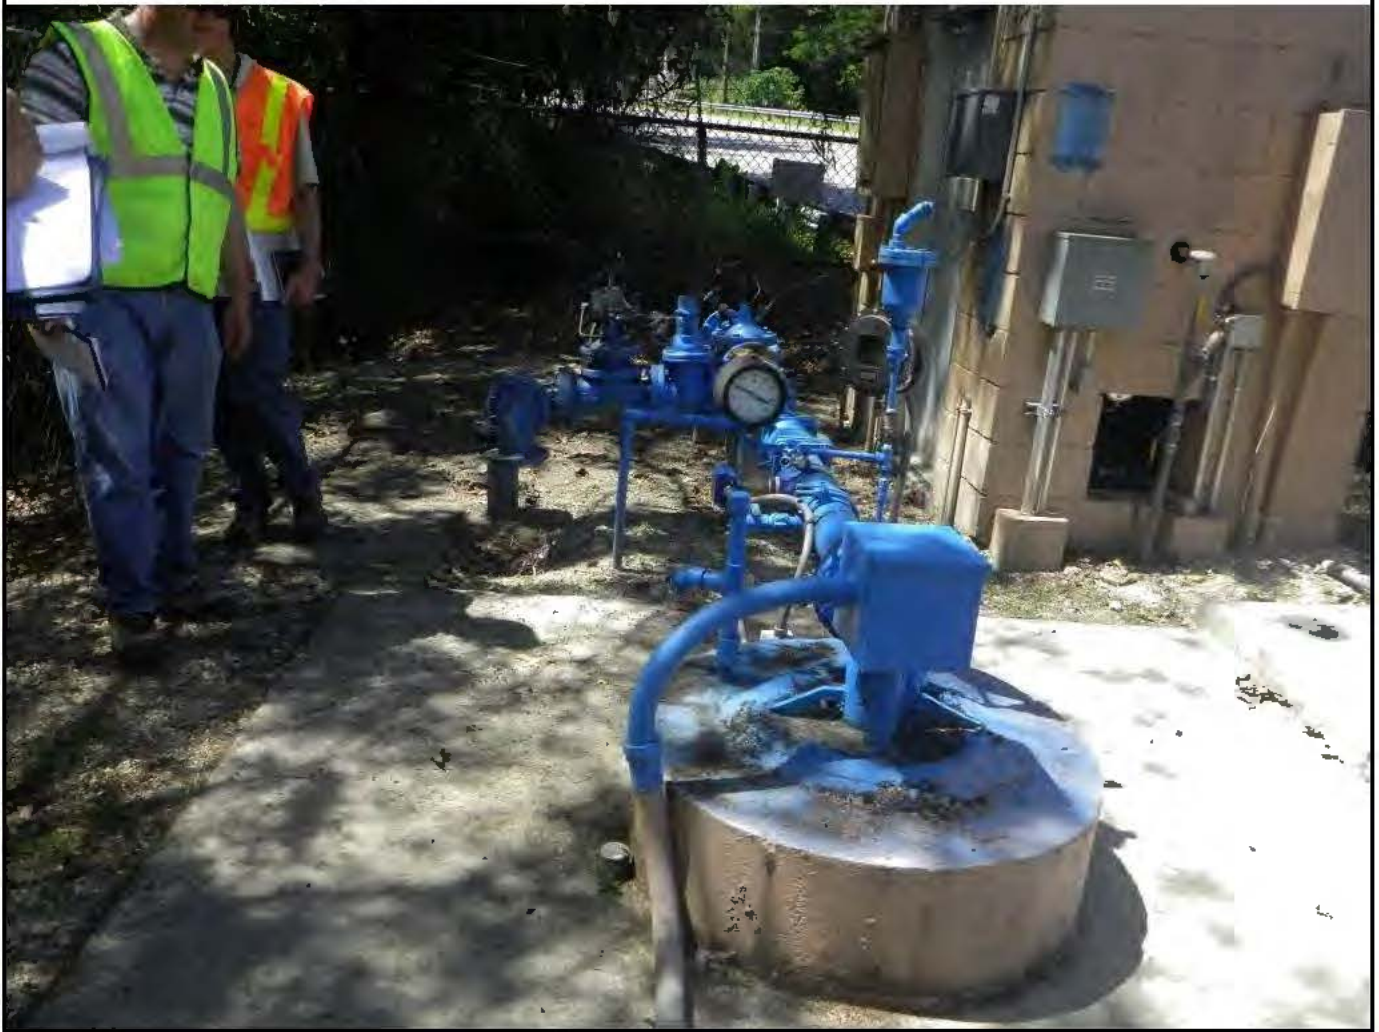
File Name: RIMG0174.JPG

Title	Guam Waterworks Authority (VP0989)
Subject	Northern System
Latitude	██████████
Longitude	██████████
Photo Direction	██████████
Elevation	██████████
Date Time Stamp	4/30/2012 10:30:39 AM
Photographer	K. Sable
Comment	A 23 Well
Description	Well assembly

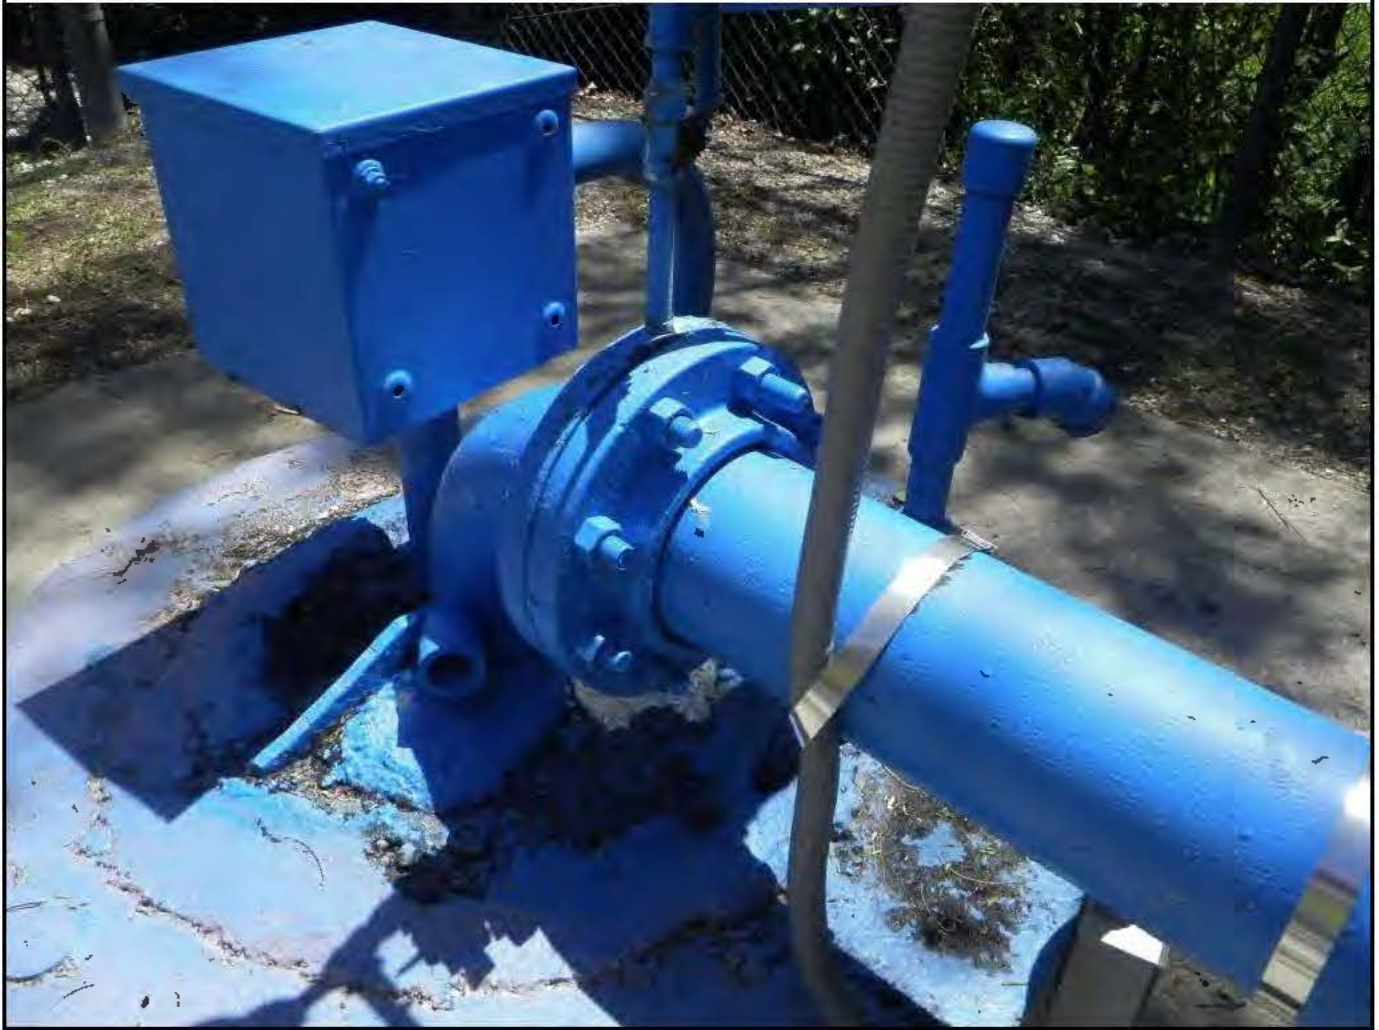
File Name: RIMG0175.JPG

Title	Guam Waterworks Authority (VP0989)
Subject	Northern System
Latitude	██████████
Longitude	██████████
Photo Direction	██████████
Elevation	██████
Date Time Stamp	4/30/2012 10:43:24 AM
Photographer	K. Sable
Comment	A 23 Well
Description	Question on number of air vents on well head

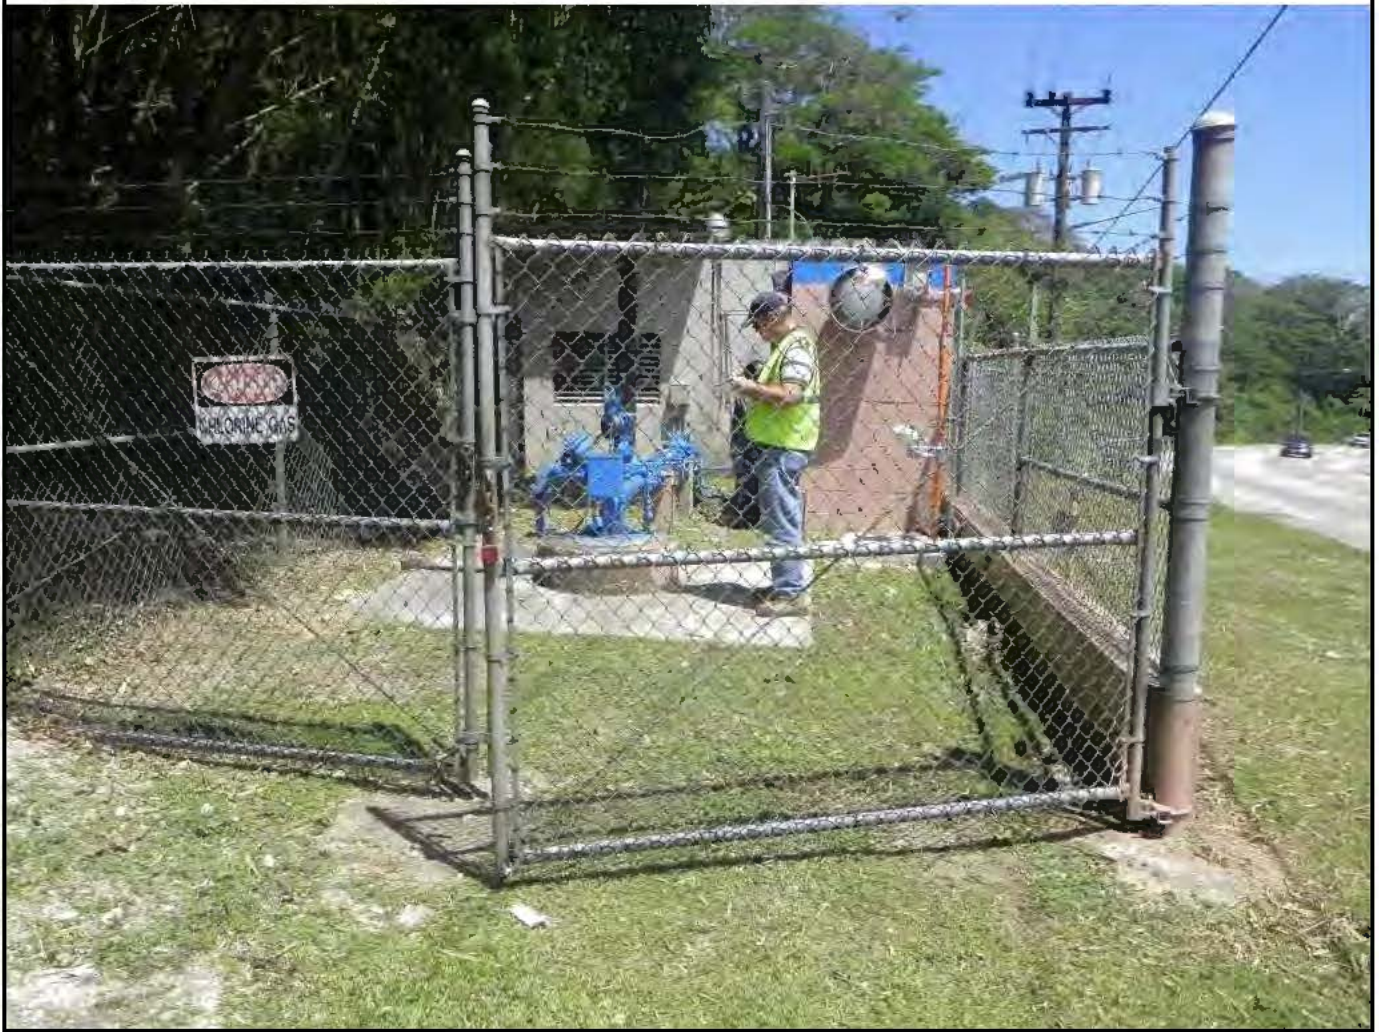
File Name: RIMG0176.JPG

Title	Guam Waterworks Authority (VP0989)
Subject	Northern System
Latitude	██████████
Longitude	██████████
Photo Direction	██████
Elevation	███
Date Time Stamp	4/30/2012 10:53:51 AM
Photographer	K. Sable
Comment	A 25 Well
Description	Overview of well

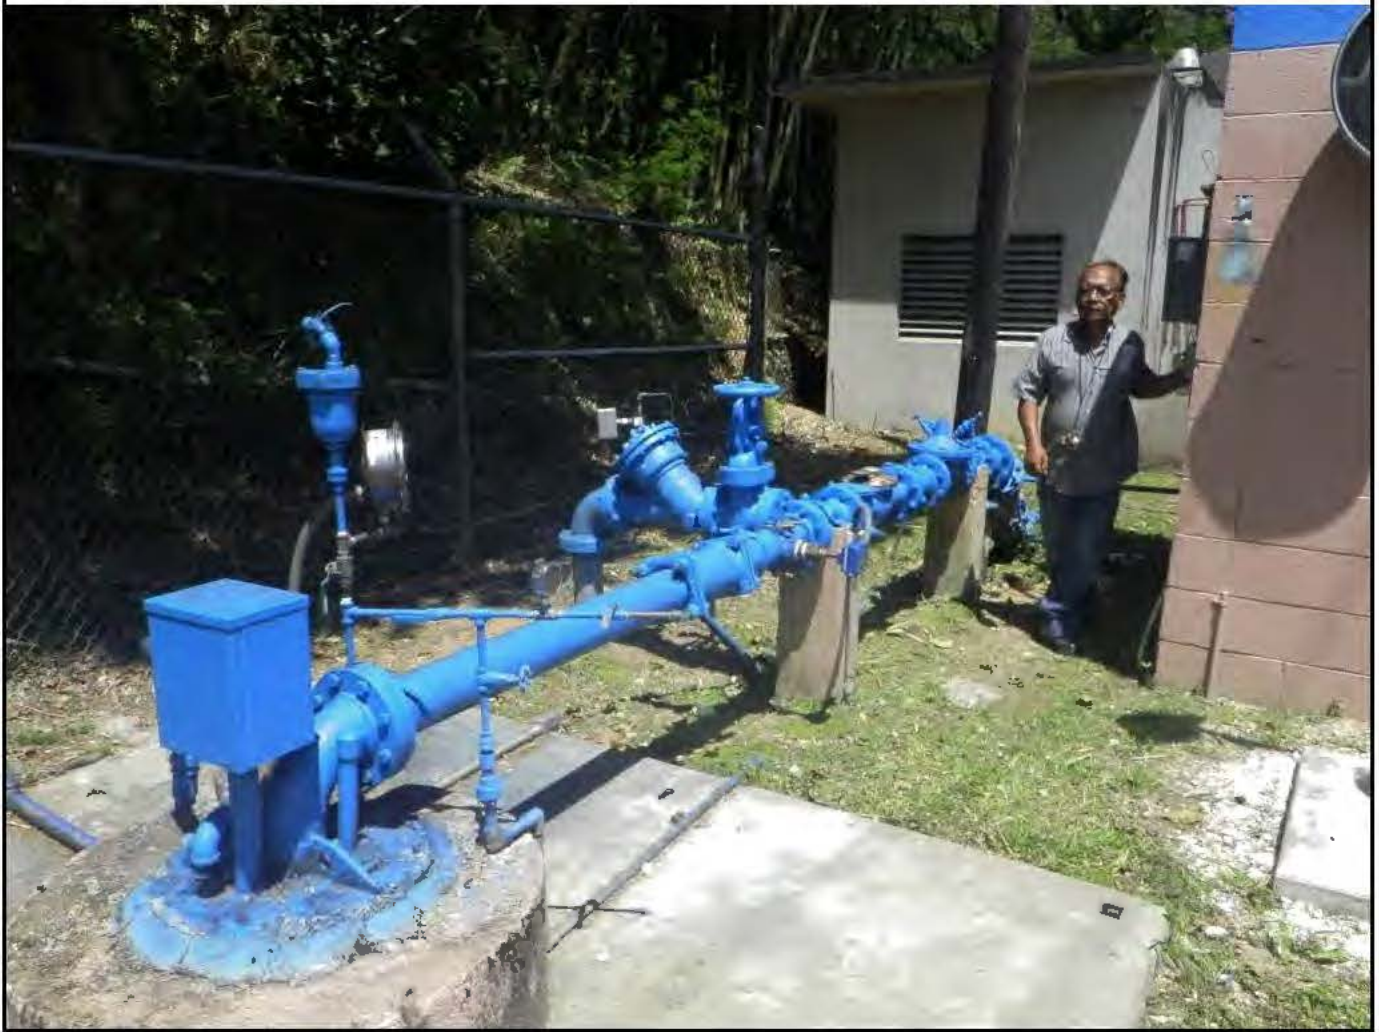
File Name: RIMG0177.JPG

Title	Guam Waterworks Authority (VP0989)
Subject	Northern System
Latitude	██████████
Longitude	██████████
Photo Direction	██████ /
Elevation	████
Date Time Stamp	4/30/2012 10:54:07 AM
Photographer	K. Sable
Comment	A 25 Well
Description	Well assembly

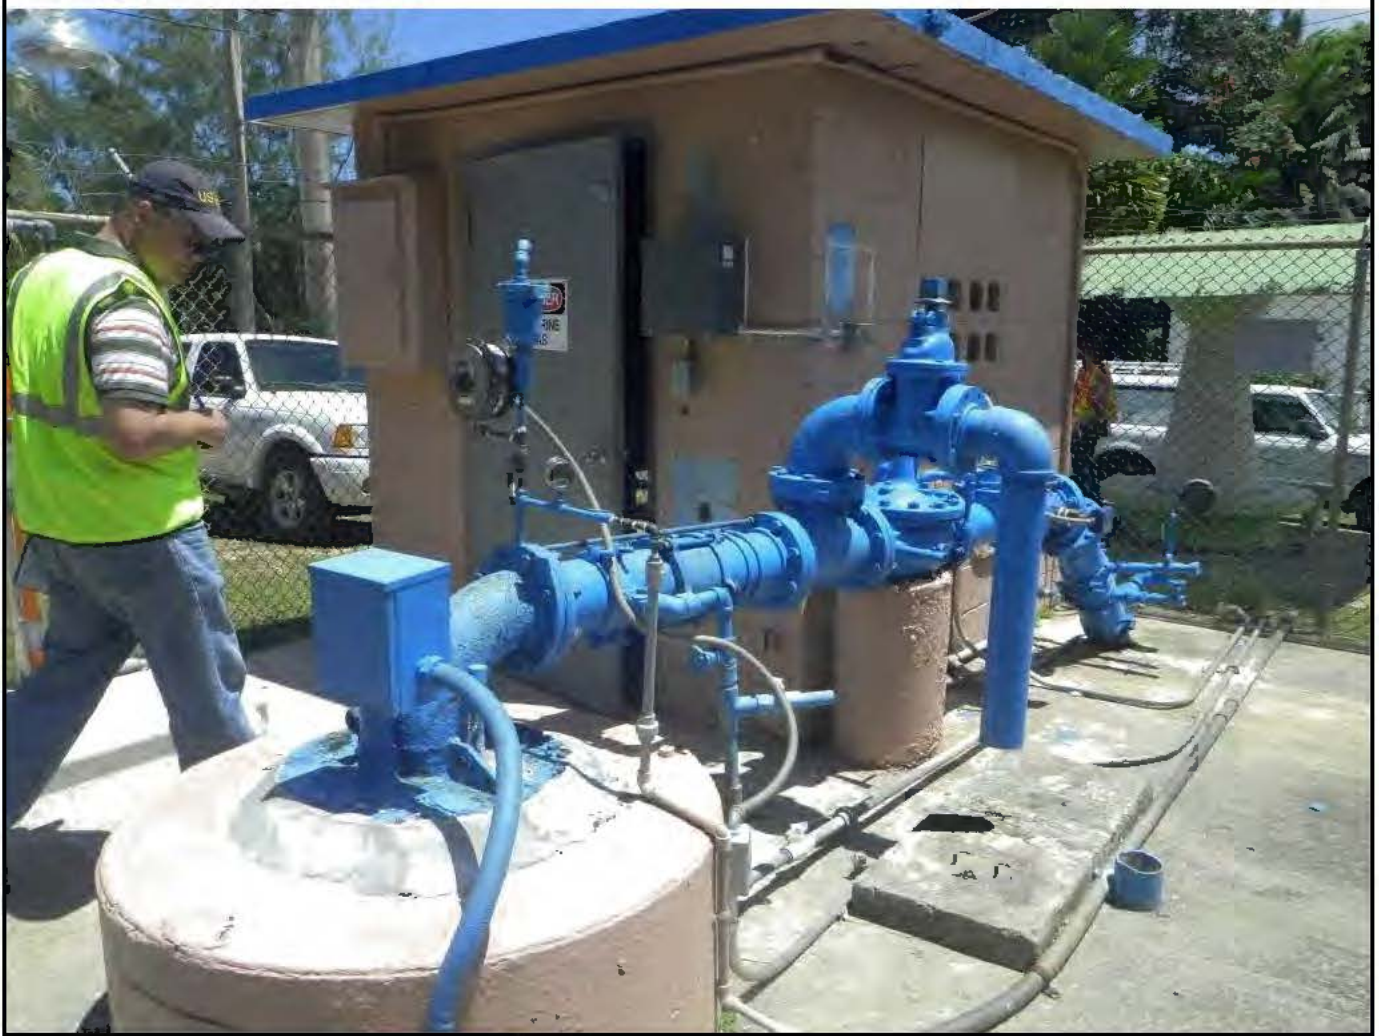
File Name: RIMG0179.JPG

Title	Guam Waterworks Authority (VP0989)
Subject	Northern System
Latitude	██████████
Longitude	██████████
Photo Direction	██████████
Elevation	██████
Date Time Stamp	4/30/2012 11:16:15 AM
Photographer	K. Sable
Comment	A 6 Well
Description	Well assembly

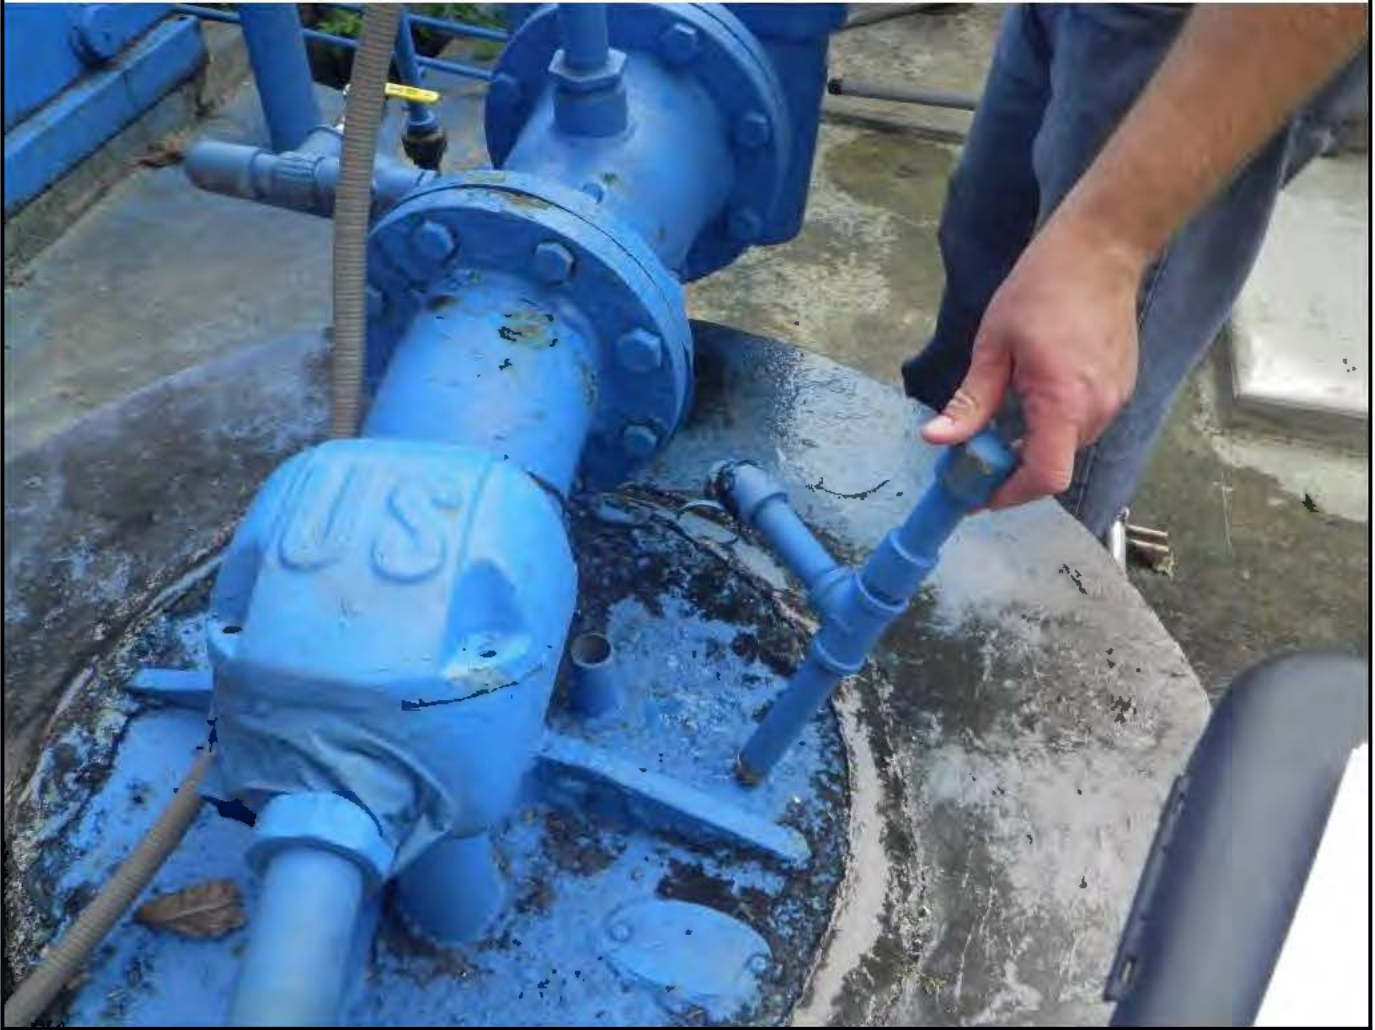
File Name: RIMG0181.JPG

Title	Guam Waterworks Authority (VP0989)
Subject	Northern System
Latitude	██████████
Longitude	██████████
Photo Direction	████
Elevation	████
Date Time Stamp	4/30/2012 1:29:55 PM
Photographer	K. Sable
Comment	A 1 Well
Description	Sounding tube

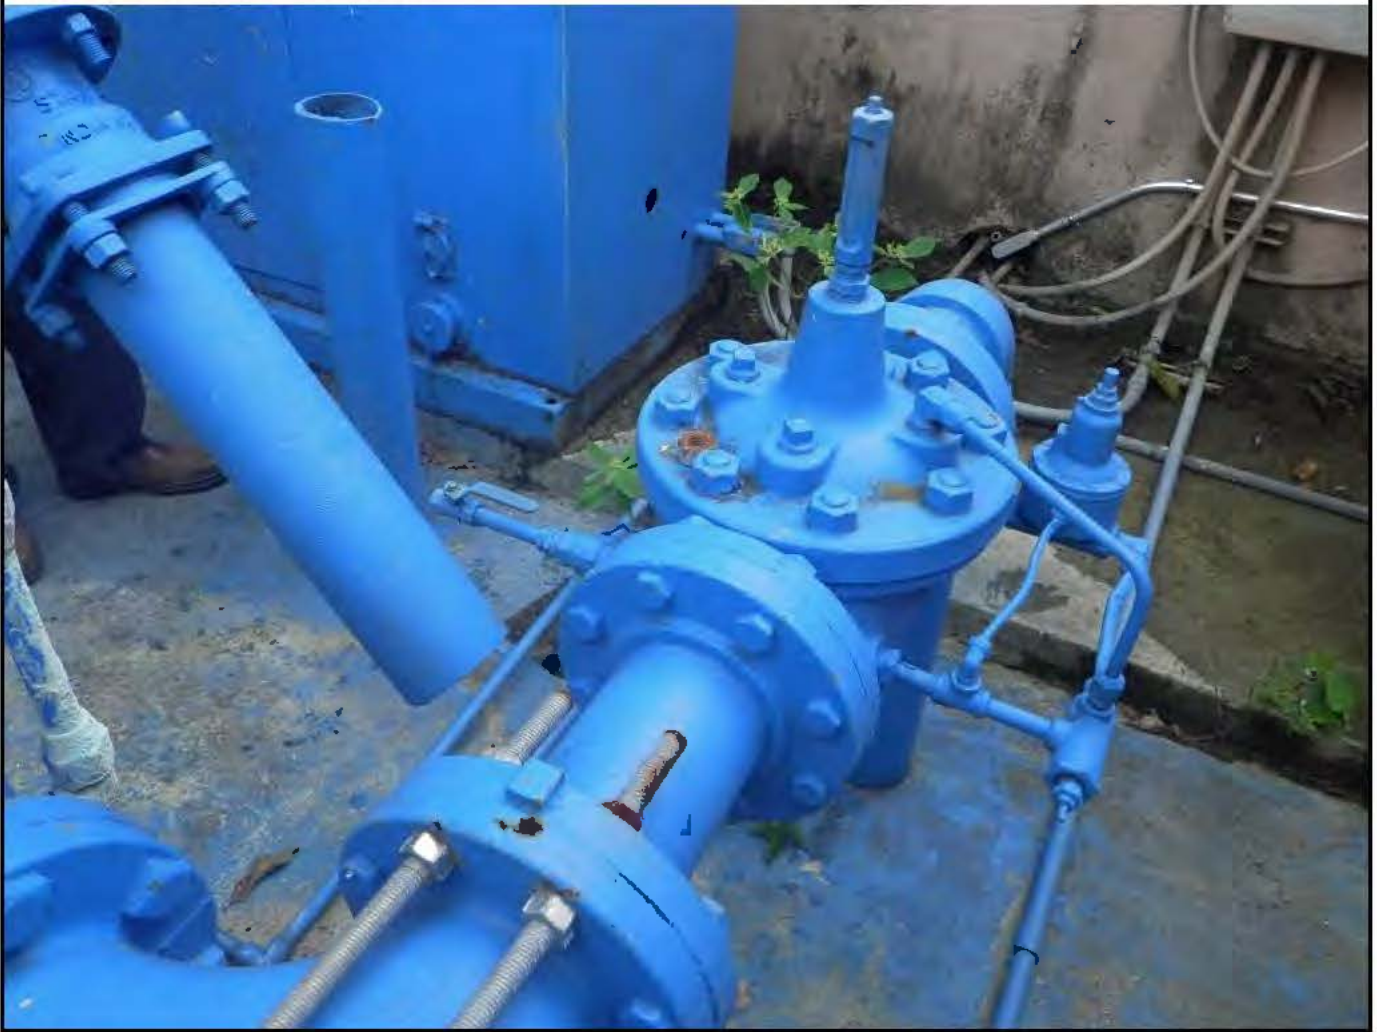
File Name: RIMG0182.JPG

Title	Guam Waterworks Authority (VP0989)
Subject	Northern System
Latitude	██████████
Longitude	██████████
Photo Direction	██████████
Elevation	██████████
Date Time Stamp	4/30/2012 1:32:49 PM
Photographer	K. Sable
Comment	A 1 Well
Description	Bypass and check valves

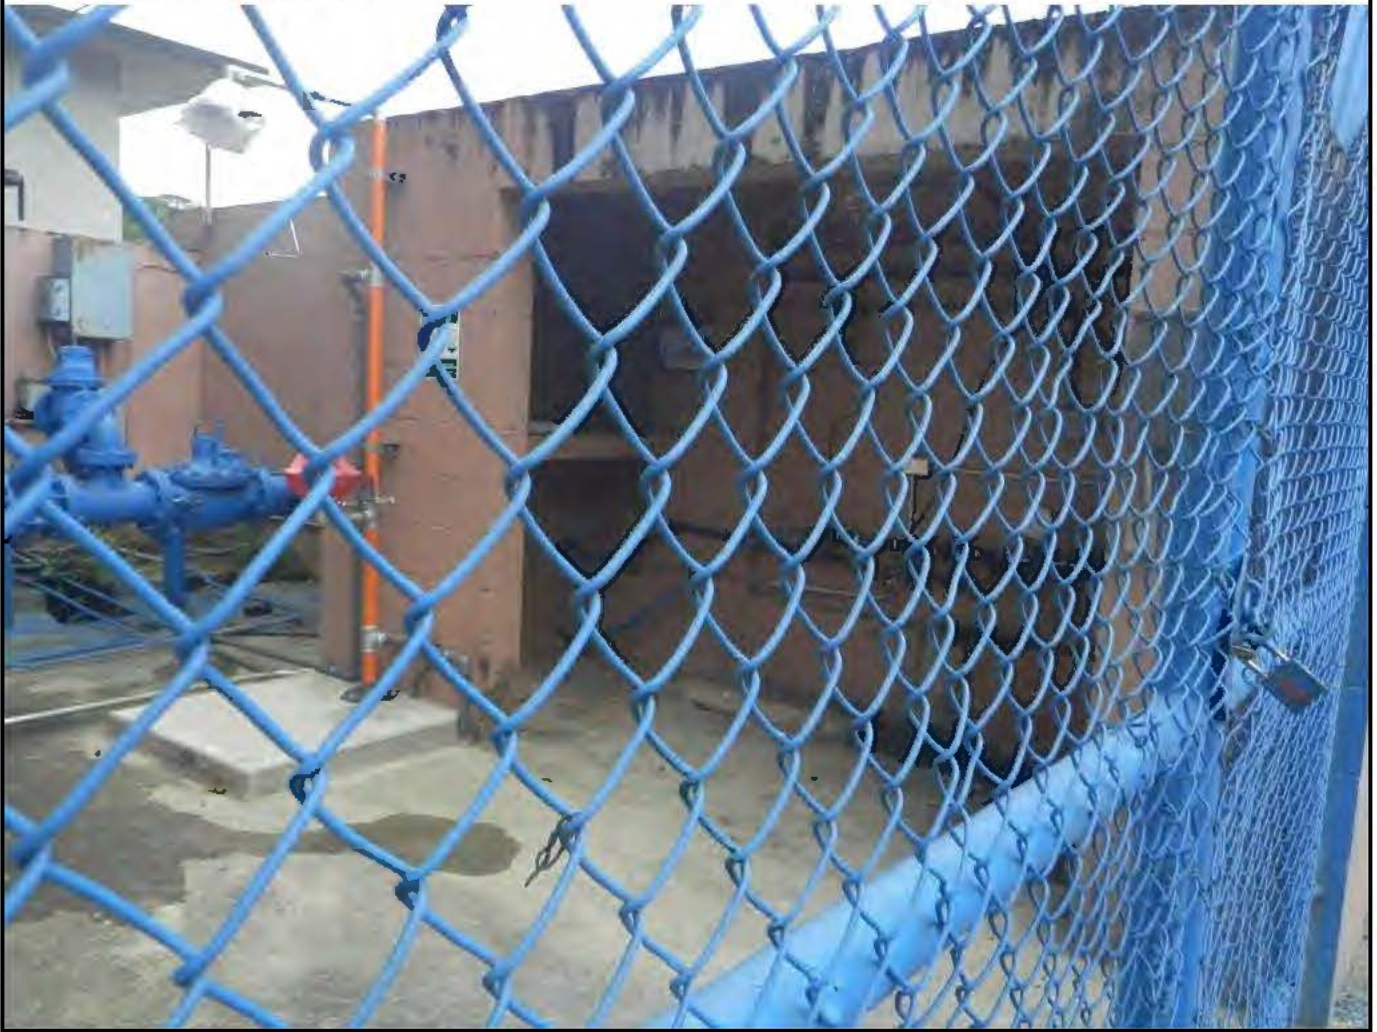
File Name: RIMG0183.JPG

Title	Guam Waterworks Authority (VP0989)
Subject	Northern System
Latitude	[REDACTED]
Longitude	[REDACTED]
Photo Direction	[REDACTED]
Elevation	[REDACTED]
Date Time Stamp	4/30/2012 1:40:37 PM
Photographer	K. Sable
Comment	A 1 Well
Description	Chlorine room without doors
