Title	Guam Waterworks Authority (VP0989)
Subject	Northern System
Latitude	██████████
Longitude	██████████
Photo Direction	██████
Elevation	████
Date Time Stamp	4/27/2012 9:37:55 AM
Photographer	K. Sable
Comment	Y 15 Well
Description	Overview of Y 15 well

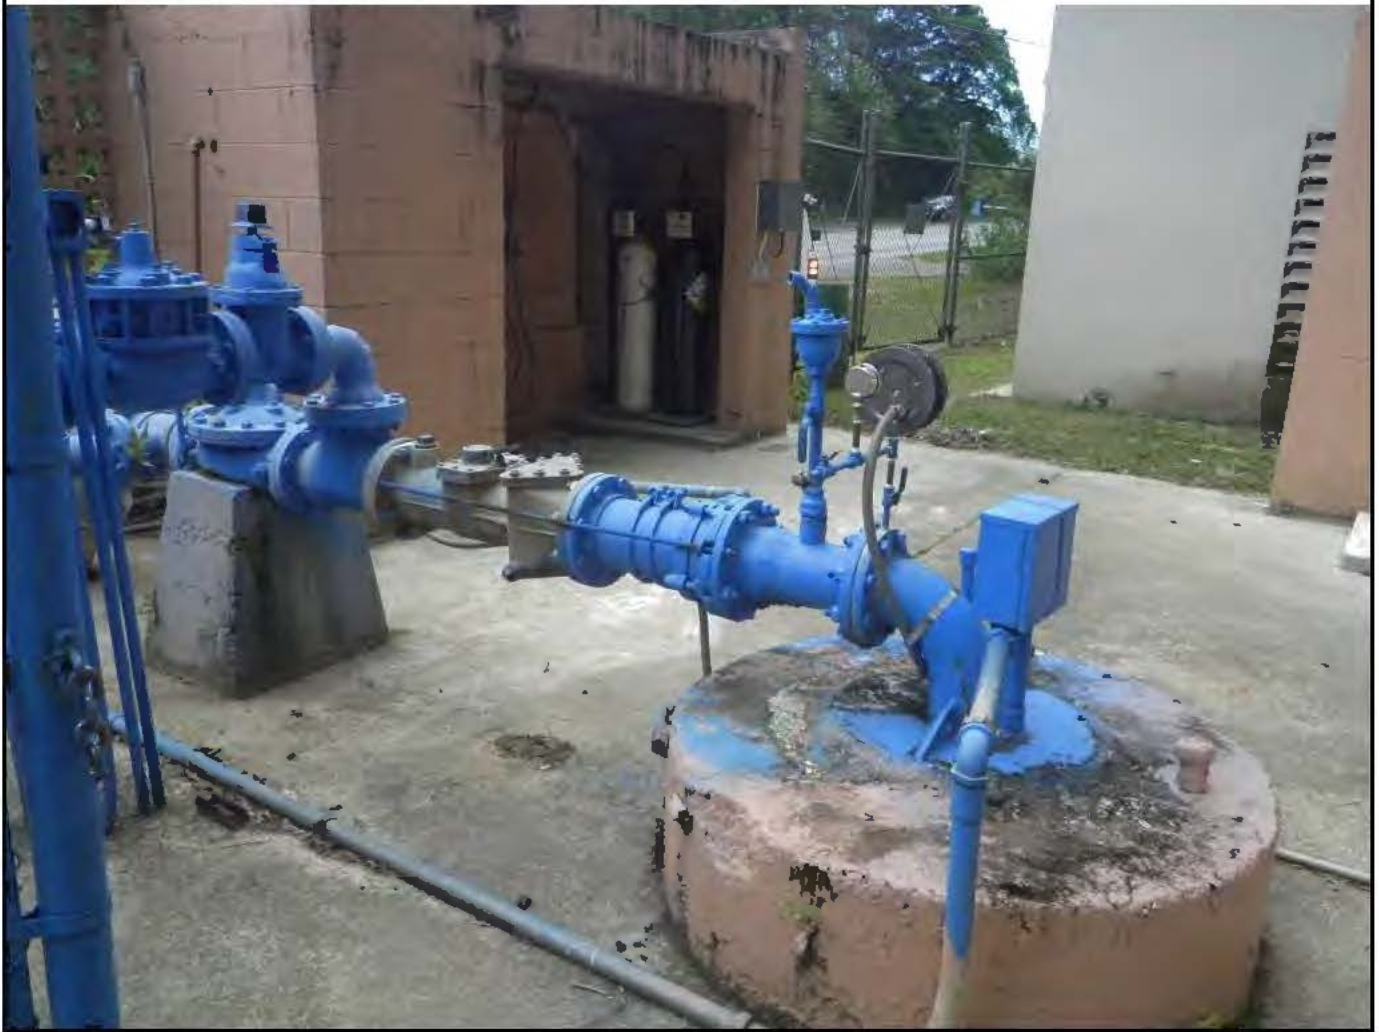
File Name: RIMG0184.JPG

Title	Guam Waterworks Authority (VP0989)
Subject	Northern System
Latitude	██████████
Longitude	██████████
Photo Direction	██████████
Elevation	██████████
Date Time Stamp	4/30/2012 1:49:44 PM
Photographer	K. Sable
Comment	A 3 Well
Description	Well assembly

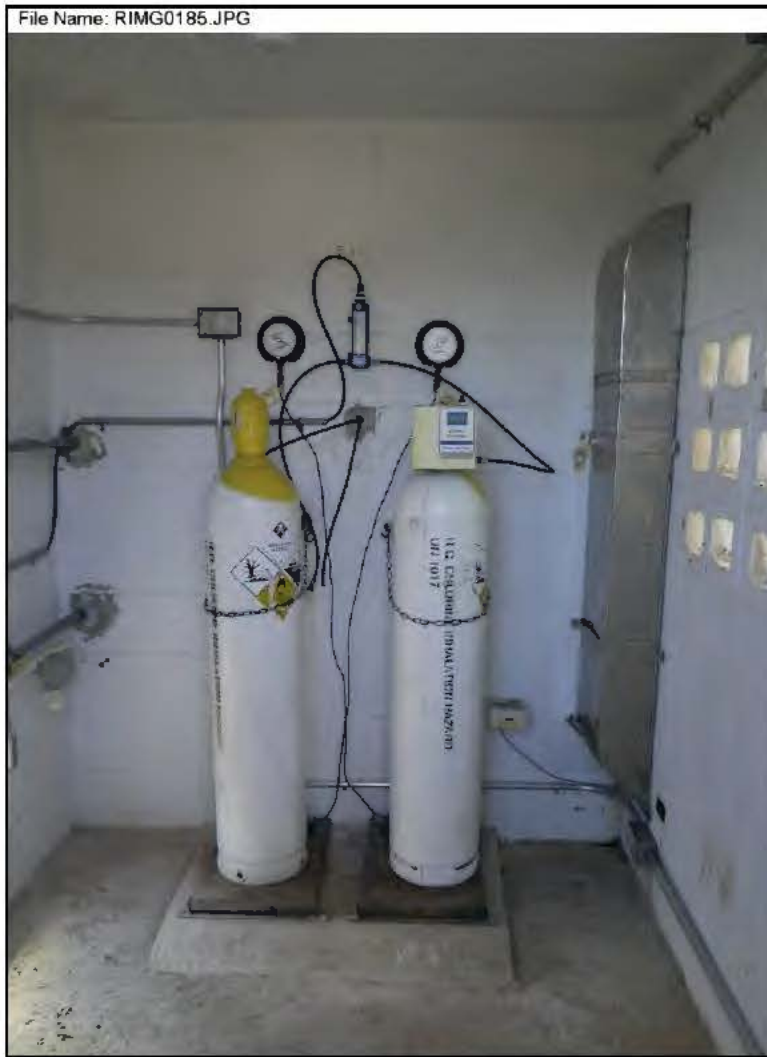
Attributes	
Title	Guam Waterworks Authority (VP0989)
Subject	Northern System
Latitude	[REDACTED]
Longitude	[REDACTED]
Photo Direction	[REDACTED]
Elevation	[REDACTED]
Date Time Stamp	4/30/2012 2:45:00 PM
Photographer	K. Sable
Comment	A 9 Well
Description	Chlorine tanks

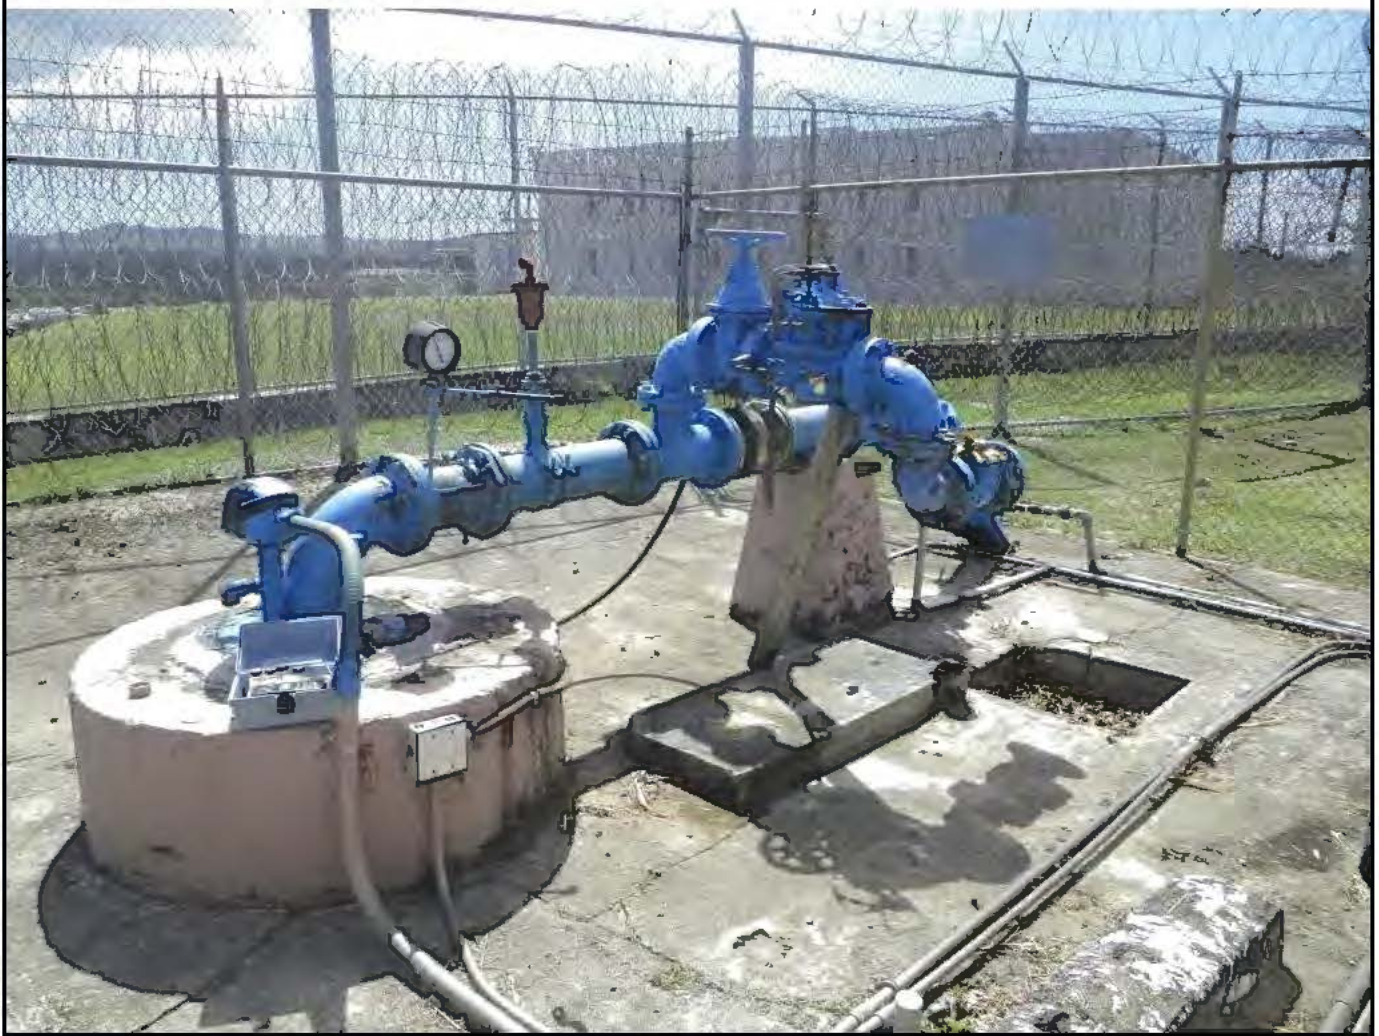
File Name: RIMG0186.JPG

Title	Guam Waterworks Authority (VP0989)
Subject	Northern System
Latitude	██████████
Longitude	██████████
Photo Direction	██████████
Elevation	██████
Date Time Stamp	4/30/2012 2:46:02 PM
Photographer	K. Sable
Comment	A 9 Well
Description	Well assembly

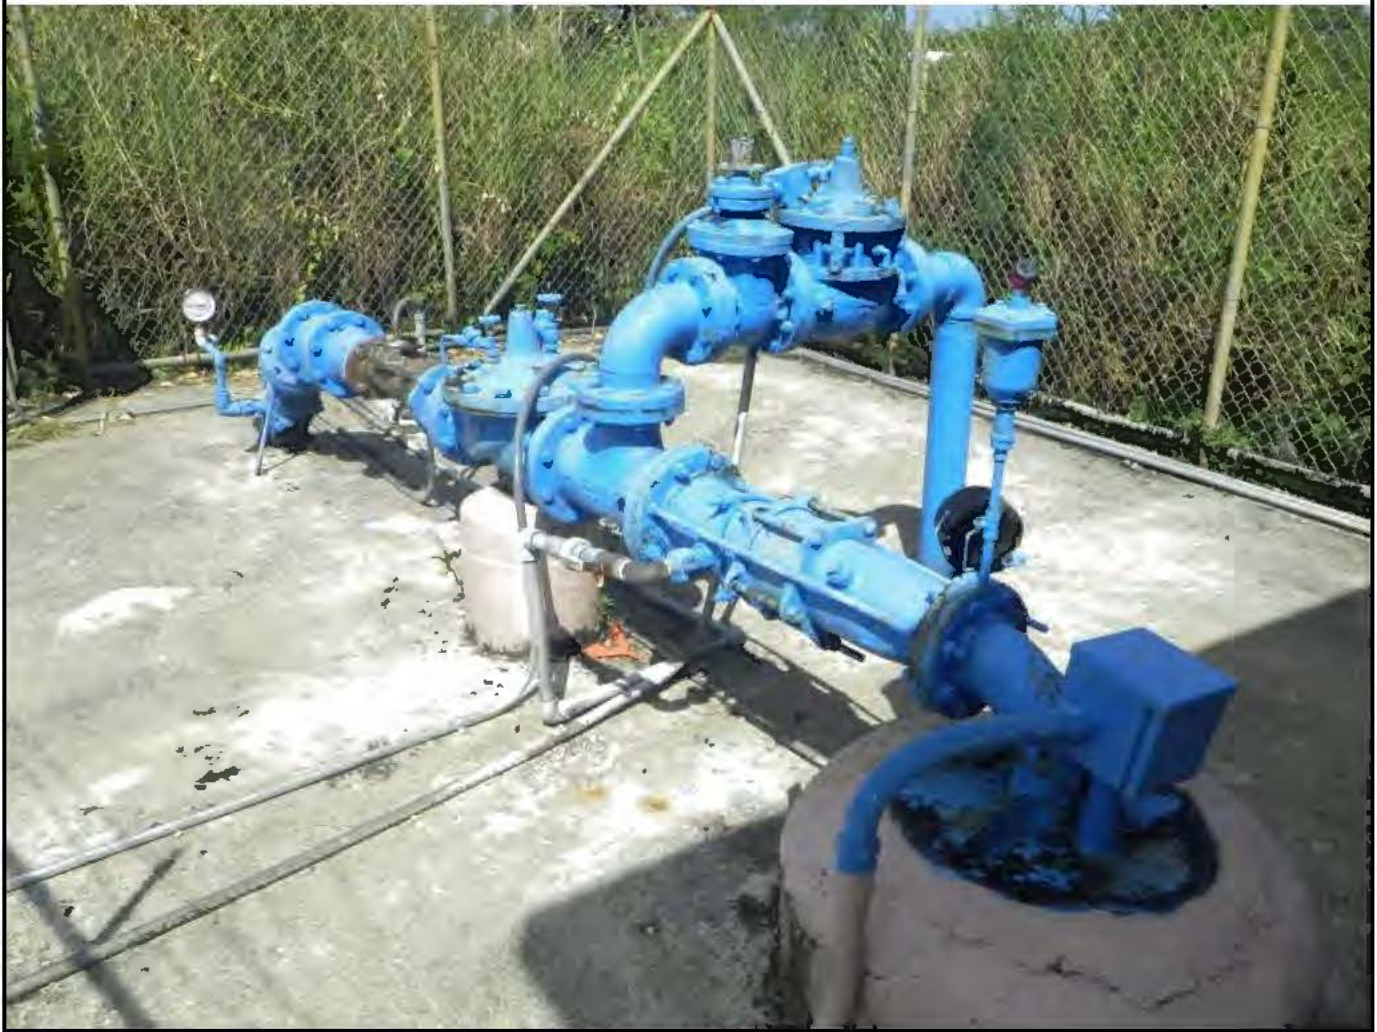
File Name: RIMG0187.JPG

Title	Guam Waterworks Authority (VP0989)
Subject	Northern System
Latitude	██████████
Longitude	██████████
Photo Direction	██████████
Elevation	██████
Date Time Stamp	4/30/2012 2:54:42 PM
Photographer	K. Sable
Comment	A 10 Well
Description	Overview of well assembly (not in operation)

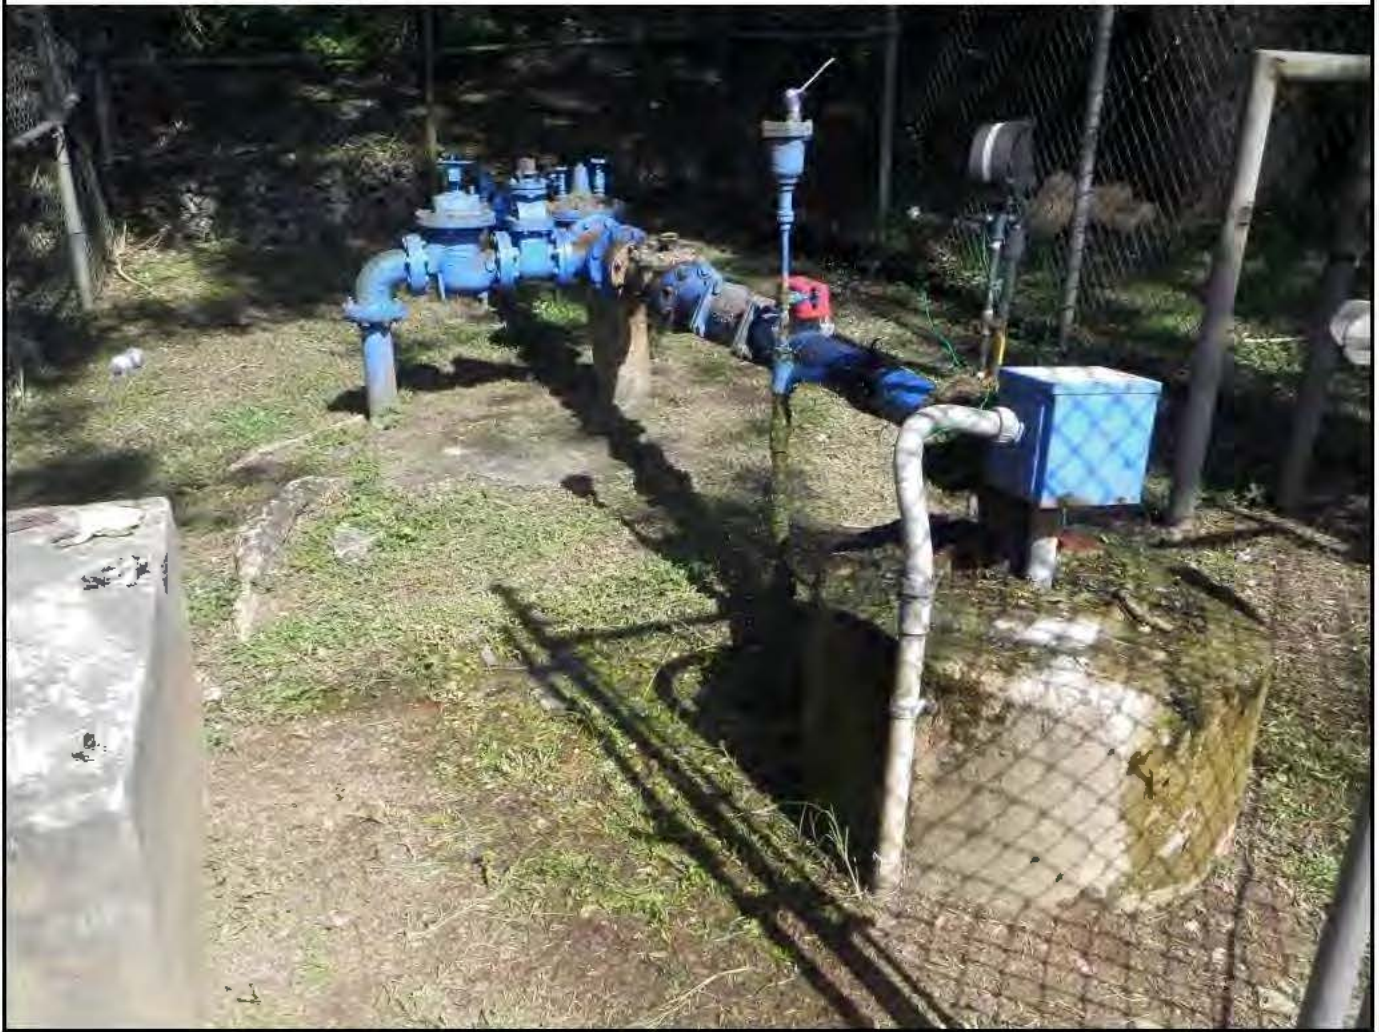
File Name: RIMG0188.JPG

Title	Guam Waterworks Authority (VP0989)
Subject	Northern System
Latitude	██████████
Longitude	██████████
Photo Direction	██████
Elevation	████
Date Time Stamp	4/30/2012 3:19:58 PM
Photographer	K. Sable
Comment	A 21 Well
Description	Well assembly

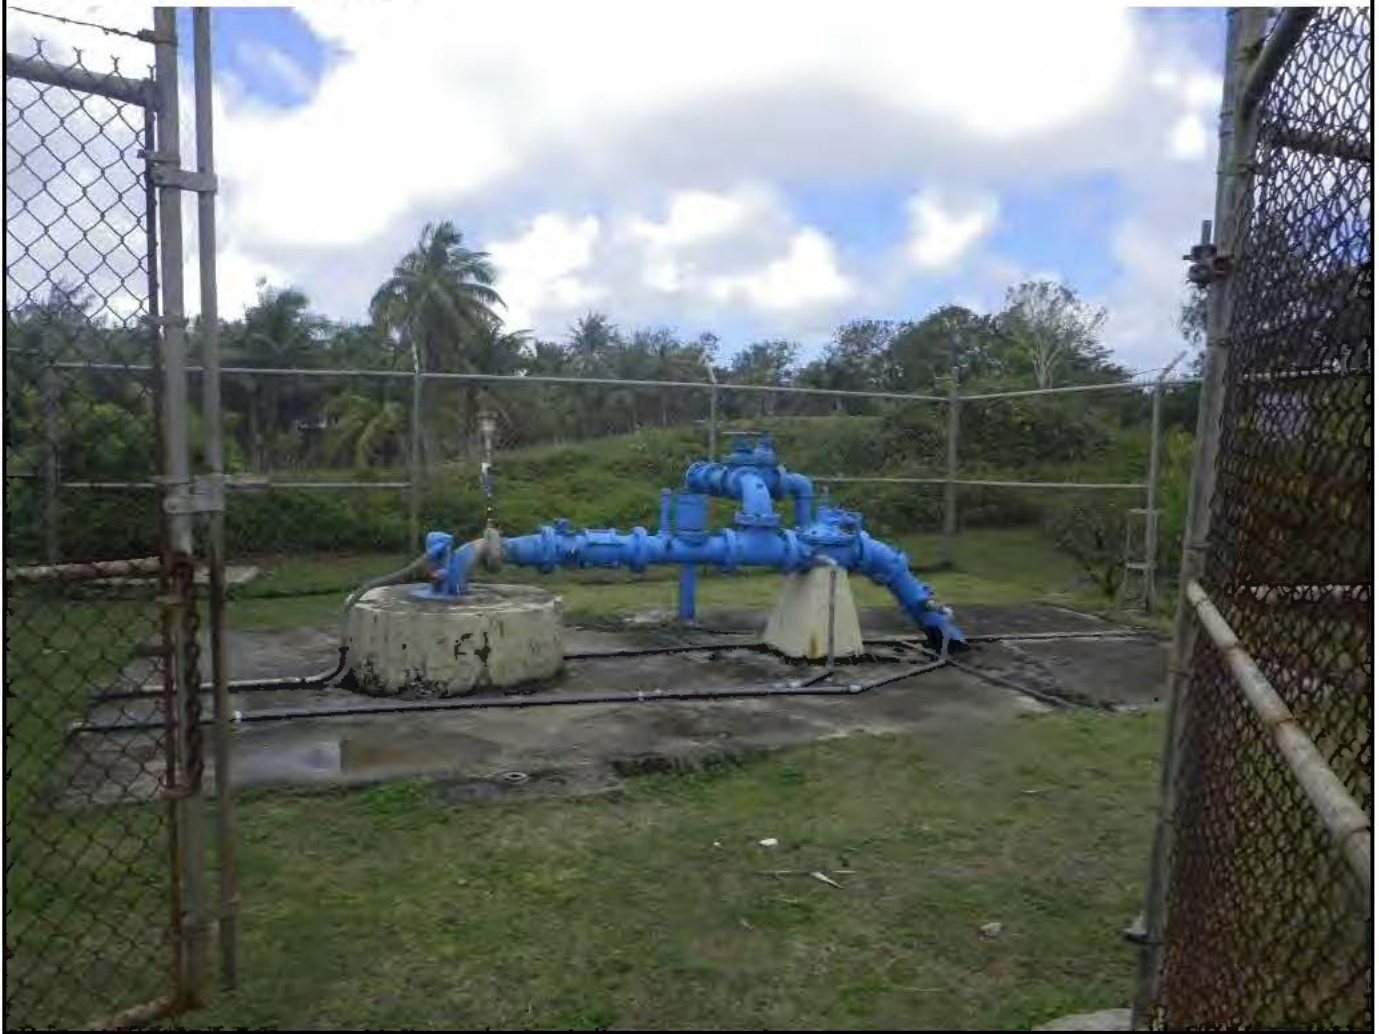
File Name: RIMG0190.JPG

Title	Guam Waterworks Authority (VP0989)
Subject	Northern System
Latitude	██████████
Longitude	██████████
Photo Direction	██████████
Elevation	██████
Date Time Stamp	5/1/2012 10:19:07 AM
Photographer	K. Sable
Comment	D 5 Well
Description	Well assembly

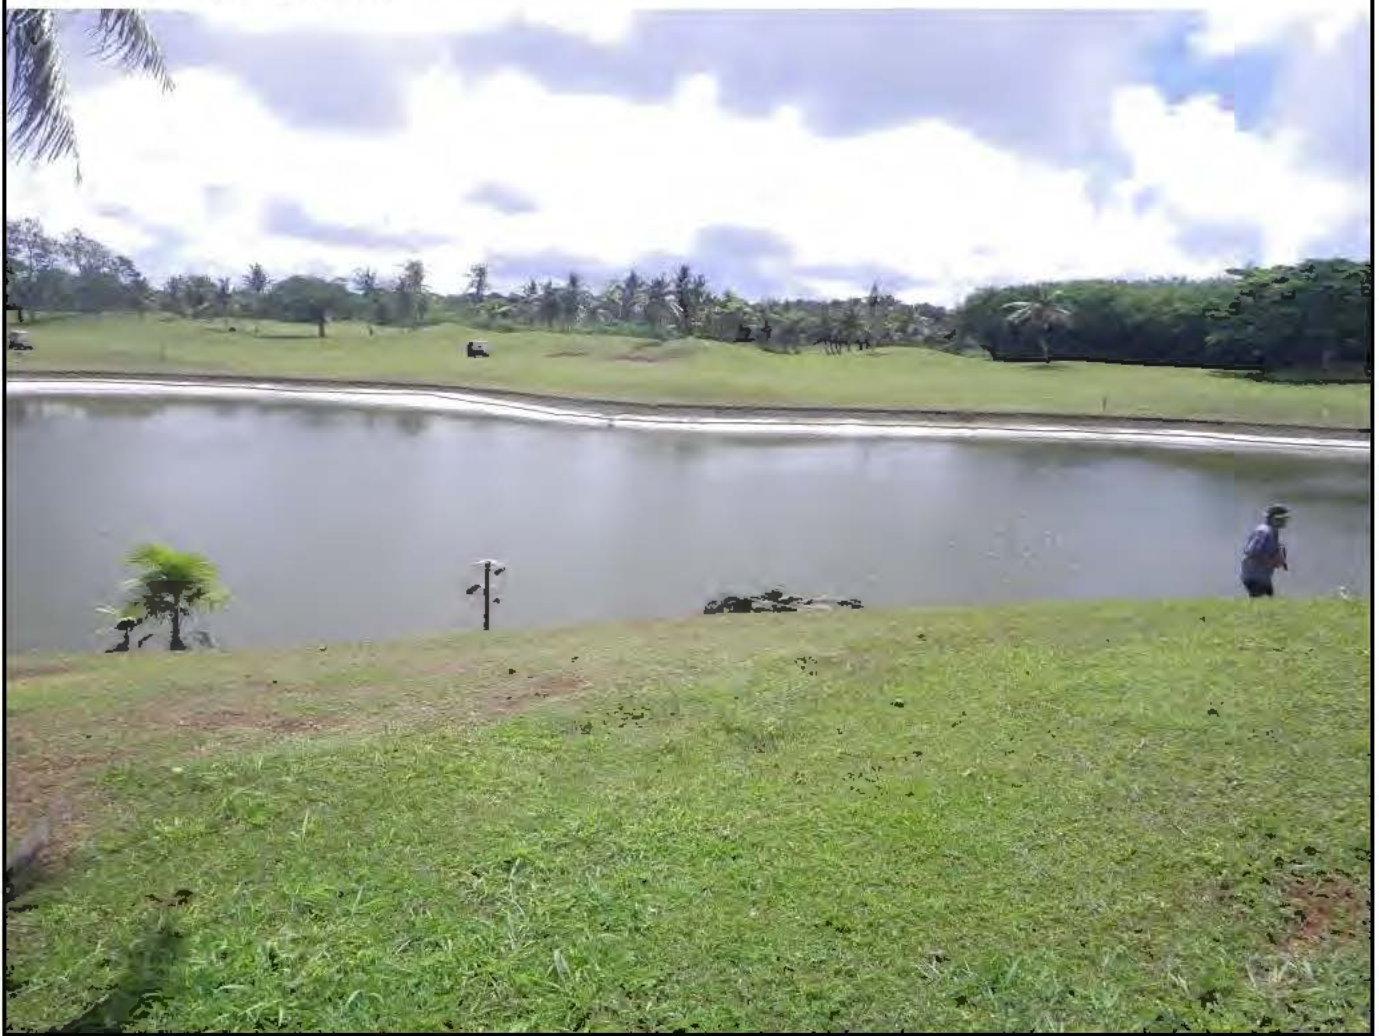
File Name: RIMG0191.JPG

Title	Guam Waterworks Authority (VP0989)
Subject	Northern System
Latitude	[REDACTED]
Longitude	[REDACTED]
Photo Direction	[REDACTED]
Elevation	[REDACTED]
Date Time Stamp	5/1/2012 10:31:52 AM
Photographer	K. Sable
Comment	D 5 Well
Description	From well fence line to lake at discharge location

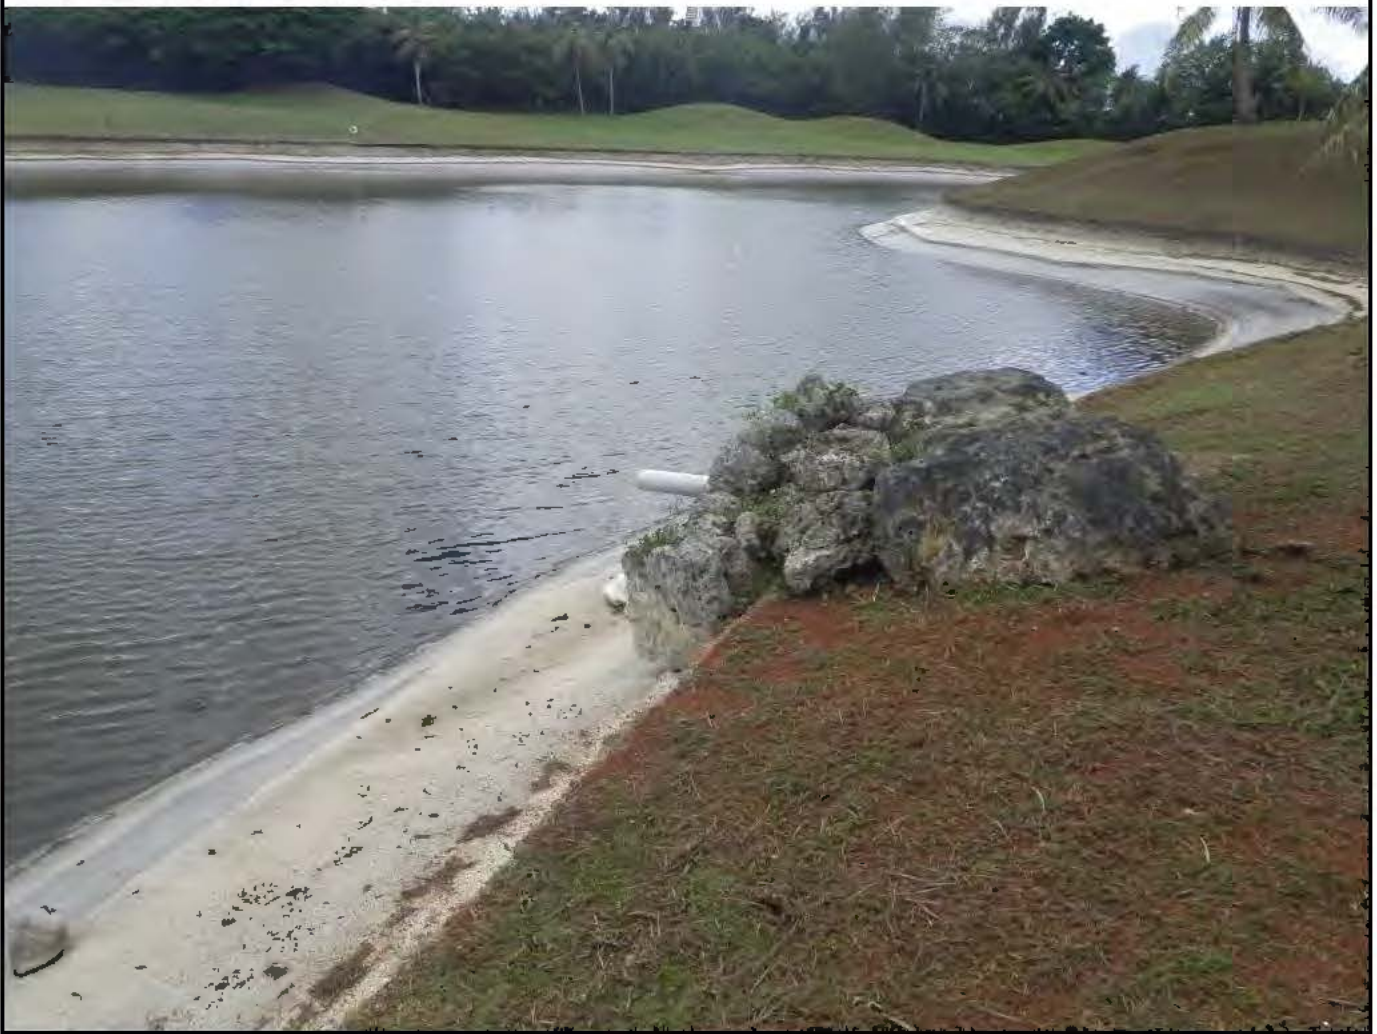
File Name: RIMG0192.JPG

Title	Guam Waterworks Authority (VP0989)
Subject	Northern System
Latitude	██████████
Longitude	██████████
Photo Direction	██████
Elevation	████
Date Time Stamp	5/1/2012 10:33:36 AM
Photographer	K. Sable
Comment	D 5 Well
Description	Lake at discharge location

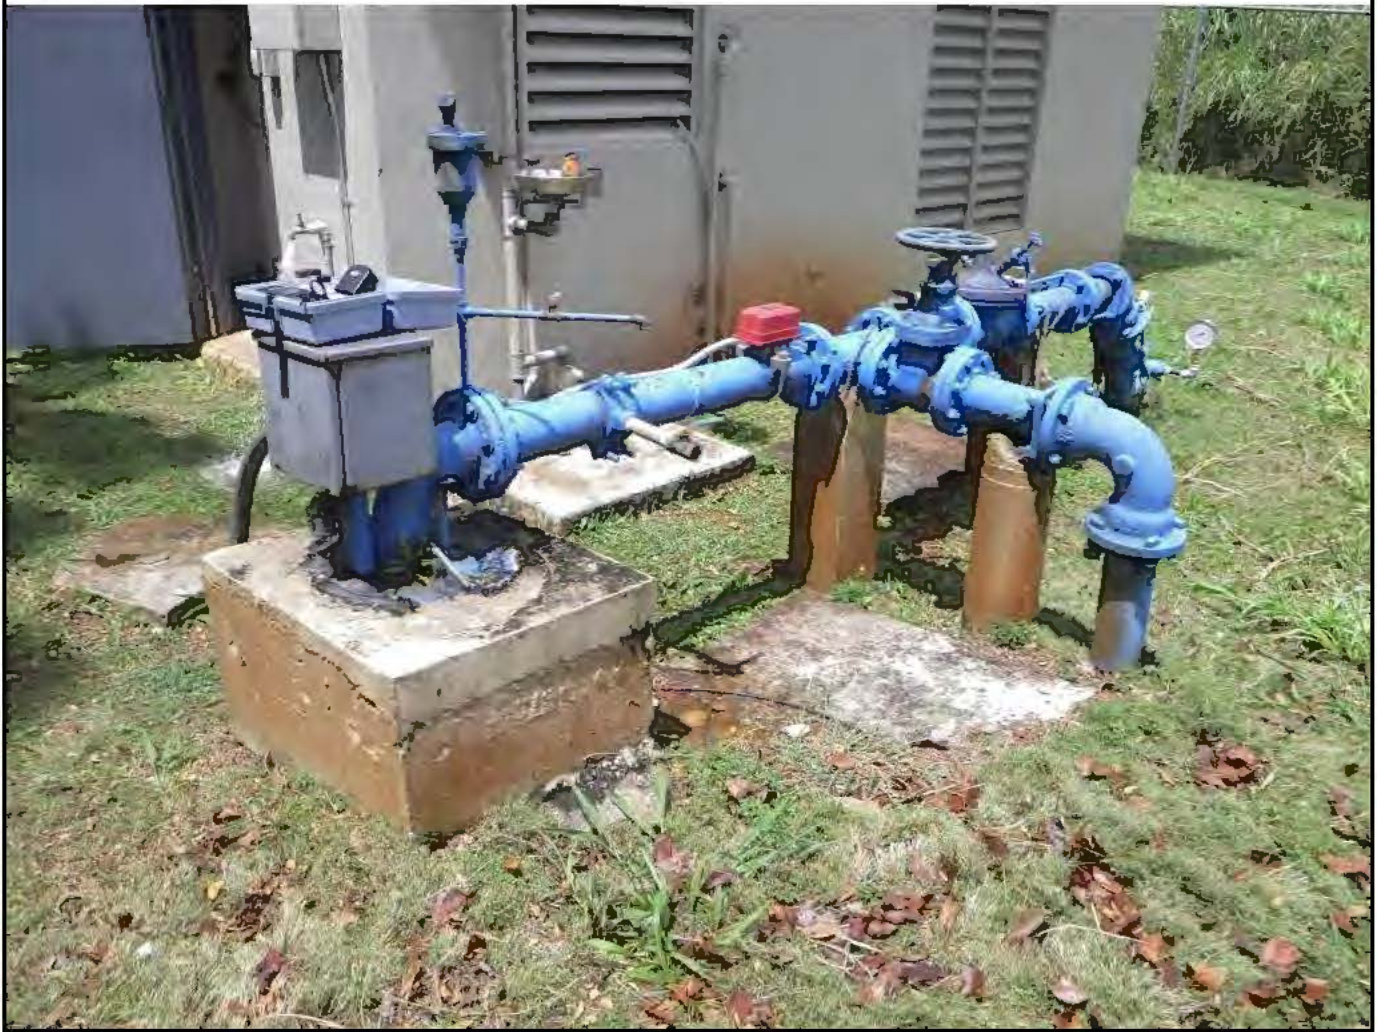
File Name: RIMG0193.JPG

Title	Guam Waterworks Authority (VP0989)
Subject	Northern System
Latitude	[REDACTED]
Longitude	[REDACTED]
Photo Direction	[REDACTED]
Elevation	[REDACTED]
Date Time Stamp	5/1/2012 10:49:26 AM
Photographer	K. Sable
Comment	EX 5 Well
Description	Minimal concrete pad not under well casement

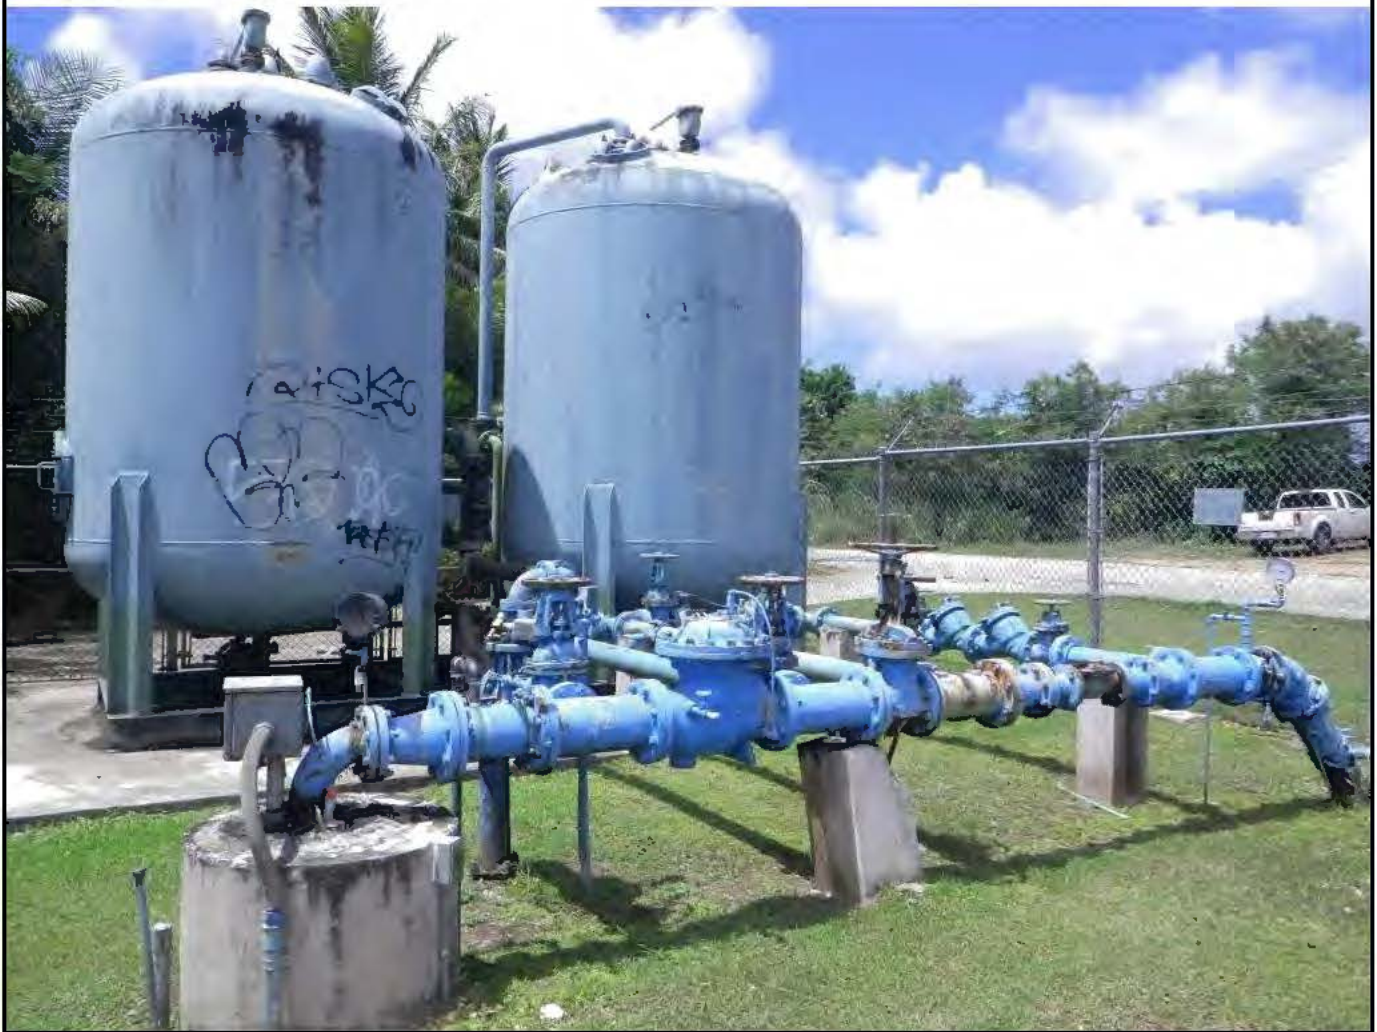
File Name: RIMG0196.JPG

Title	Guam Waterworks Authority (VP0989)
Subject	Northern System
Latitude	██████████
Longitude	██████████
Photo Direction	██████
Elevation	██████
Date Time Stamp	5/1/2012 1:32:54 PM
Photographer	K. Sable
Comment	F 8 Well
Description	Granular activated carbon (GAC) tanks and well assembly

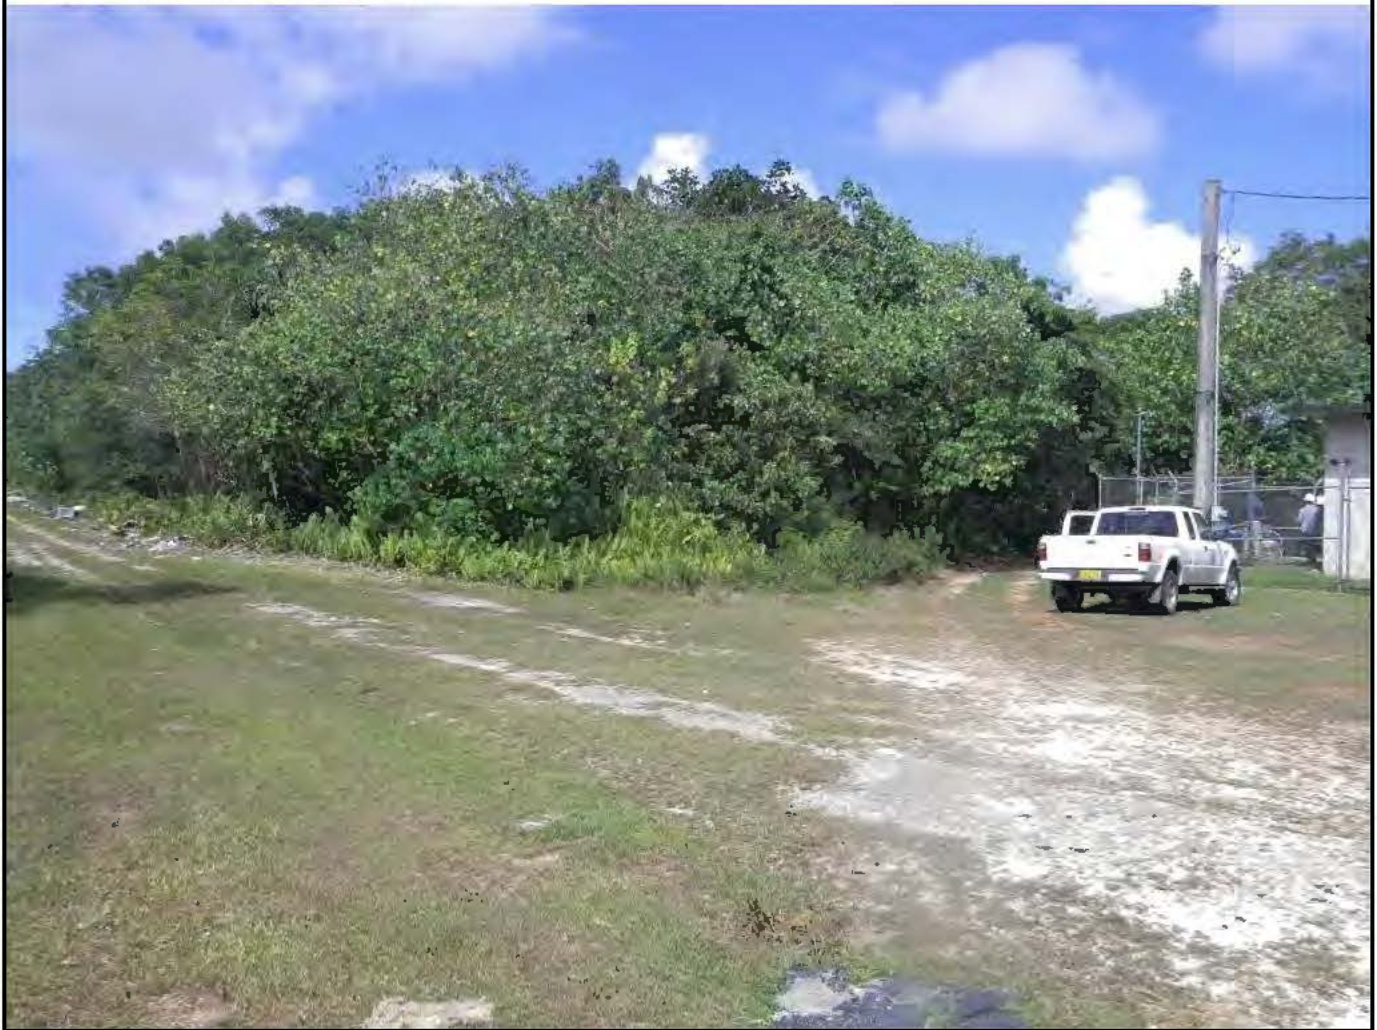
File Name: RIMG0198.JPG

Title	Guam Waterworks Authority (VP0989)
Subject	Northern System
Latitude	██████████
Longitude	██████████
Photo Direction	██████
Elevation	██████
Date Time Stamp	5/1/2012 2:45:05 PM
Photographer	K. Sable
Comment	F 3 Well
Description	Well pad to right with spilt in road that contained trash

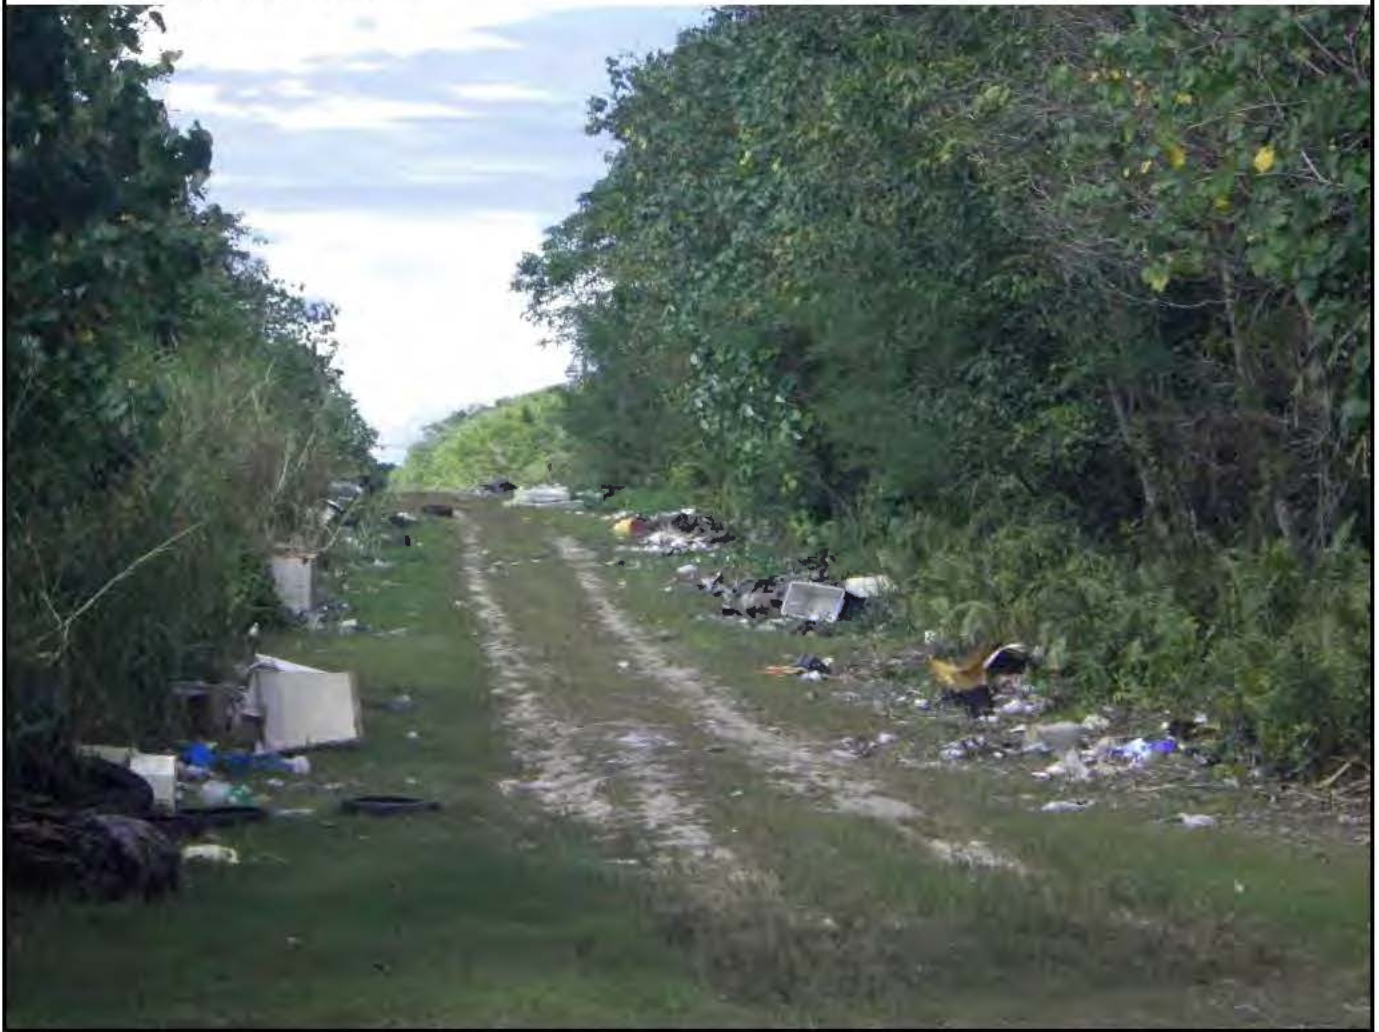
File Name: RIMG0199.JPG

Title	Guam Waterworks Authority (VP0989)
Subject	Northern System
Latitude	[REDACTED]
Longitude	[REDACTED]
Photo Direction	[REDACTED]
Elevation	[REDACTED]
Date Time Stamp	5/1/2012 2:45:26 PM
Photographer	K. Sable
Comment	F 3 Well
Description	Close-up of road next to well pad with trash

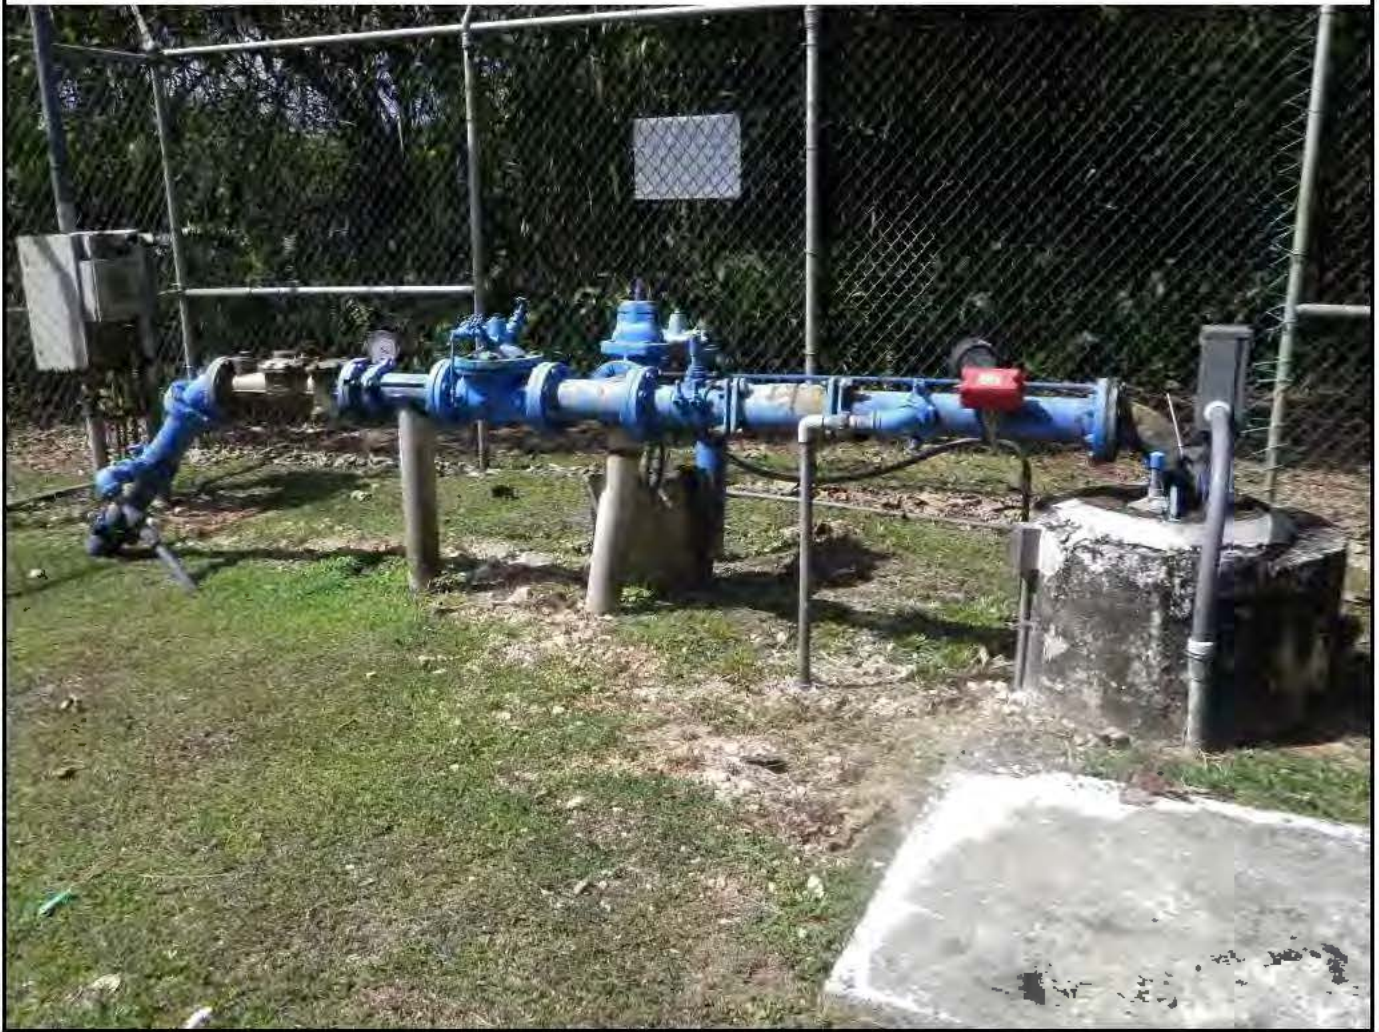
File Name: RIMG0200.JPG

Title	Guam Waterworks Authority (VP0989)
Subject	Northern System
Latitude	██████████
██████████	██████████
Photo Direction	██████
Elevation	██████t
Date Time Stamp	5/1/2012 2:50:28 PM
Photographer	K. Sable
Comment	F 3 Well
Description	Well assembly

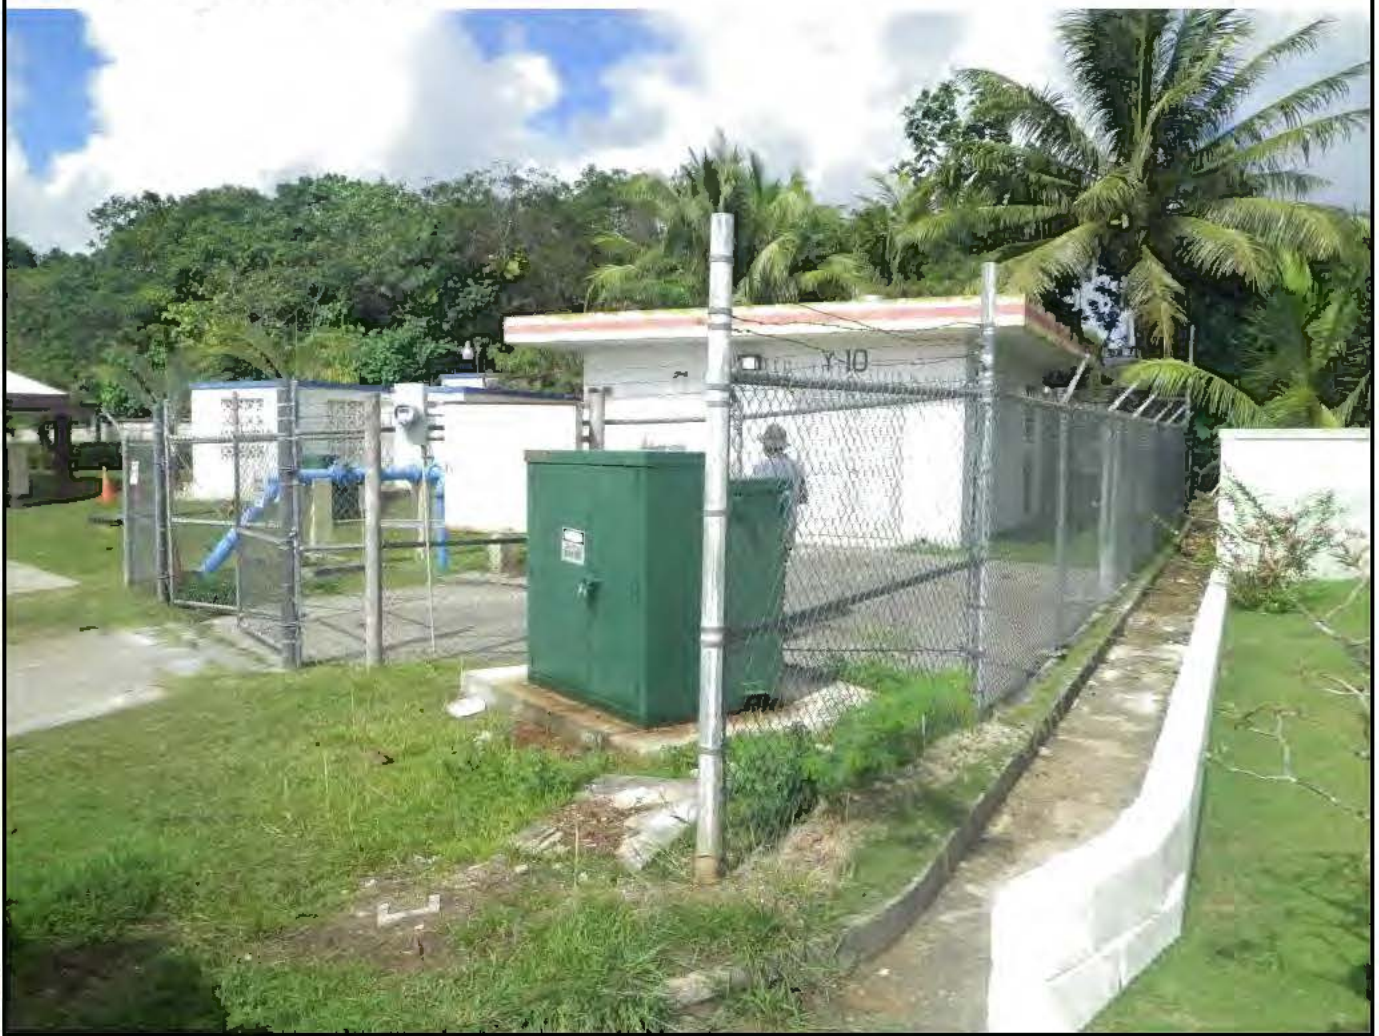
File Name: RIMG0201.JPG

Title	Guam Waterworks Authority (VP0989)
Subject	Northern System
Latitude	██████████
Longitude	██████████
Photo Direction	██████
Elevation	██████
Date Time Stamp	5/1/2012 3:17:58 PM
Photographer	K. Sable
Comment	Y 10 Well
Description	Storm sewer ditch adjacent to well pad

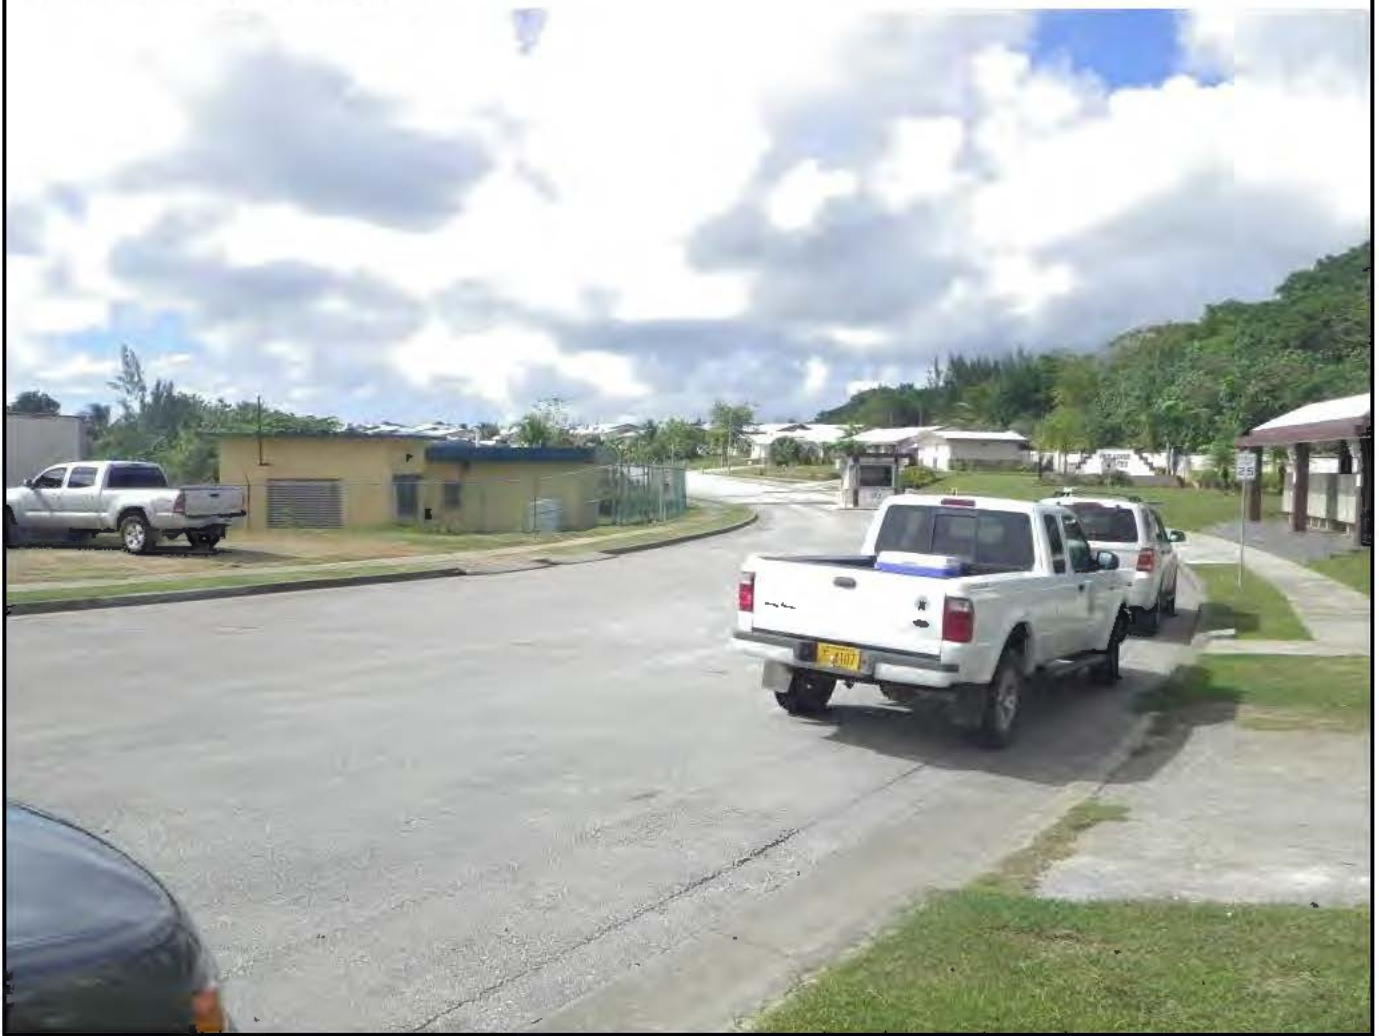
File Name: RIMG0202.JPG

Title	Guam Waterworks Authority (VP0989)
Subject	Northern System
Latitude	██████████
Longitude	██████████
Photo Direction	██████
Elevation	██████
Date Time Stamp	5/1/2012 3:18:08 PM
Photographer	K. Sable
Comment	Y 10 Well
Description	From well toward nearby Ypaopao wastewater pump station
