Title	Guam Waterworks Authority (VP0989)
Subject	Northern System
Latitude	██████████
Longitude	██████████
Photo Direction	██████
Elevation	████
Date Time Stamp	4/27/2012 9:37:55 AM
Photographer	K. Sable
Comment	Y 15 Well
Description	Overview of Y 15 well

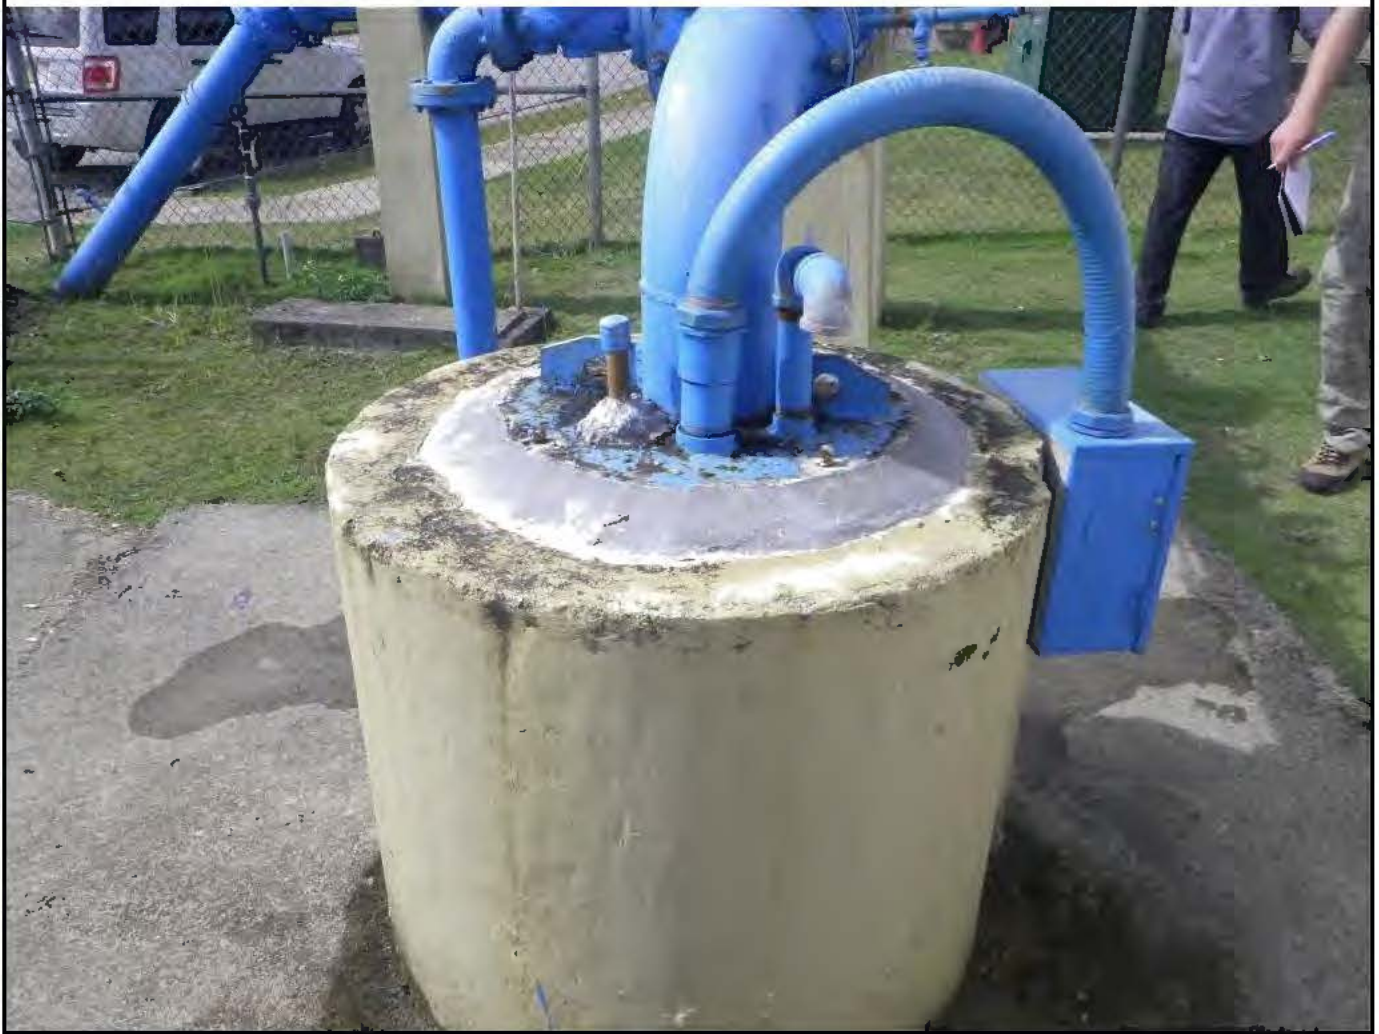
File Name: RIMG0203.JPG

Title	Guam Waterworks Authority (VP0989)
Subject	Northern System
Latitude	██████████
Longitude	██████████
Photo Direction	██
Elevation	████
Date Time Stamp	5/1/2012 3:21:24 PM
Photographer	K. Sable
Comment	Y 10 Well
Description	Well casing with holes

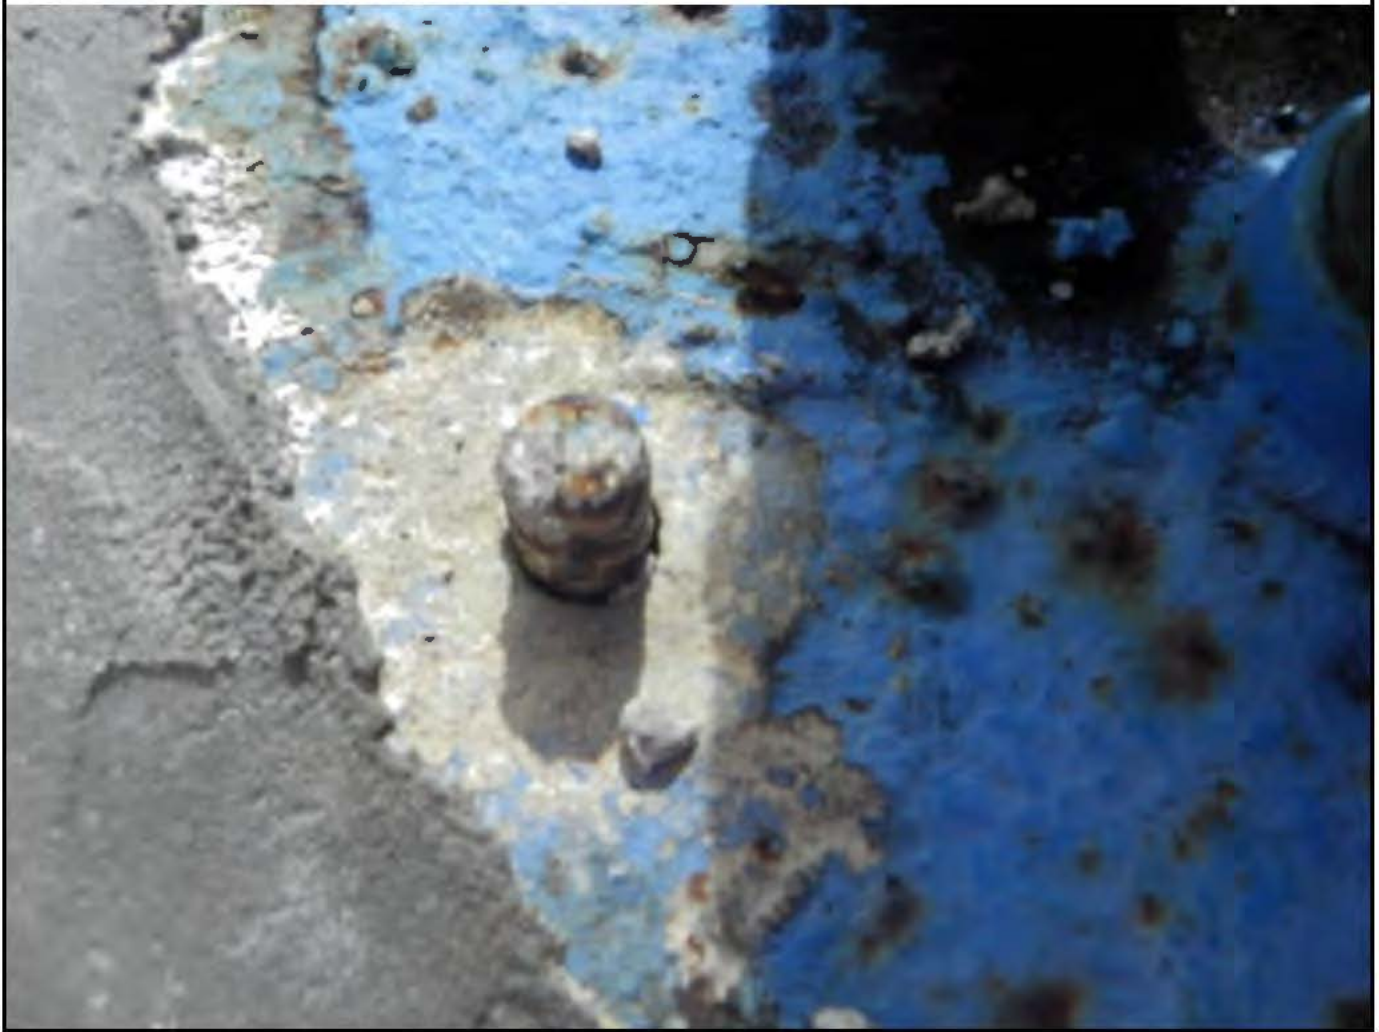
File Name: RIMG0204.JPG

Title	Guam Waterworks Authority (VP0989)
Subject	Northern System
Latitude	██████████
Longitude	██████████
Photo Direction	██████
Elevation	██████
Date Time Stamp	5/1/2012 3:21:44 PM
Photographer	K. Sable
Comment	Y 10 Well
Description	Close-up of alignment pins with holes in casing

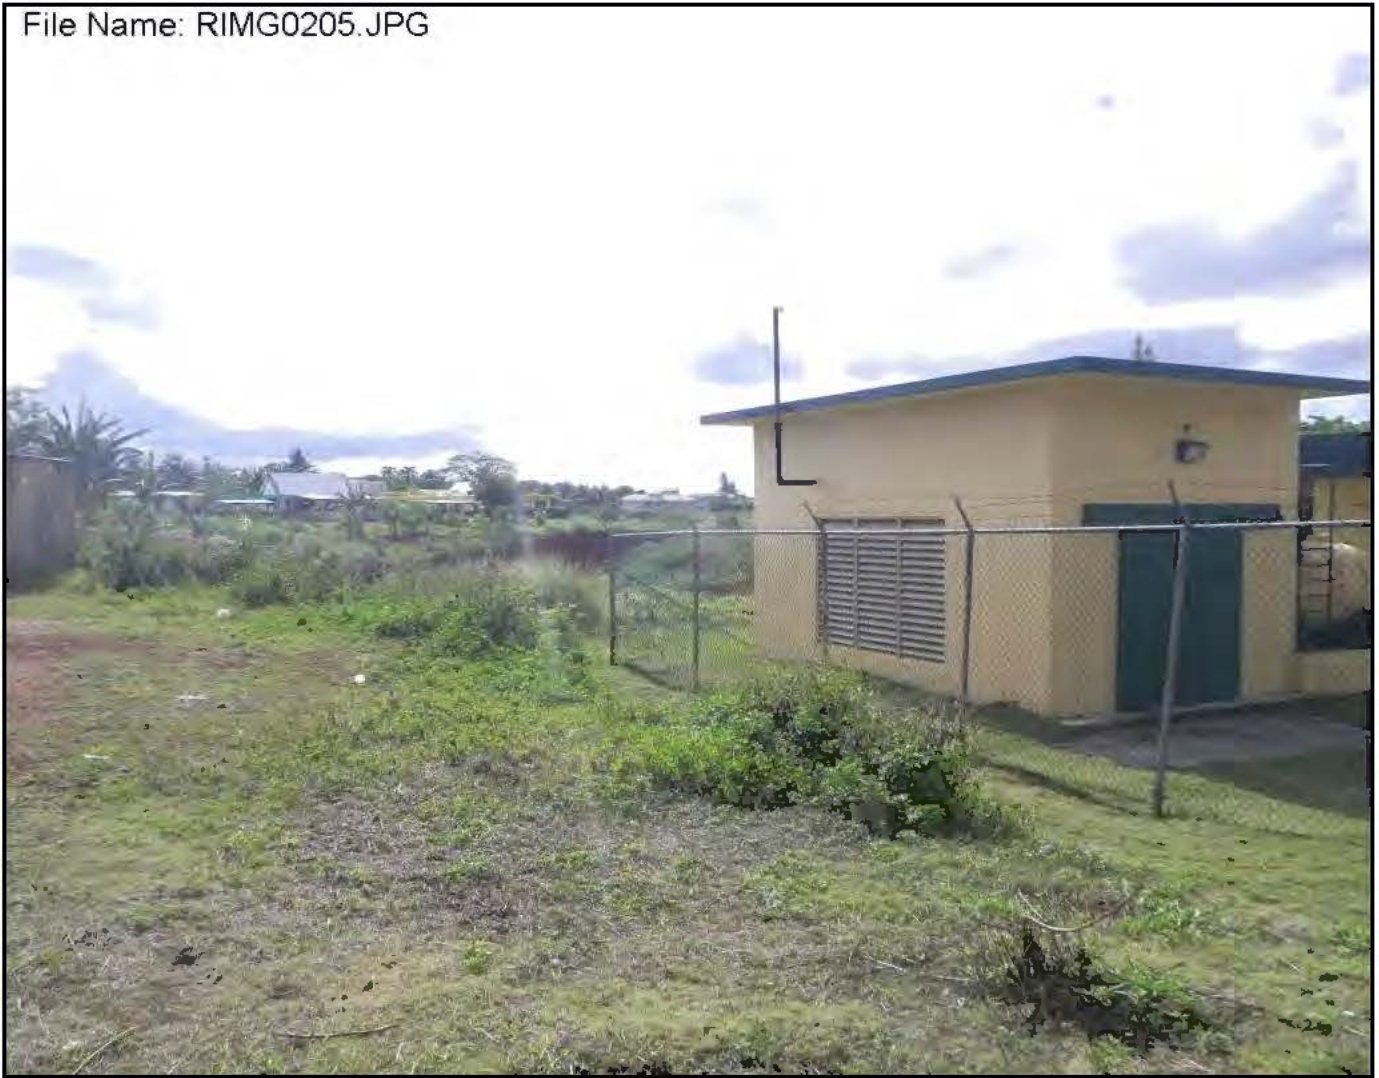
File Name: RIMG0205.JPG

Title	Guam Waterworks Authority (VP0989)
Subject	Northern System
Latitude	██████████
Longitude	██████████
Photo Direction	██████████
Elevation	██████
Date Time Stamp	5/1/2012 3:26:42 PM
Photographer	K. Sable
Comment	Y 10 Well
Description	Ypaopao wastewater pump station near well with sink hole and storm water detention basin behind

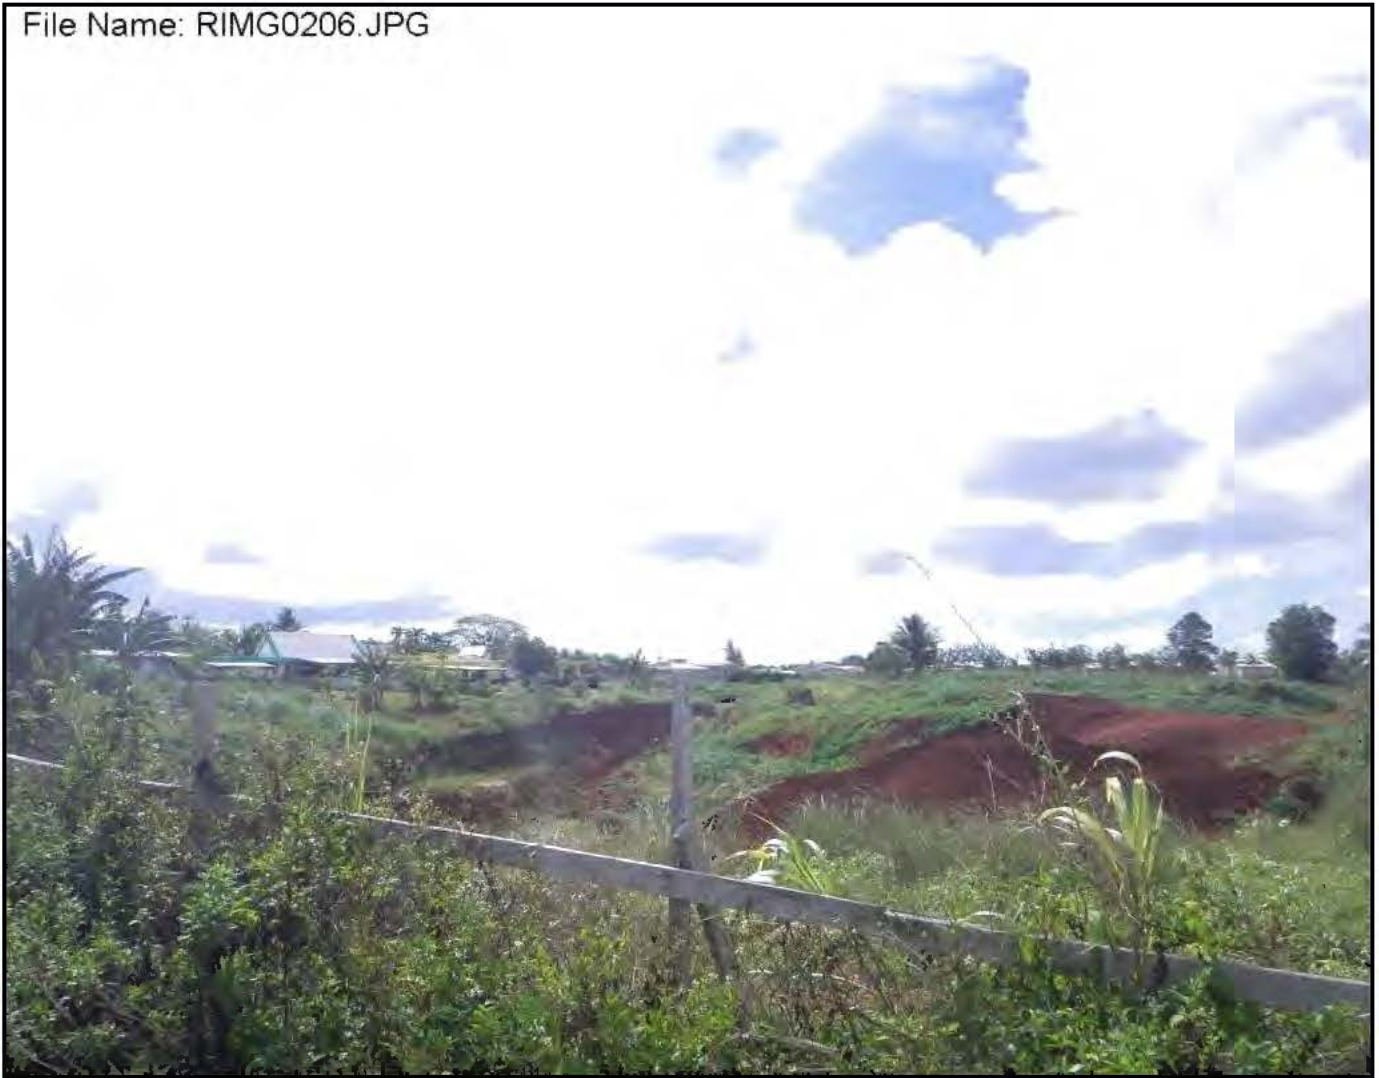
File Name: RIMG0206.JPG

Title	Guam Waterworks Authority (VP0989)
Subject	Northern System
Latitude	██████████
Longitude	██████████
Photo Direction	██████████
Elevation	██████
Date Time Stamp	5/1/2012 3:29:02 PM
Photographer	K. Sable
Comment	Y 10 Well
Description	Sink hole and storm water detention basin
