UNITED STATES ENVIRONMENTAL PROTECTION AGENCY
REGION IX
75 Hawthorne Street
San Francisco, CA 94105-3901

Mr. Richard Aschieris, Director
Port of Stockton
P.O. Box 2089
Stockton, CA 95201

Subject: Transmittal of "Port of Stockton Municipal Separate Storm Sewer Audit Report"

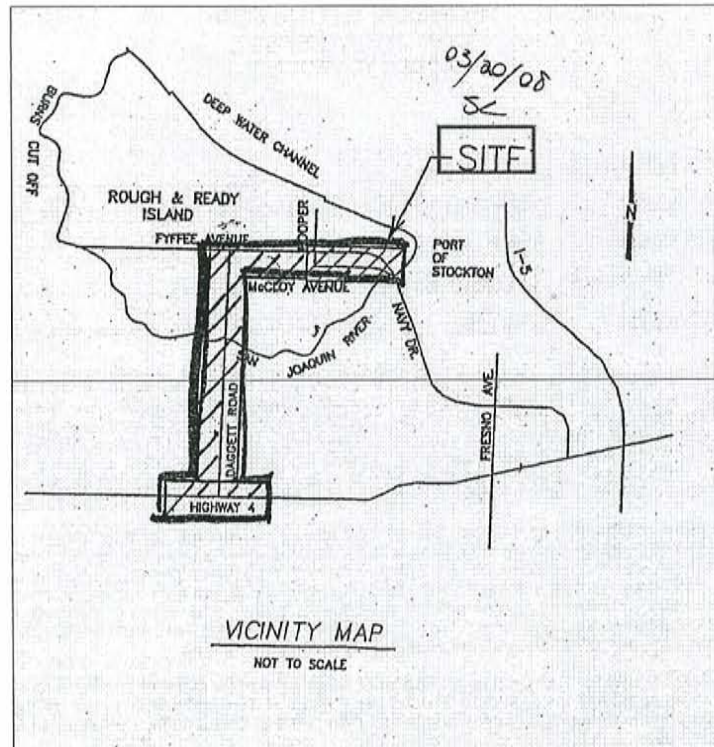
Exhibit 1 – Approximate location of the Daggett Road Project Packages A, B, C, D, and E (adapted from the SWPPP for Navy Drive to McCloy Security Reroute Project Package D, dated April 13, 2007).

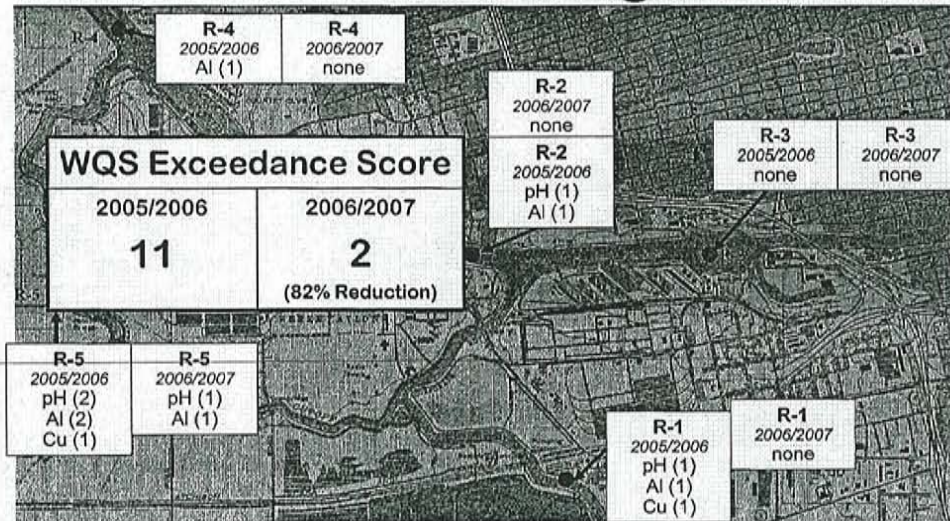
Exhibit 8 (continued) – Excerpt from Port of Stockton May 23, 2007 PowerPoint Presentation to Central Valley Regional Water Board.
