UNITED STATES ENVIRONMENTAL PROTECTION AGENCY
REGION IX
75 Hawthorne Street
San Francisco, CA 94105-3901

Enclosed is the U.S. Environmental Protection Agency's (EPA) report of the Nevada Department on the Transportation (NDOT) Storm Water Management Program (Program) Audit. Representatives from EPA Region 9 and the Nevada Department of Environmental Protection (NDEP) conducted the Audit from August 9 – 12, 2011.

MS4 Audit Report

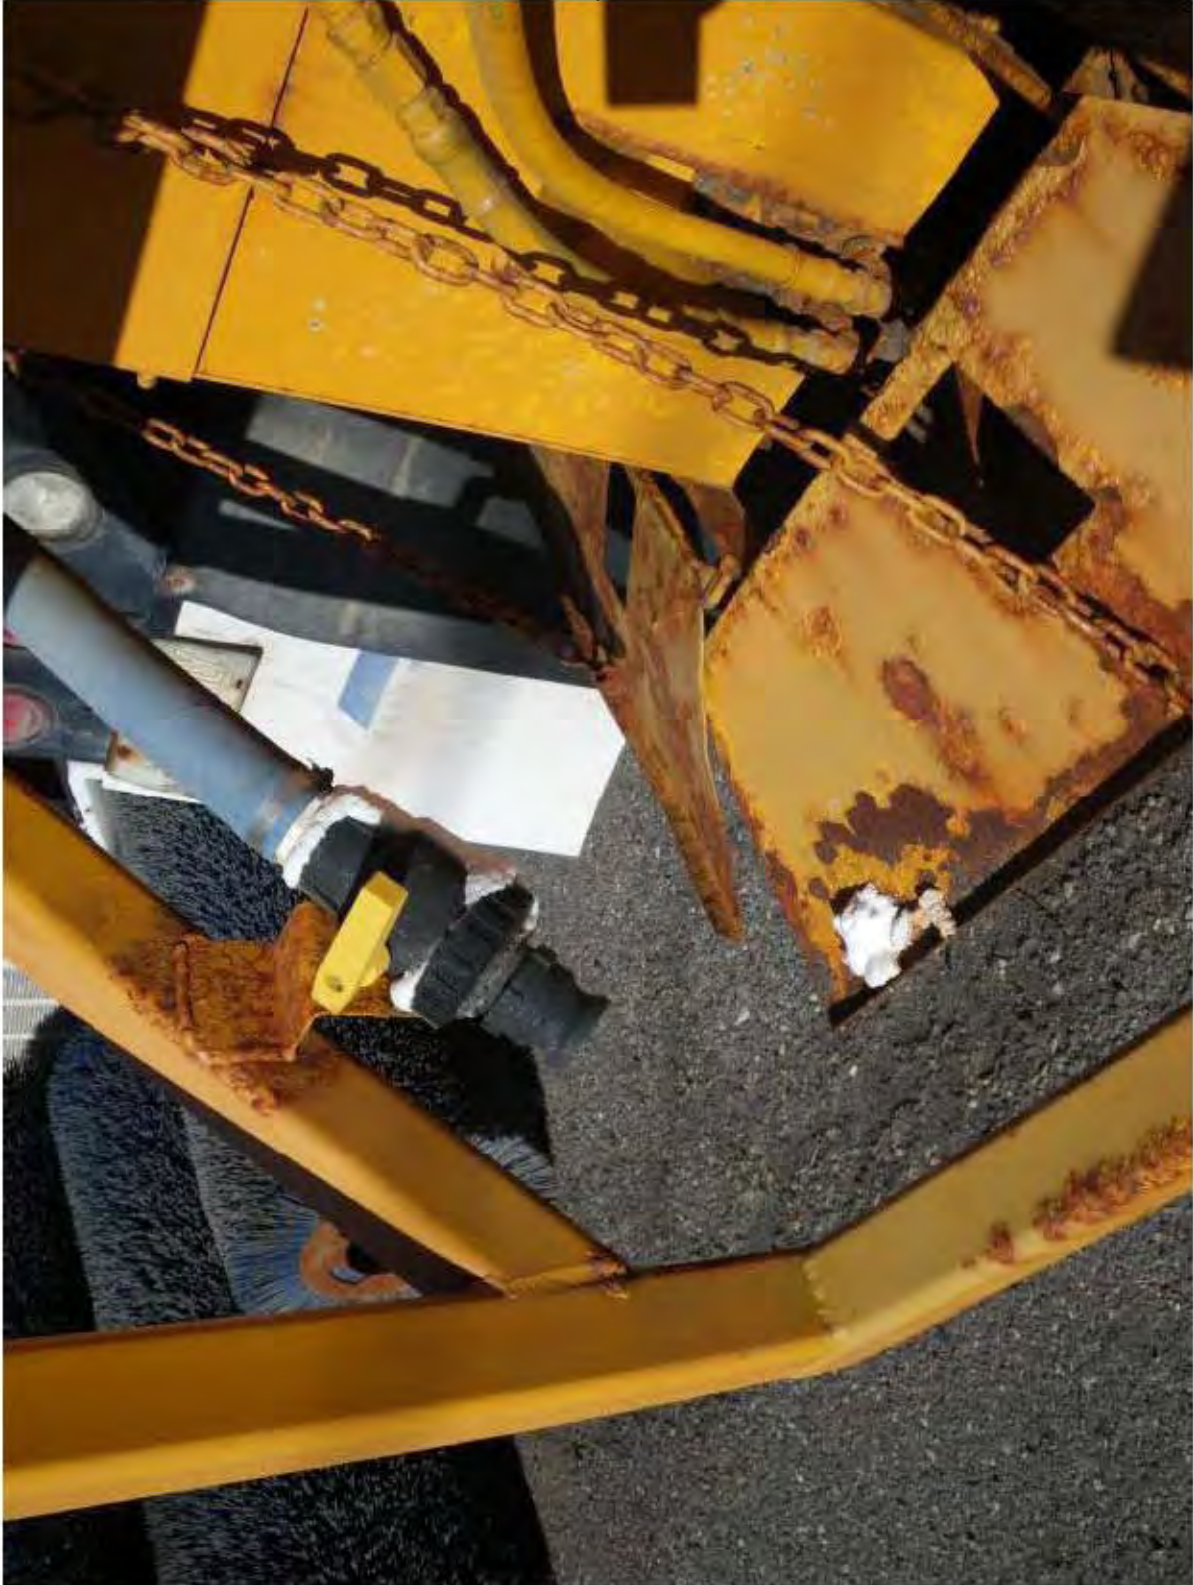
IMGP0579.JPG

IMGP0579 – Accumulated salt residue at the discharge nozzle for the brine system, blistering paint and rust on the sand spreading chute.

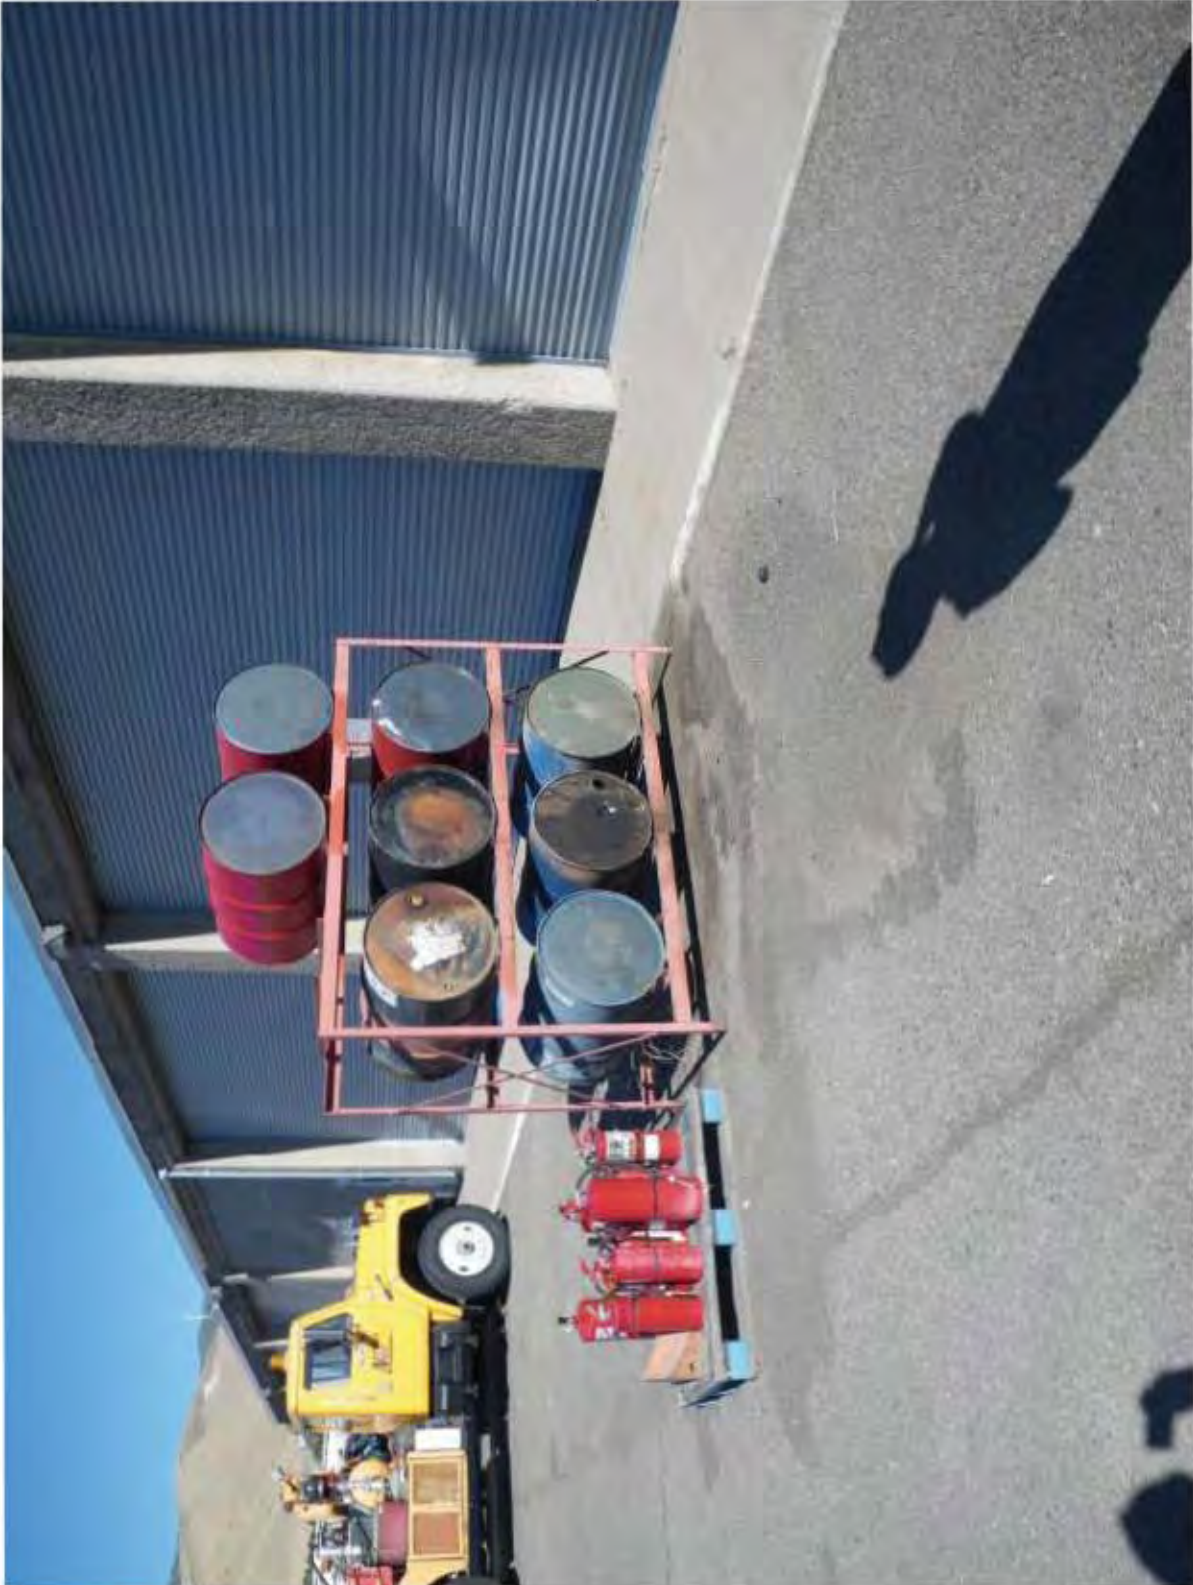
IMG0587.JPG

IMGP0587 – Uncovered empty-barrel storage area with staining on the ground.

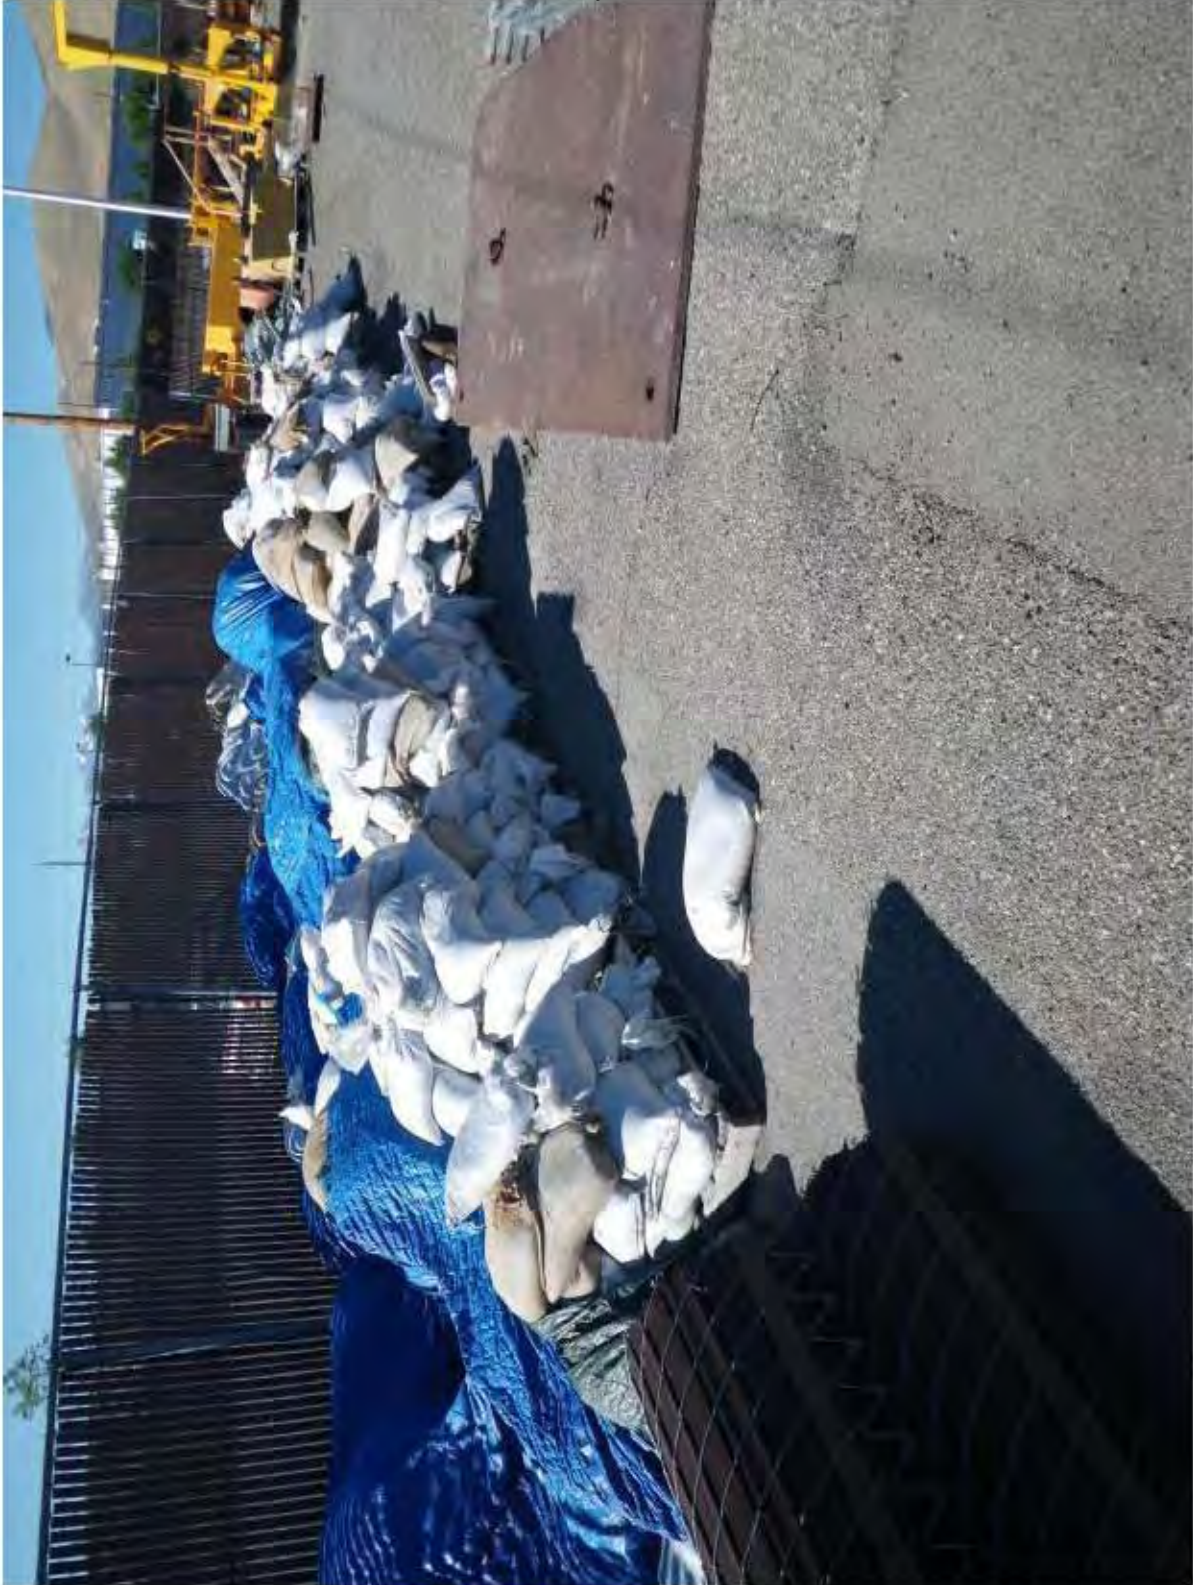
IMGP0596.JPG

IMGP0596 – Partially covered sand/gravel bags. Plastic bags were partially deteriorated and beginning to leak material. Tarps were also partially deteriorated condition and also partially pulled back.

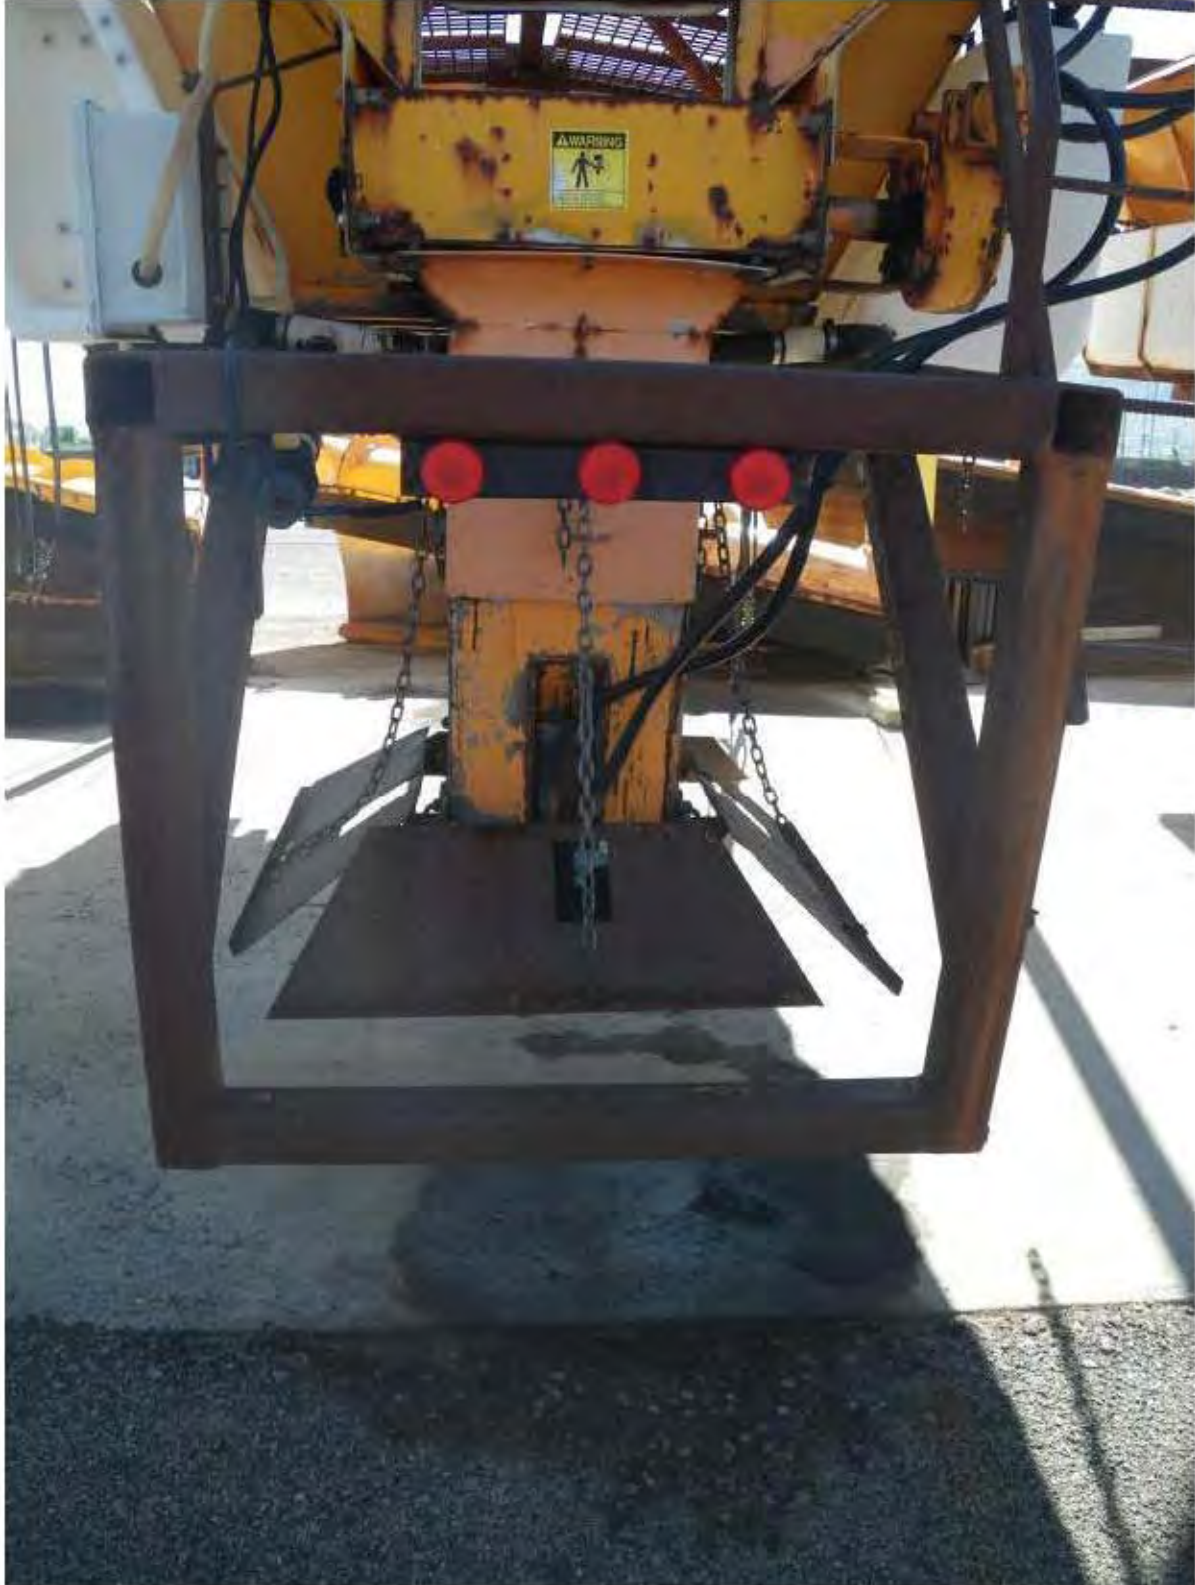
IMGP0600.JPG

IMGP0600 – Rear of a sand/brine rig with oil staining beneath the sand spreader chute.

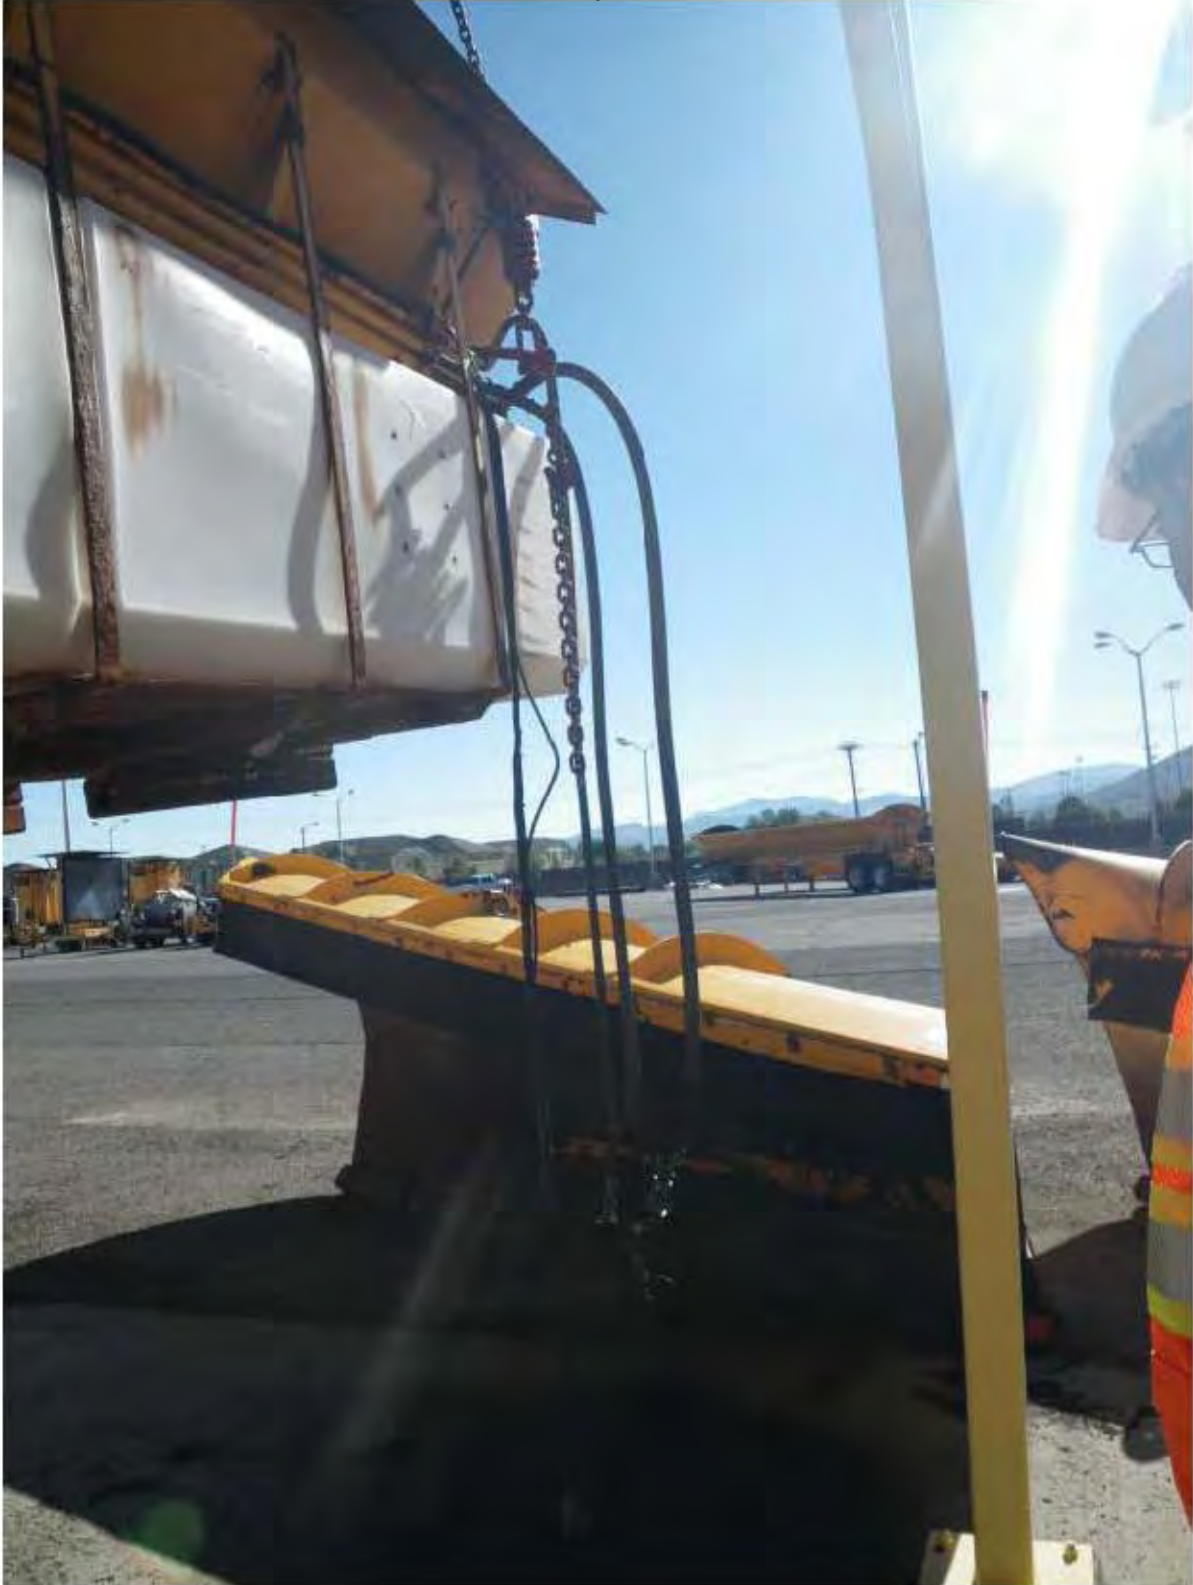
IMGP0601.JPG

IMGP0601 – Hanging hydraulic lines were contributing to staining on the yard surface.

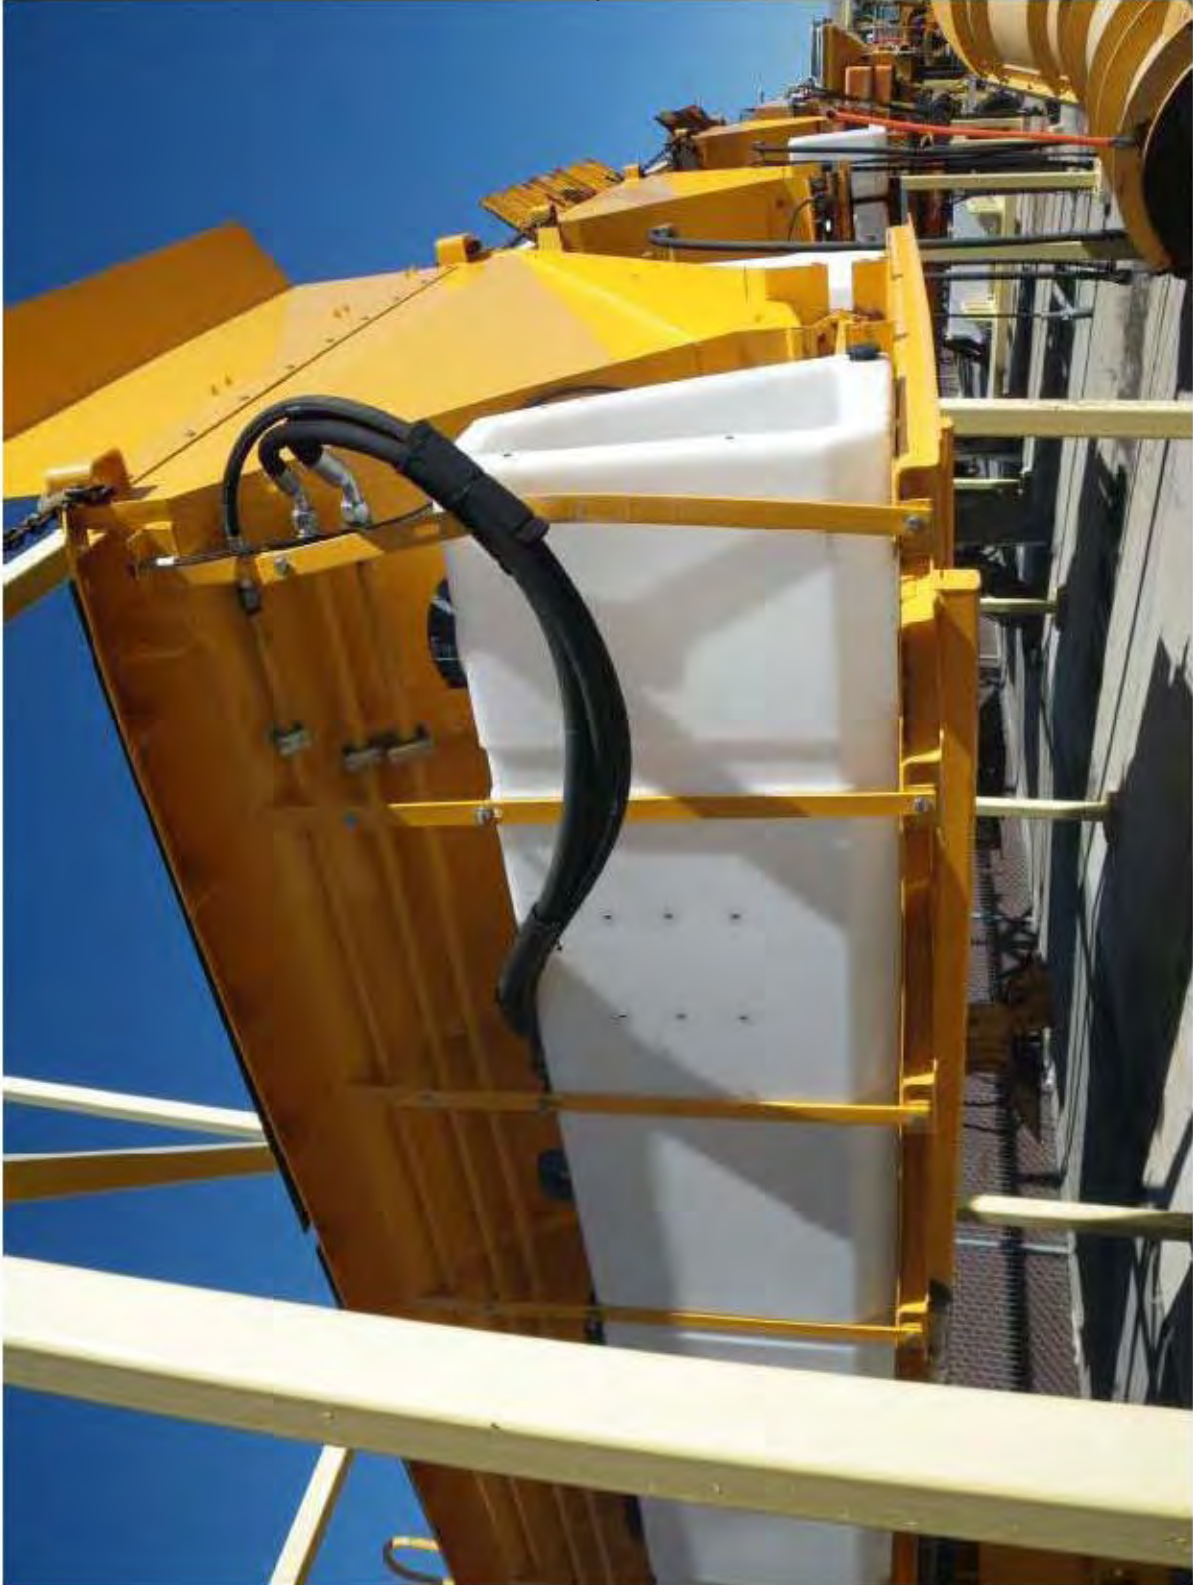
IMGP0602.JPG

IMGP0602 – The only rig with hydraulic lines tucked away, and the only rig with no oil staining at the front of the rig. The other rigs down the line had hanging hydraulic lines and had oil staining underneath.

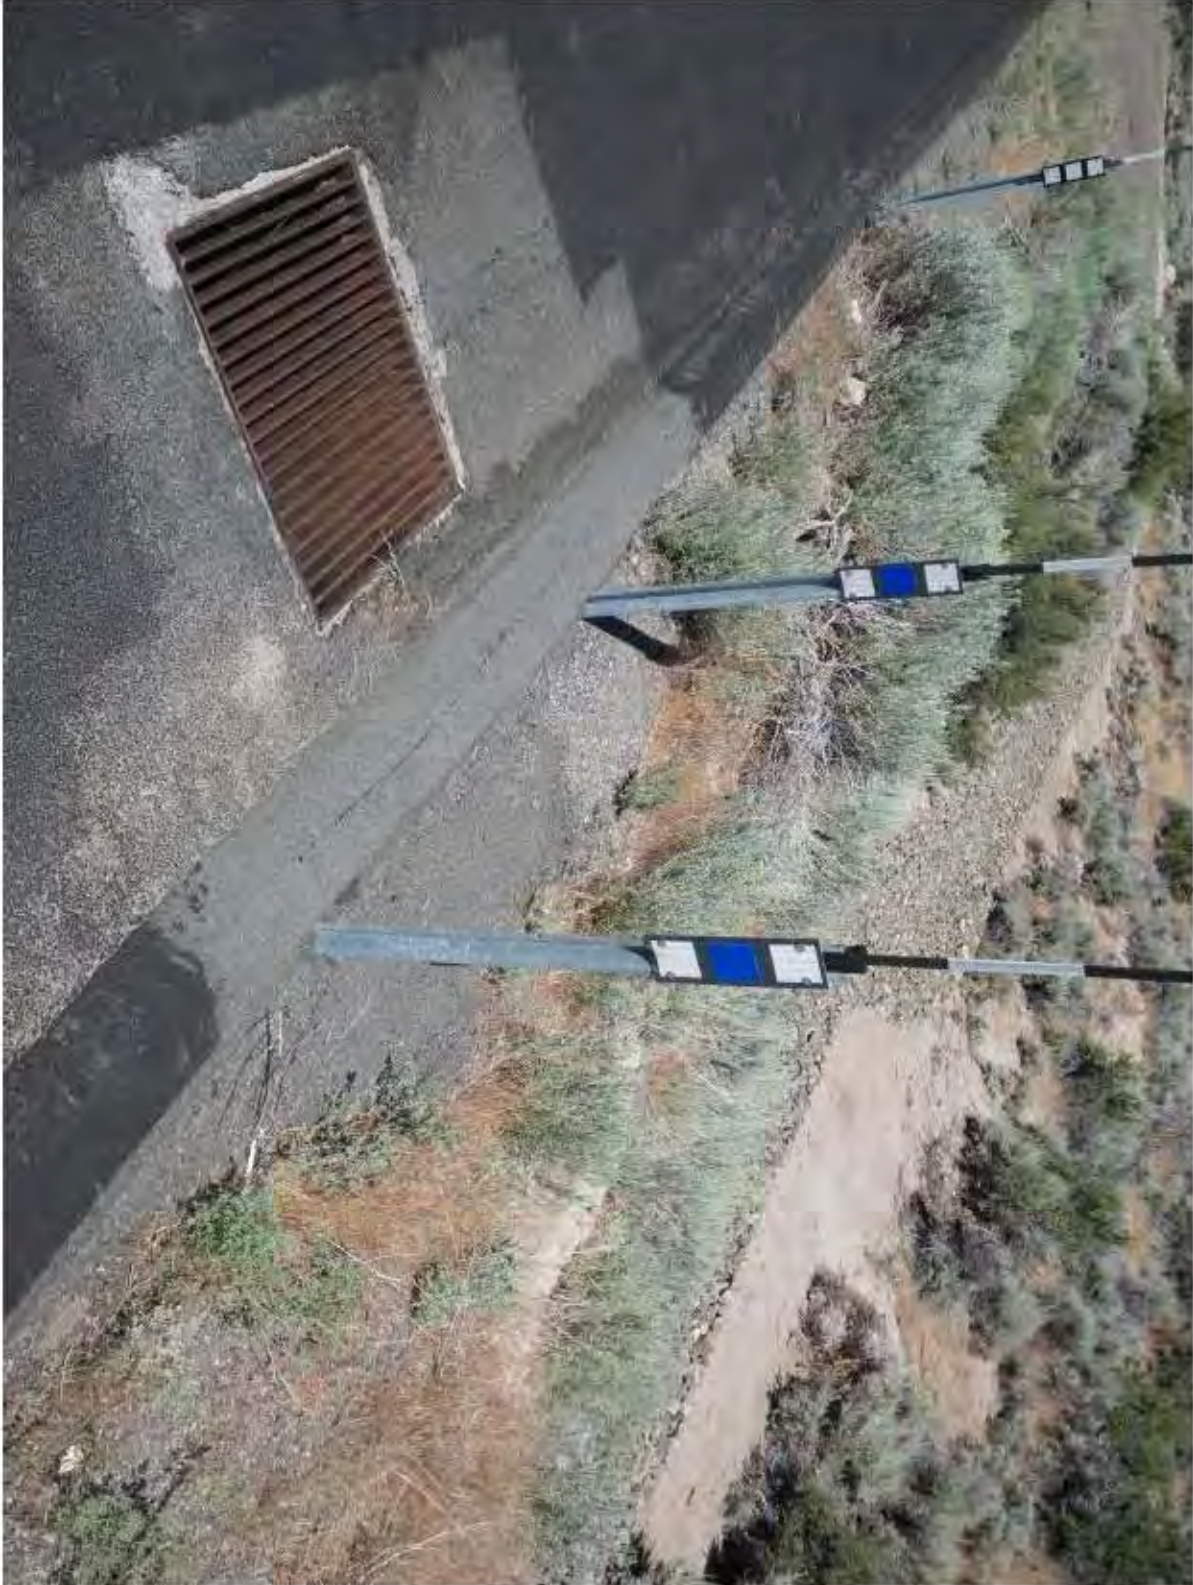
IMGP0621.JPG

IMGP0621 – (Area 1) Culvert outfall noted in IMGP0620.

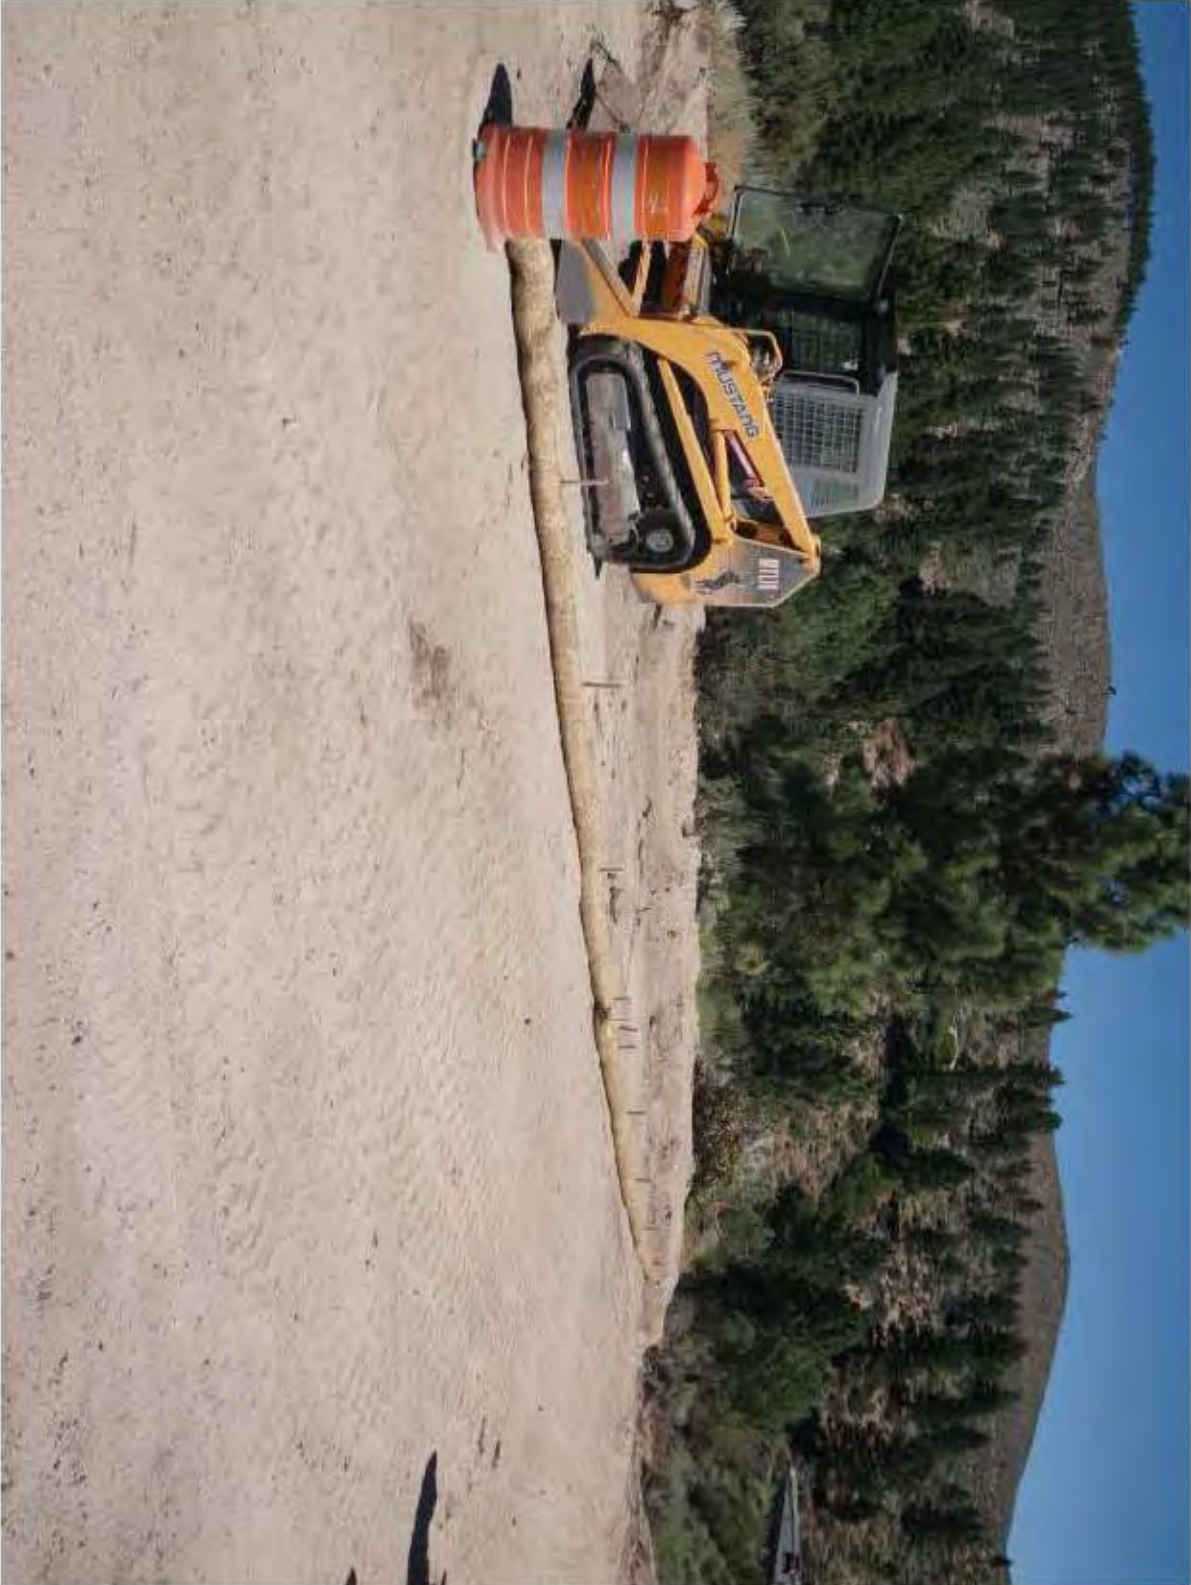
IMGP0622.JPG

IMGP0622 – (Area 1) Drop inlet that feeds the culvert and outfall noted in IMGP0621.

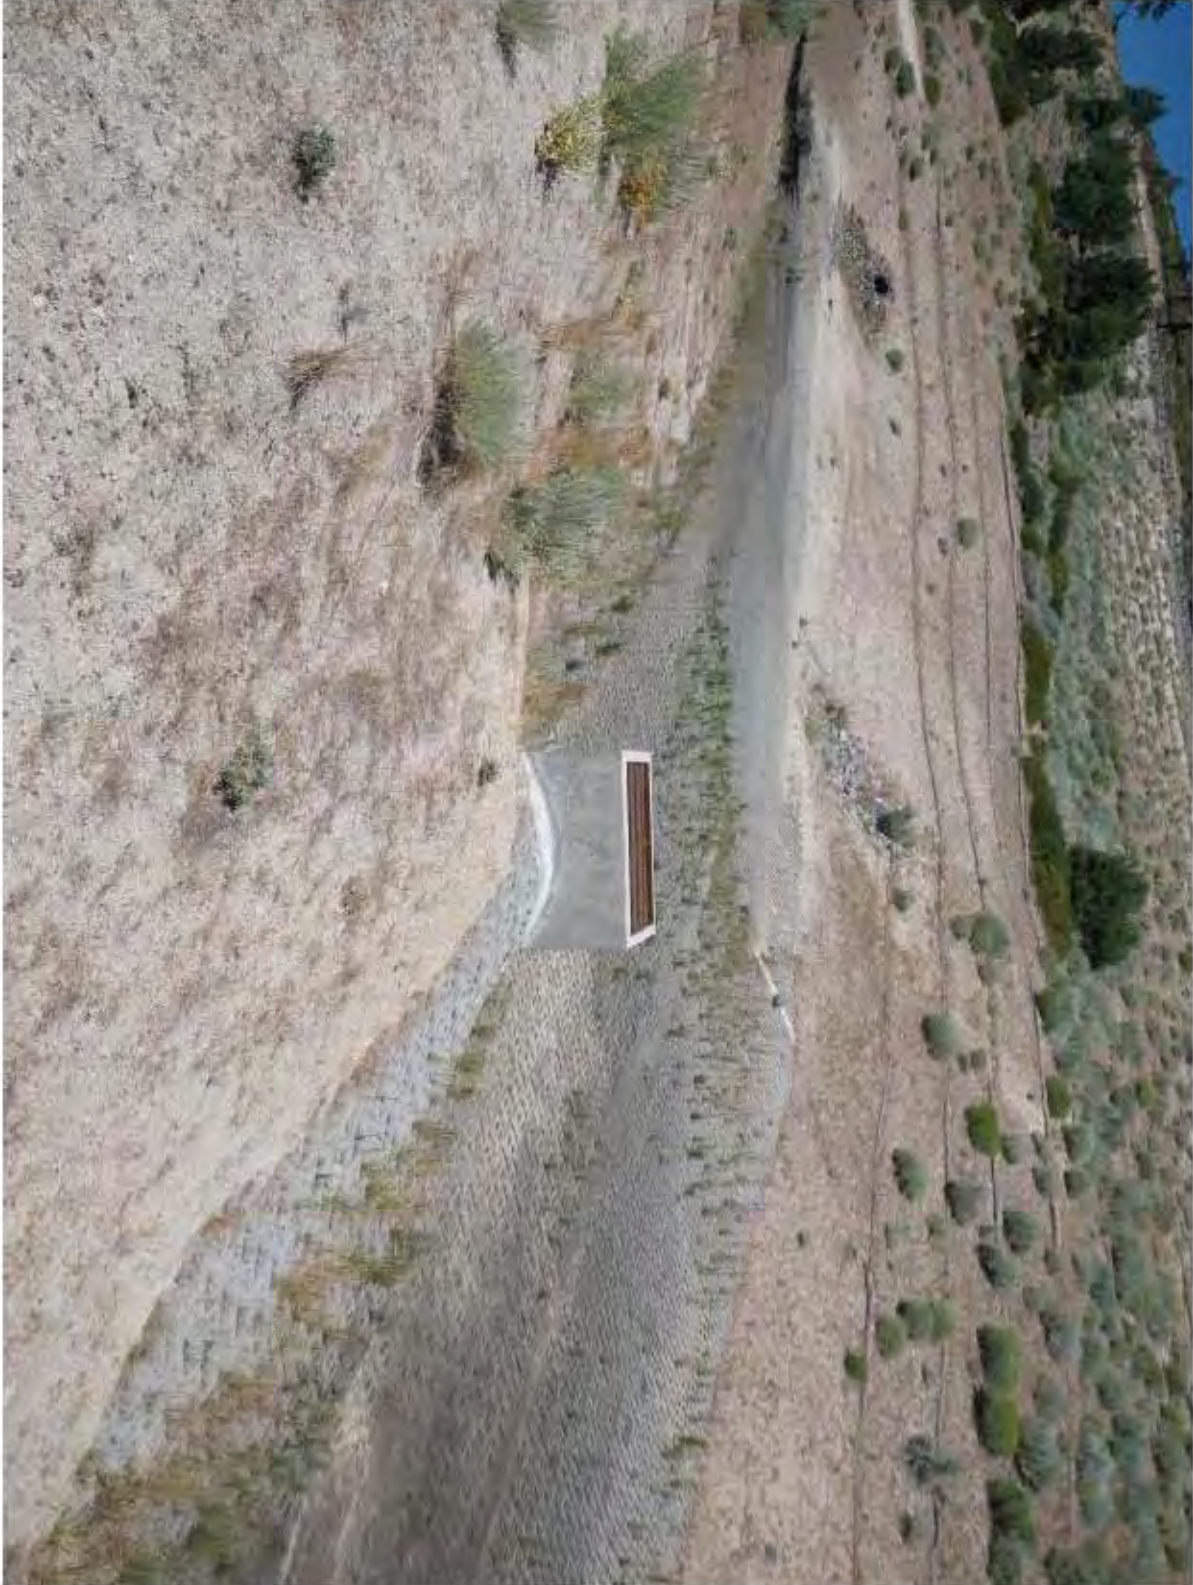
IMGP0634.JPG

IMG0634 – (Area 3) Culvert out falls that discharge to the detention basin. Stabilized and revegetated hillside, and articulated blocks that serve as the bottom liner for the basin and promote infiltration of storm water.

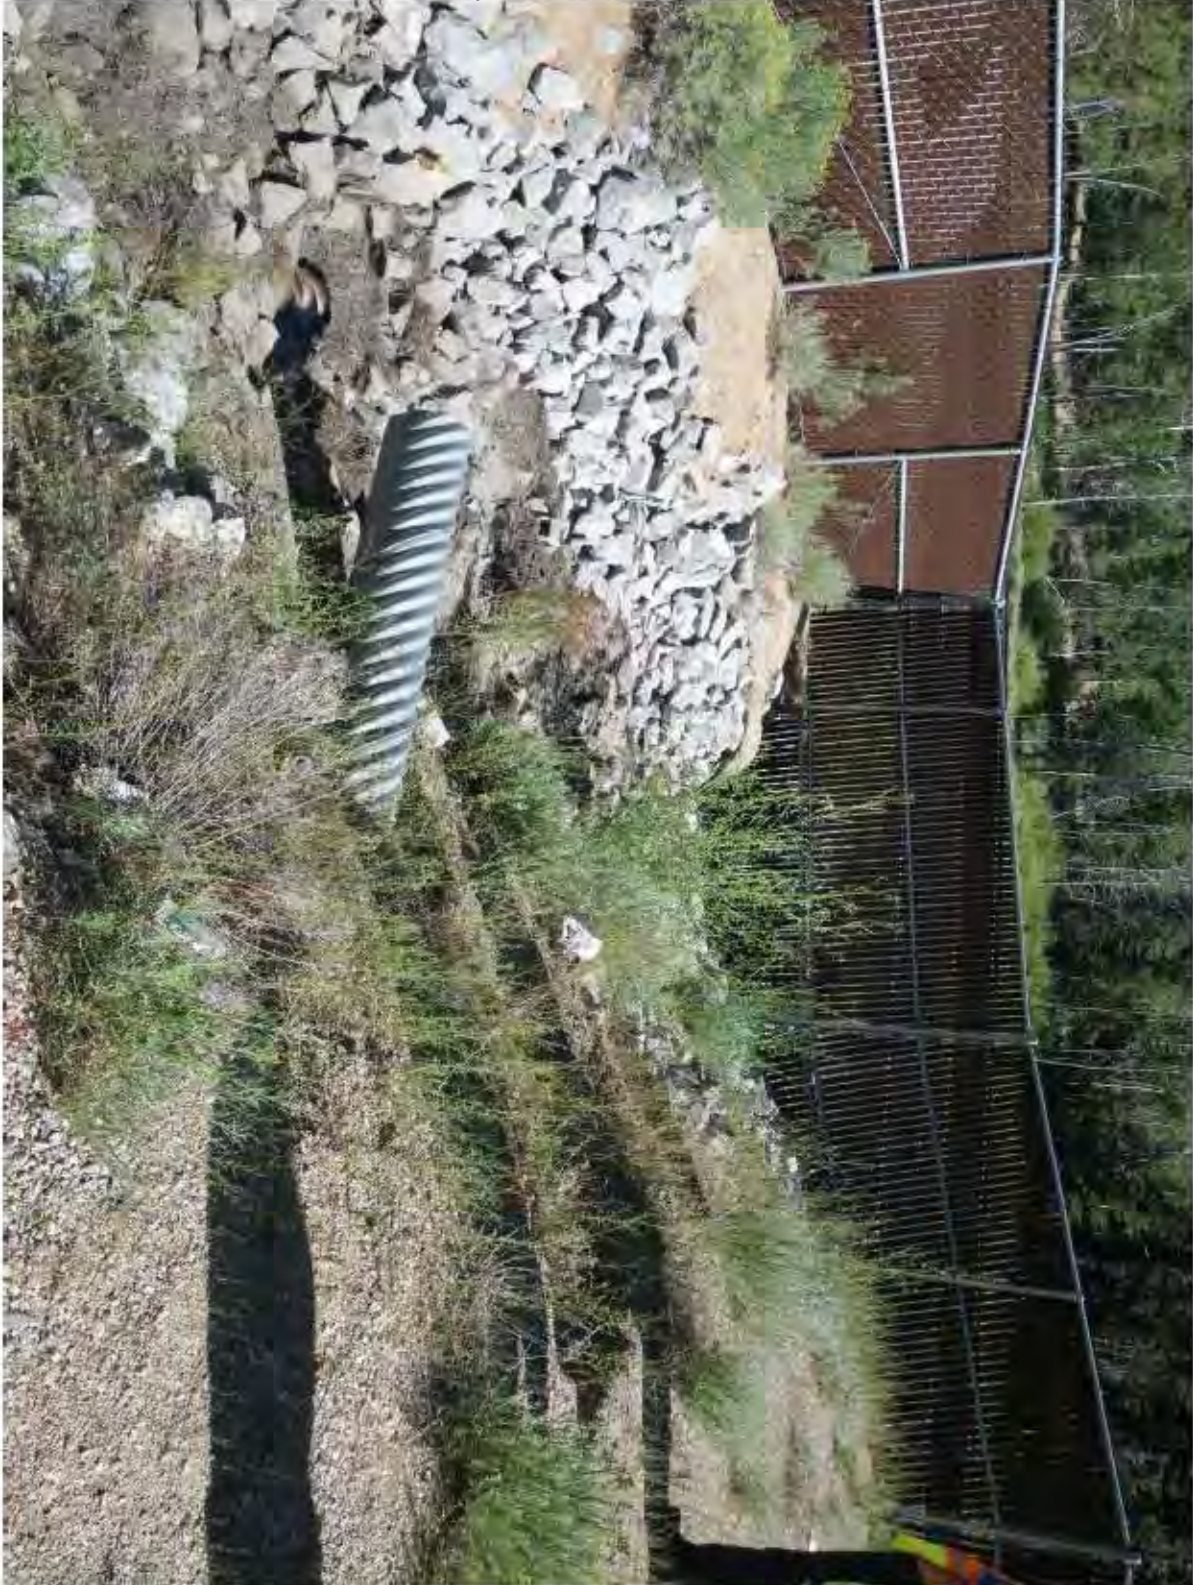
IMGP0643.JPG

IMG0643 – The outfall culvert discharges into a rock-lined drainage channel. Accumulated sediment was observed in the channel resulting from opening the outfall gate during heavy runoff that was causing the pond to over-top its berm.

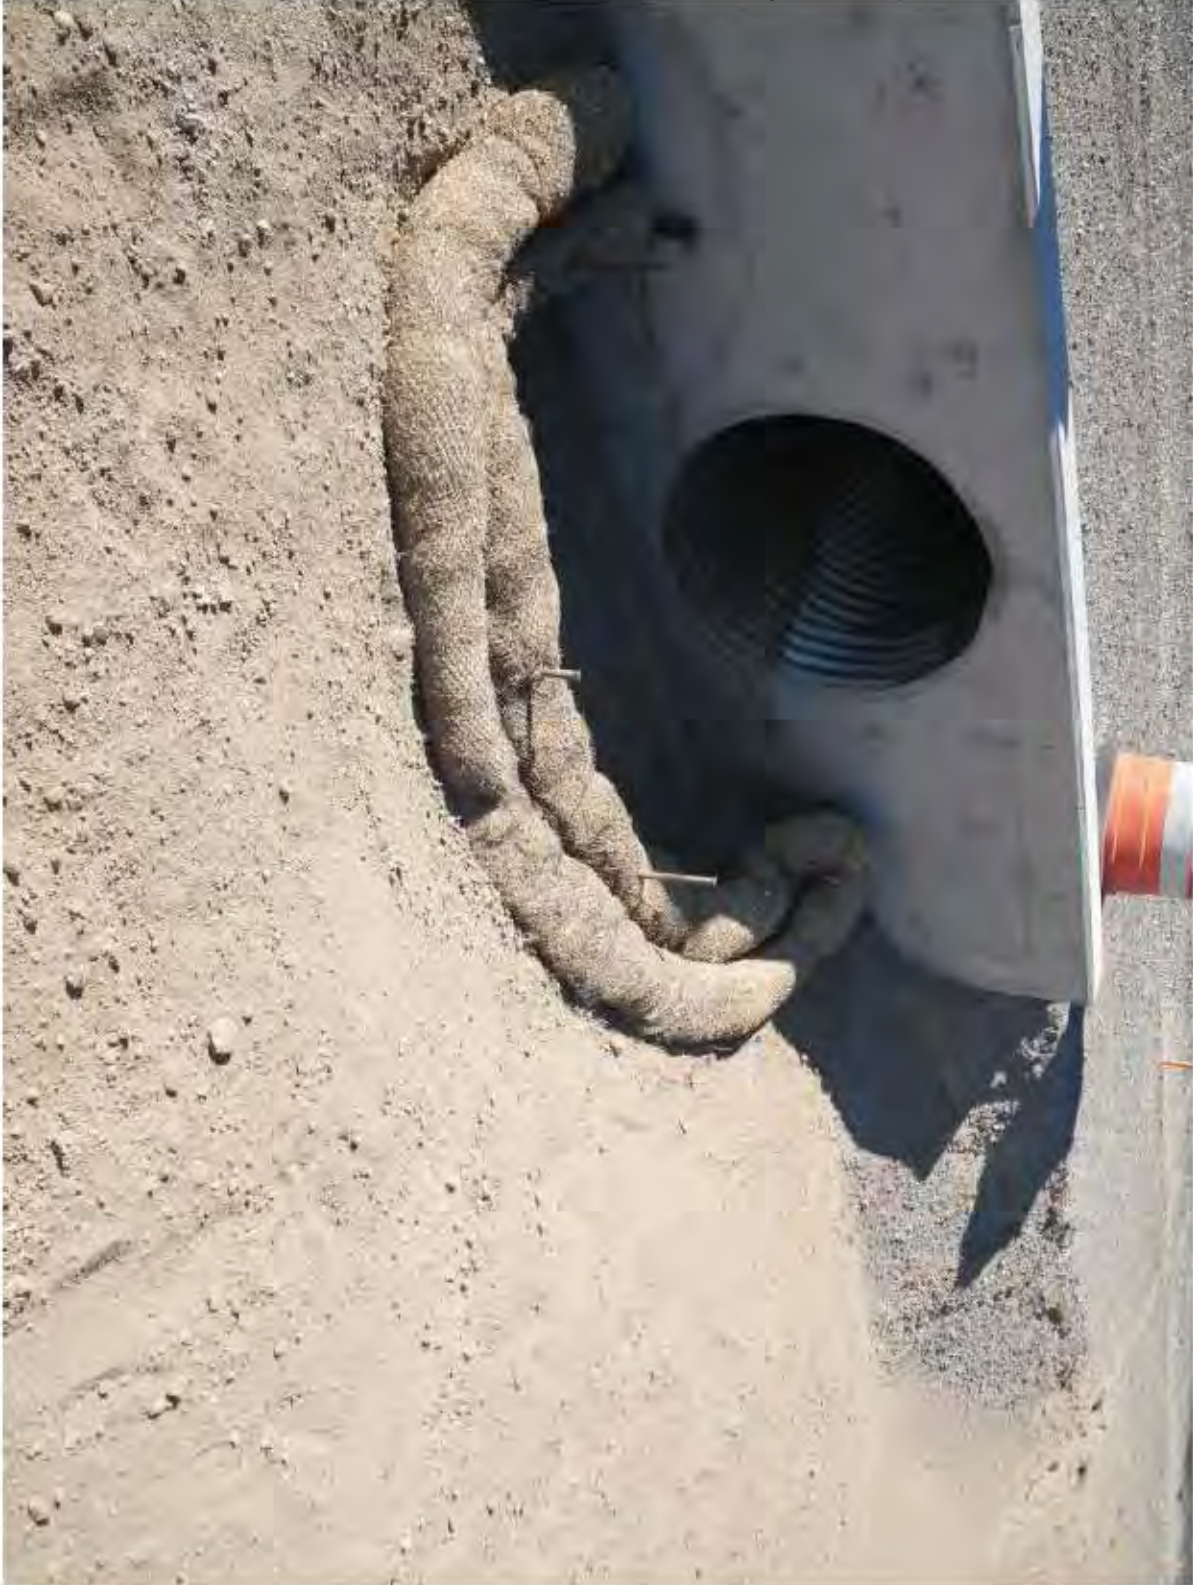
IMGP0645.JPG

IMG0645 – Newly constructed culvert inlet that had been cleaned out and maintained after failure during a storm event. Accumulated wind-deposited sediment inundated the inlet basin, and sediment laden storm water caused a failure of the fiber roll. Sediment was cleared from the inlet, and the fiber-roll was re-keyed and staked.

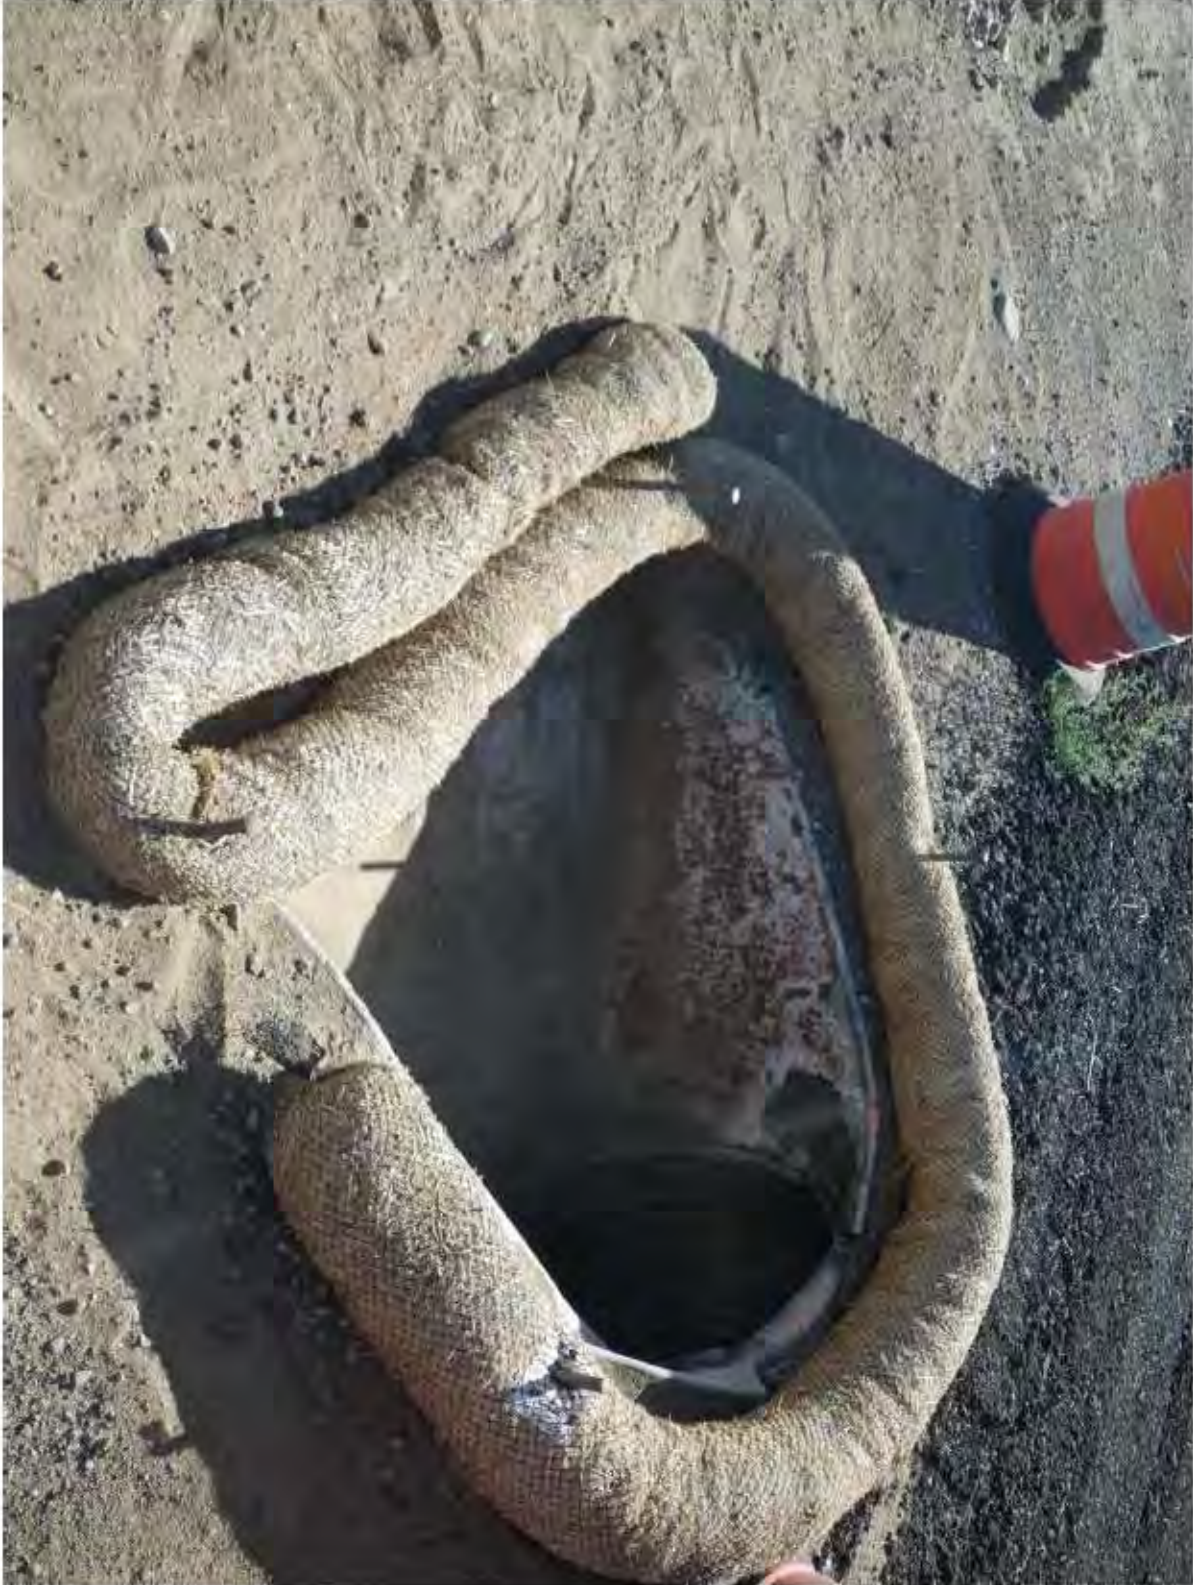
IMGP0648.JPG

IMG0648 – Rehabilitated culvert inlet that had been cleaned out and maintained after failure during a storm event. Accumulated wind-deposited sediment inundated the inlet basin, and sediment laden storm water caused a failure of the fiber roll. Sediment was cleared from the inlet, and the fiber-roll was re-keyed and staked.
