UNITED STATES ENVIRONMENTAL PROTECTION AGENCY
REGION IX
75 Hawthorne Street
San Francisco, CA 94105-3901

Enclosed is the U.S. Environmental Protection Agency's (EPA) report of the Nevada Department on the Transportation (NDOT) Storm Water Management Program (Program) Audit. Representatives from EPA Region 9 and the Nevada Department of Environmental Protection (NDEP) conducted the Audit from August 9 – 12, 2011.

MS4 Audit Report

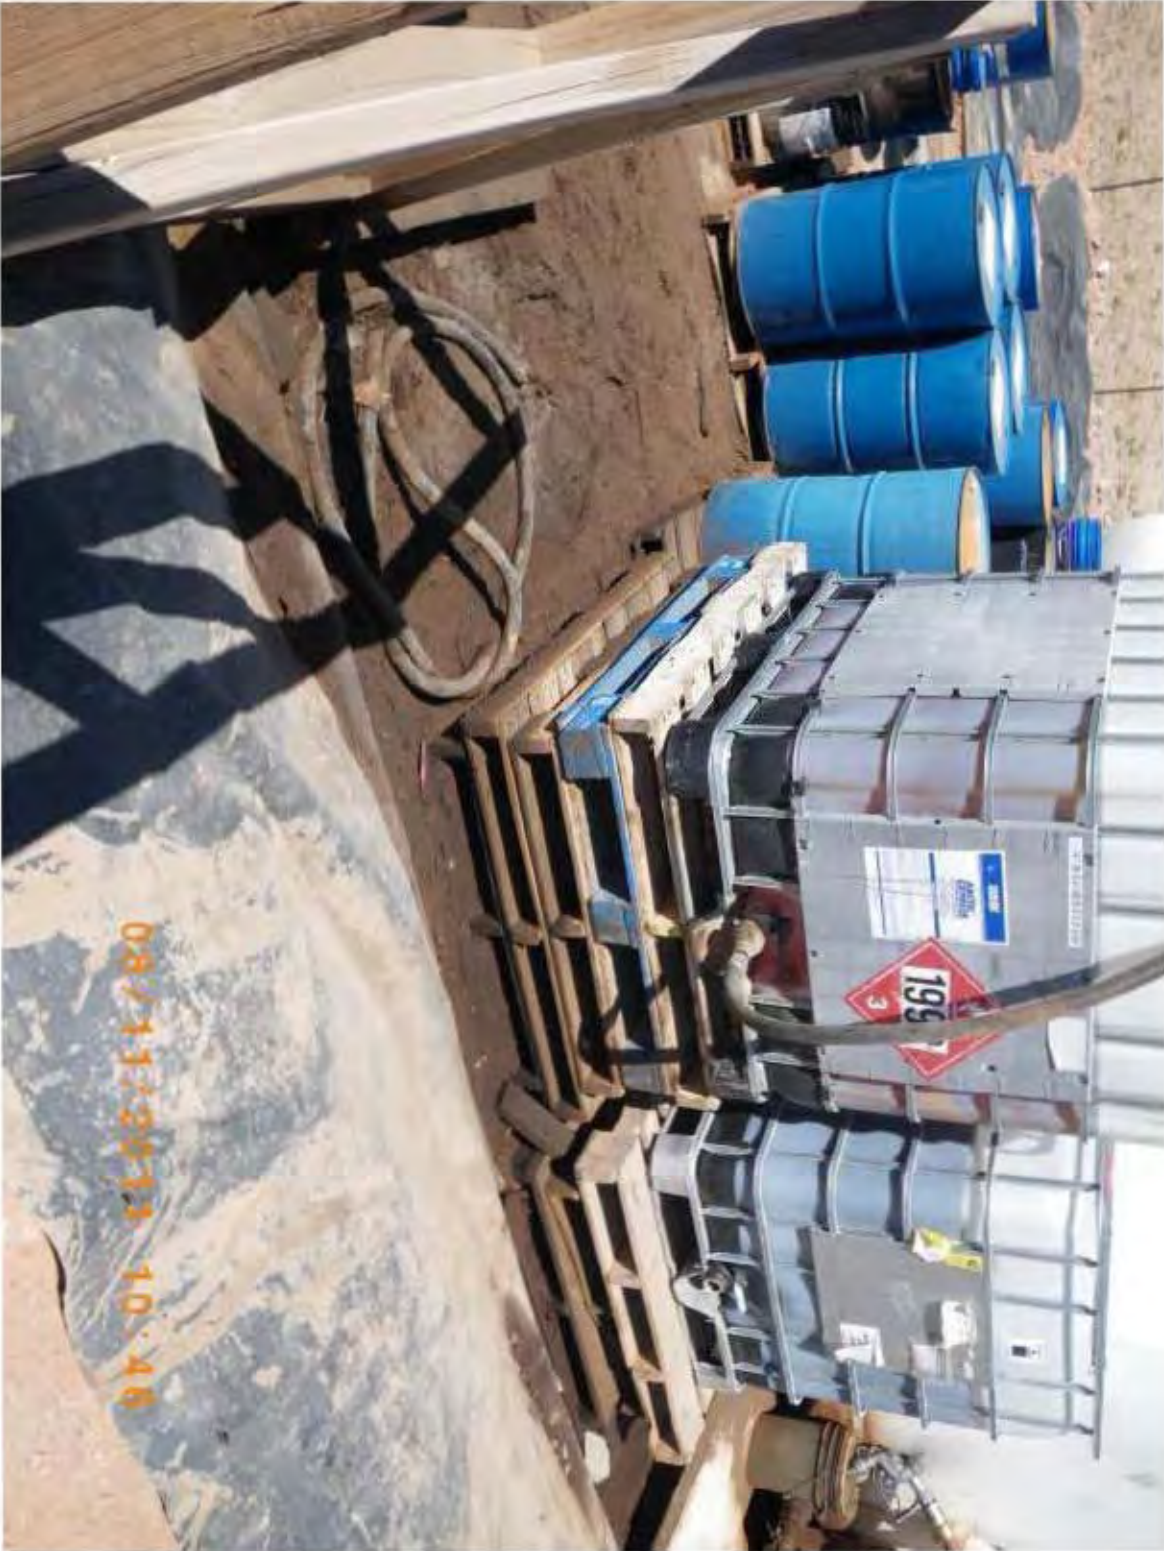
IMGP0177.JPG –Photo shows secondary containment around diesel fuel and equipment lubrication operation at the contractor staging area. Note stained area within the containment area. This area was also inspected by NDOT Contractor and reported in June 24 inspection report (photo 11) as requiring liquid at the time to be removed. I recommended that the contractor also remove the oil-stained dirt from within the area so the liner could be properly inspected for tears.

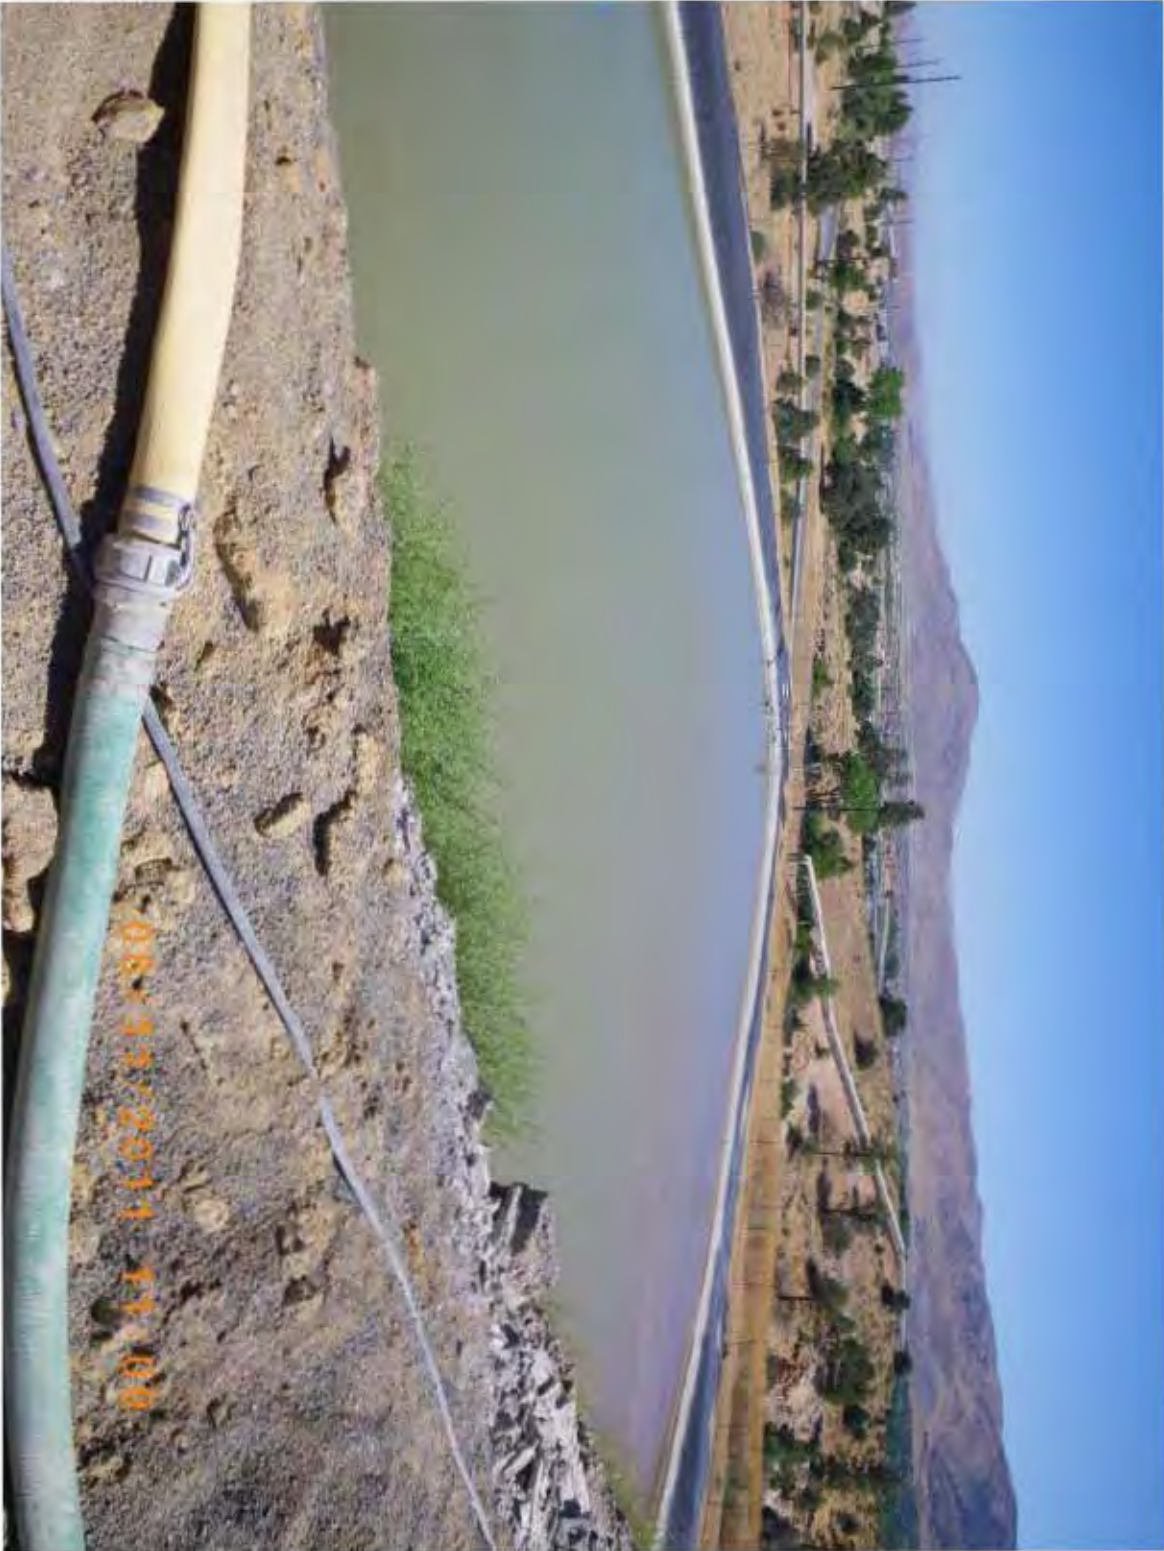
IMG0180.JPG

IMGP0180.JPG – View looking northeast of secondary settling pond at concrete batch plant. Water from this pond is pumped back up hill to the on-site aggregate washing operation. Note the low freeboard in the northeast corner of the pond. Contractor noted that this is less freeboard than they would like but said it's been permitted by the state of NV (Water Resources – Dam Construction).

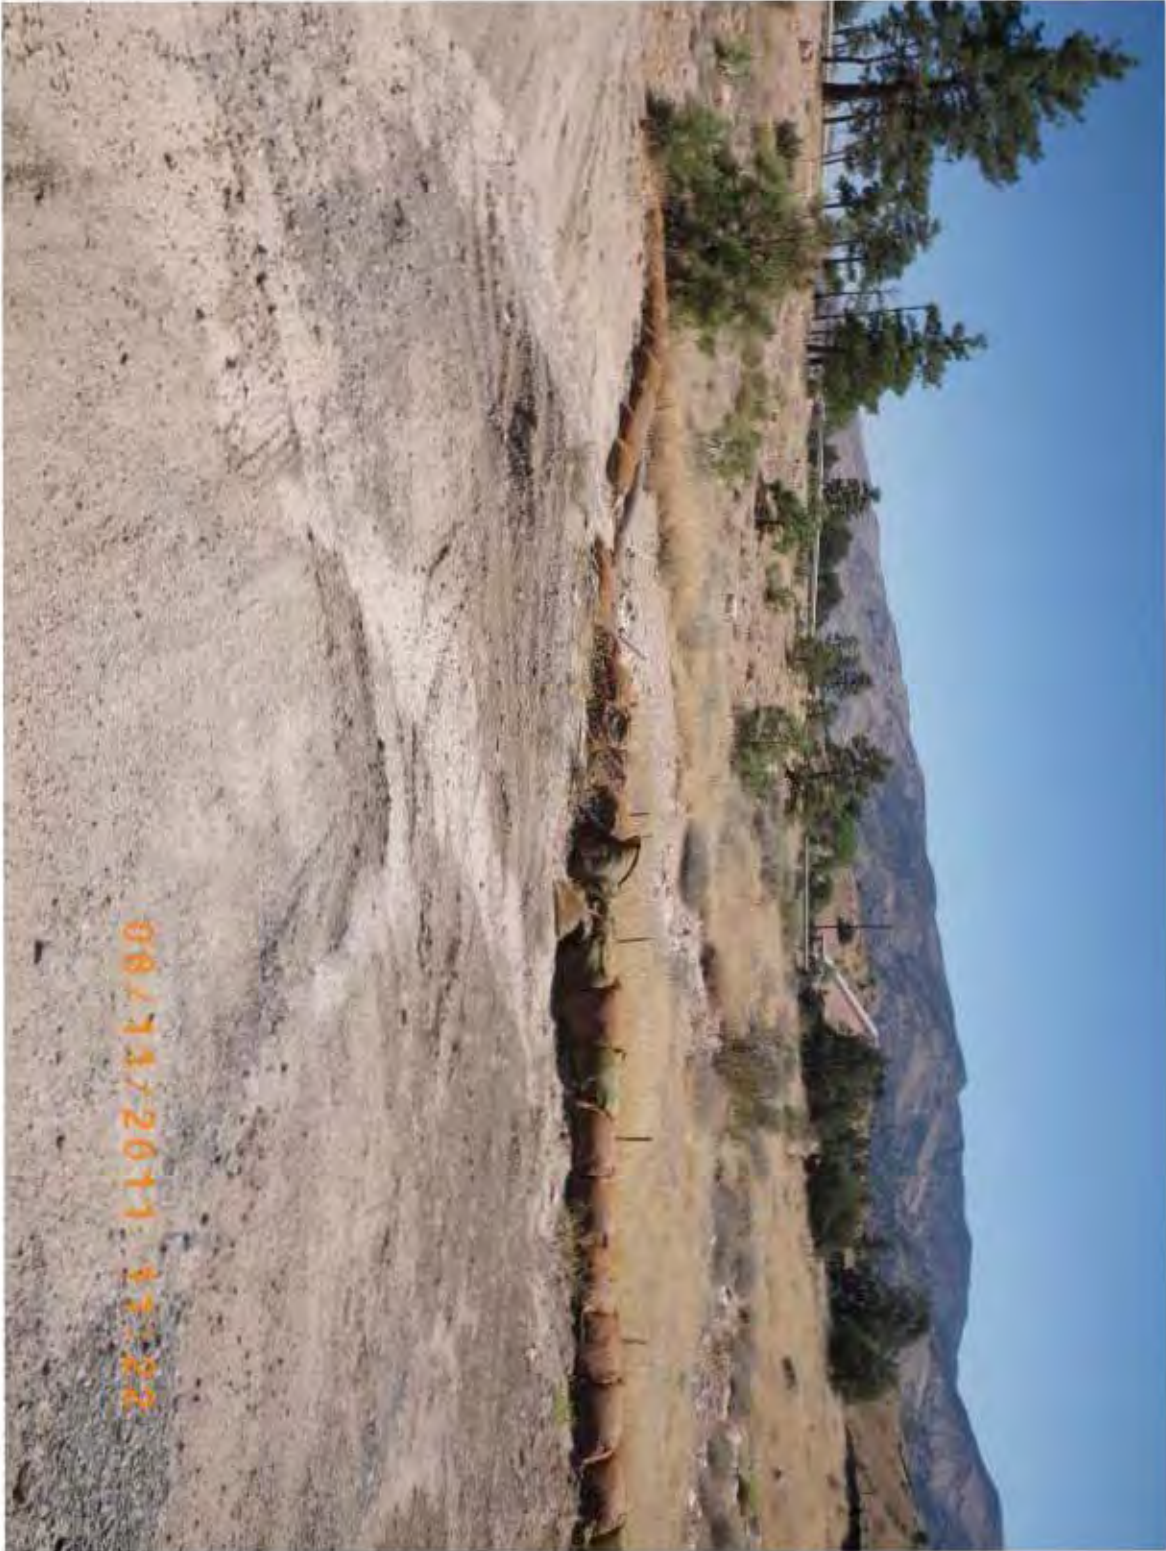
IMGP0181.JPG

- Galena forest drainage (adjacent to the concrete plant) – At this location several dirt roads criss-crossed the area and we noted the BMPs in the area had deteriorated (see photo IMGP0181).

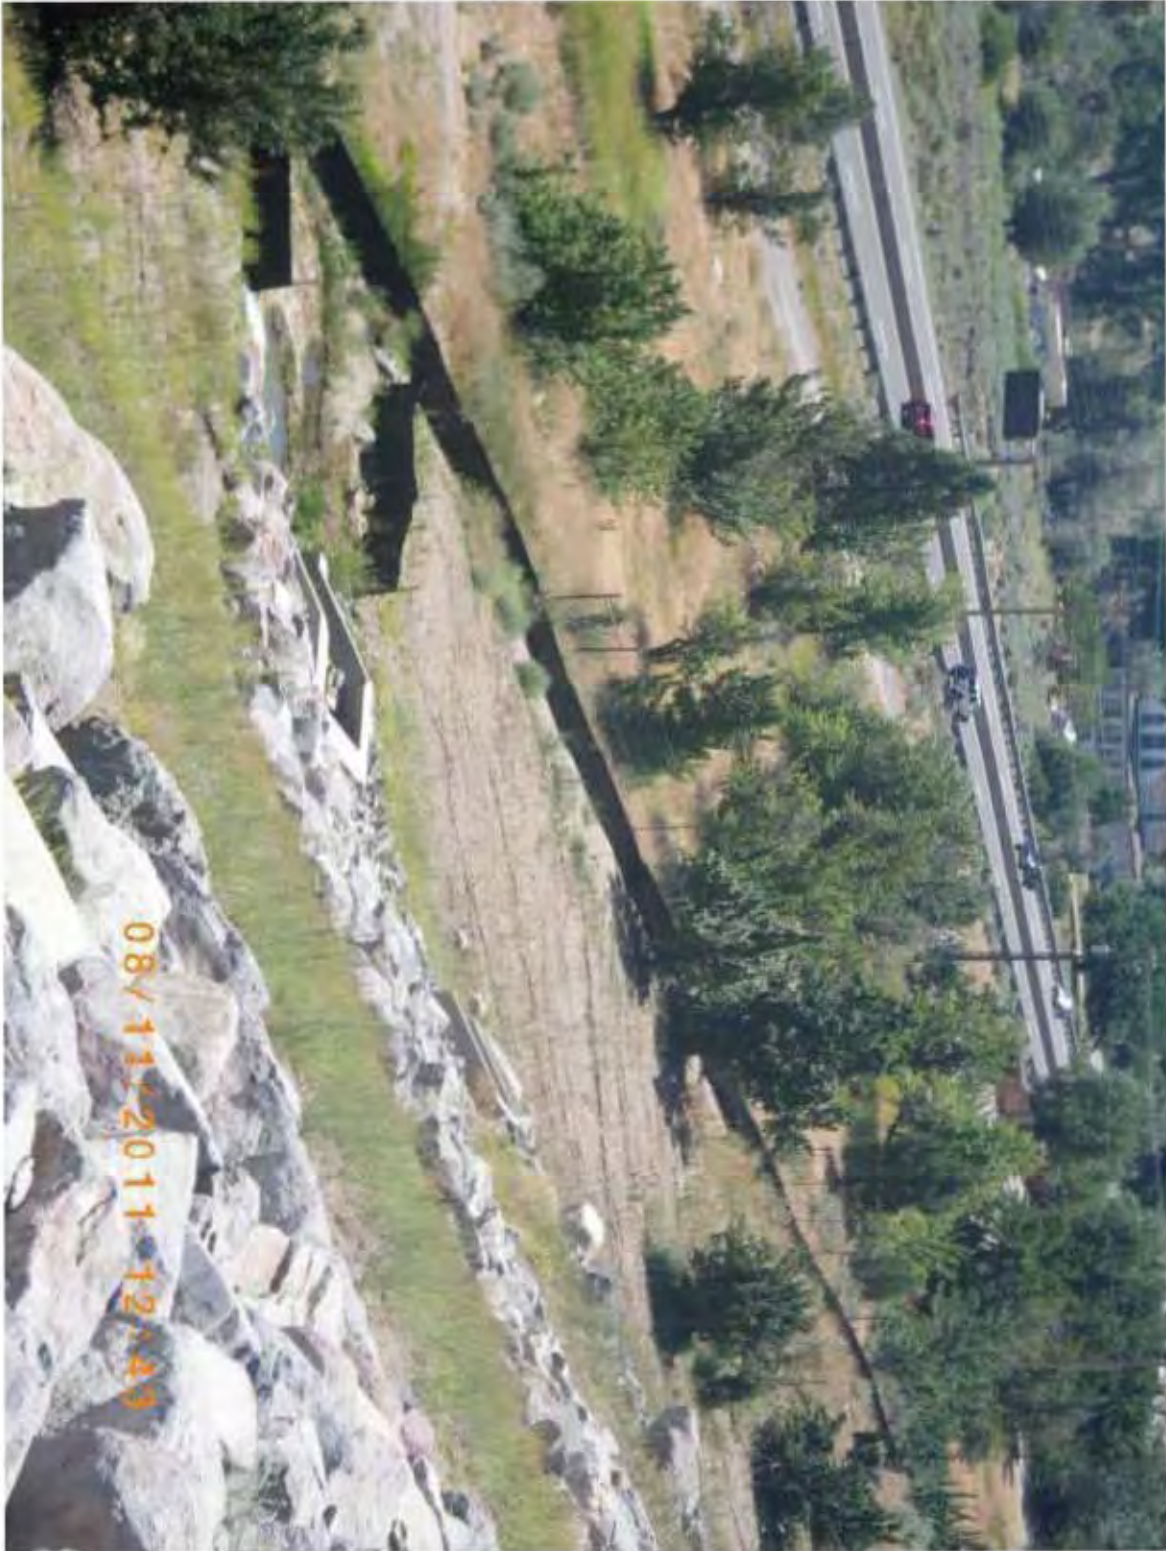
IMGP0185.JPG – View looking southeast near Winters Creek. Note silt fences at toe of slope and Hwy 395 in the background. Considerable amounts of rock are also used to support the slope of hwy during and after construction.

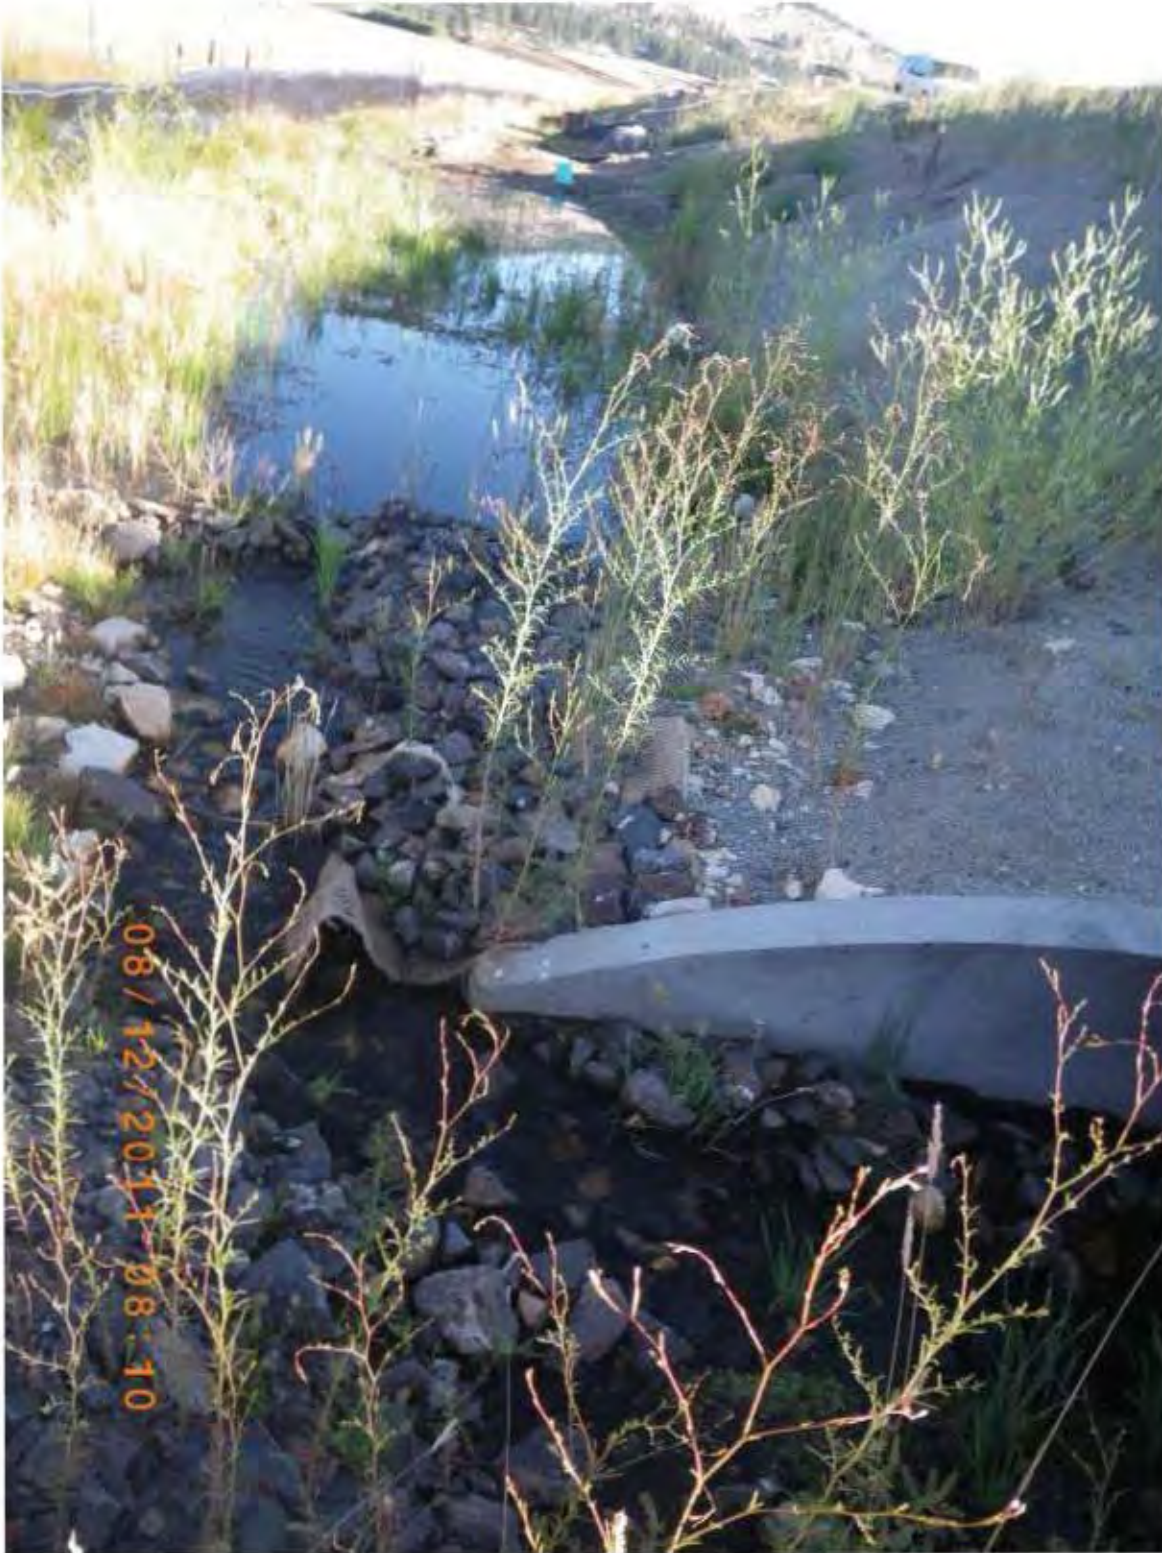
IMGP0208.JPG – Water flowing along western edge of I-395 roadway. Note there is no silt fence at the toe of this slope. NDOT Contractors stated that the slope was too unstable and the wind through this area to high to use silt fence without damage or time-consuming maintenance. Instead of using silt fencing or other temporary erosion control BMPs, they have used drain pipes and gravel to direct flow off roadbed.

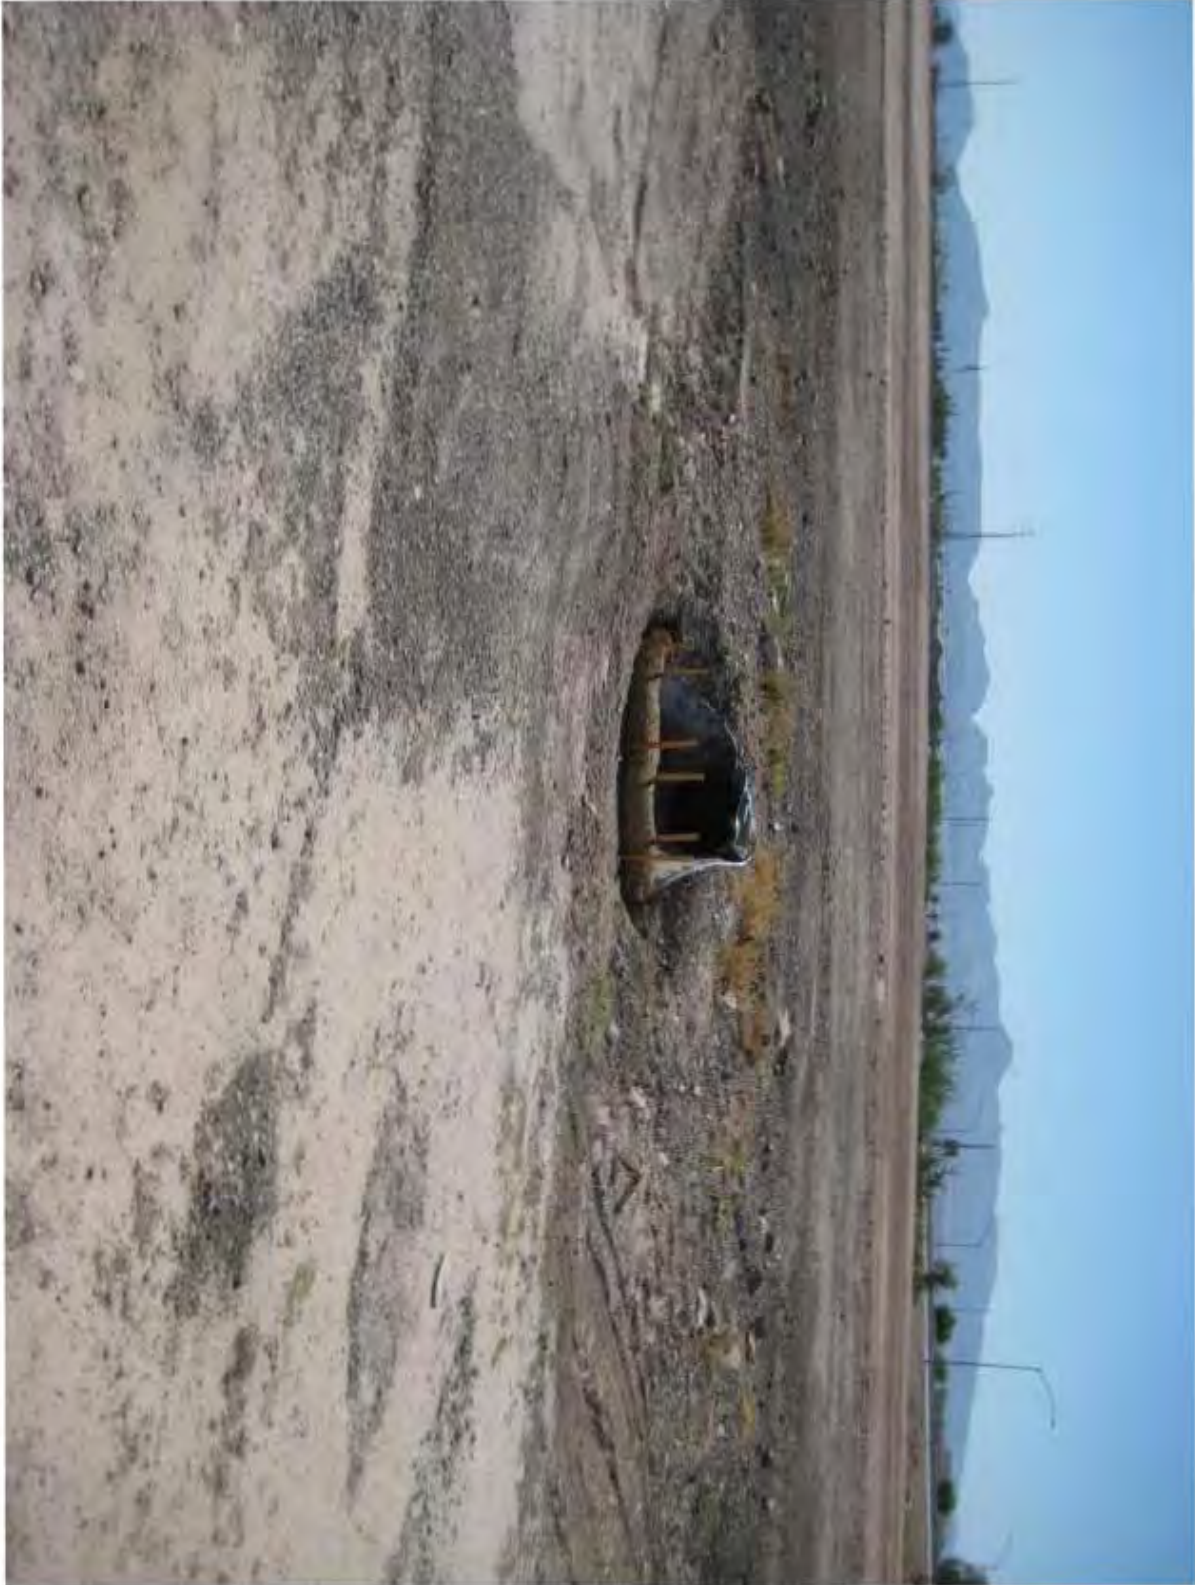
IMG_4664.jpg

IMG_4664 BMP at staging area – outlet protection consisting of straw waddle. Straw waddle recently installed, improperly installed (stakes are placed in front of & behind waddle not through waddle, not trenched).

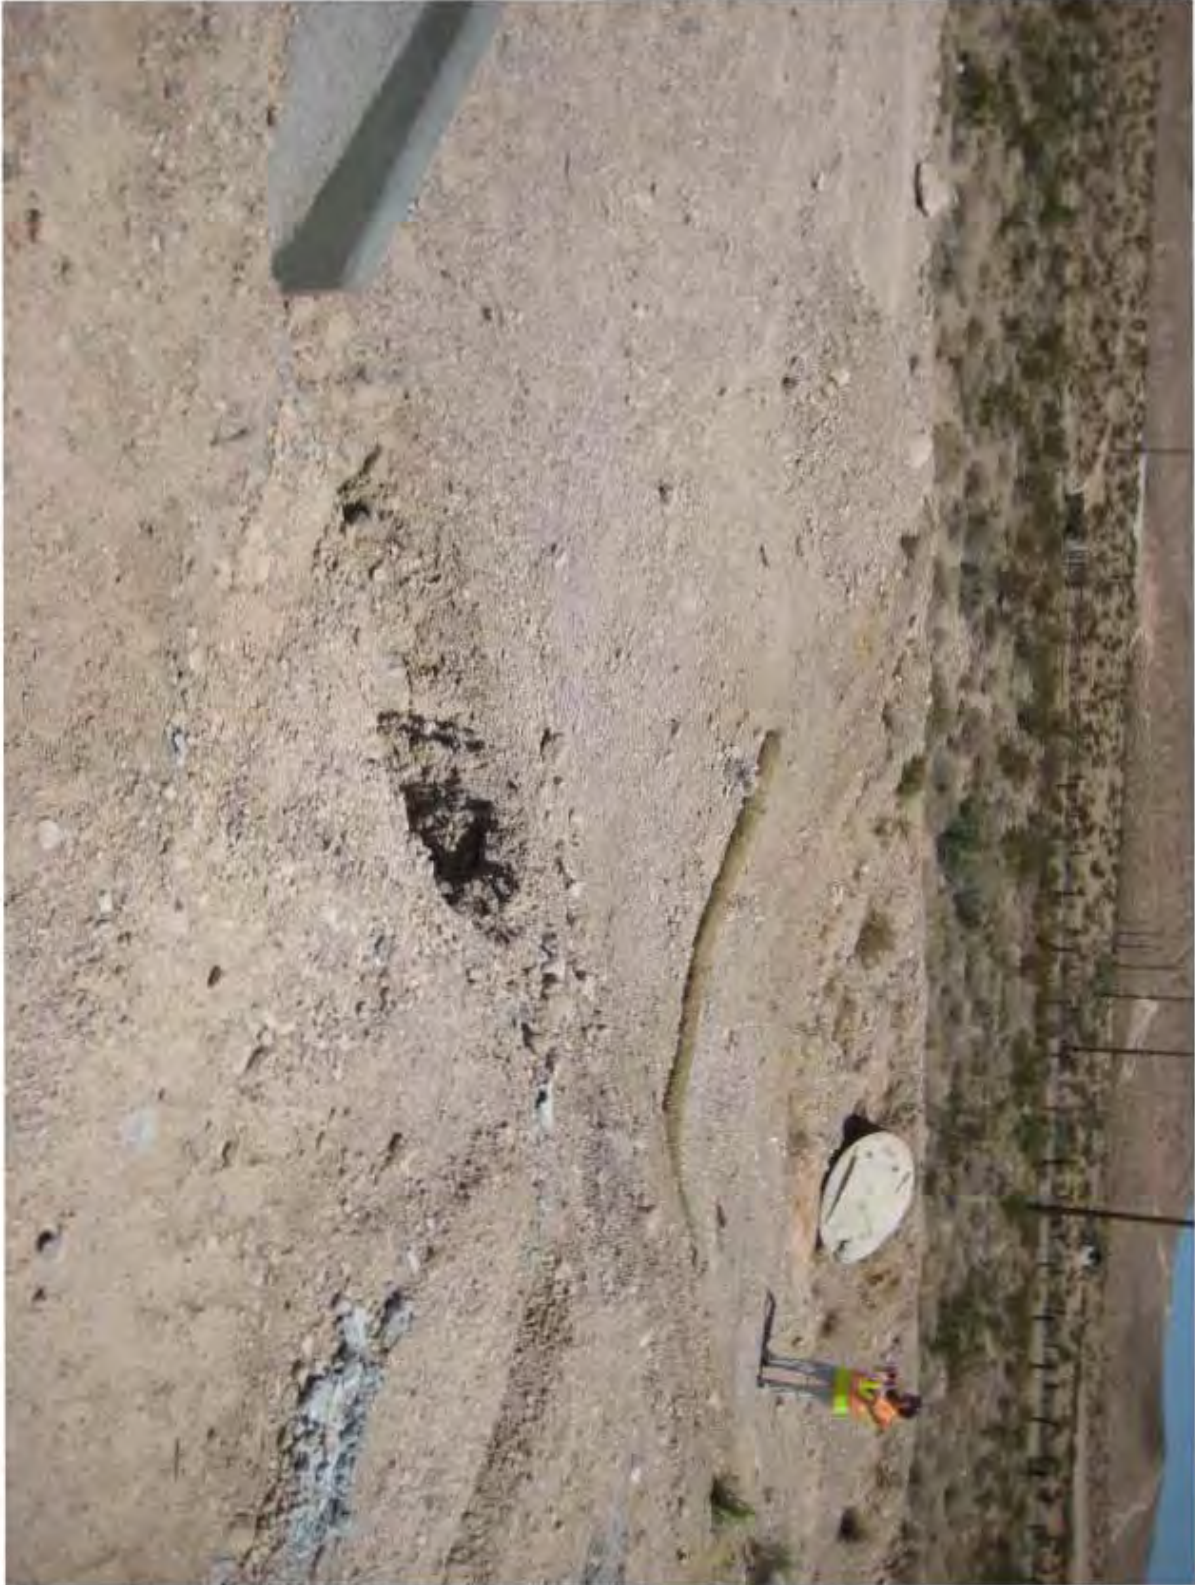
IMG_4671.jpg

IMG_4671 - looking west, north side of highway. Example of BMPs improperly installed – waddles placed in wash. BMPs for all drainages were similarly installed incorrectly in channels.

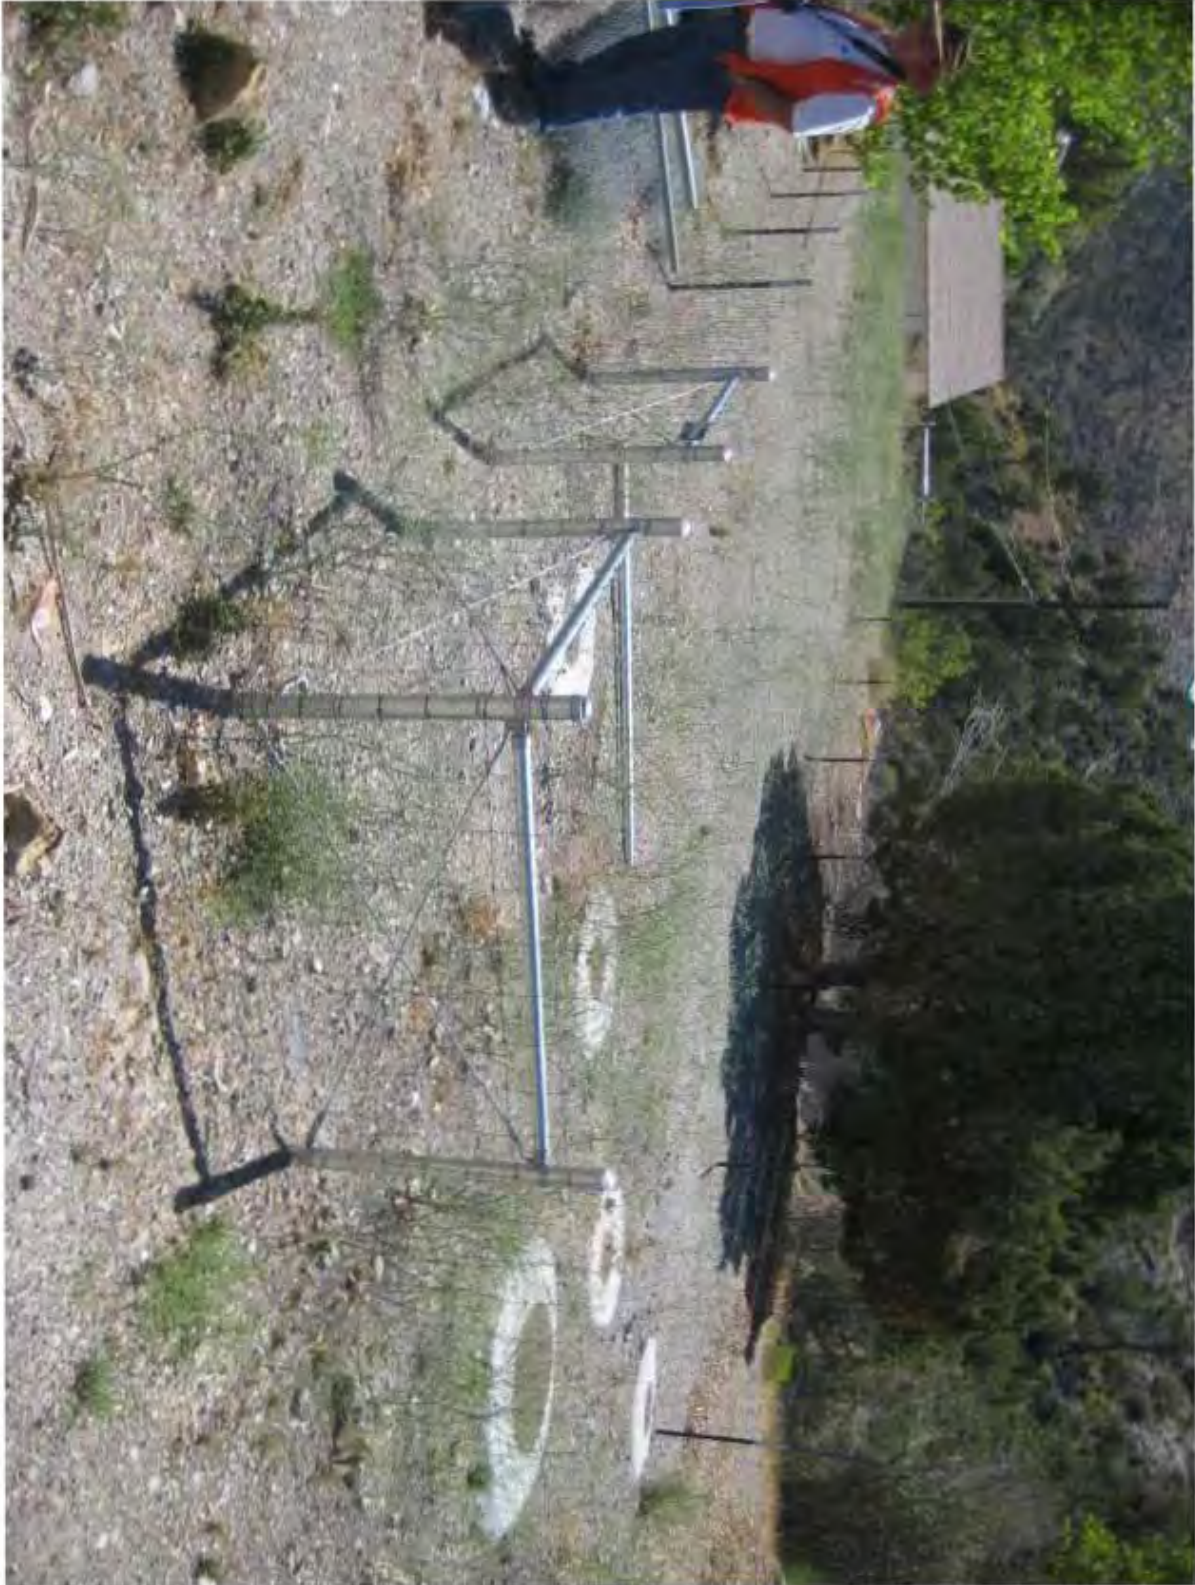
IMG_4688.jpg

IMG_4688 – leach field from wash rack.

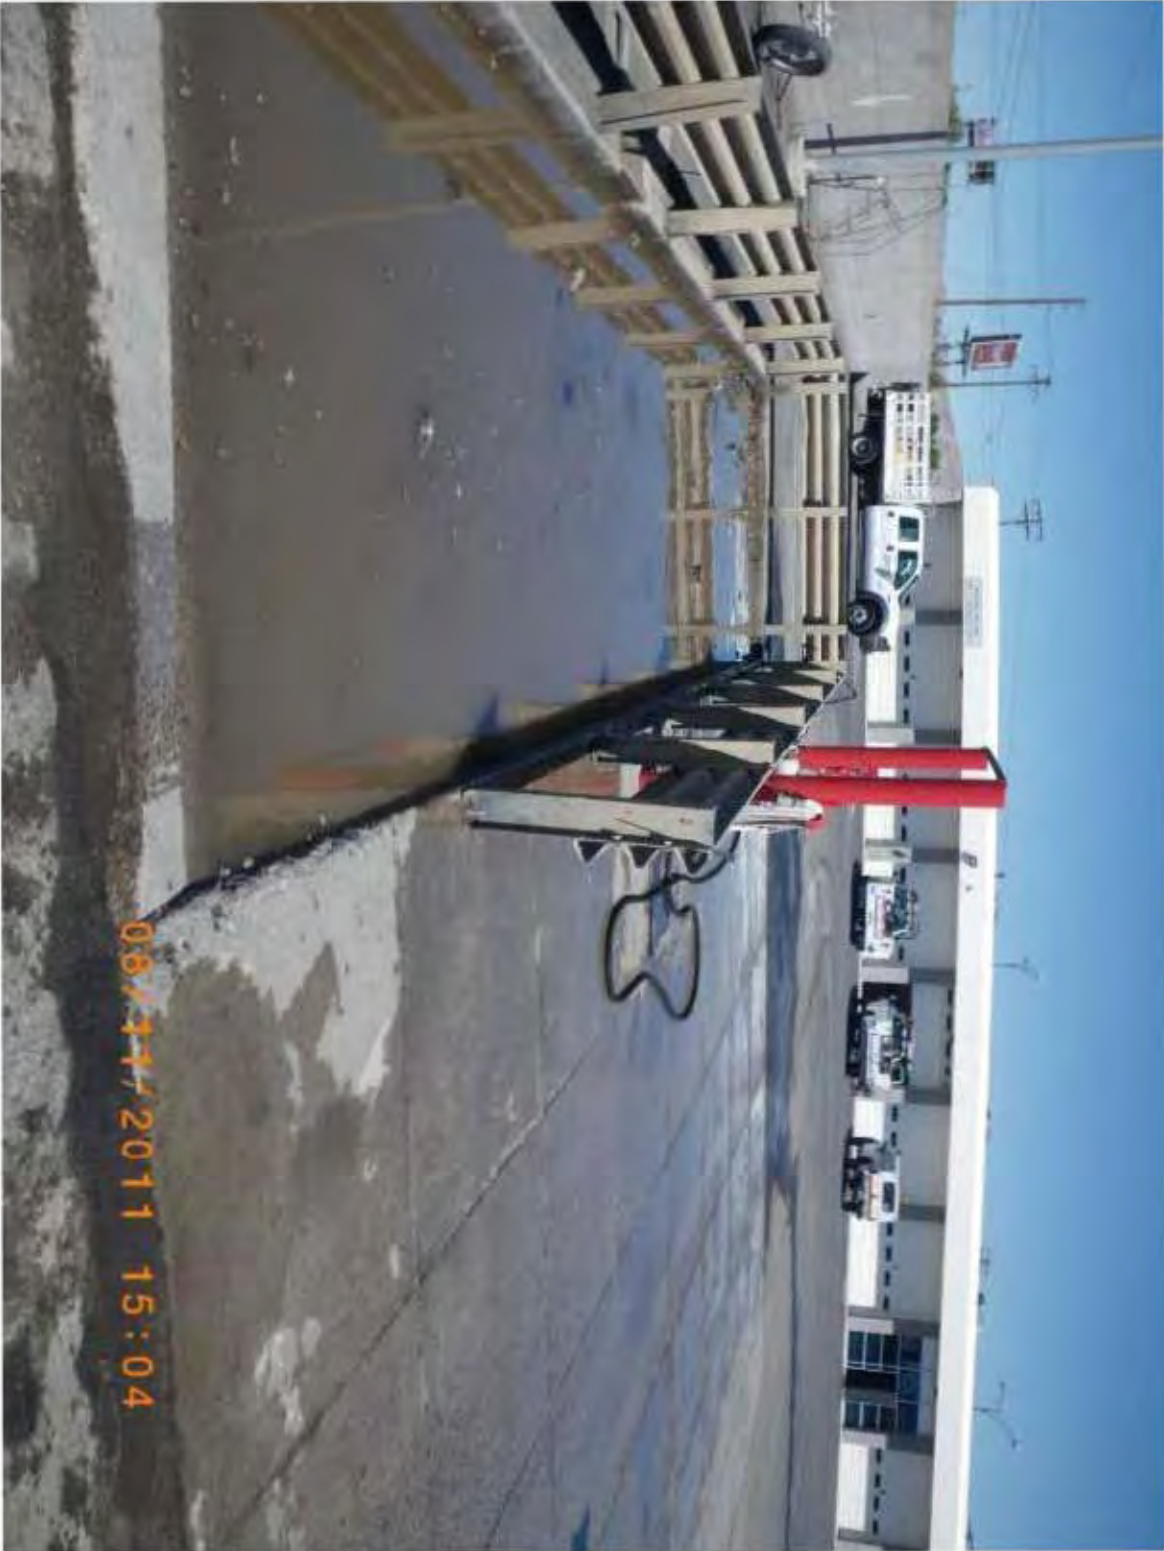
IMGP0186.JPG

- No SWPPP;
- Observed non-storm water discharges draining from an on-site tank truck (truck in distance of photo IMGP0188) to the ground and from its vehicle wash rack (photo IMGP0186). Both discharges were observed entering an unmarked on-site storm drain (photo IMGP0188);
- Observed a storm drain along the south eastern portion of the facility. Sandbags were partially blocking the storm drain inlet (photo IMGP0193). An NDOT representative looked over the fence to see if there was an apparent outlet, but he did not see one;
- Observed white staining on the asphalt from what appeared to be dry salt/brine solution along the asphalt/driveway surface near the drain but slightly to the west. This is consistent with the observation that NDOT was installing new brine mixing tanks in the vicinity (See photos IMGP0189, 0191, 0192);

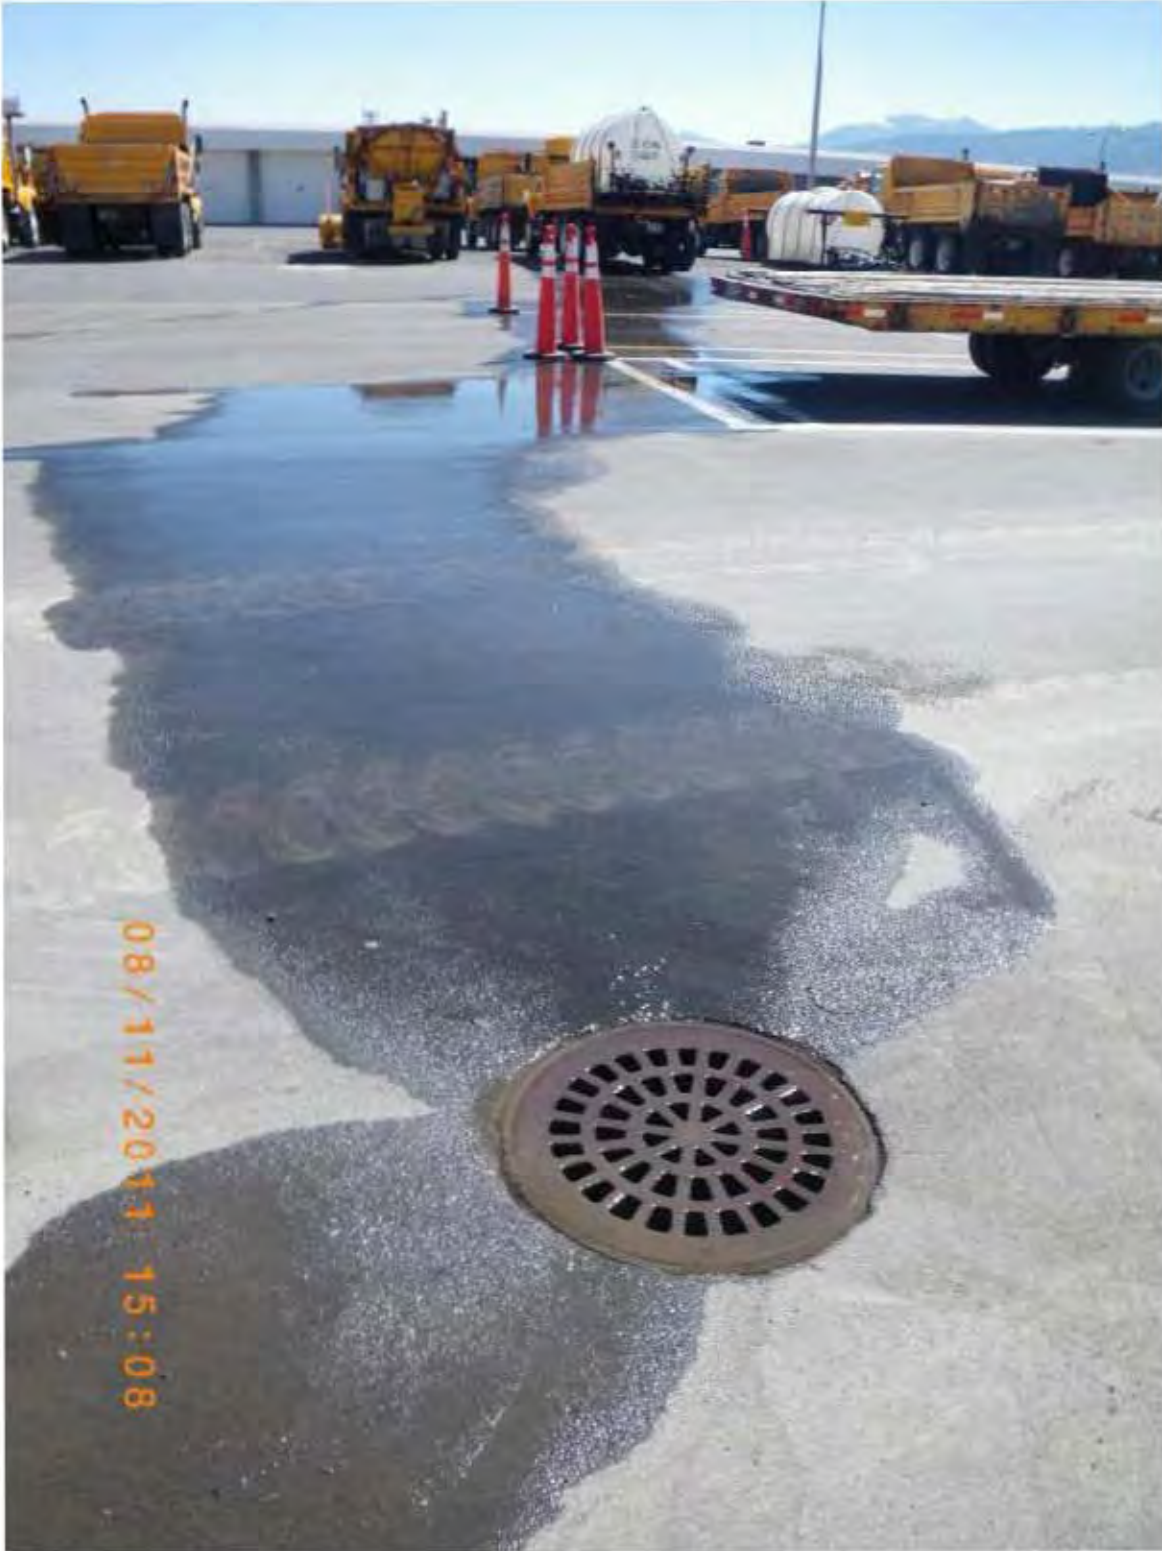
IMGP0188.JPG – Reno Maintenance Facility (eastern portion) looking south at an on-site storm drain near the vehicle wash rack. Non-storm water entering the drain comes from two locations: a) from the truck holding the large white tank which had been discharging liquid at the time of the inspection and whose operator had just shut off the water valve immediately before this photo being taken; and b) from the truck wash pad to the north of where this photo was taken (see IMGP0186). Note that this drain (and all drains observed during the Reno Maintenance Facility Audit) did not have any markings to identify it or alert NDOT personnel that certain non-stormwater discharges are not allowed.

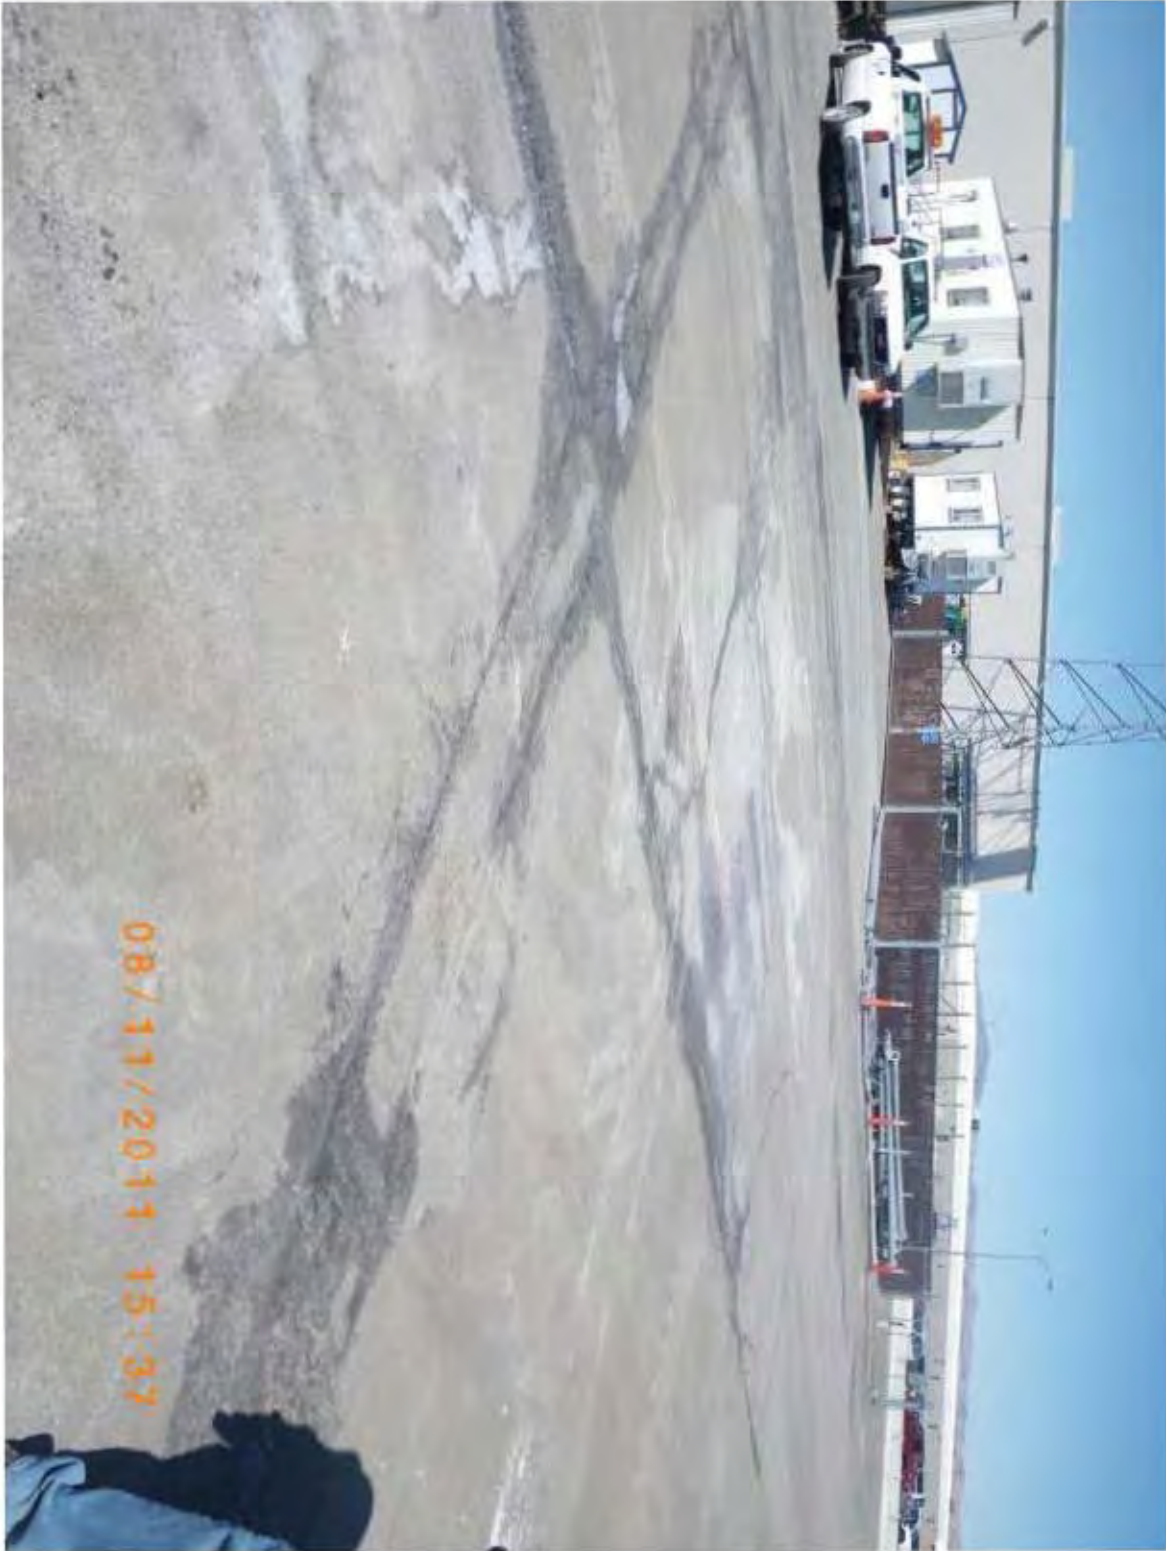
IMGP0189.JPG – Looking northeast at brine/salt staining on ground outside brine mixing building (photo IMGP0190) at the NDOT Reno Maintenance Yard (western portion). The stains shown in this picture are in the same vicinity as the stains shown in photo IMGP0191 (note stacked pipes behind orange cones are the same as those seen in 0191).

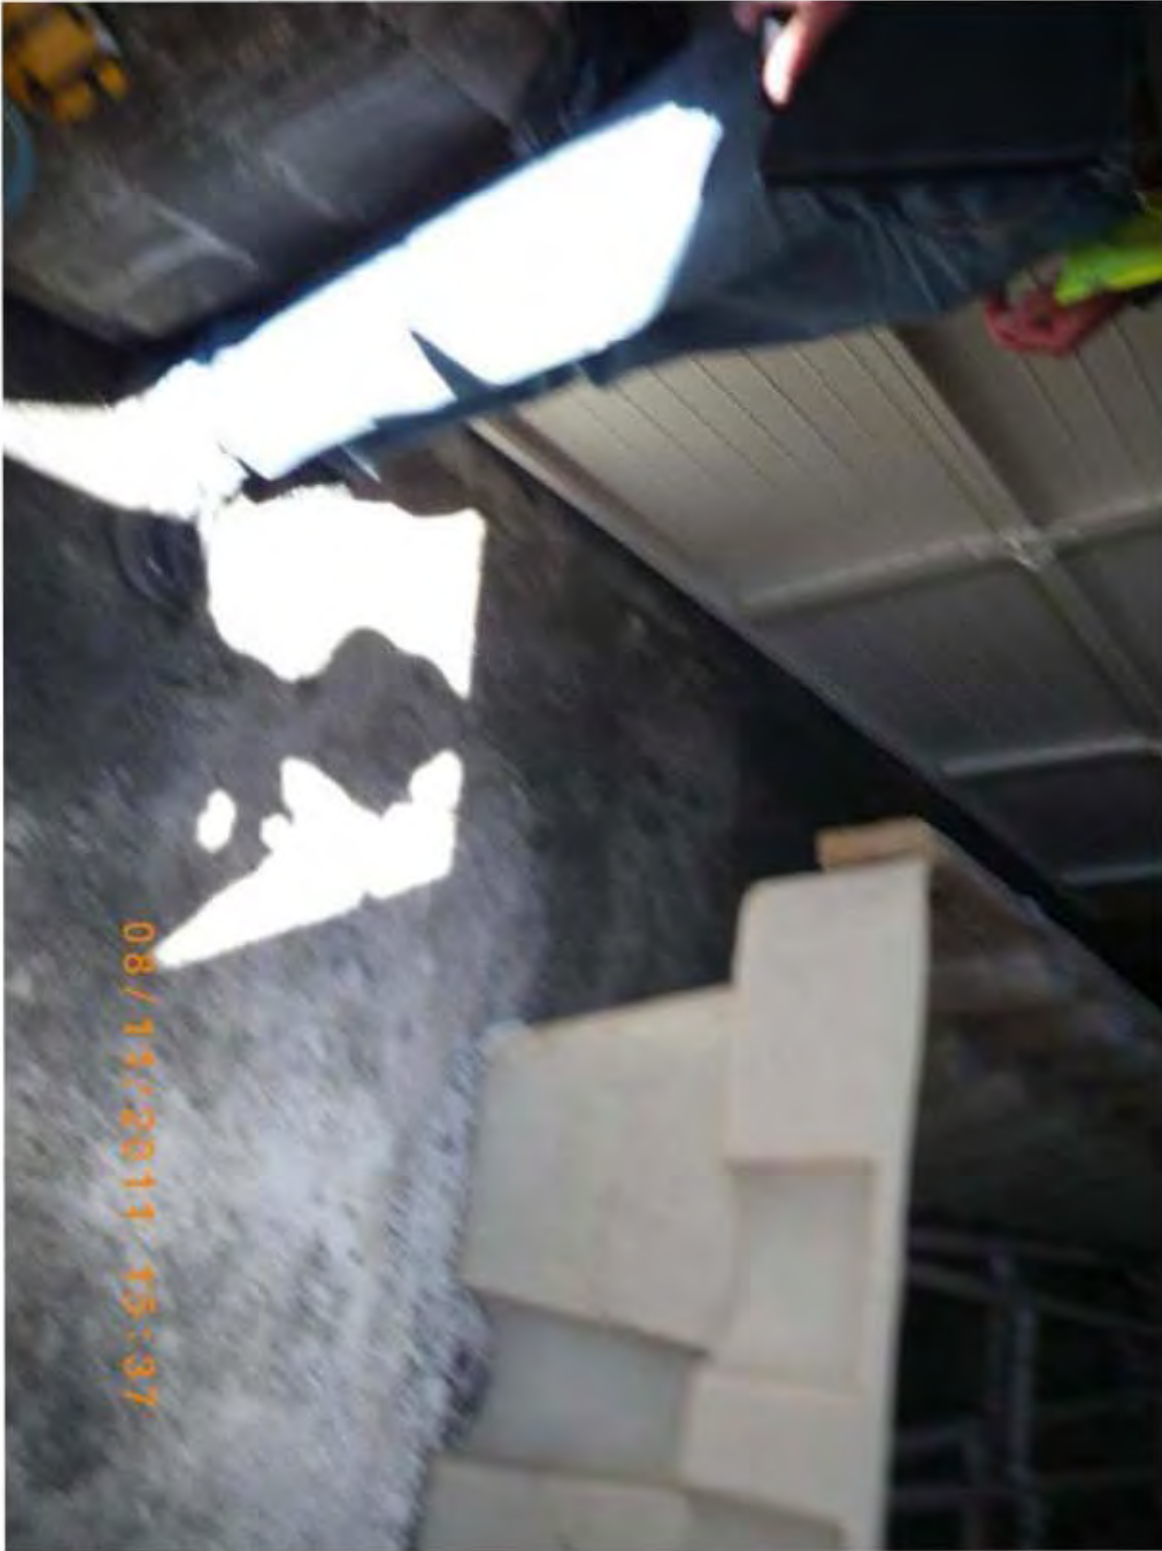
IMGP0190.JPG – Photo taken inside brine mixing tank building on southern edge of NDOT Maintenance Yard (western portion). Note salt/brine on ground and roll-up door to the left. Tank in photo was disassembled as NDOT was in the process of switching process to store and mix brine in enclosed tanks located outside this building but in a secondary containment area under construction. Brine may have been released from this building which could have resulted in brine/salt staining shown in picture IMGP0191.
