UNITED STATES ENVIRONMENTAL PROTECTION AGENCY
REGION IX
75 Hawthorne Street
San Francisco, CA 94105-3901

Enclosed is the U.S. Environmental Protection Agency's (EPA) report of the Nevada Department on the Transportation (NDOT) Storm Water Management Program (Program) Audit. Representatives from EPA Region 9 and the Nevada Department of Environmental Protection (NDEP) conducted the Audit from August 9 – 12, 2011.

MS4 Audit Report

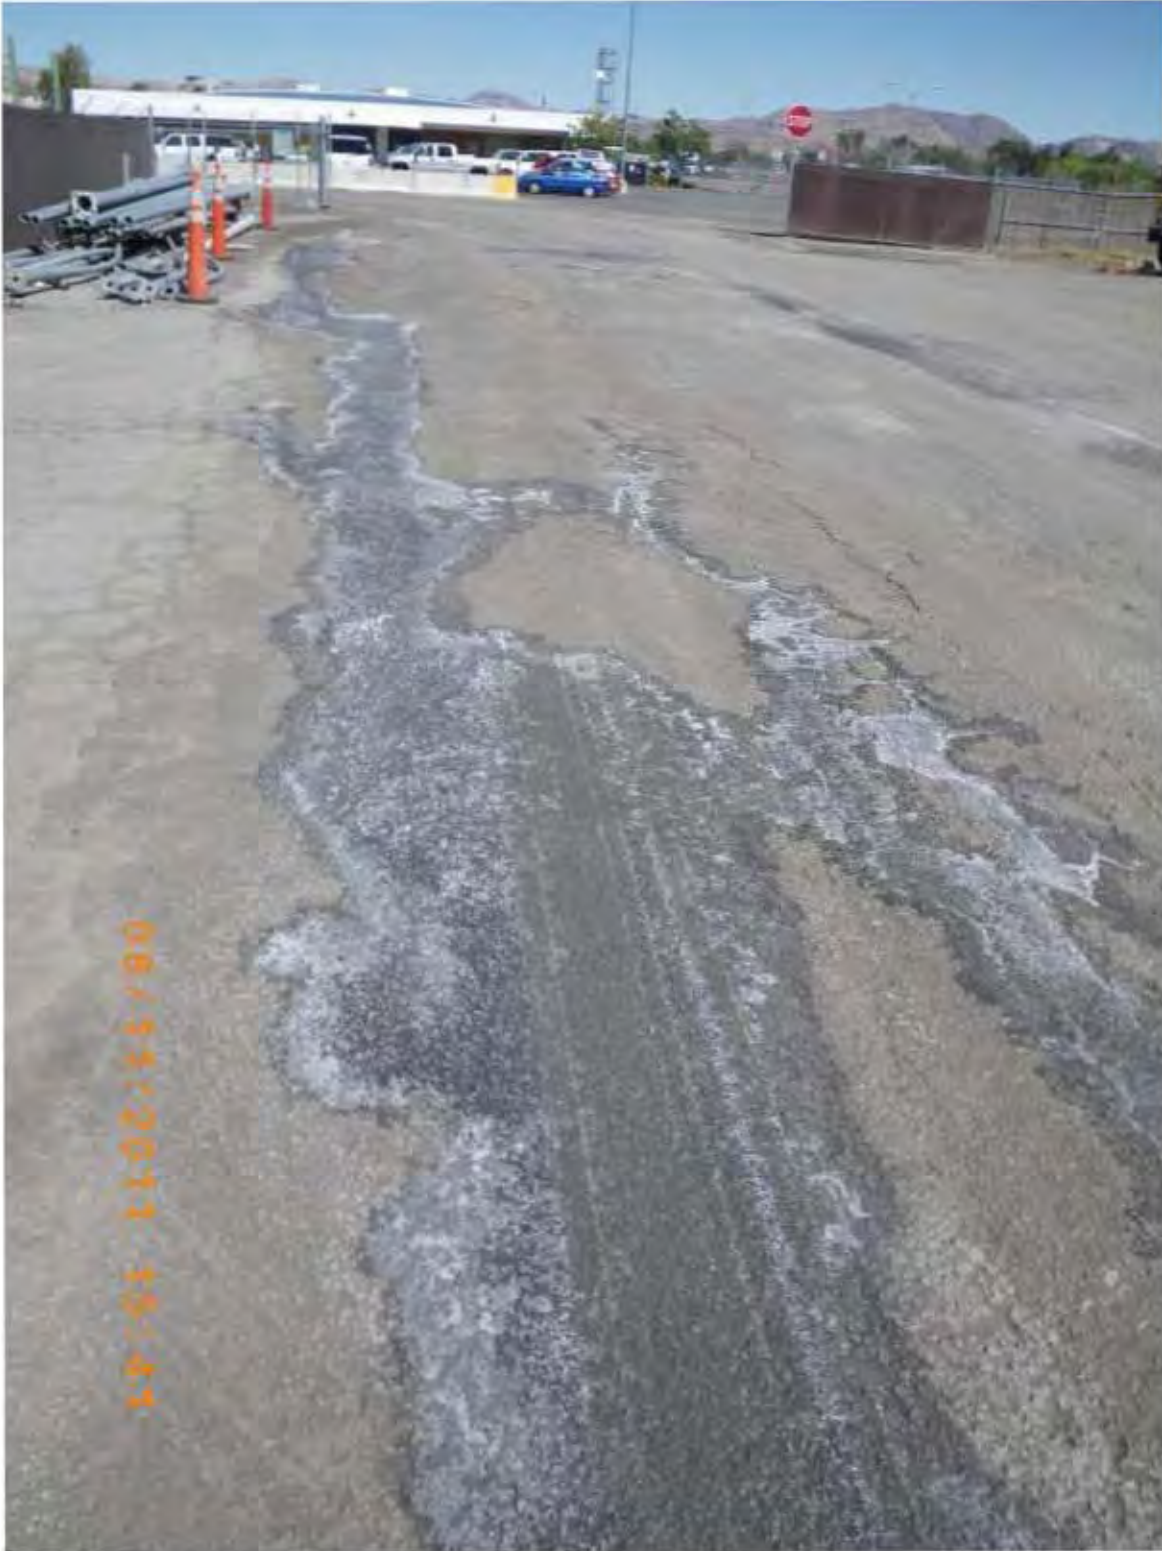
IMGP0191.JPG – Looking east at NDOT Maintenance Yard (western portion). Brine staining on ground may have originated from recent brine tank maintenance and construction. See photo IMGP0190.

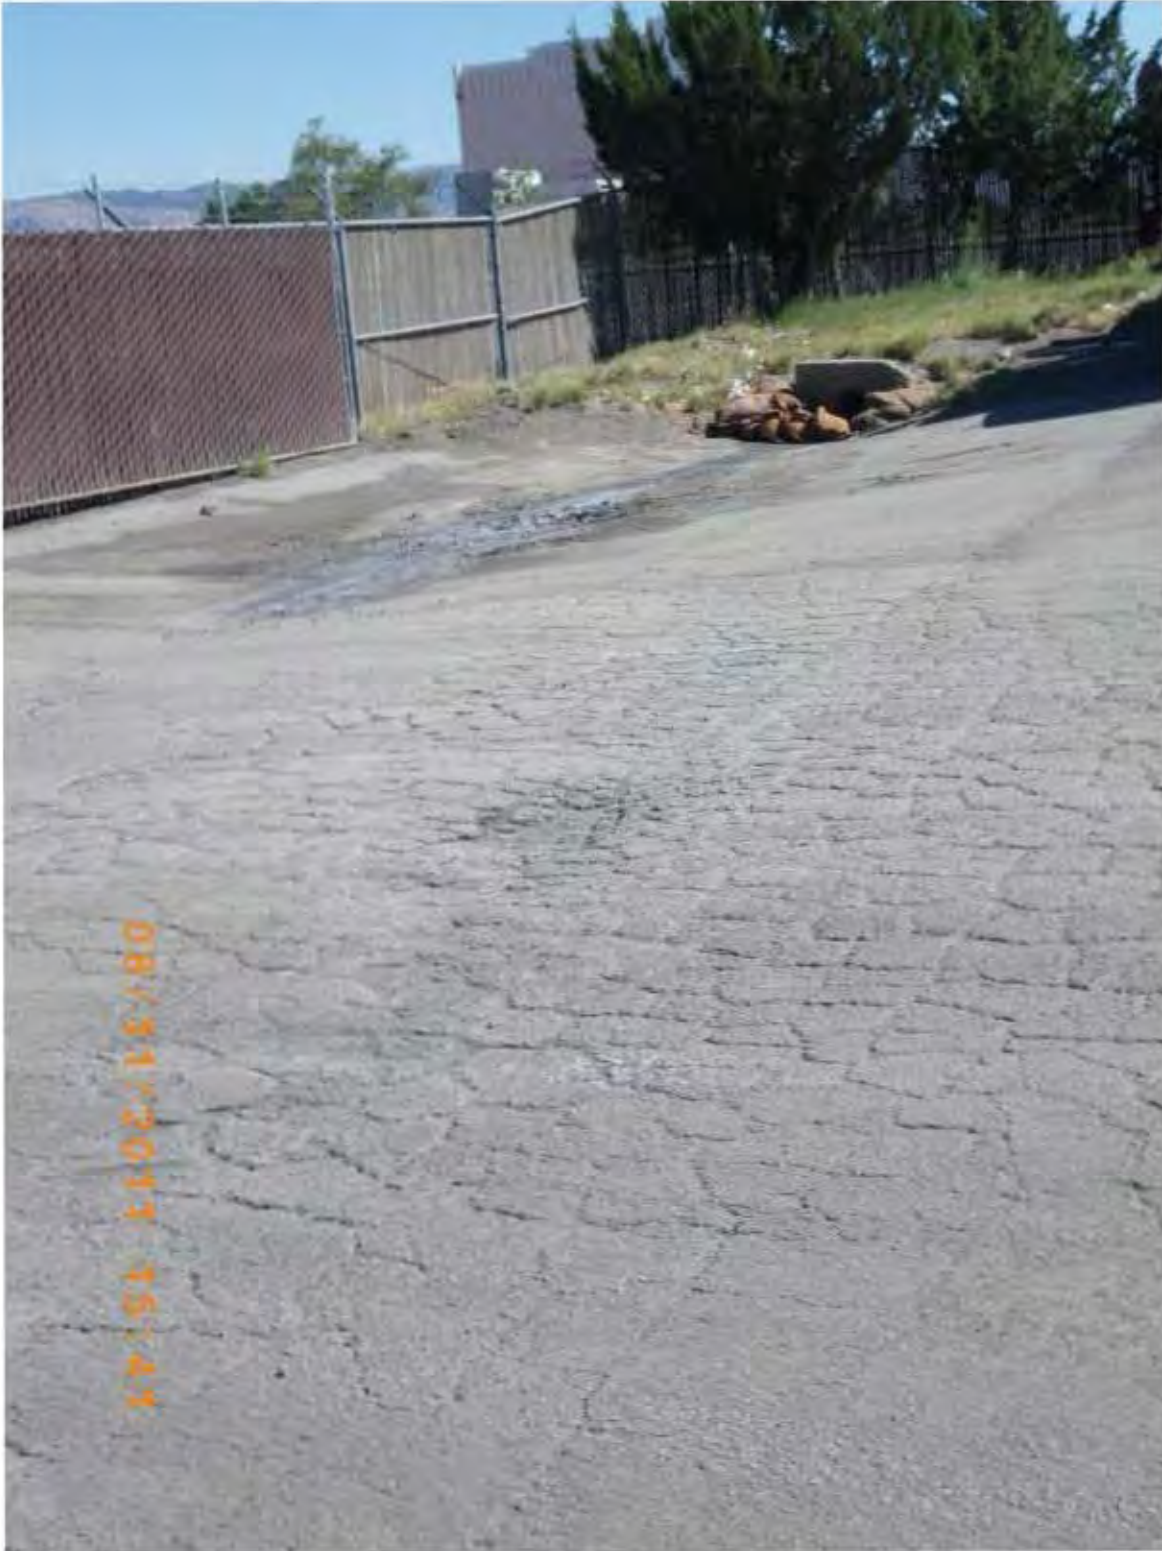
IMGP0192.JPG – Picture looking southeast shows sandbags in place around drain shown in picture IMGP0193. Brine/salt staining shown on Maintenance Yard (western portion) ground in picture IMGP0191 is to the right but just out of this photo.

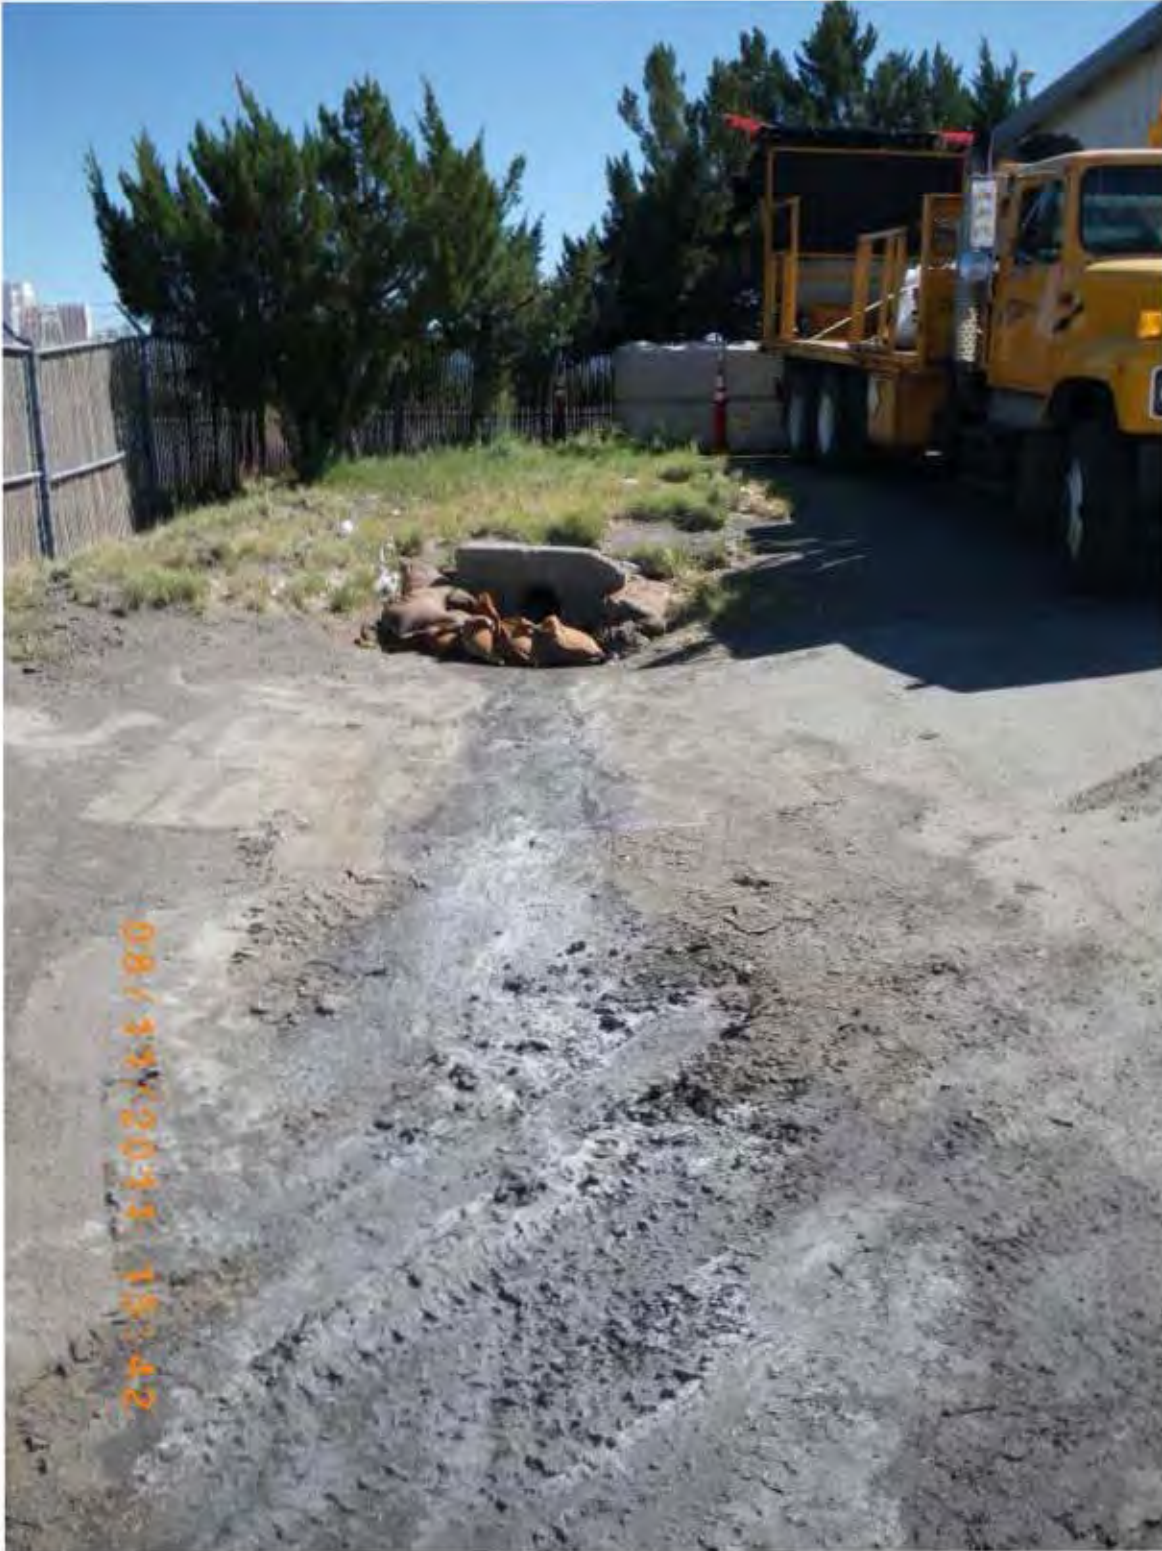
IMGP0193.JPG – Looking south at wet sediment with salt/brine staining at the Reno Maintenance Yard (western portion). Drain in background is located along the southern edge of the property next to N. Kietzke Lane (NV Route 667) but to the east of drain shown in IMGP0195. Sandbags were in place to prevent some material from entering the drain. NDOT employees joining the inspection did not know the location of the outfall of this drain. The Truckee River is immediately to the south of the property, just across N. Kietzke Lane (NV Route 667).

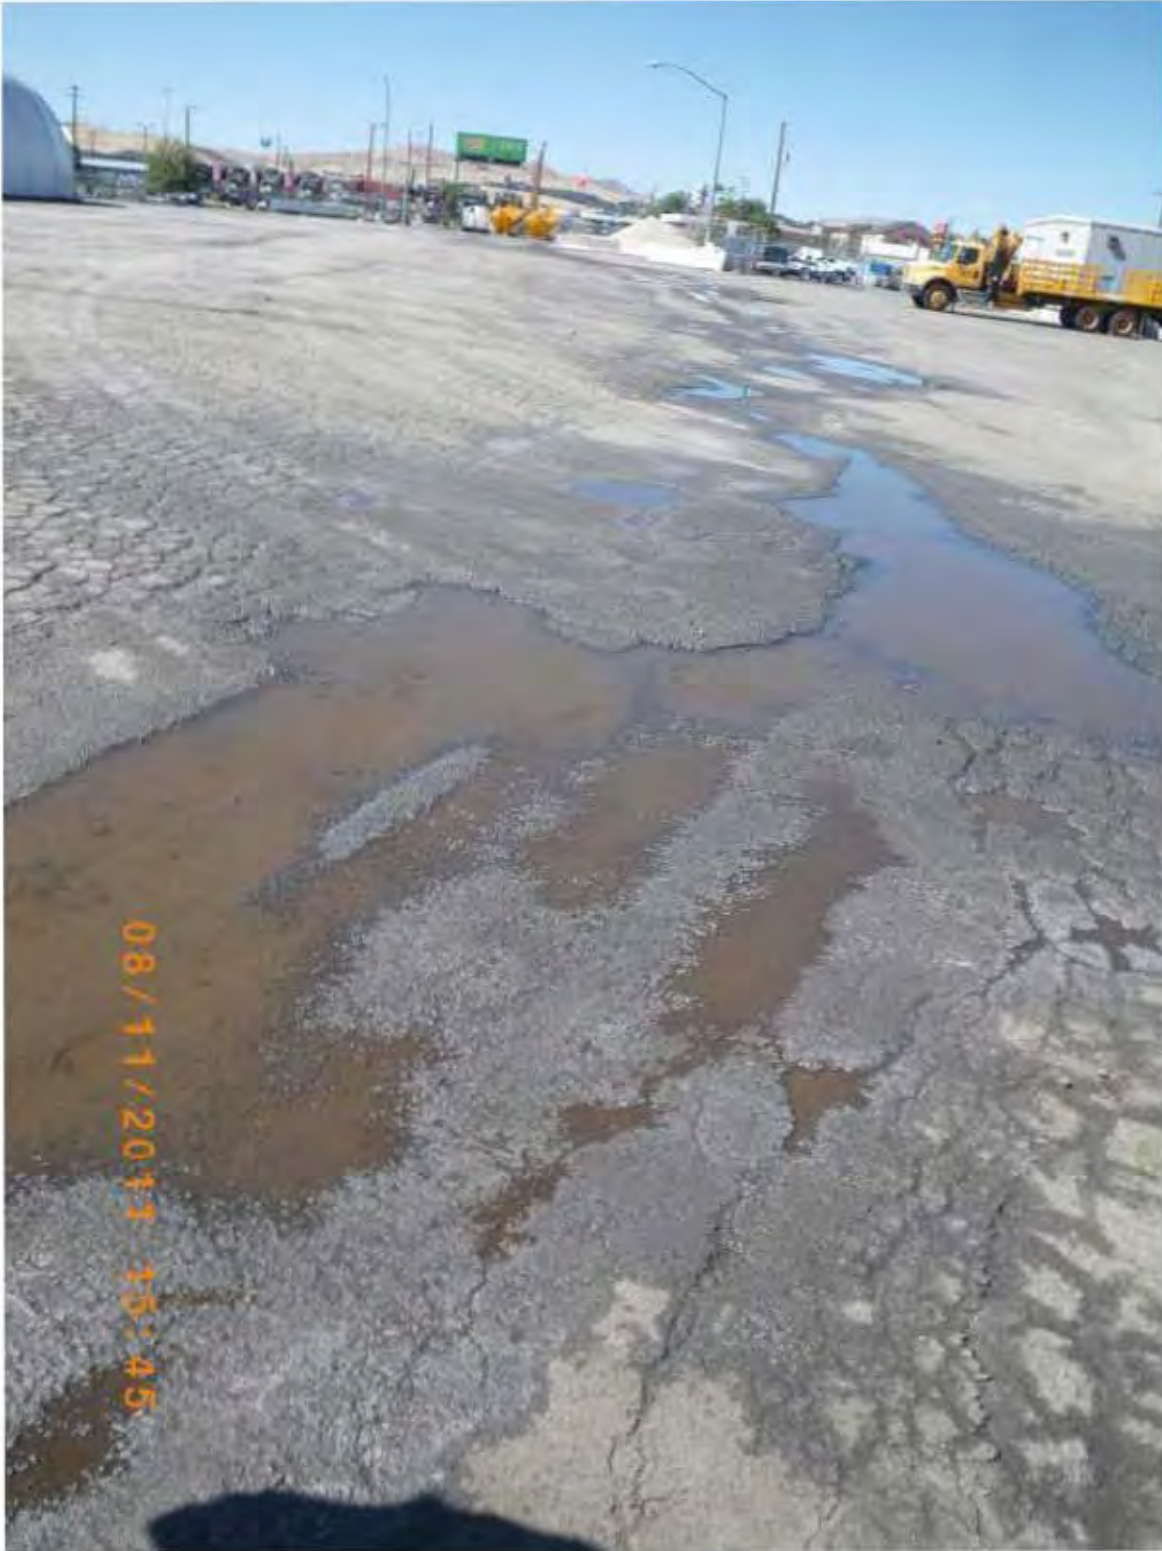
IMGP0194.JPG

- Observed discharge on the ground (IMGP0194) from a water truck filling station in the distance (IMGP0198). Water on the ground in photo IMGP0194 drained to an unmarked storm drain in far southwest corner of maintenance facility (IMGP0195). Furthermore, water shown in the drain includes waste water from a vactor decant site (IMGP0197) uphill from the drain. At the drain, BMPs were in place (e.g., straw waddles, sandbags, and sand/oil separator). NDOT representative stated that discharge from the drain (IMGP0196) goes directly to Truckee River (to the west) after passing through an oil/sand separator immediately downstream of the drain on the property line of the NDOT facility. We saw the vactor decant site and the indoor salt/sand storage facility (big tented structure in photo IMGP0198);

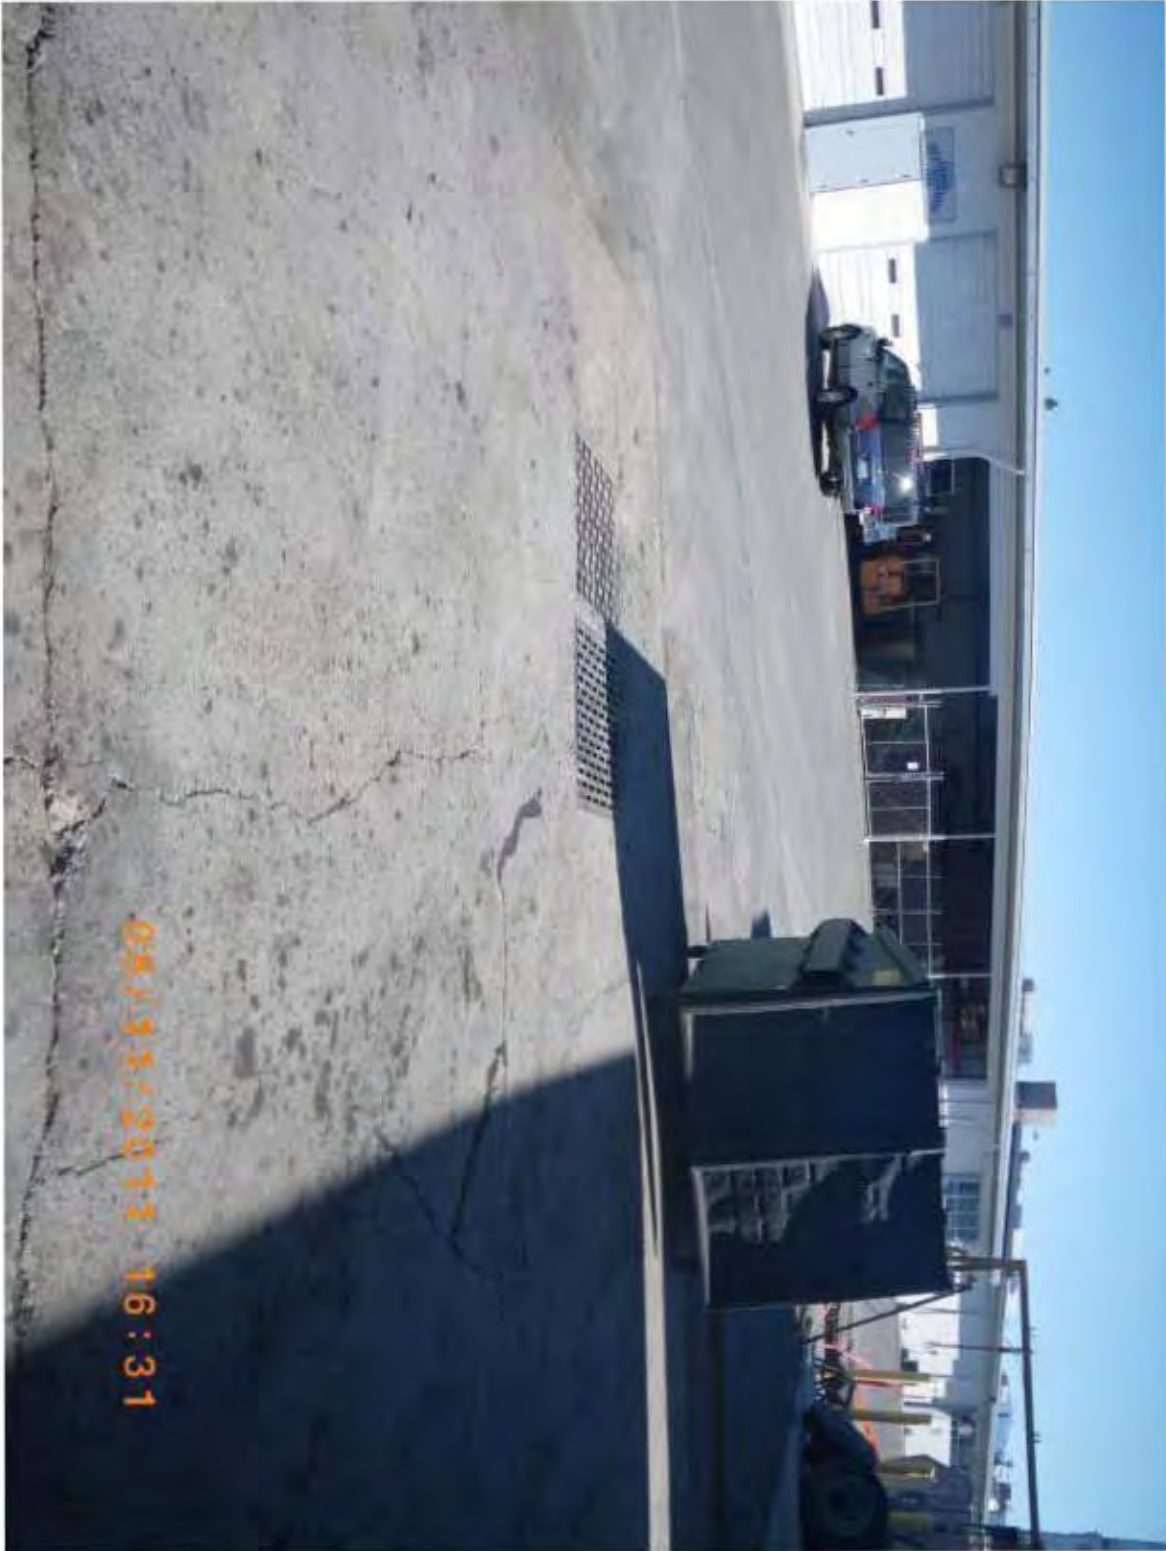
IMGP0199.JPG – Wash Rack Drainage inlets at Reno Maintenance – Vehicle/Equipment Repair Shop. The Vehicle/Equipment repair shop is separately managed and across Galletti Way to the east from the Reno Maintenance Yard. The wash rack is not shown in the photo but is located slightly behind and to the right in the photo. The area was dry and no vehicles were being cleaned at the time.

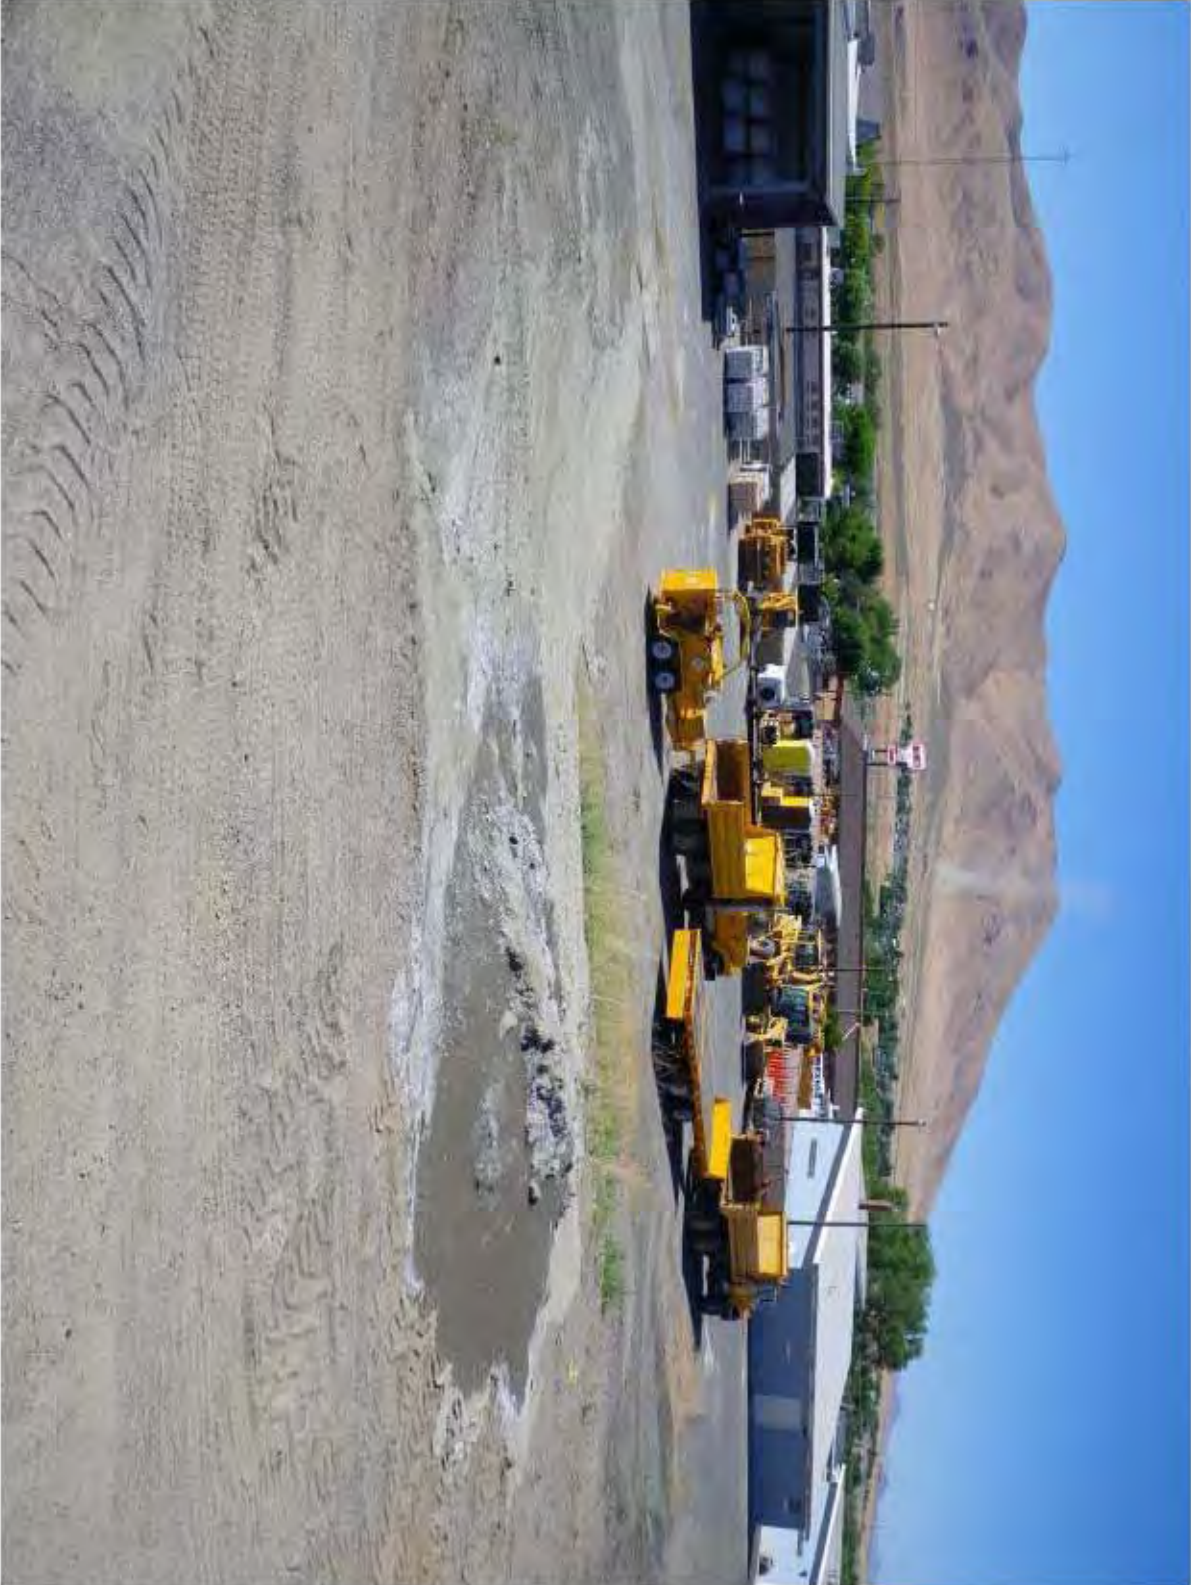
IMGP0681.JPG

IMGP0681 – Uncontrolled pile of waste material extracted from the wash rack catchment basin, with a slurry tongue that runs downhill the staging area below. (Also noted in IMGP0678)

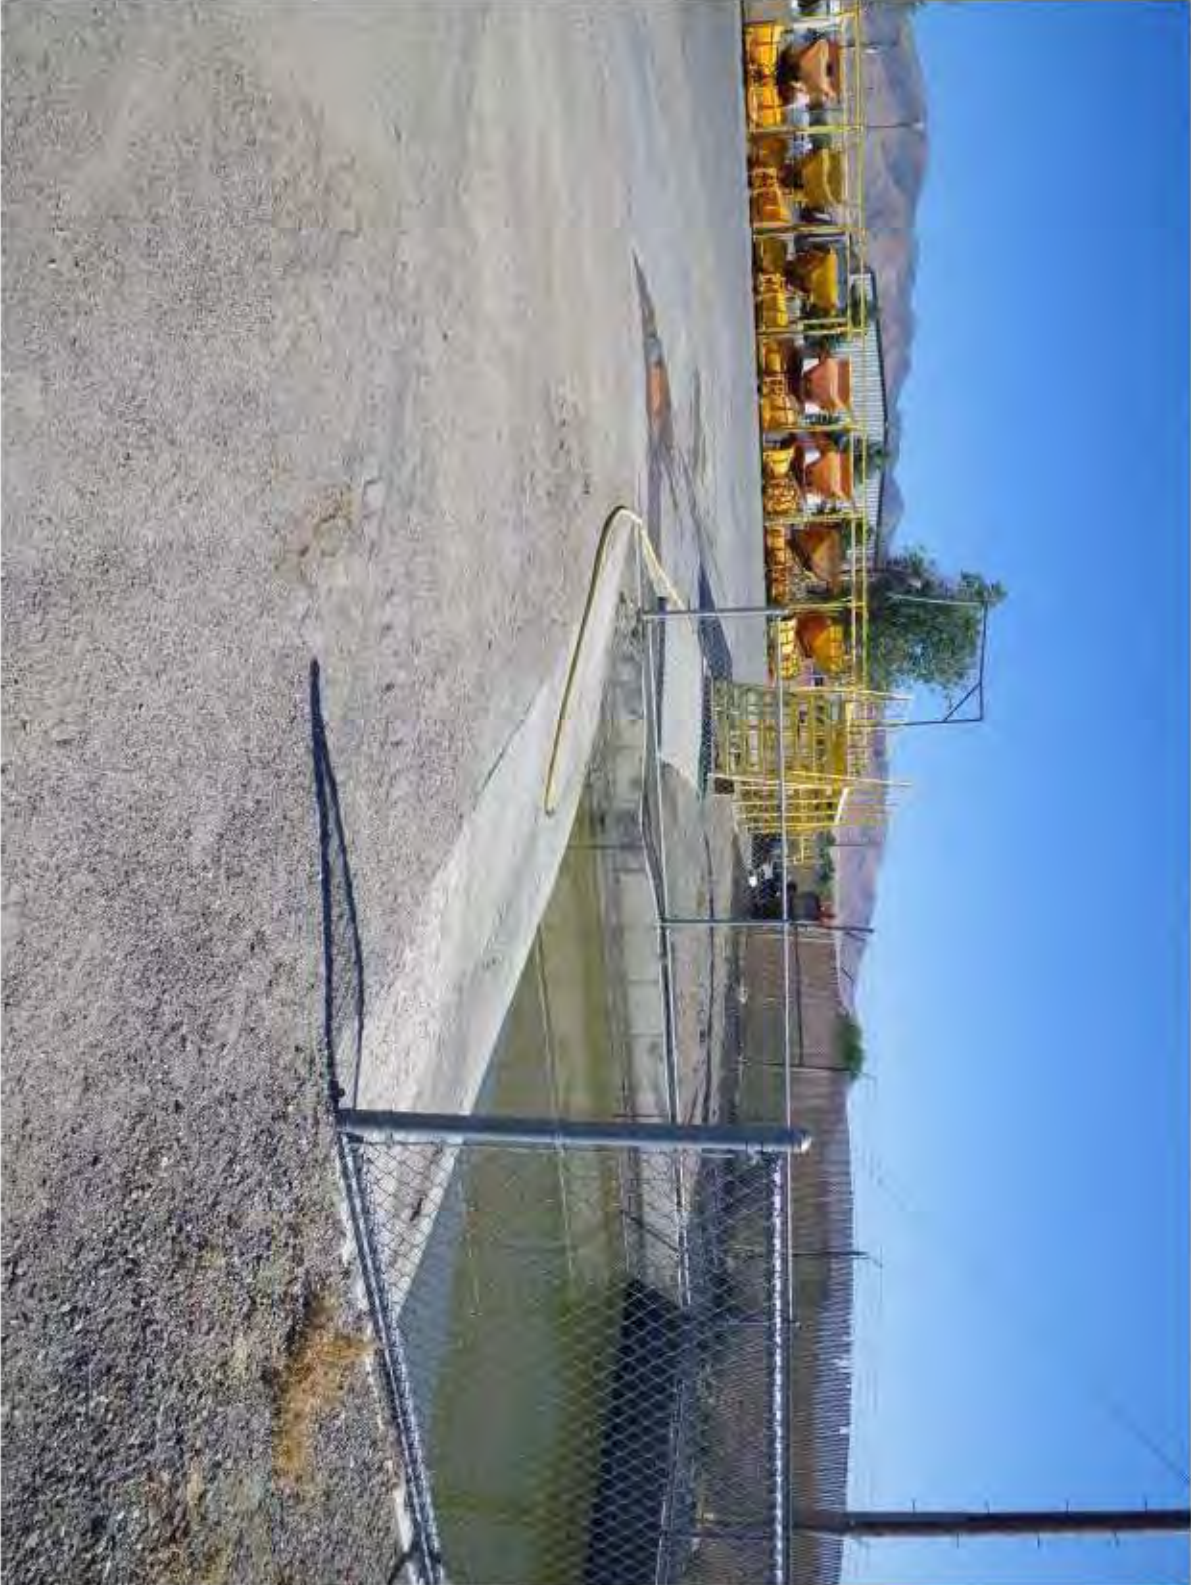
IMGP0682.JPG

IMGP0682 – Wash rack and catchment basin. Inspection participants observed a vehicle get rinsed and that the site-engineering appropriately directed the rinsate to the catchment basin.

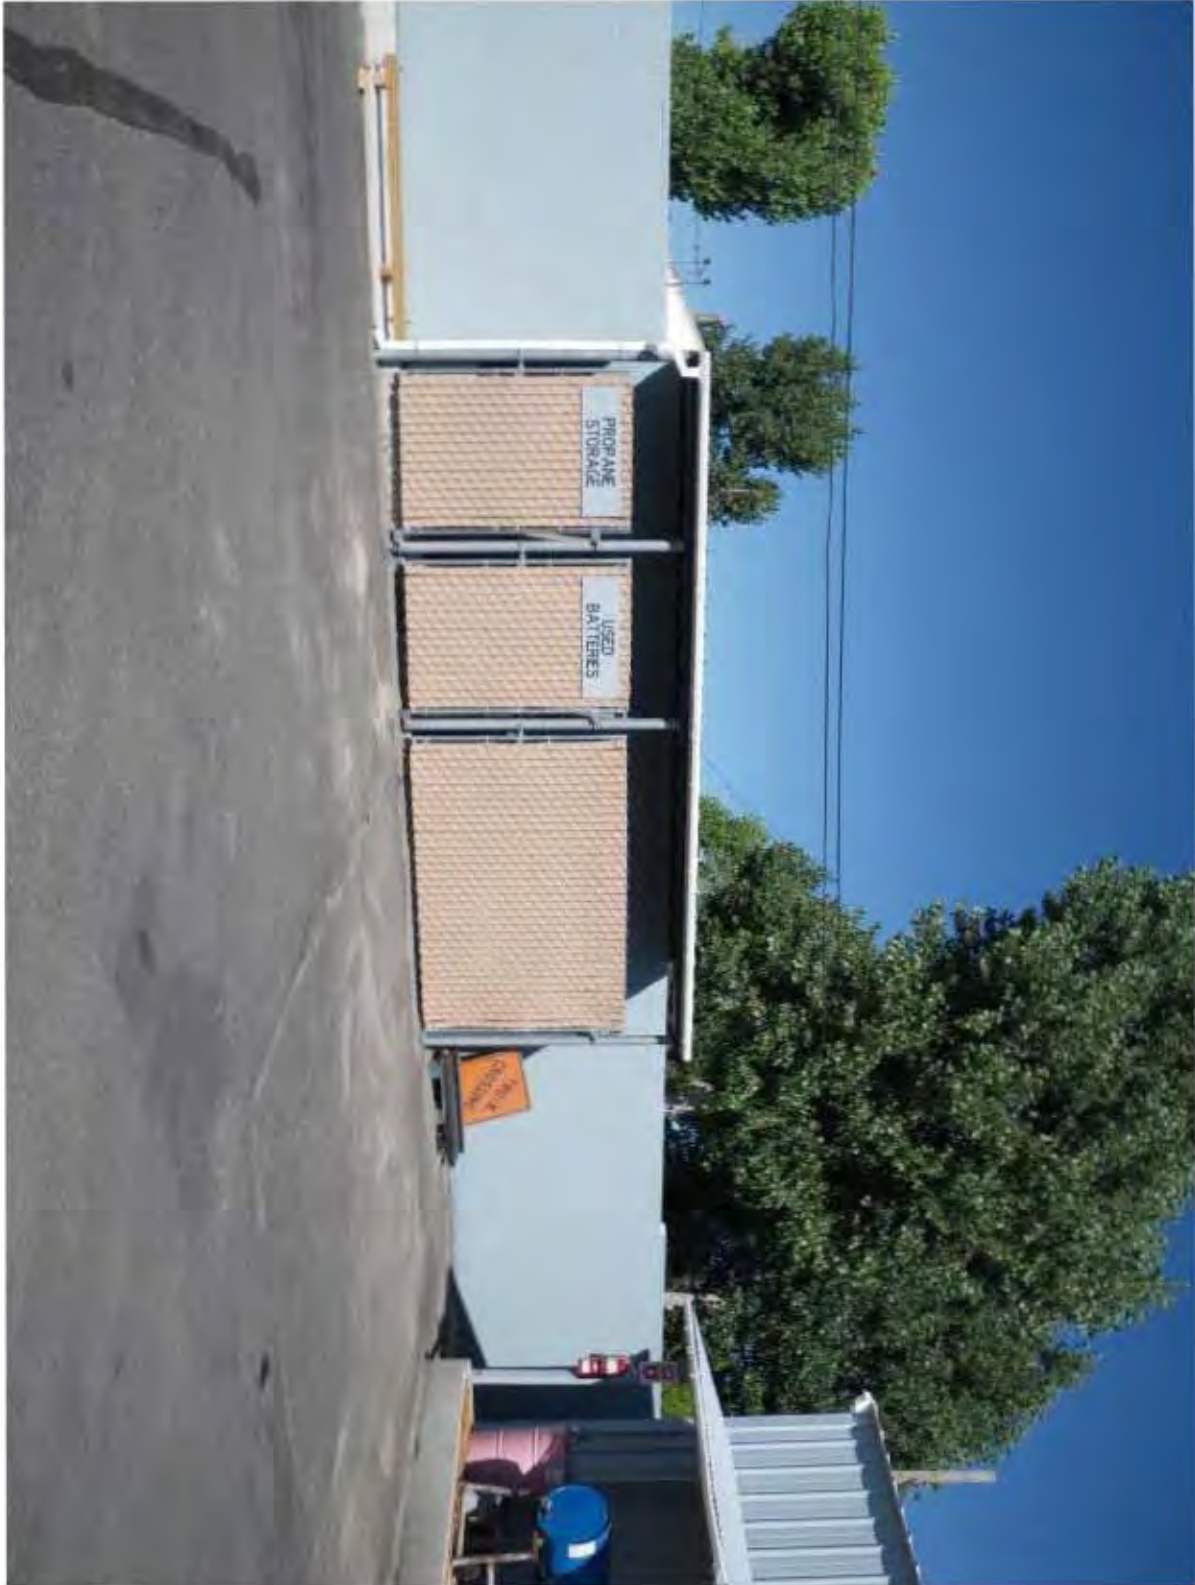
IMGP0684.JPG

IMGP0684 – Covered and screened hazardous materials staging areas.

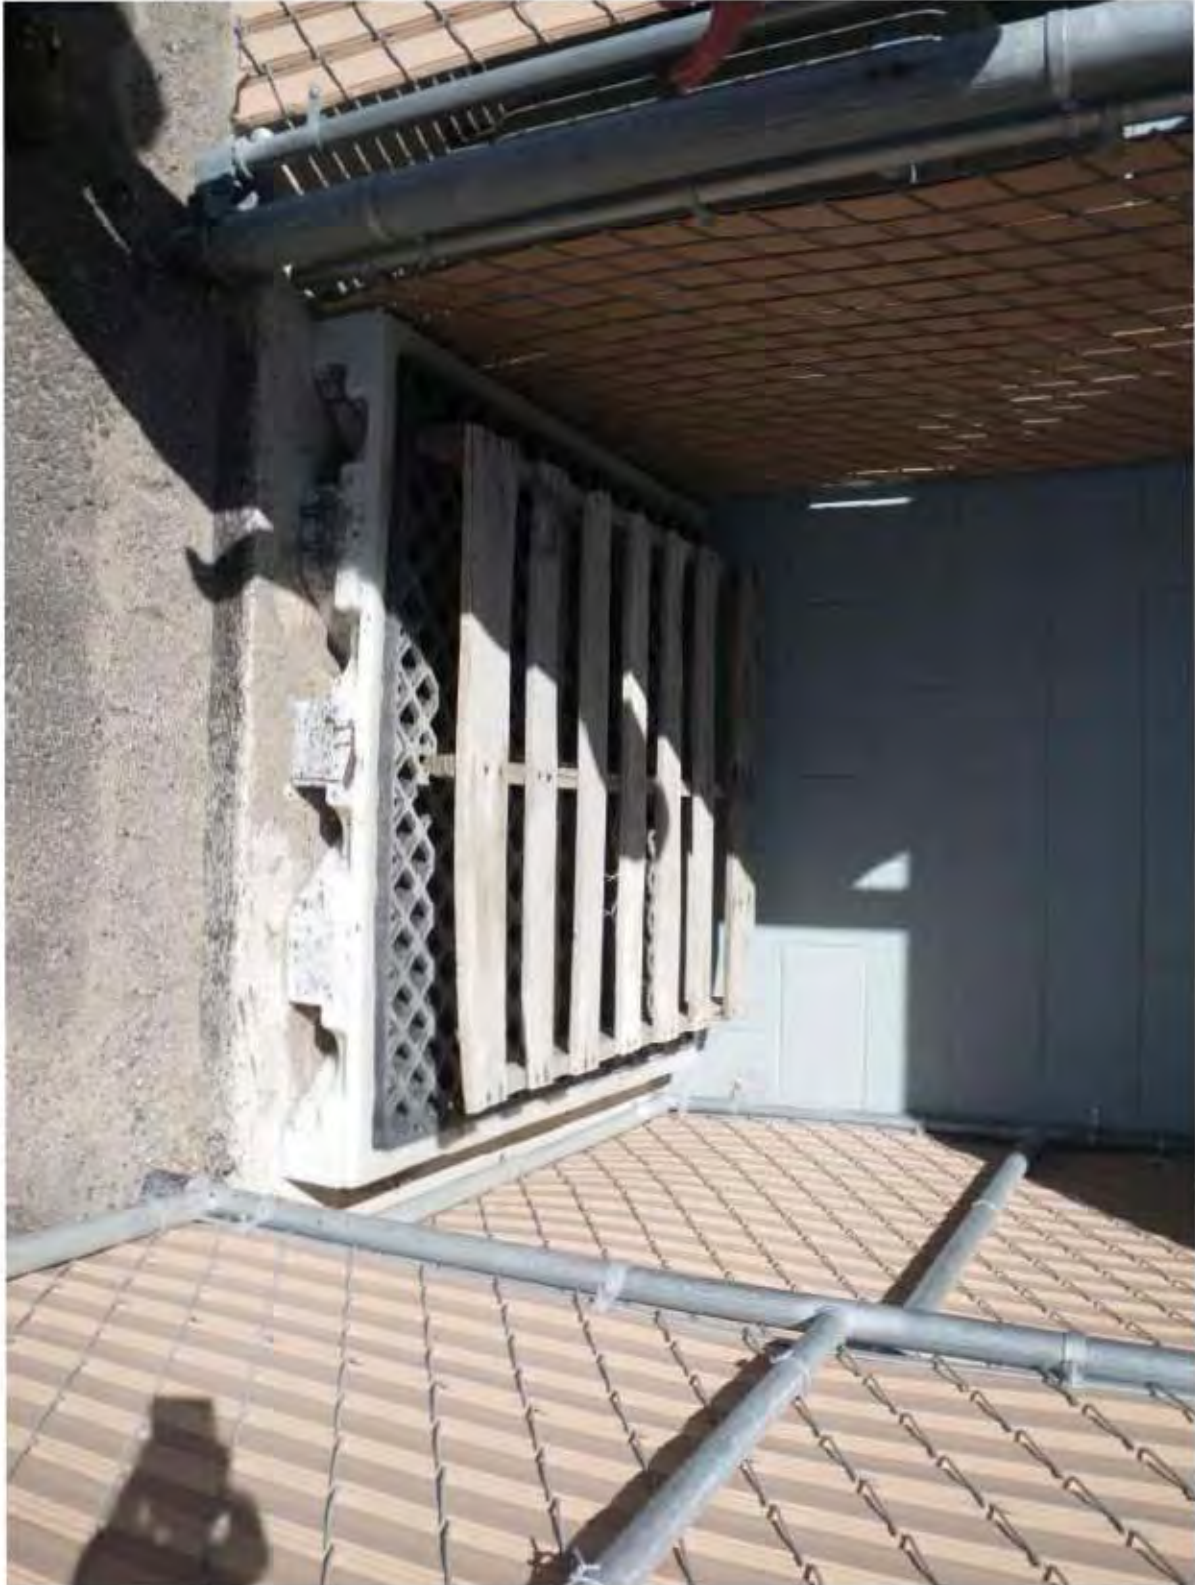
IMGP0686.JPG

IMGP0686 – Secondary containment platform within the covered and screened hazardous materials staging area, used battery staging area is depicted.

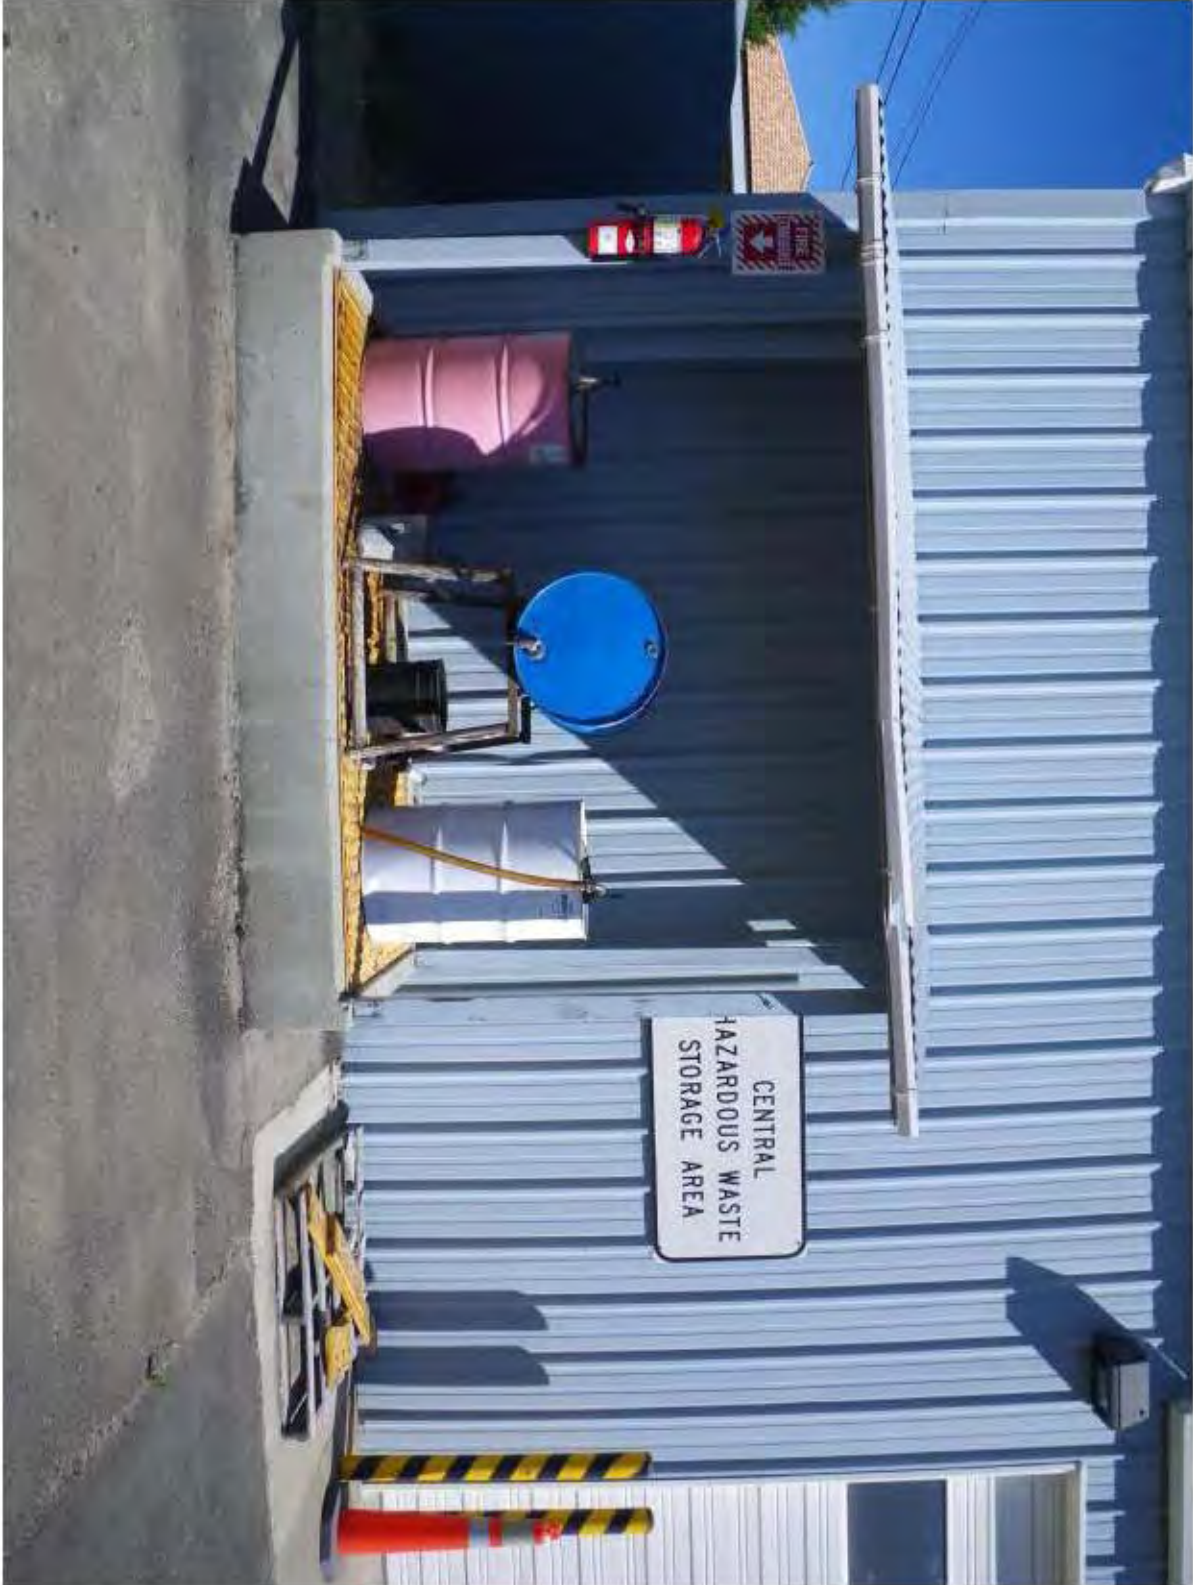
IMGP0687.JPG

IMGP0687 – Covered and contained, central hazardous waste storage area.

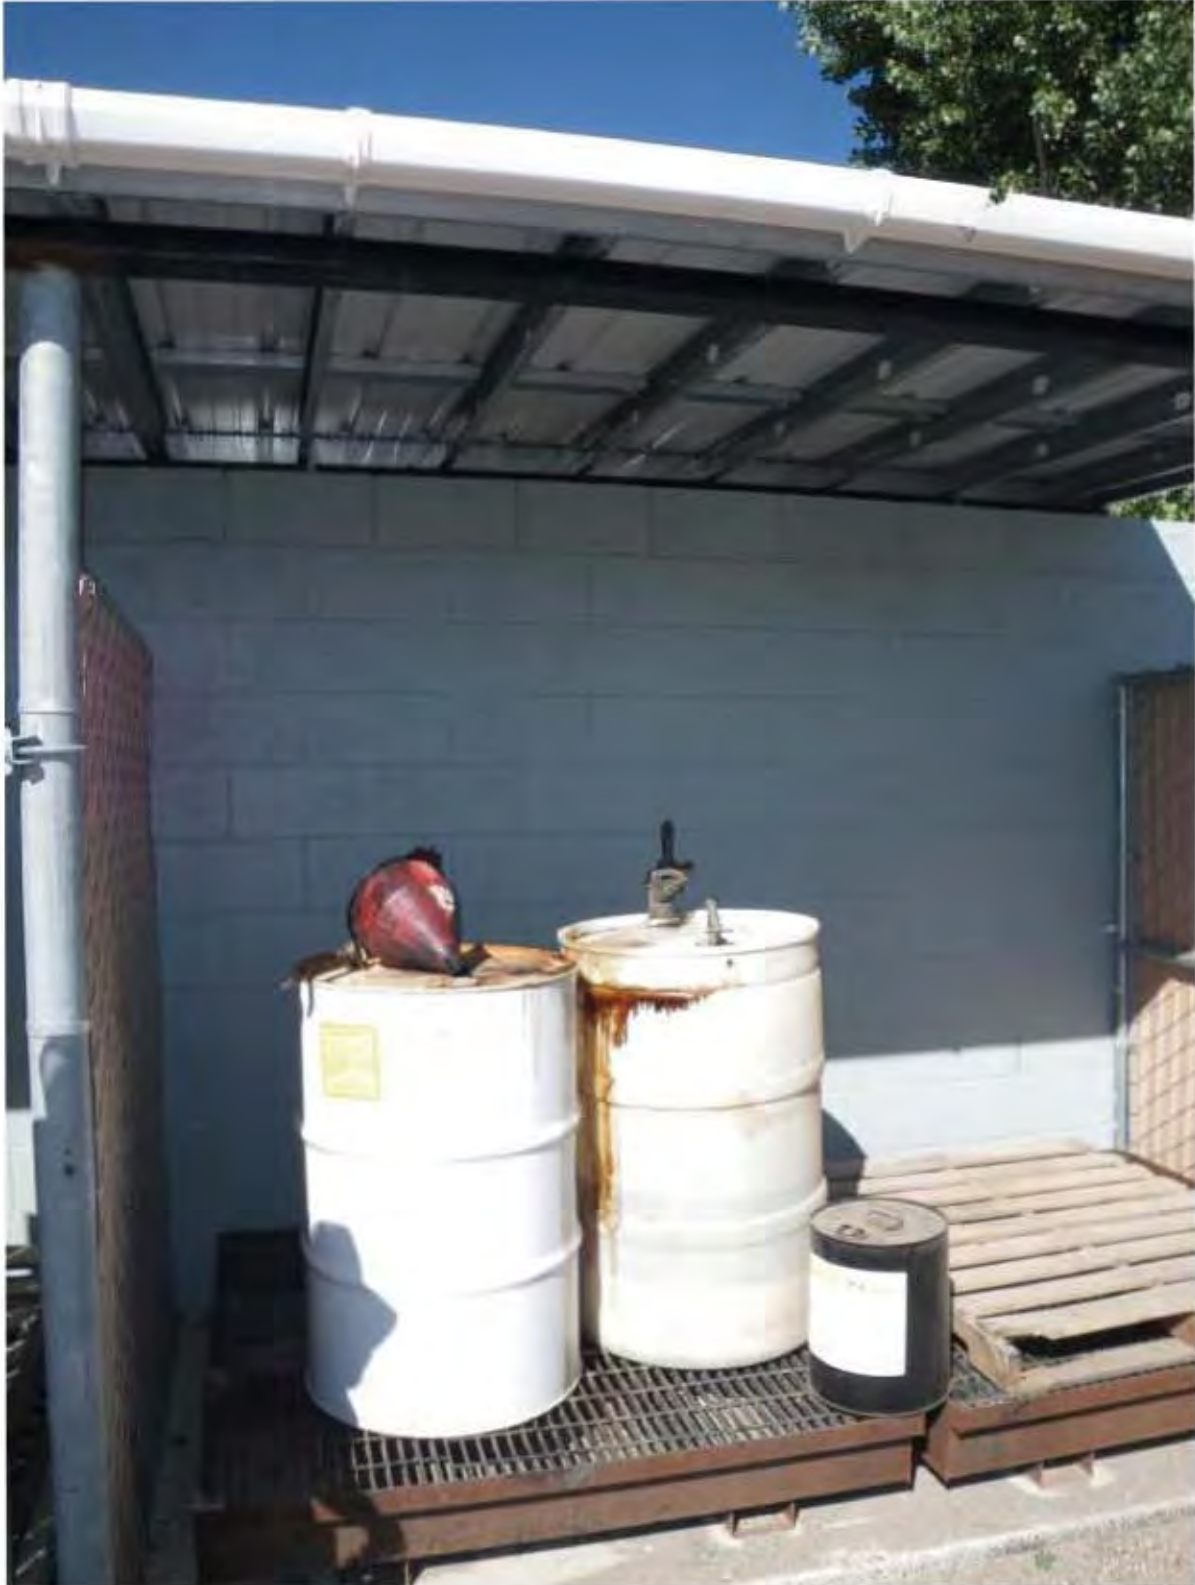
IMGP0688.JPG

IMGP0688 – Used oil barrels on secondary containment platforms in the covered and screened hazardous materials staging area.

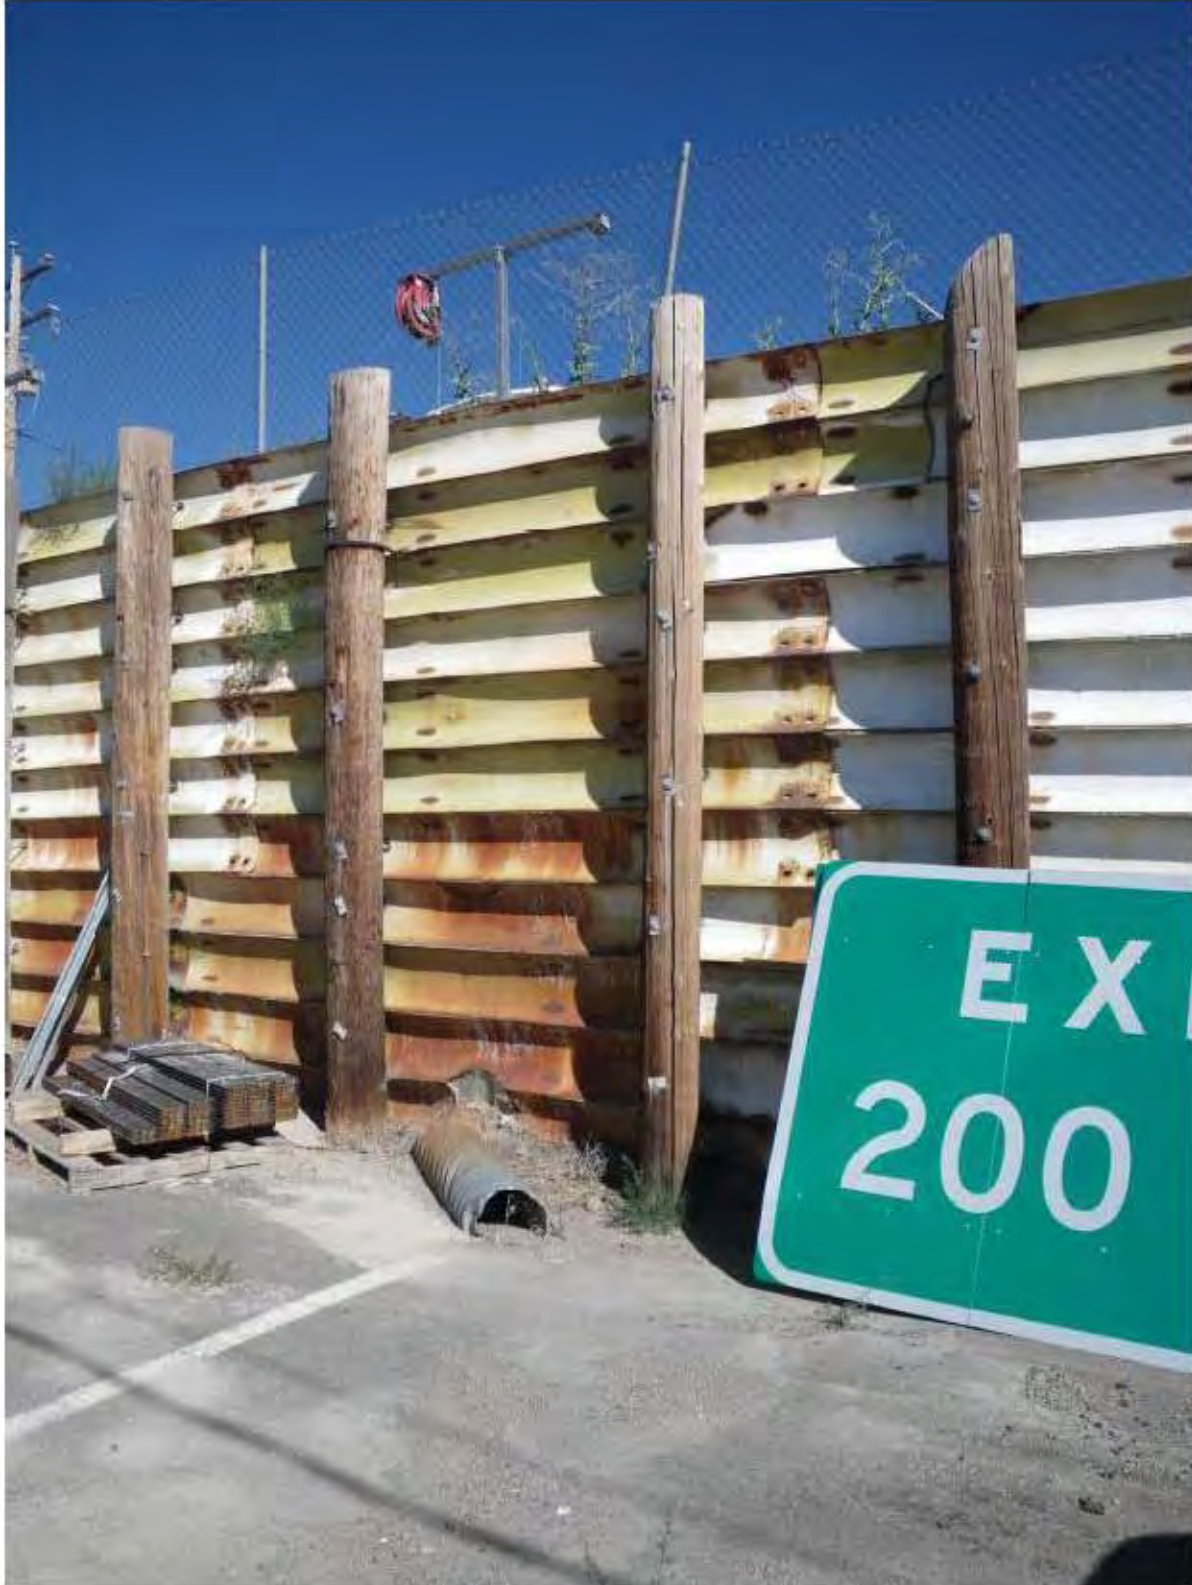
IMGP0691.JPG

IMGP0691 – Outfall of the previous drop inlet to lower parking/staging area.
