UNITED STATES ENVIRONMENTAL PROTECTION AGENCY
REGION IX
75 Hawthorne Street
San Francisco, CA 94105-3901

Enclosed is the U.S. Environmental Protection Agency's (EPA) report of the Nevada Department on the Transportation (NDOT) Storm Water Management Program (Program) Audit. Representatives from EPA Region 9 and the Nevada Department of Environmental Protection (NDEP) conducted the Audit from August 9 – 12, 2011.

MS4 Audit Report

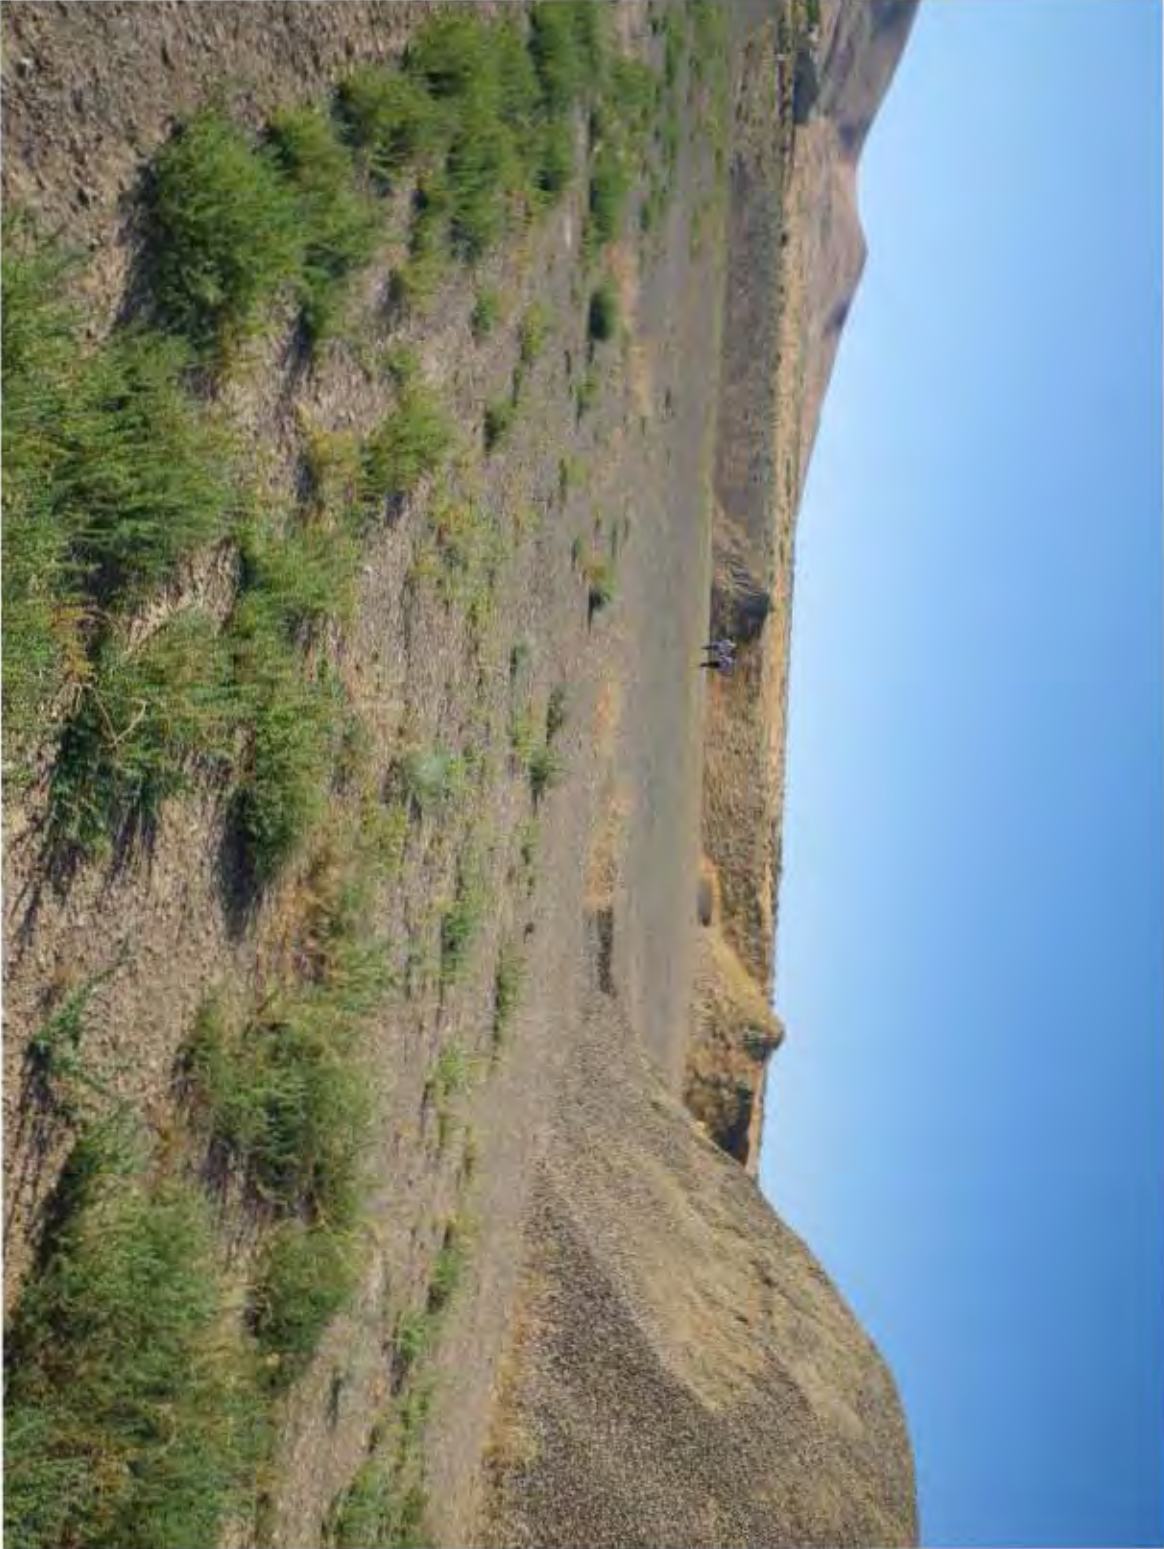
IMGP0704.JPG

NDOT MS4 Audit - Material Extraction Pit 8.11.11

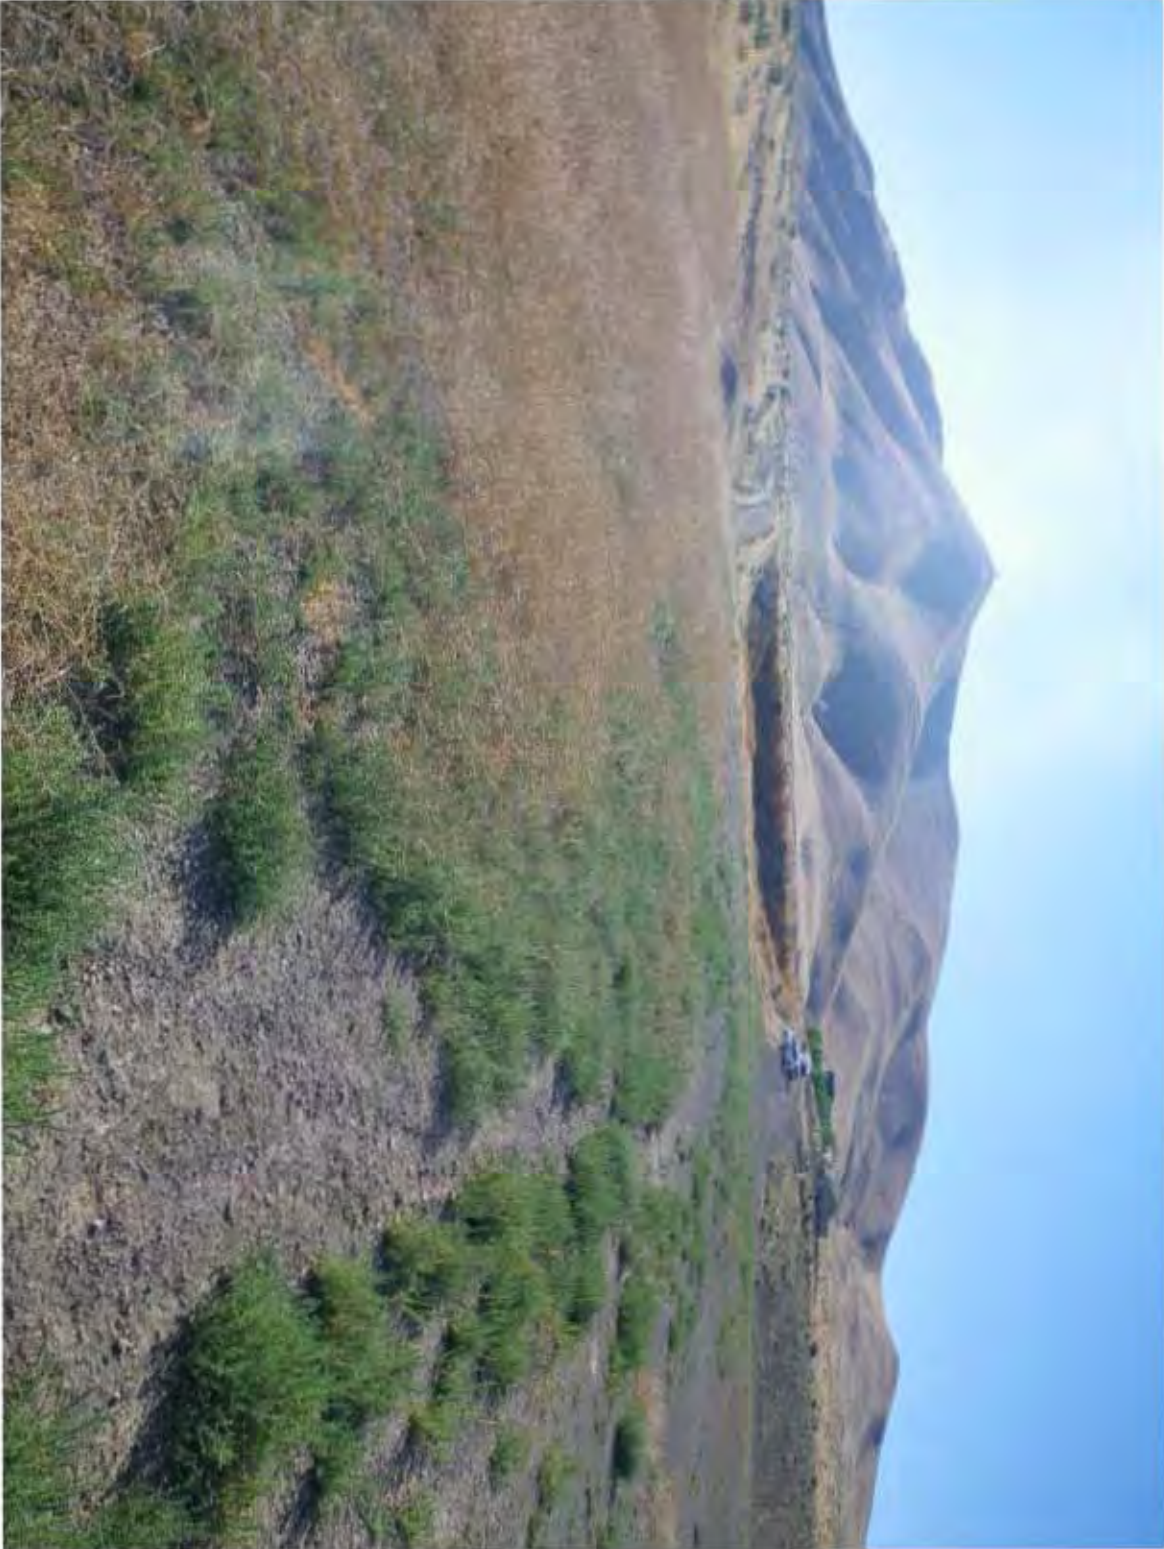
IMGP0705.JPG

NDOT MS4 Audit - Material Extraction Pit 8.11.11

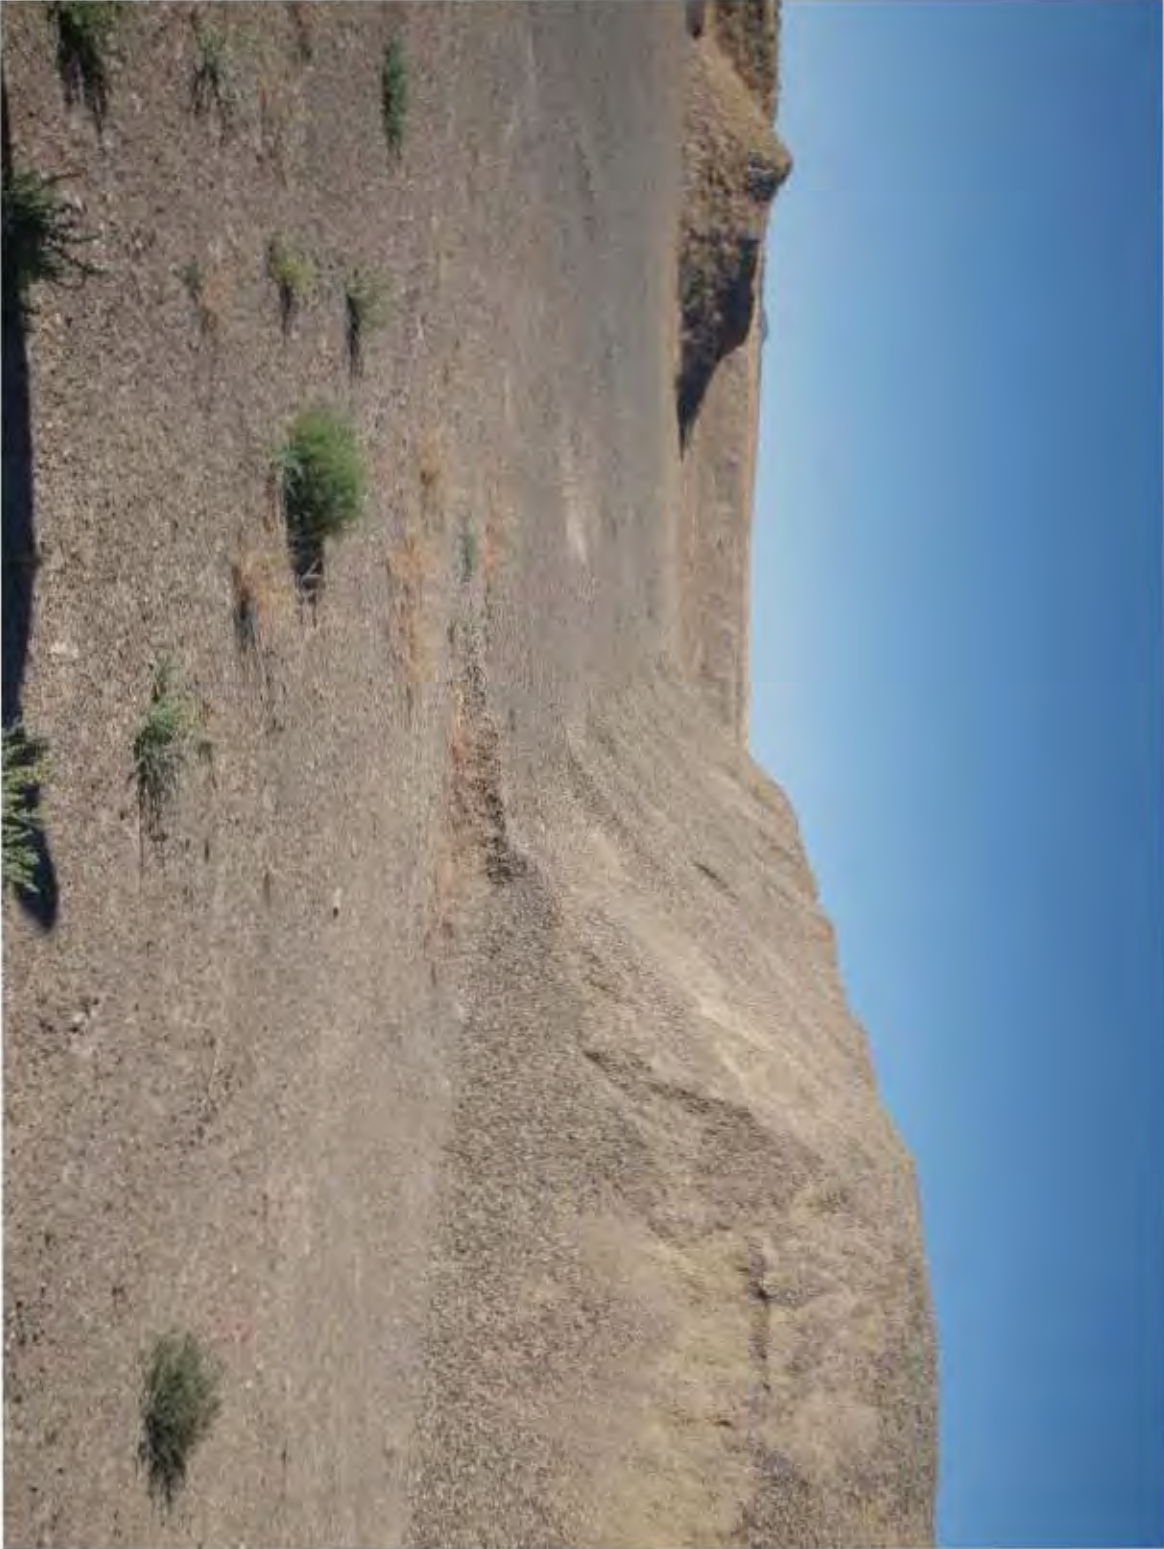
IMGP0706.JPG

NDOT MS4 Audit - Material Extraction Pit 8.11.11

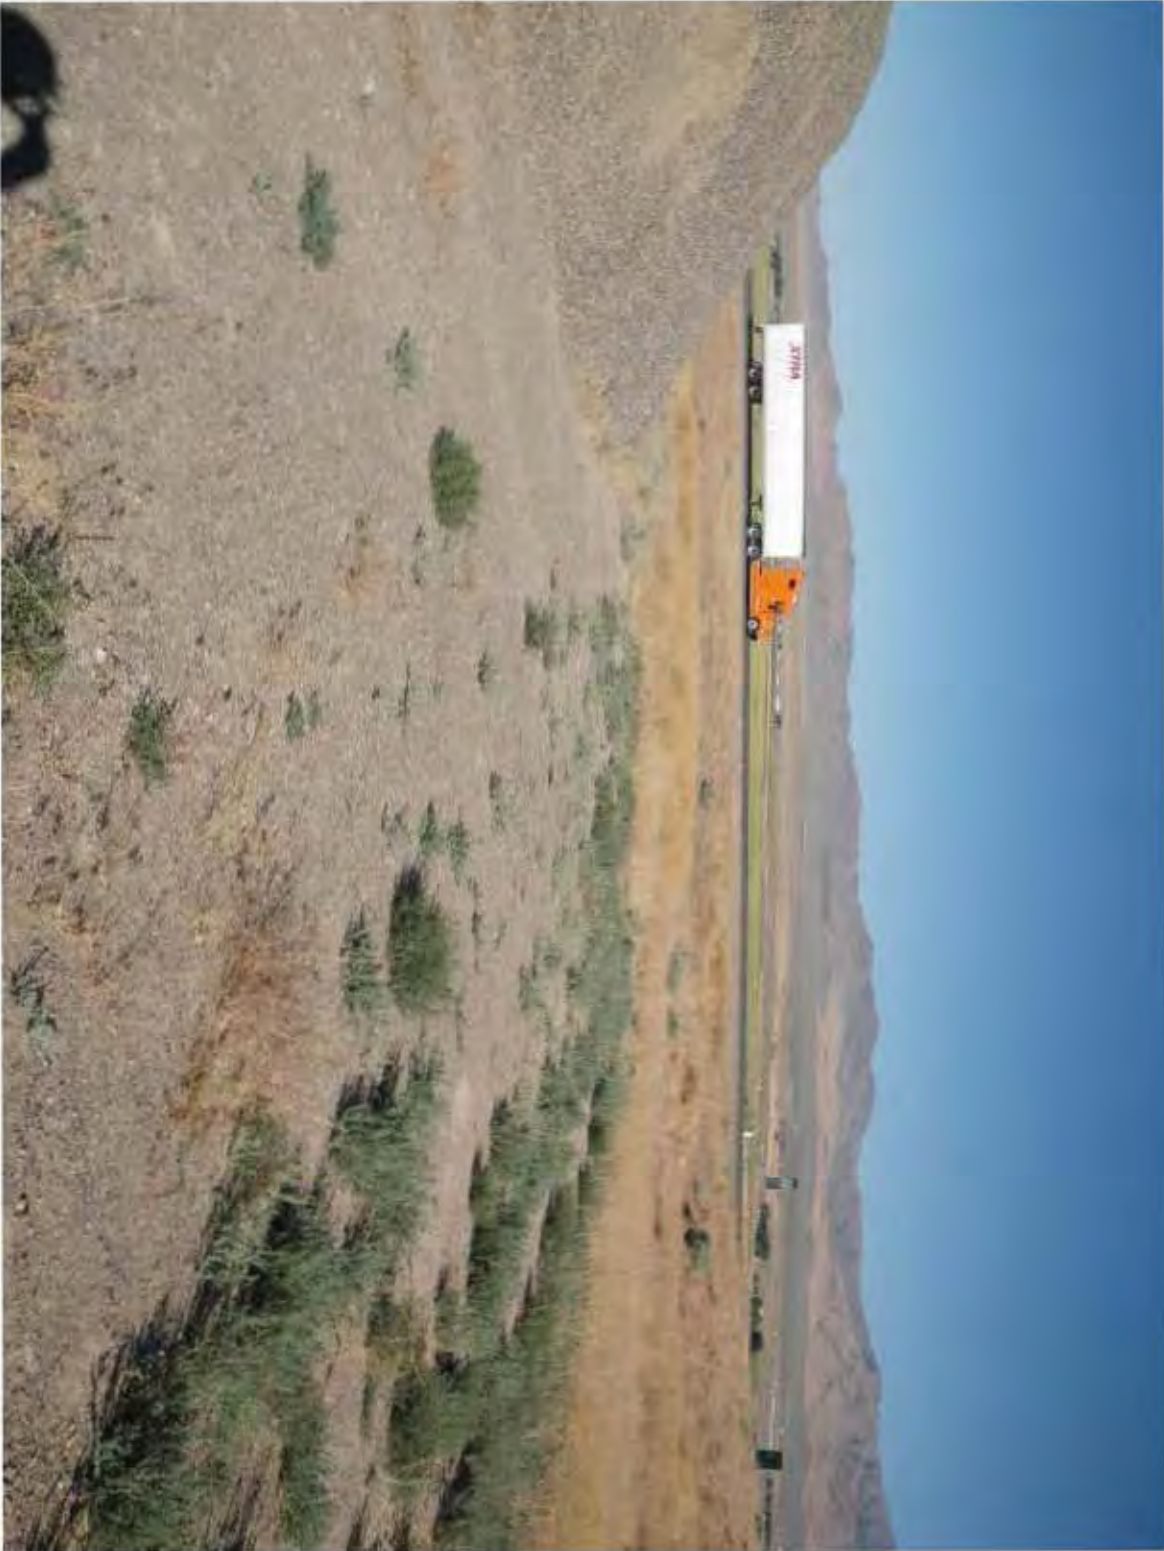
IMG0707.JPG

NDOT MS4 Audit - Material Extraction Pit 8.11.11

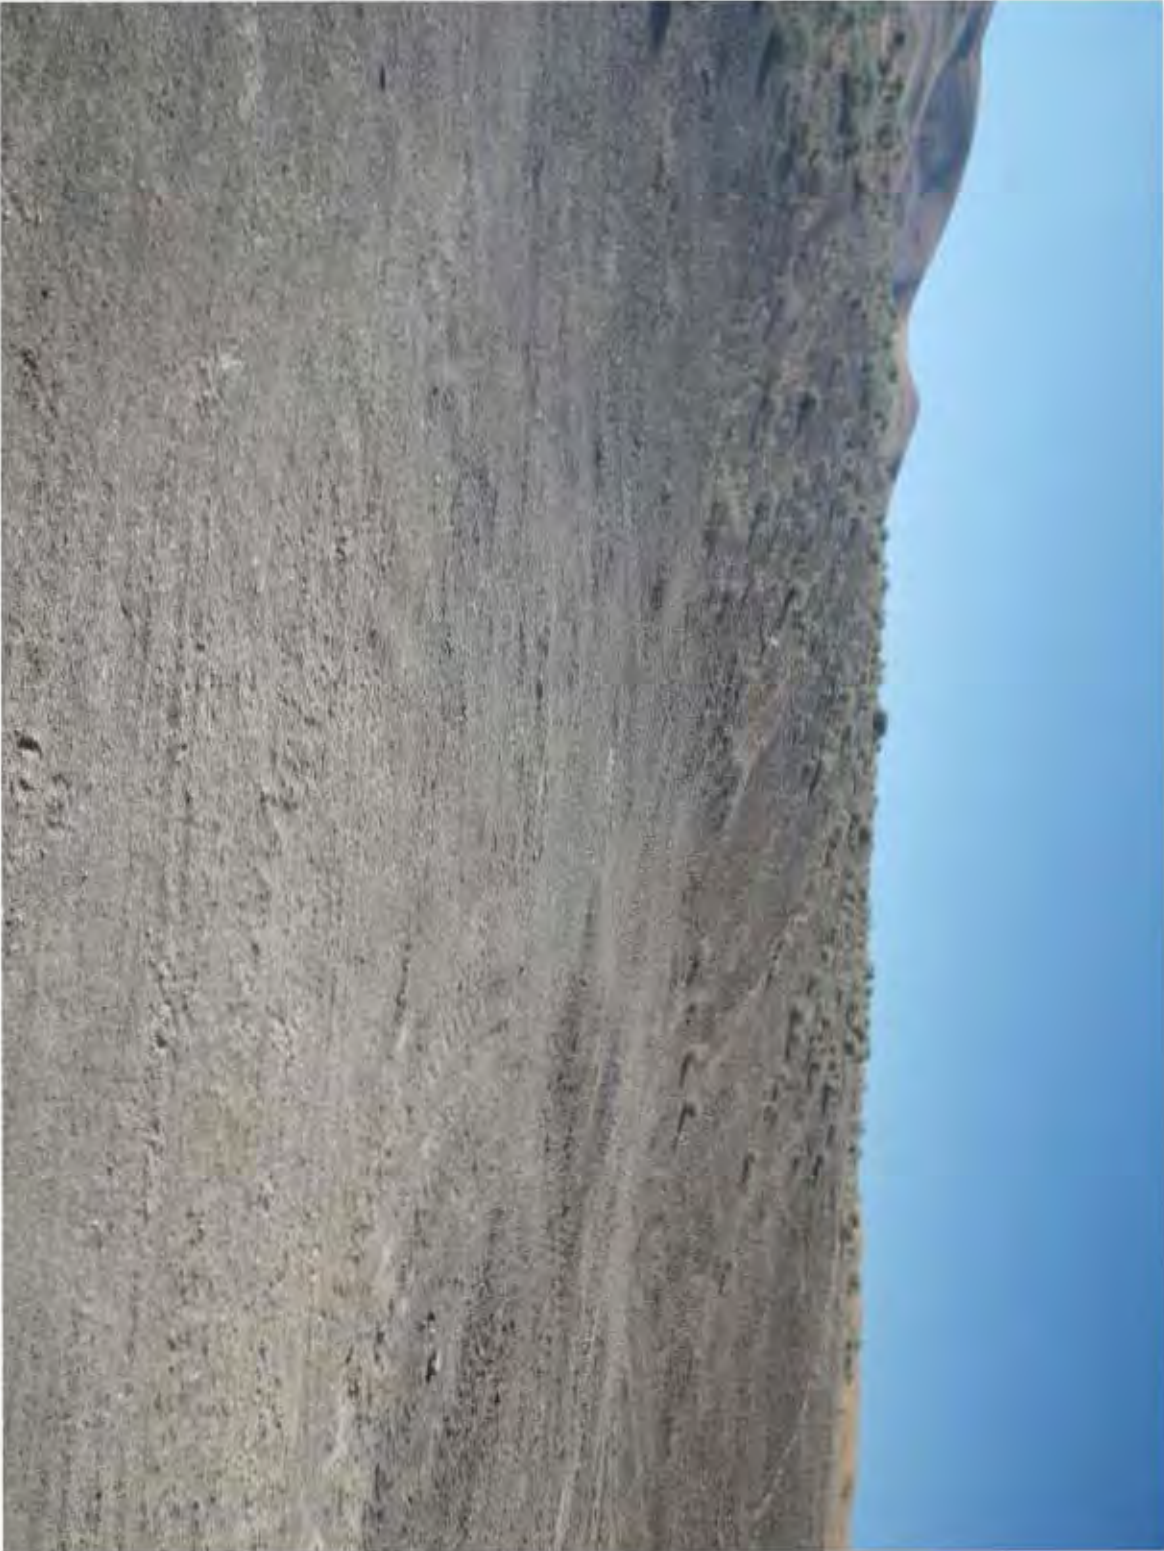
IMGP0708.JPG

NDOT MS4 Audit - Material Extraction Pit 8.11.11
