**Appendix A**  
**Storm Water Management Plan: Comments from NDEP and Co-Permittee Response**

## Storm Water Management Plan: Comments from NDEP and Co-Permittee Response

**Appendix B**  
**Clark County**

**Appendix B.1**  
**Documentation of Findings**

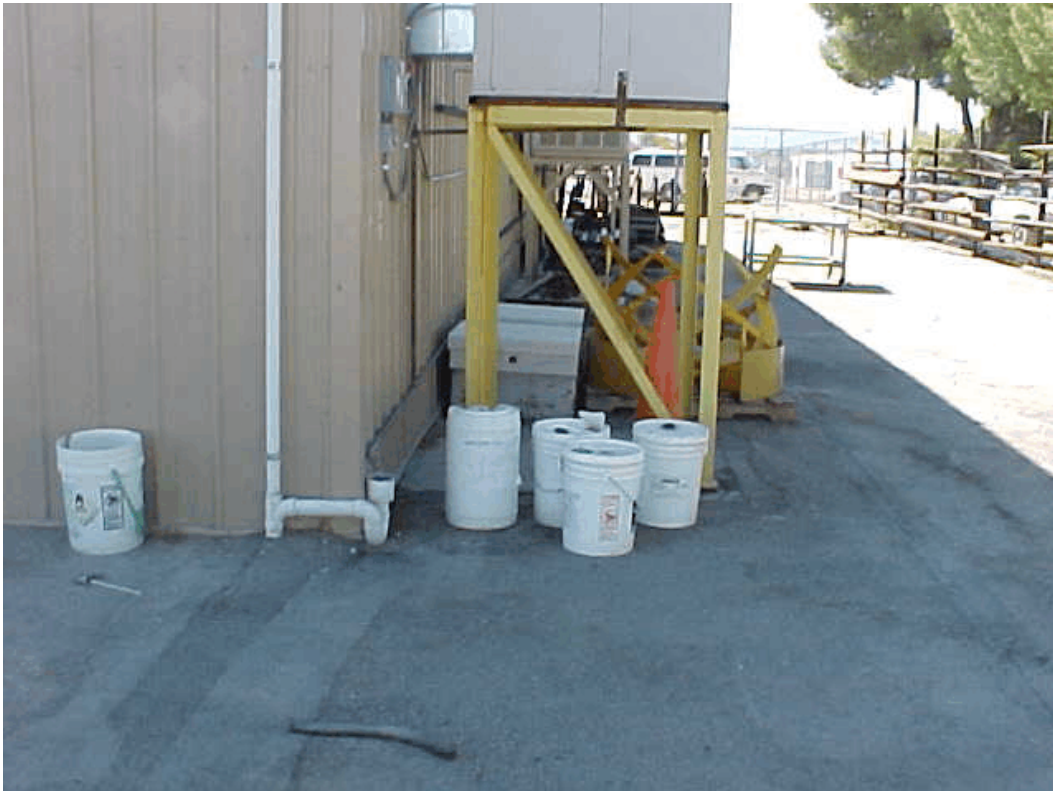
**Photo 3.** Fleet (primary) facility: Four uncovered and uncontained 5-gallon pails of truck wash chemical.

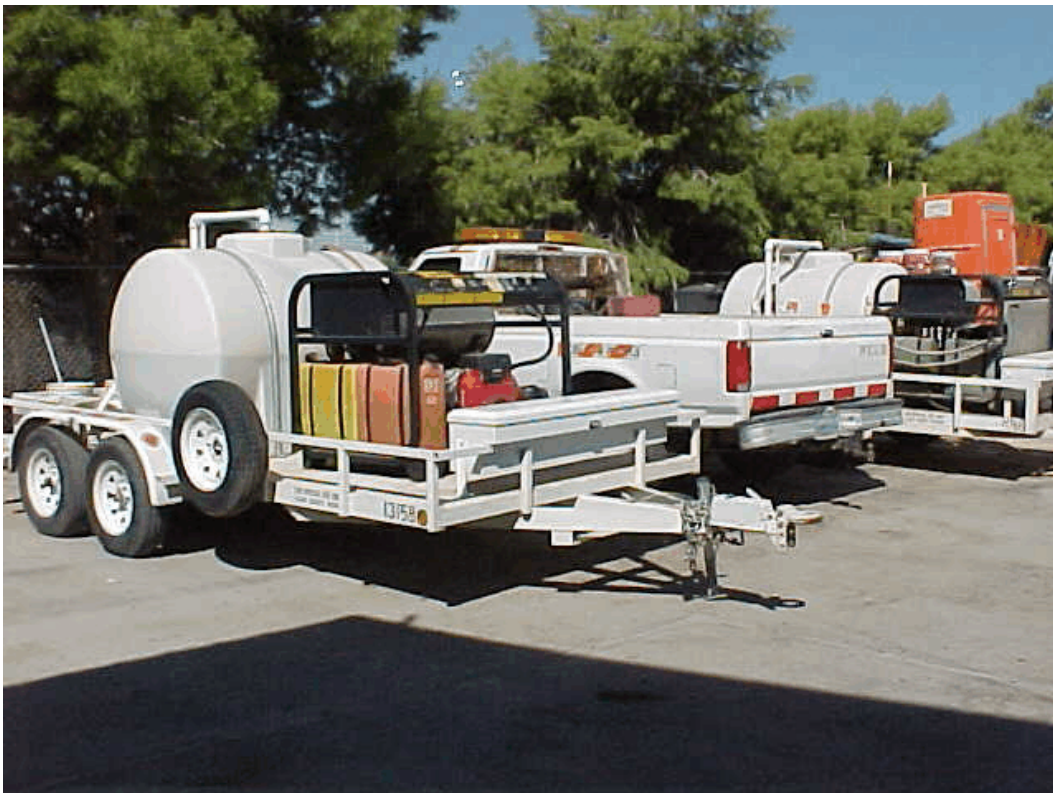
**Photo 4.** Fleet (primary) facility: Power washer for trucks.

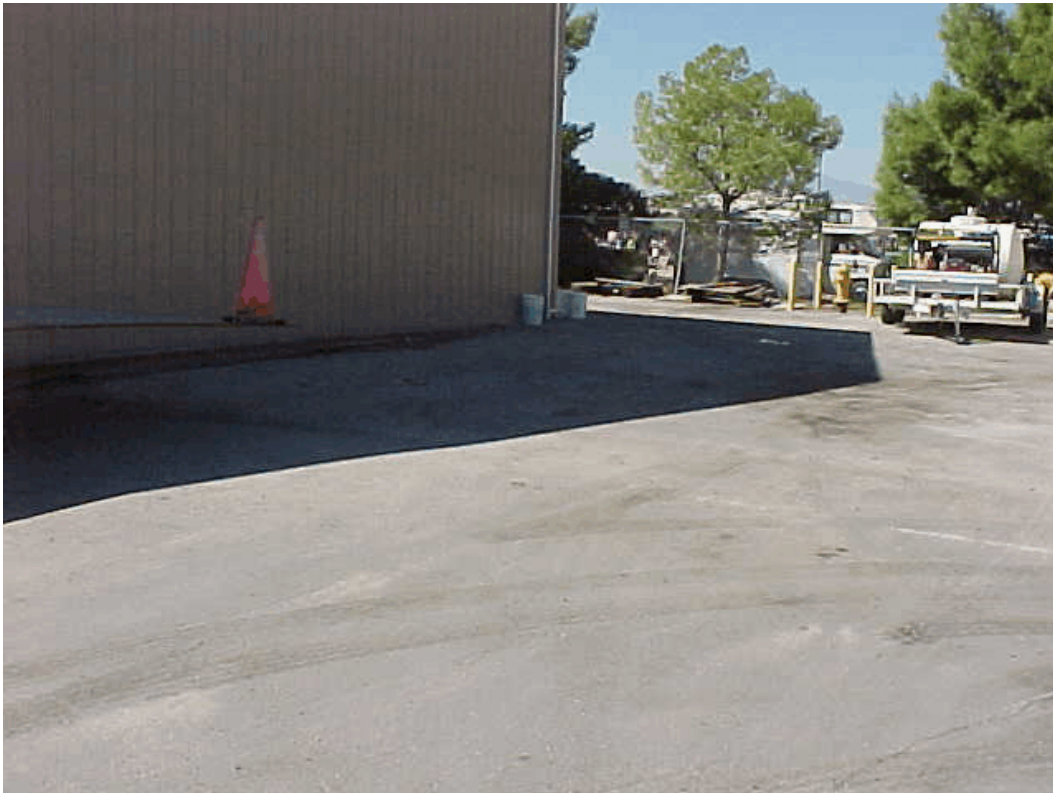
**Photo 5.** Fleet (primary) facility: Truck wash area is outside, uncontained, uncovered.

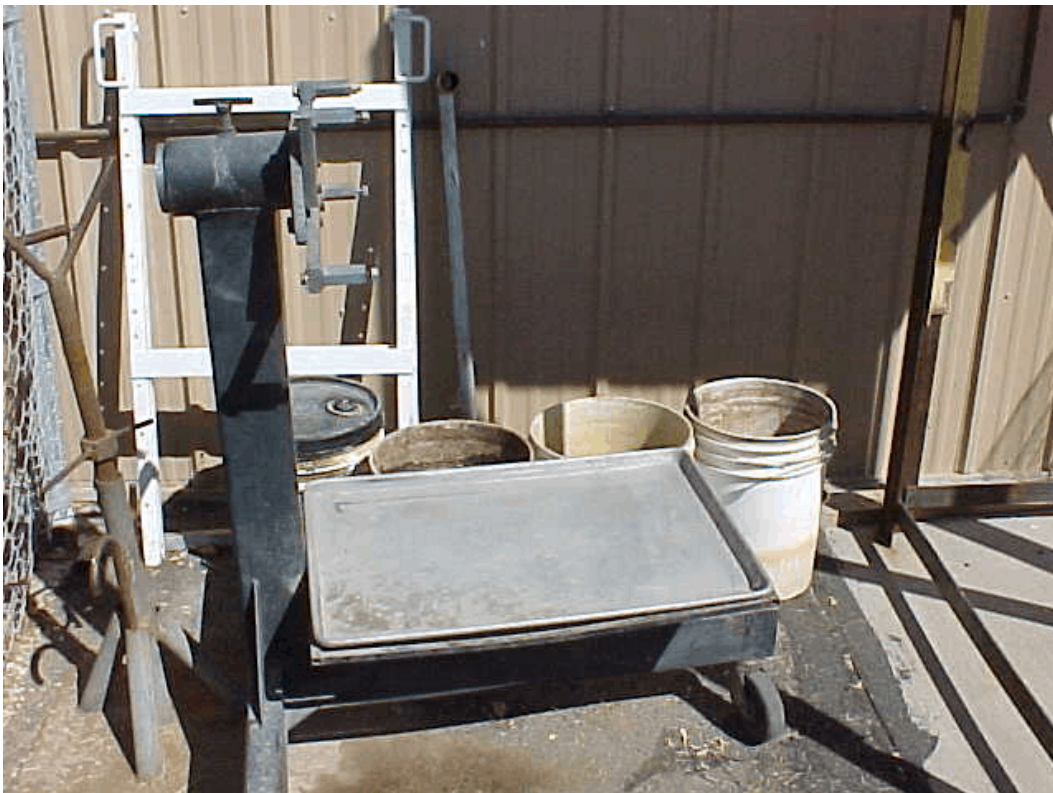
**Photo 6.** Fleet (primary) facility: Four 5-gallon pails stored outside. One, without a lid, is 50% full of used petroleum product.

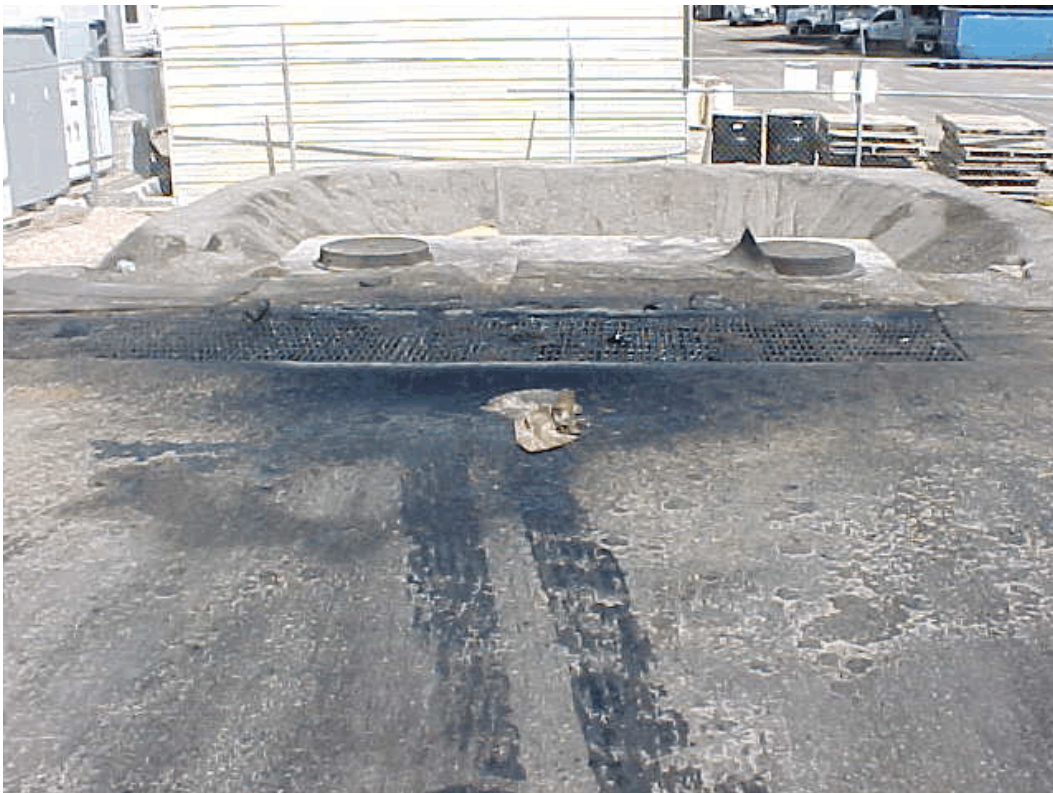
**Photo 16.** Fleet (secondary) facility: Abandoned asphalt washout area.

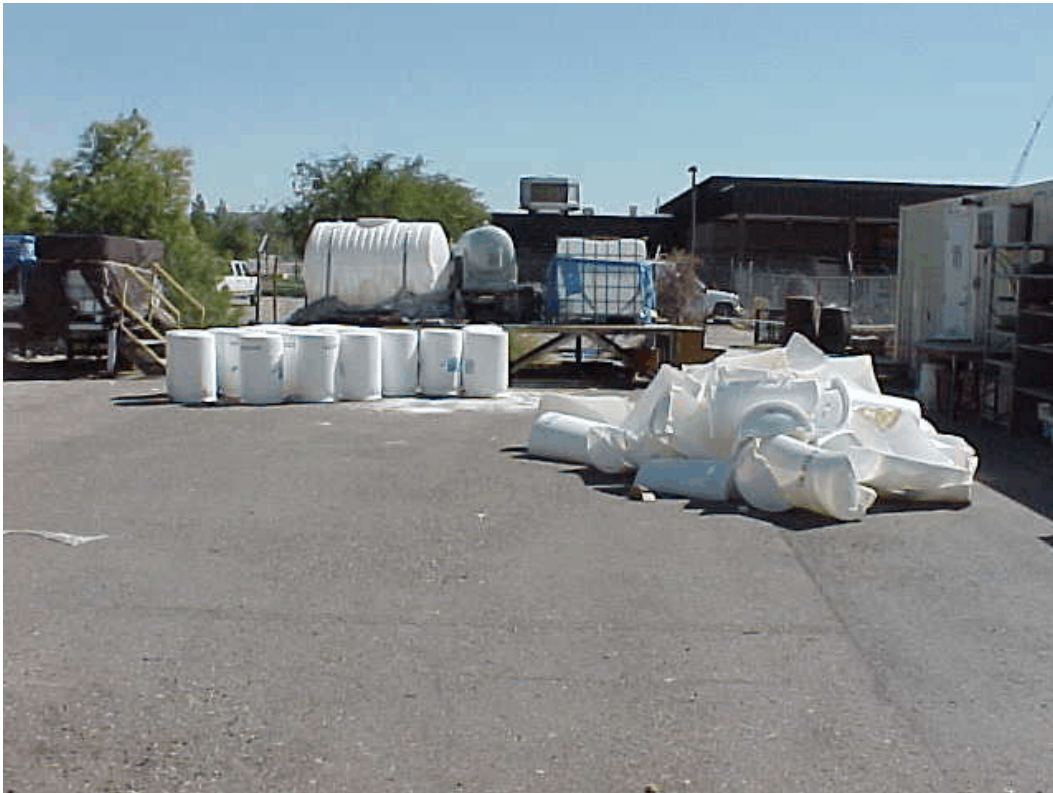
**Photo 17.** Vector Control facility: Empty drums of larvicide had been cut open in an uncontained location and residue spilled to the pavement.

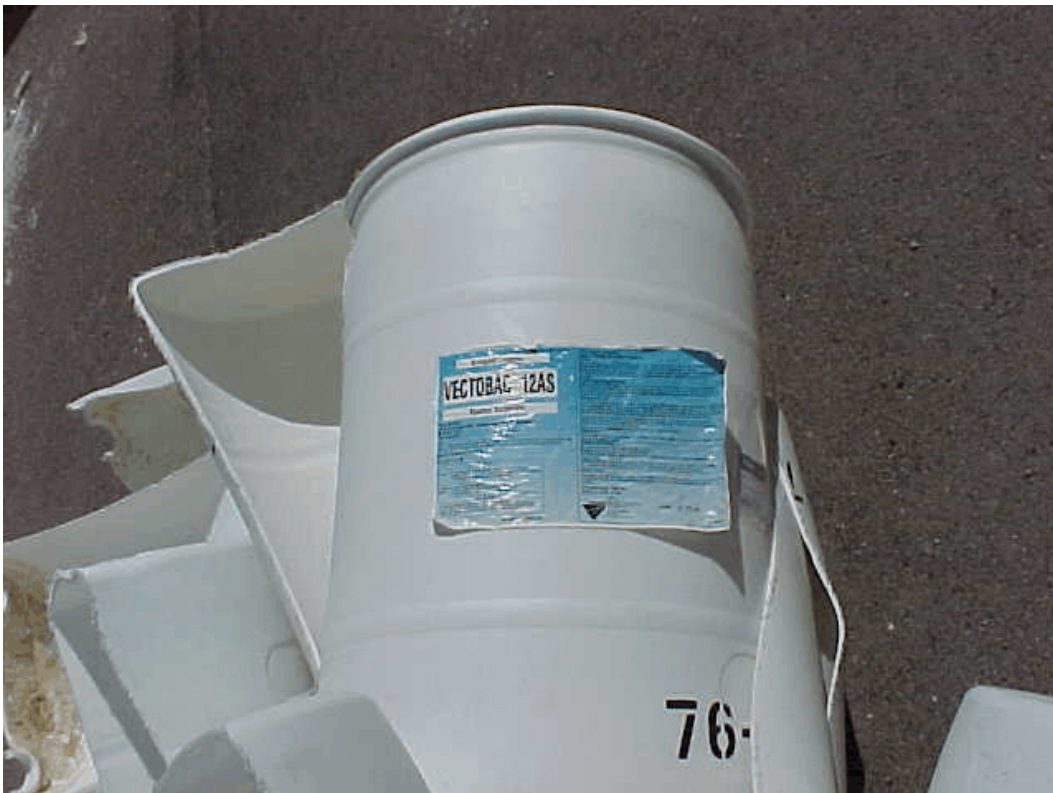
**Photo 18.** Vector Control facility: Empty drums of larvicide had been cut open in an uncontained location and residue spilled to the pavement.

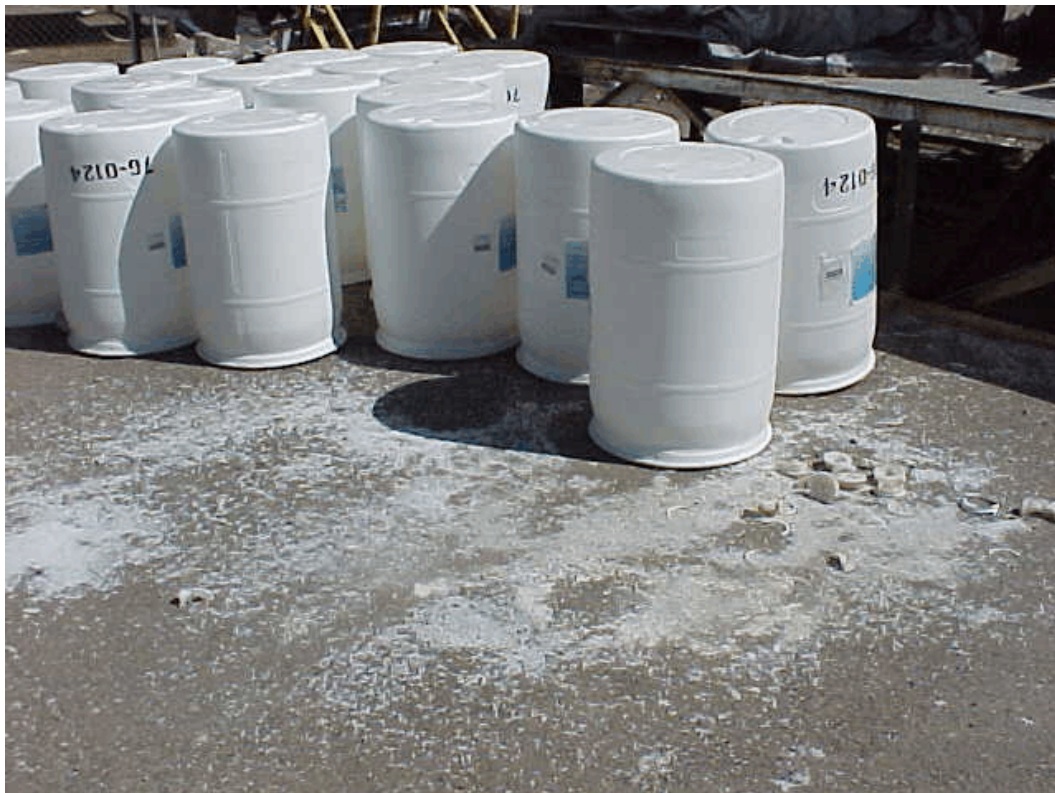
**Photo 20.** Vector Control facility: Empty drums of larvicide had been cut open in an uncontained location and residue spilled to the pavement.

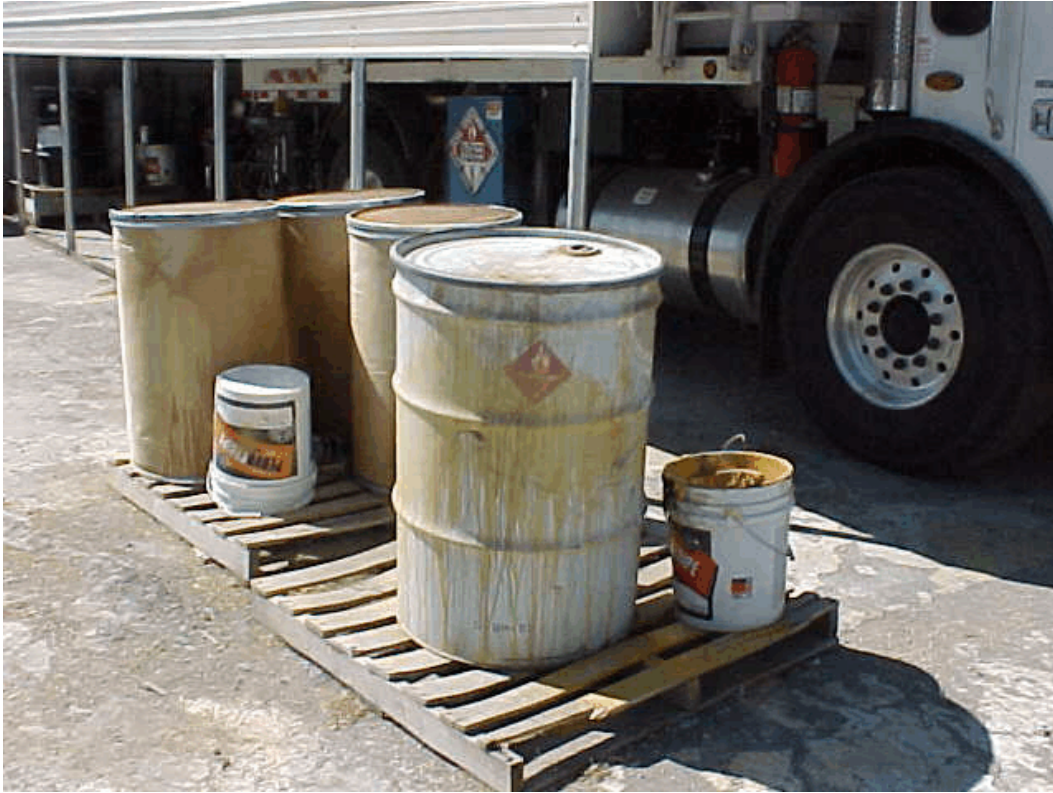
**Photo 21.** Traffic facility: One 55-gallon drum of flammable contents and three fiber drums of unknown contents were uncovered and uncontained.

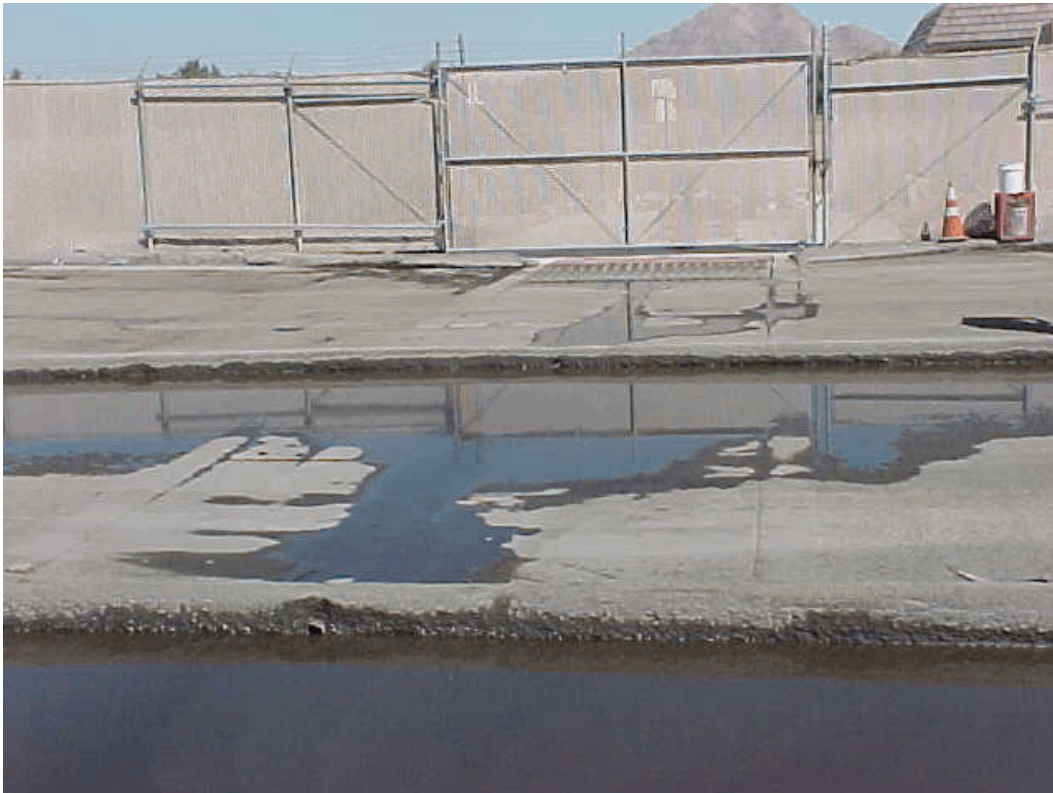
**Photo 3.** Sediment traps to collect soil and debris from street sweeper unloading.

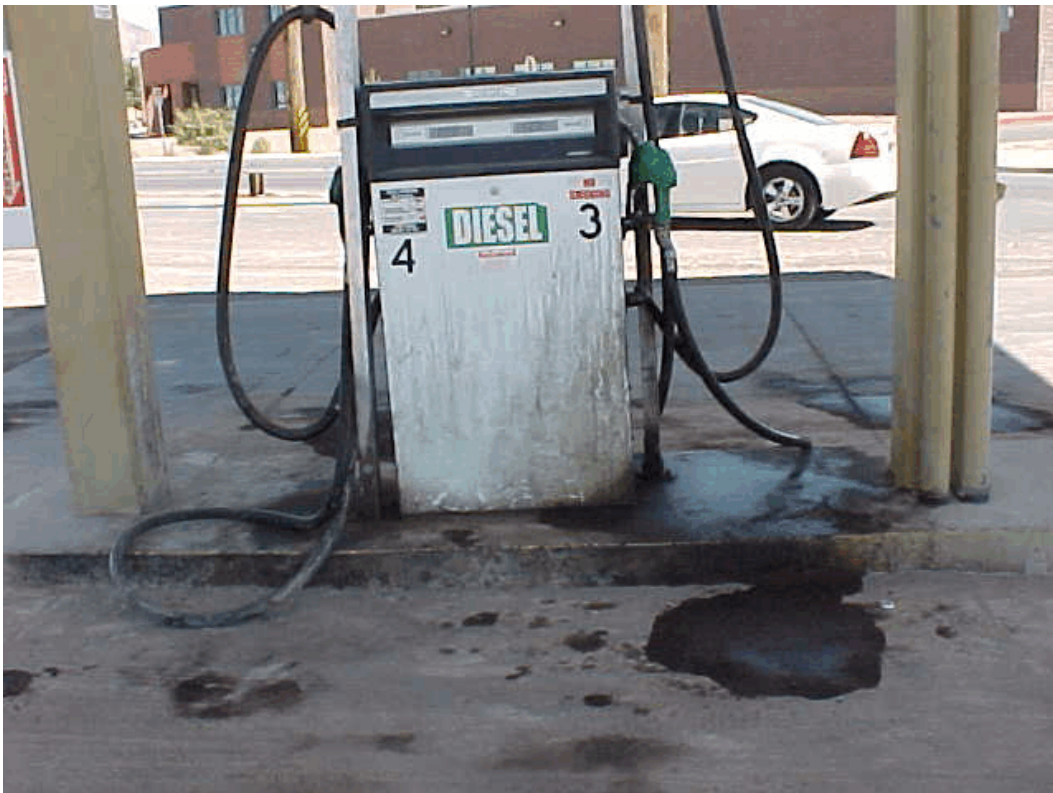
1. The Automotive Repair facility had minimal staining of pavement from petroleum spills/leakage. The facility had used batteries located outside, uncontained, and uncovered.
2. The Fuel Point area had several fresh spills. The audit team did not observe a spill kit or emergency shutoff at the fuel island. Signage directed calling 911 in case of a fuel spill.

1. Exposed and uncontained used batteries at the Automotive Repair facility had the potential to lose acid to storm water runoff.
2. The spillage at the Fuel Point area was under the canopy, but had the potential to be tracked out of the canopy area and be carried to the adjacent street by storm water.

**Photo 6.** Spillage at fuel island.

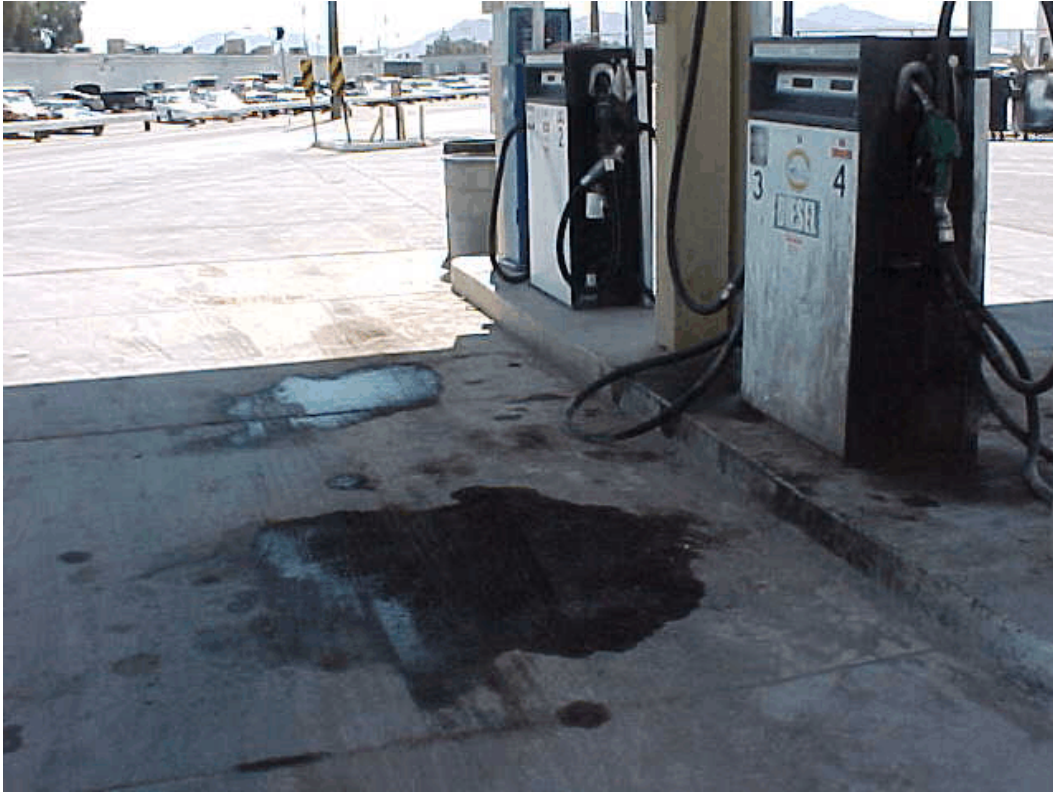
**Photo 7.** Spillage at fuel island.

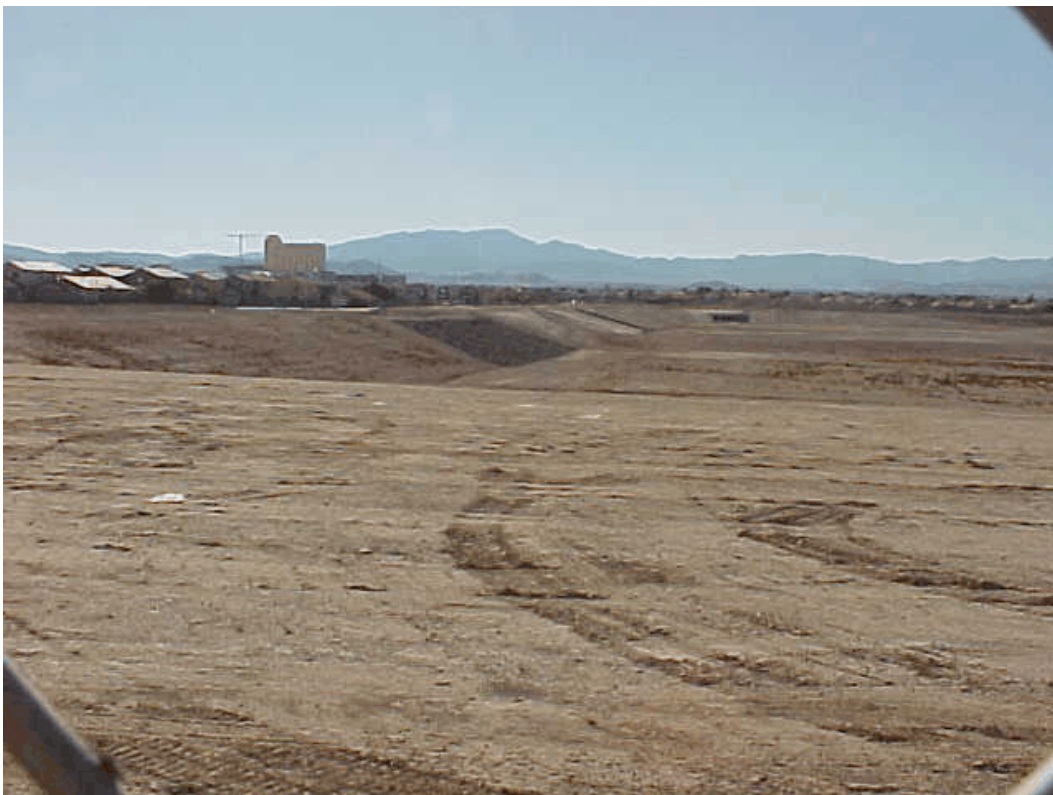
**Photo 2.** Southwest view of the detention basin from the east fence.

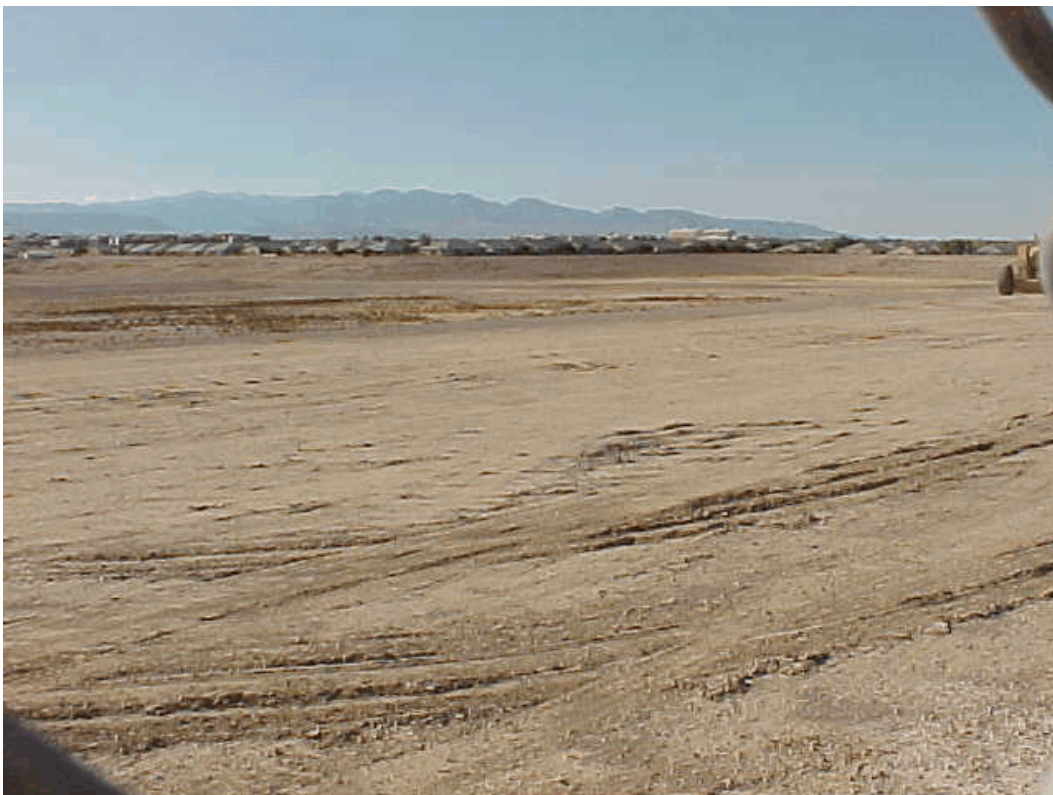
**Photo 4.** Northwest view of the detention basin from the east fence.

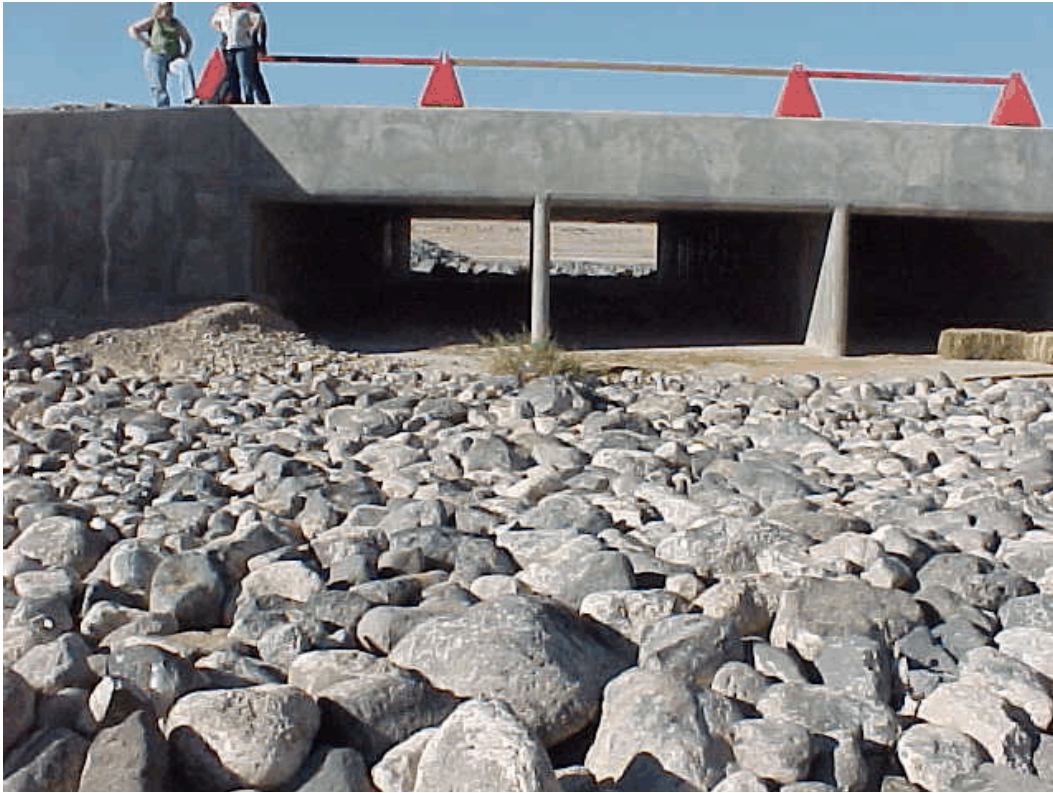
**Photo 5.** View of the wash passing under the street to the detention basin.

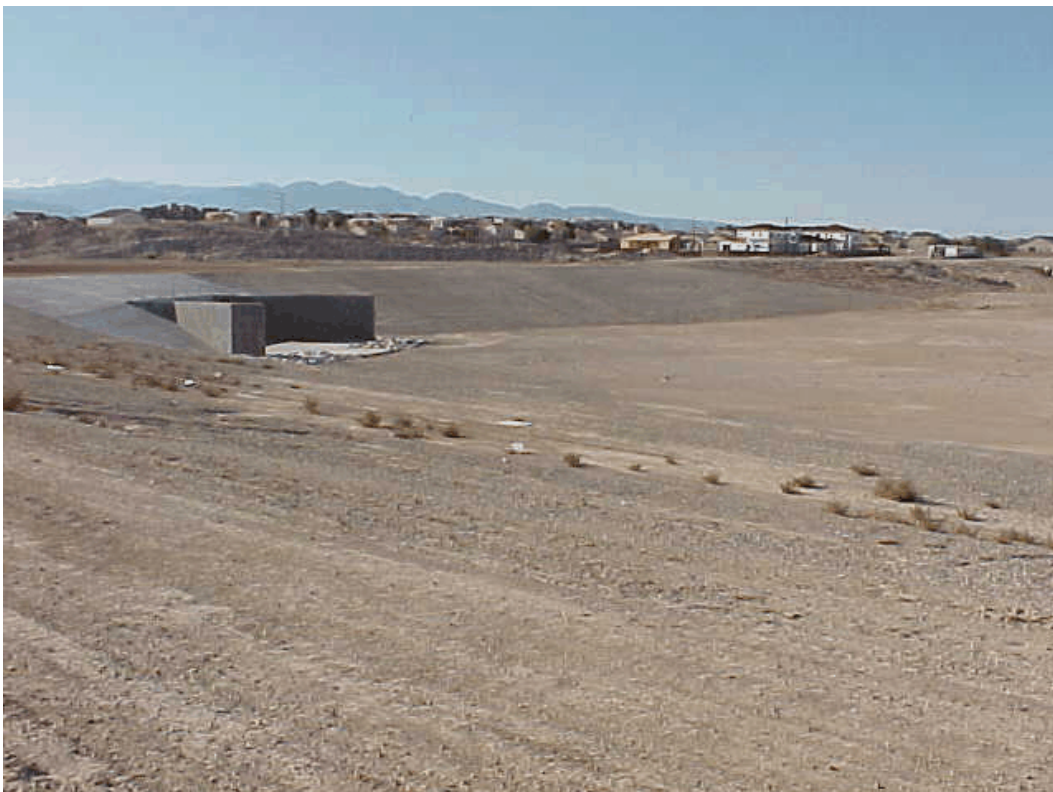
- Installation of discharge pipes to the detention basin may result in erosion where the pipe enters the basin and may cause scouring of the basin floor at the discharge point. Loose soils will potentially be carried by storm water to Duck Creek Channel when a rain event occurs.

**Photo 6.** Inlet to detention basin at southwest corner.

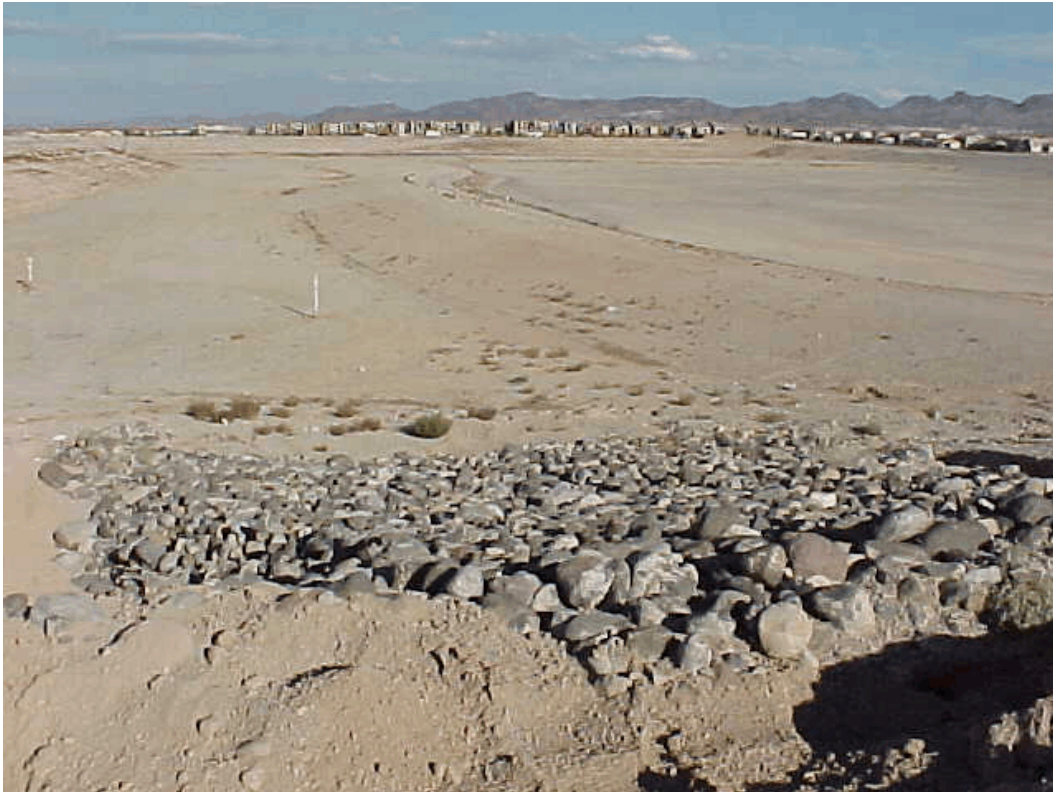
**Photo 7.** East view of detention basin.

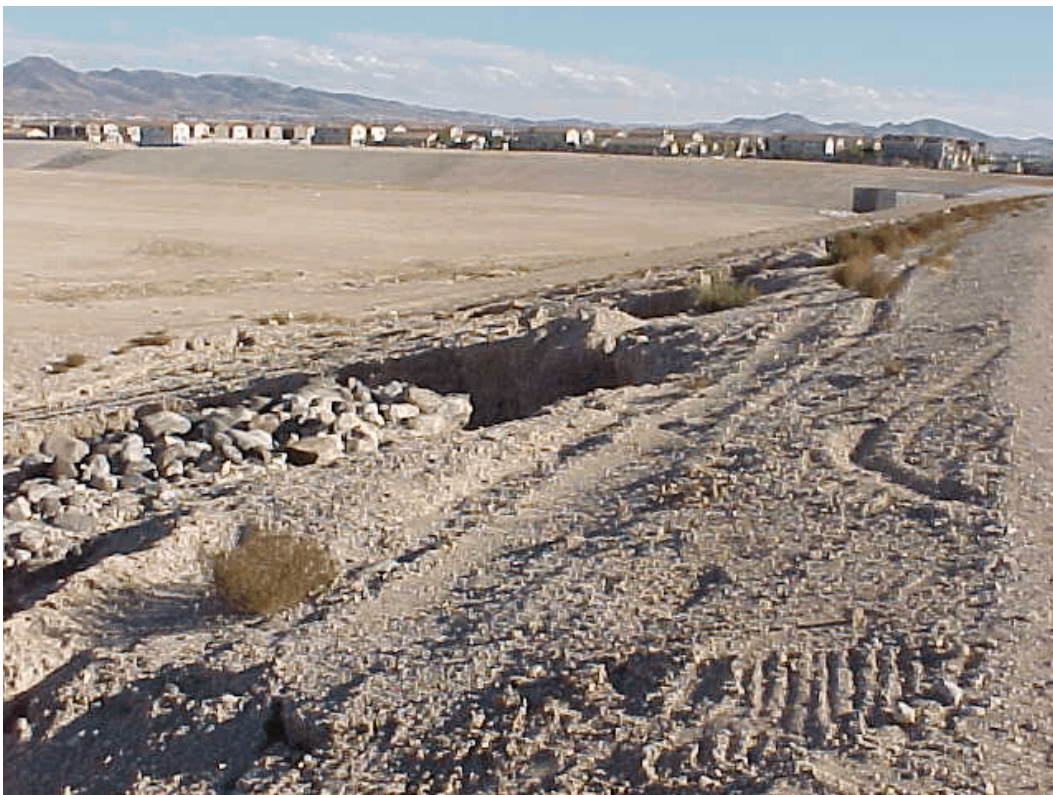
1. Erosion into the detention basin was observed at several locations. Some erosion channels in the west wall of the detention basin were at least four feet deep and six feet wide. Mr. Suckow stated that the erosion in the west wall had occurred several months ago.
2. Utility work was ongoing outside the east fence of the detention basin. The heavy equipment was parked inside a locked gate to the detention basin area. Mr. Suckow was unaware of the ongoing work.
3. An approximately 36-inch pipe for storm water discharge to the detention basin had recently been installed at the northwest corner of the detention basin. The pipe appeared to have been installed by the developer of an adjacent subdivision. Mr. Suckow was unaware of the installation.

1. Clark County is not actively repairing erosion into the detention basin and has not implemented Best Management Practices (BMPs) such as stabilization and/or riprap of the basin walls. Loose soils eroded into the basin will potentially be carried by storm water to the Duck Creek Channel when a rain event occurs.

**Photo 8.** Erosion on west wall of detention basin.

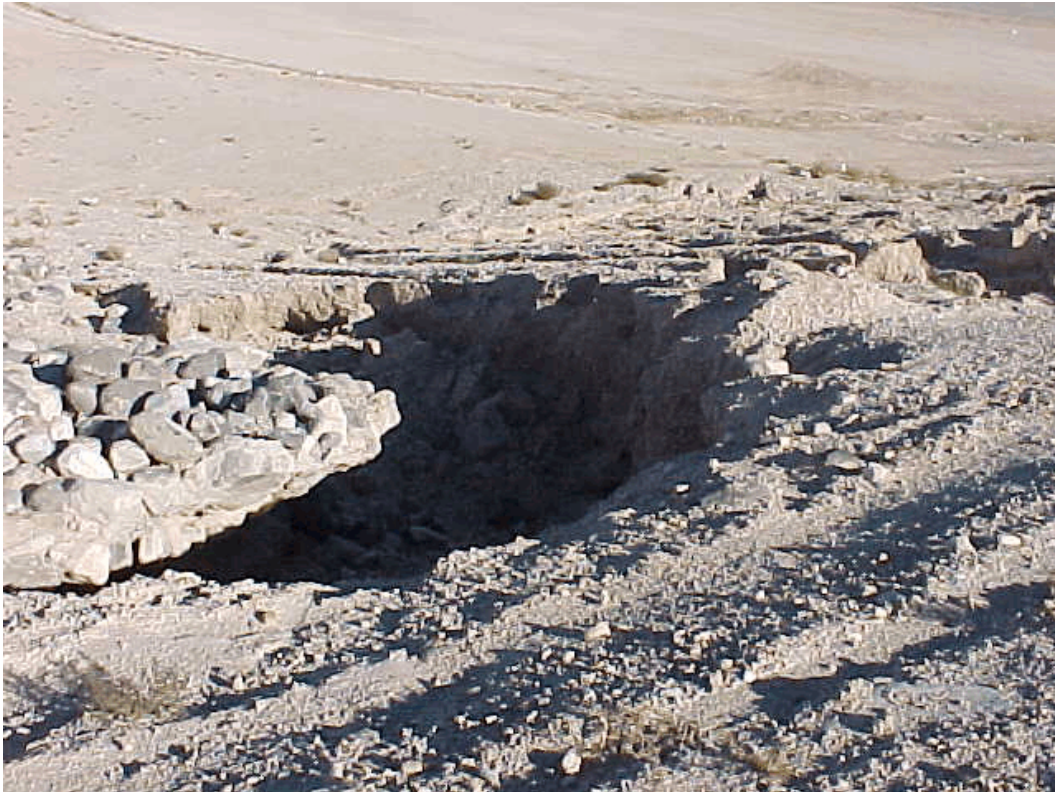
**Photo 9.** Erosion on west wall of detention basin.

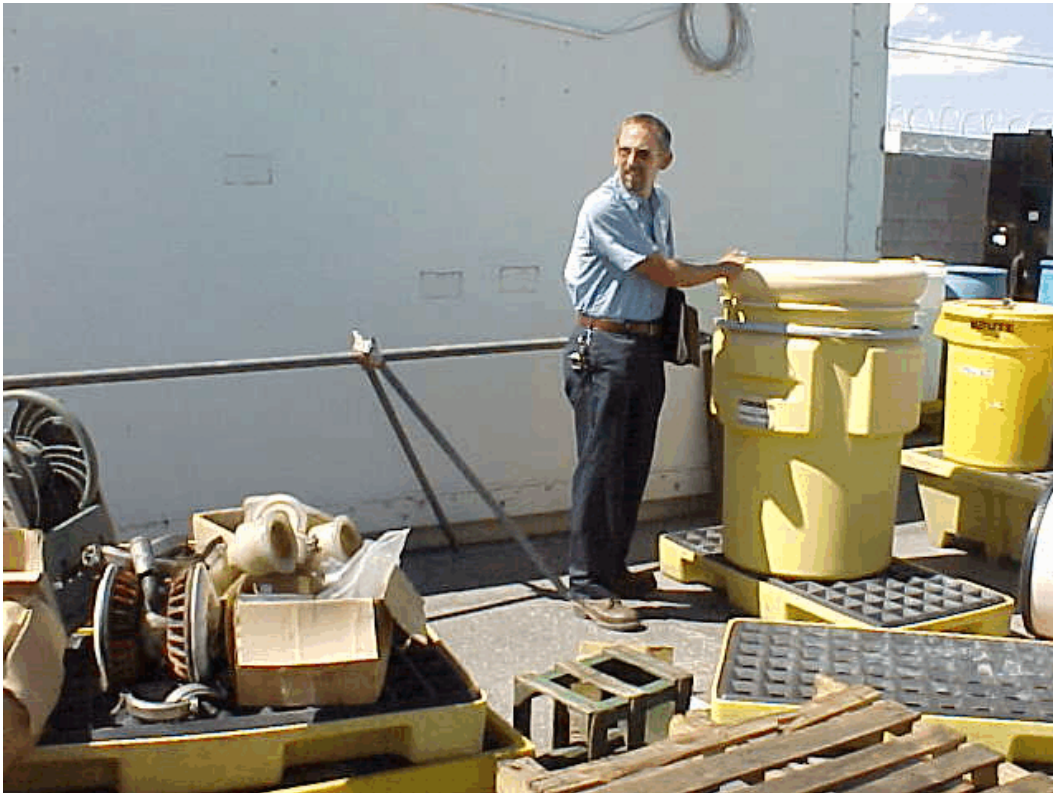
**Photo 1.** Mr. Palsgrove inspecting containers located on containment in the used equipment storage area.

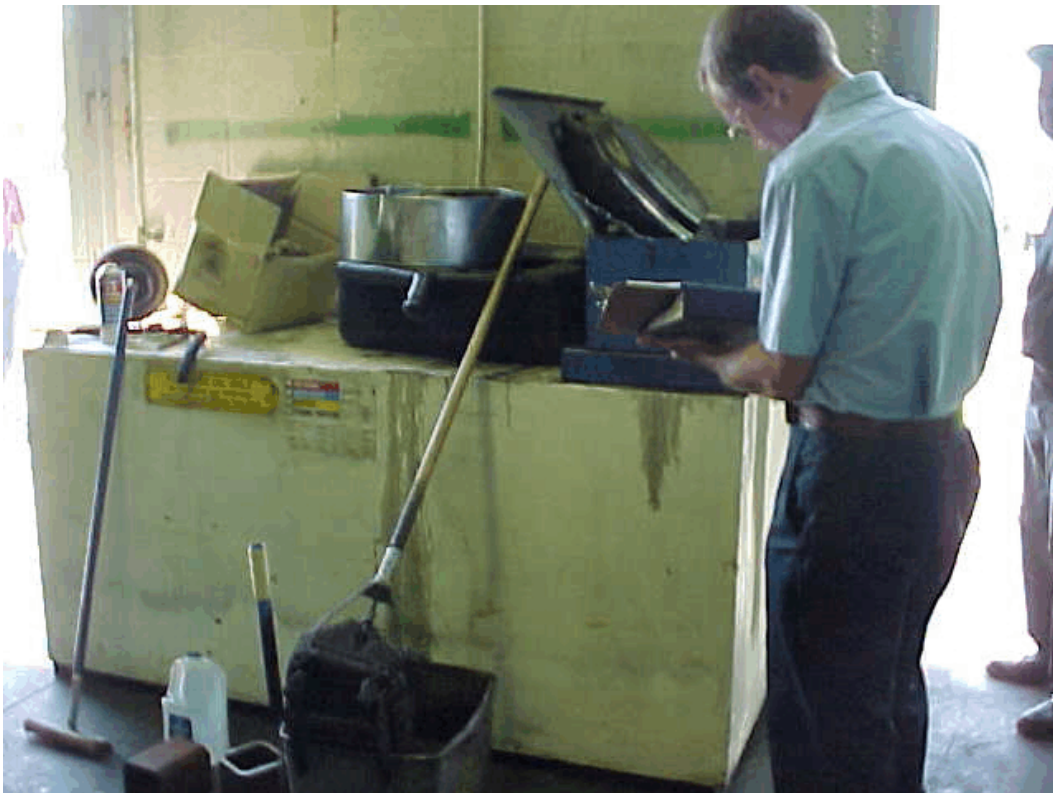
**Photo 2.** Mr. Palsgrove inspecting used oil containment tank.

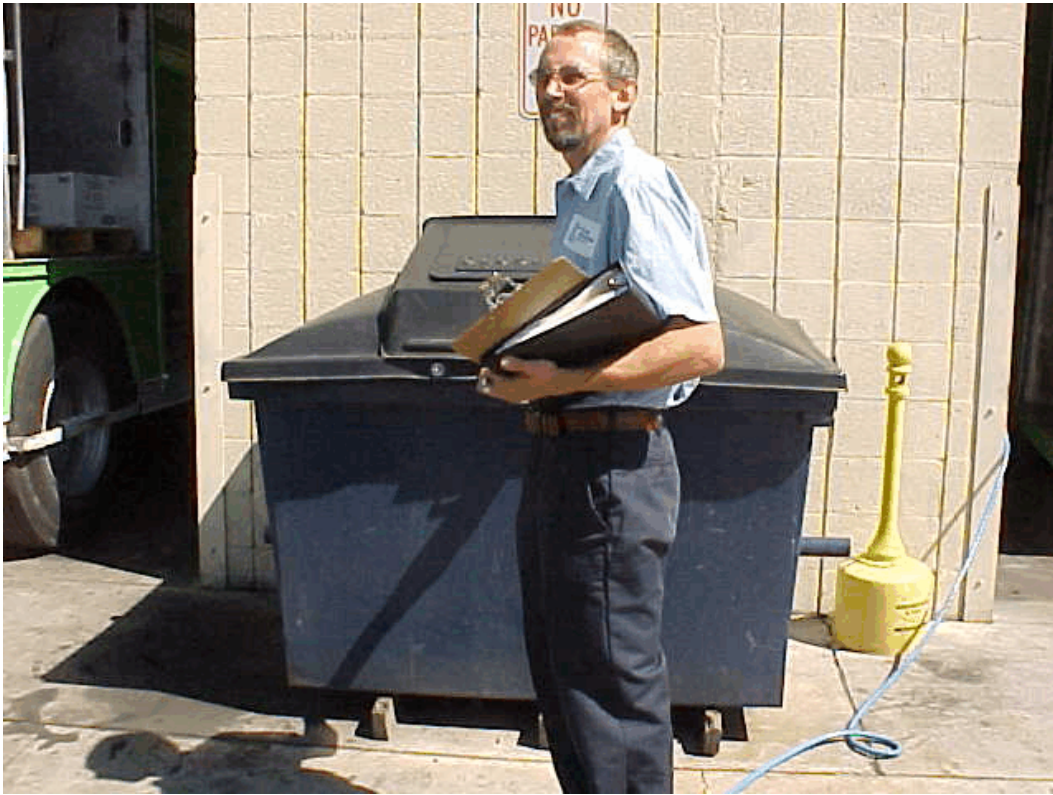
**Photo 3.** Mr. Palsgrove inspecting used oil filter disposal.

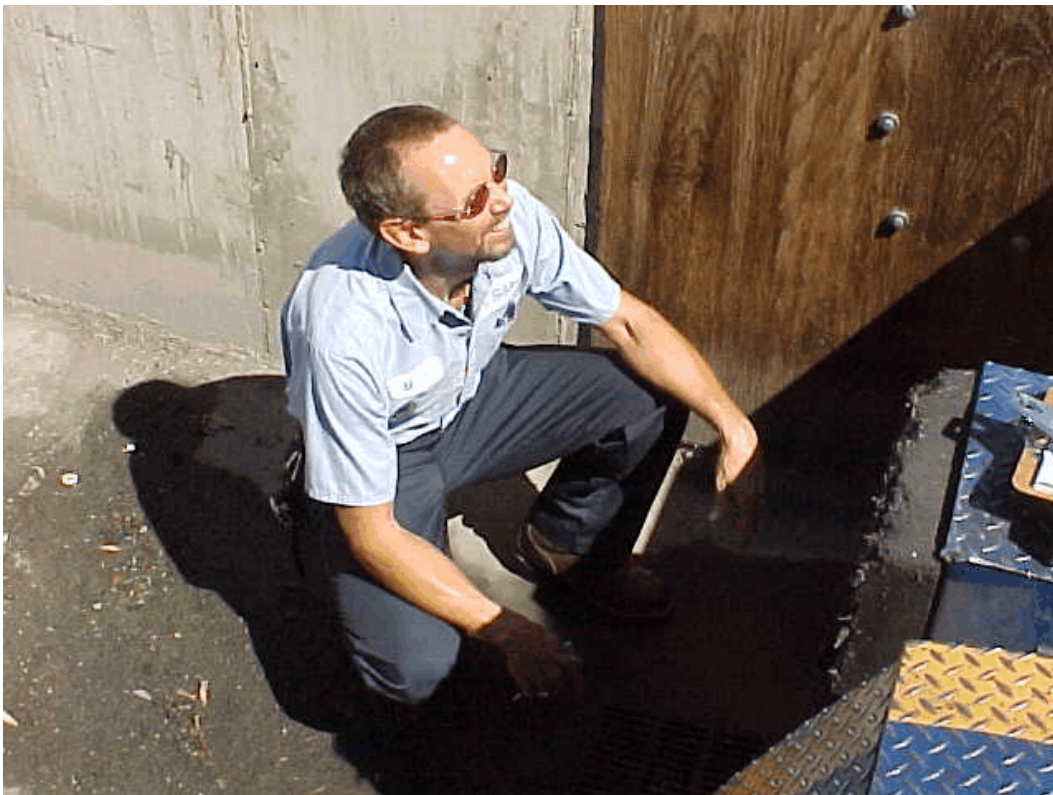
**Photo 4.** Mr. Palsgrove inspecting loading dock and dead sump for collection of storm water.

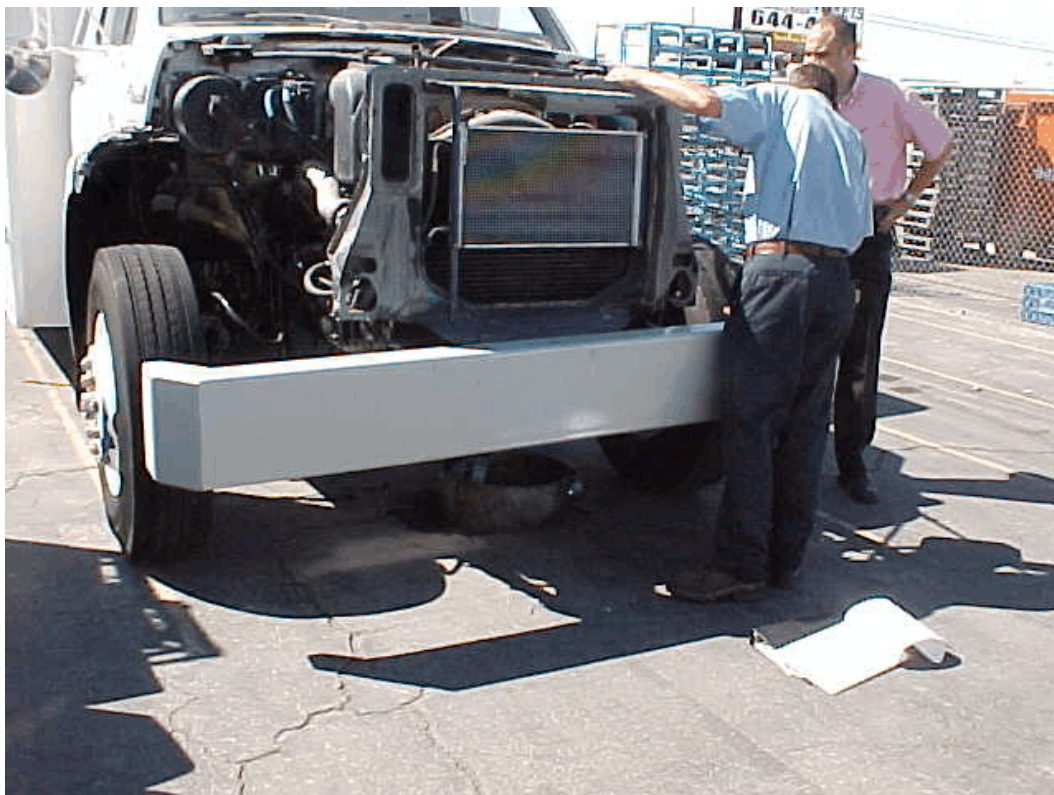
**Photo 6.** Mr. Palsgrove inspecting a truck that was being repaired. A drip pan was being used under the engine.

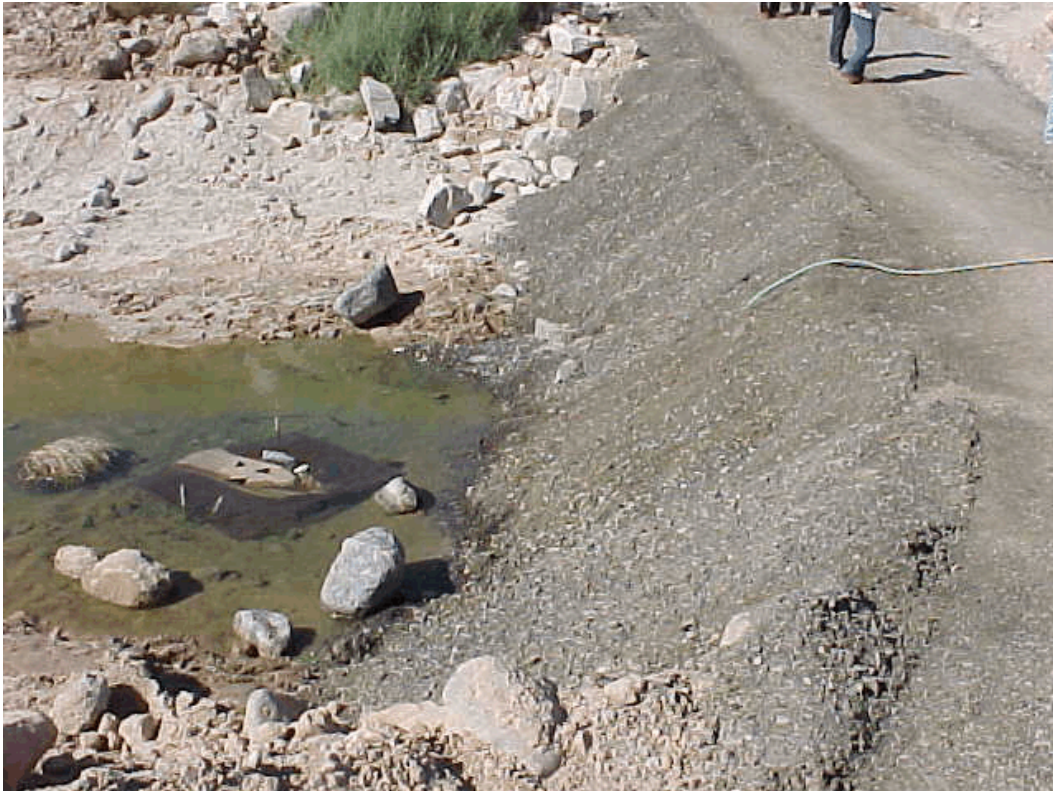
**Photo 1.** Diversion inlet (photo left) and earthen dam.

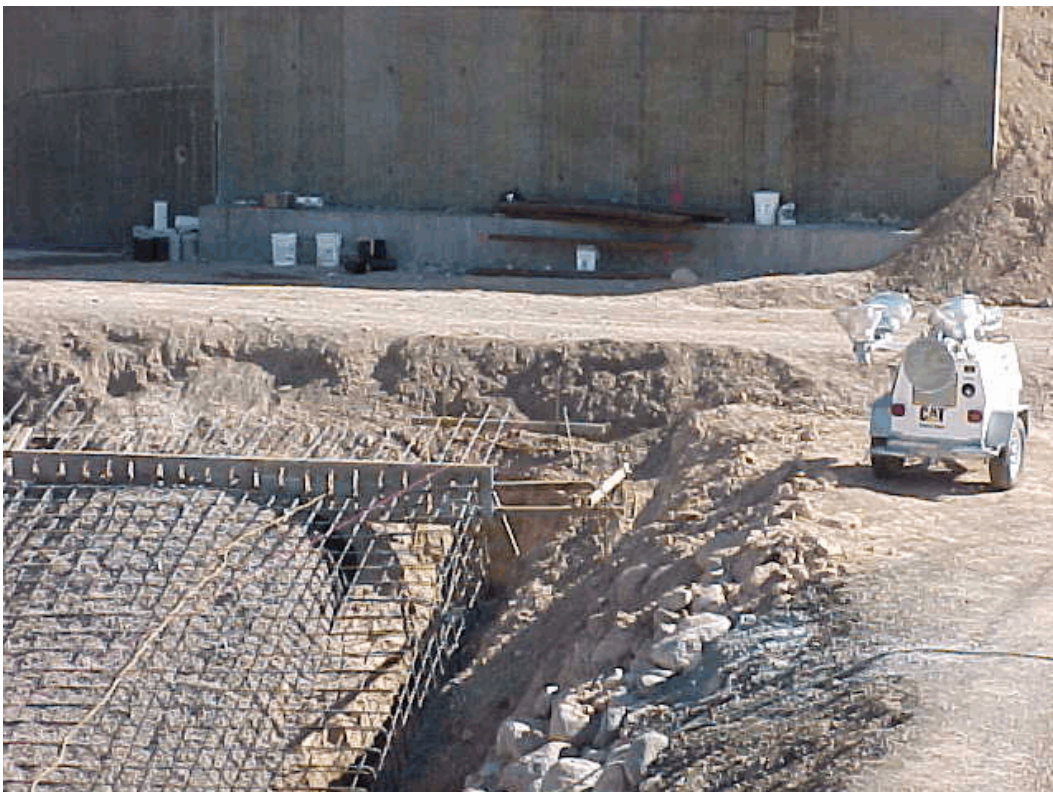
4. Concrete washout had occurred above the sump and likely concrete washout runoff was pumped to the diversion and entered the Duck Creek Channel waters below the project area.
5. Chemicals (e.g., concrete chemicals, gasoline) were not contained and/or located to minimize the potential for accidental spillage and loss to the soil or Duck Creek Channel.
6. The staging areas included disturbed soils that are part of the project and must be protected and inspected for storm water.

**Photo 2.** Downstream side of earthen dam. Note concrete runoff on face of dam. Note 5-gallon pails of chemicals along the retaining wall.
