**Appendix A**  
**Storm Water Management Plan: Comments from NDEP and Co-Permittee Response**

## Storm Water Management Plan: Comments from NDEP and Co-Permittee Response

**Appendix B**  
**Clark County**

**Appendix B.1**  
**Documentation of Findings**

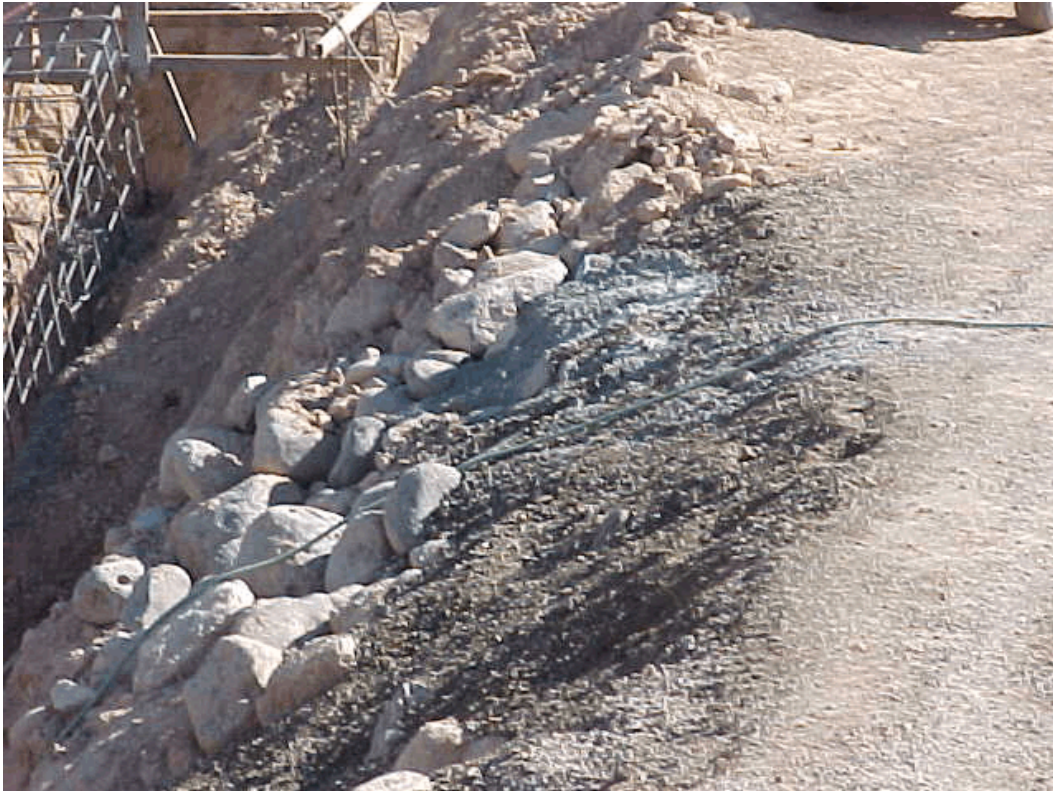
4. Concrete washout had occurred above the sump and likely concrete washout runoff was pumped to the diversion and entered the Duck Creek Channel waters below the project area.
5. Chemicals (e.g., concrete chemicals, gasoline) were not contained and/or located to minimize the potential for accidental spillage and loss to the soil or Duck Creek Channel.
6. The staging areas included disturbed soils that are part of the project and must be protected and inspected for storm water.

**Photo 3.** Closeup view of concrete washout on downstream face of earthen dam. A sump is located at the toe of the dam face (photo left).

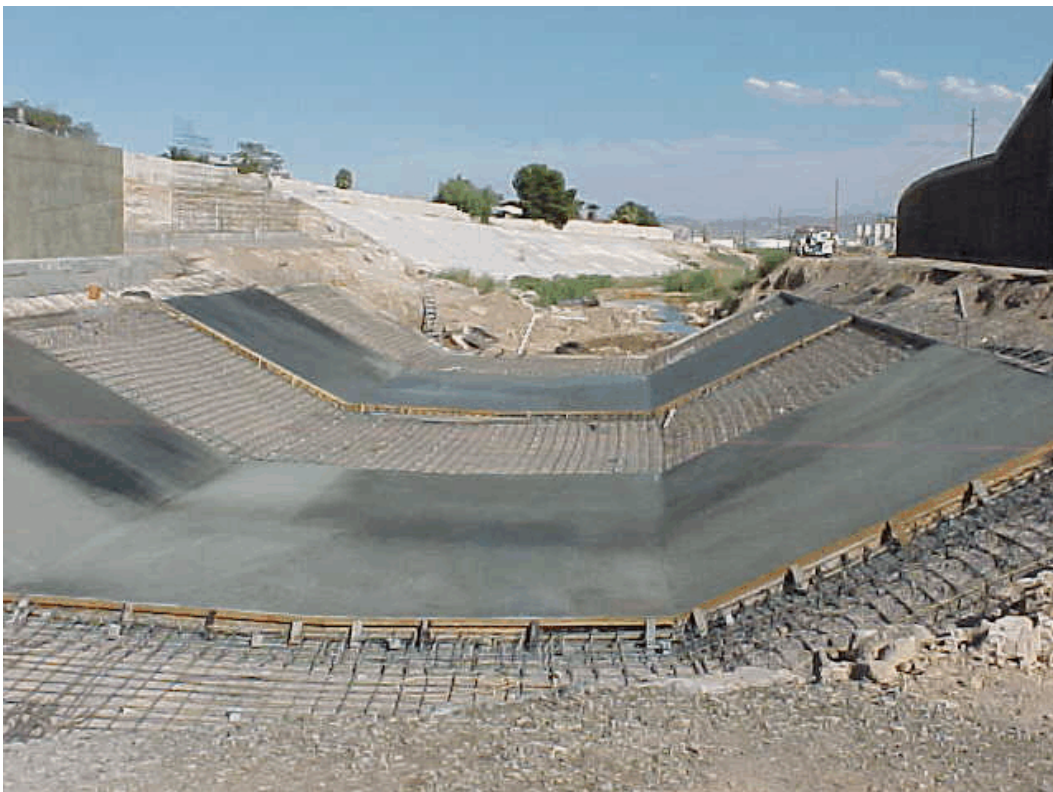
**Photo 4.** View downstream from earthen dam of Duck Creek Channel (photo center) and retaining walls (photo left and right).

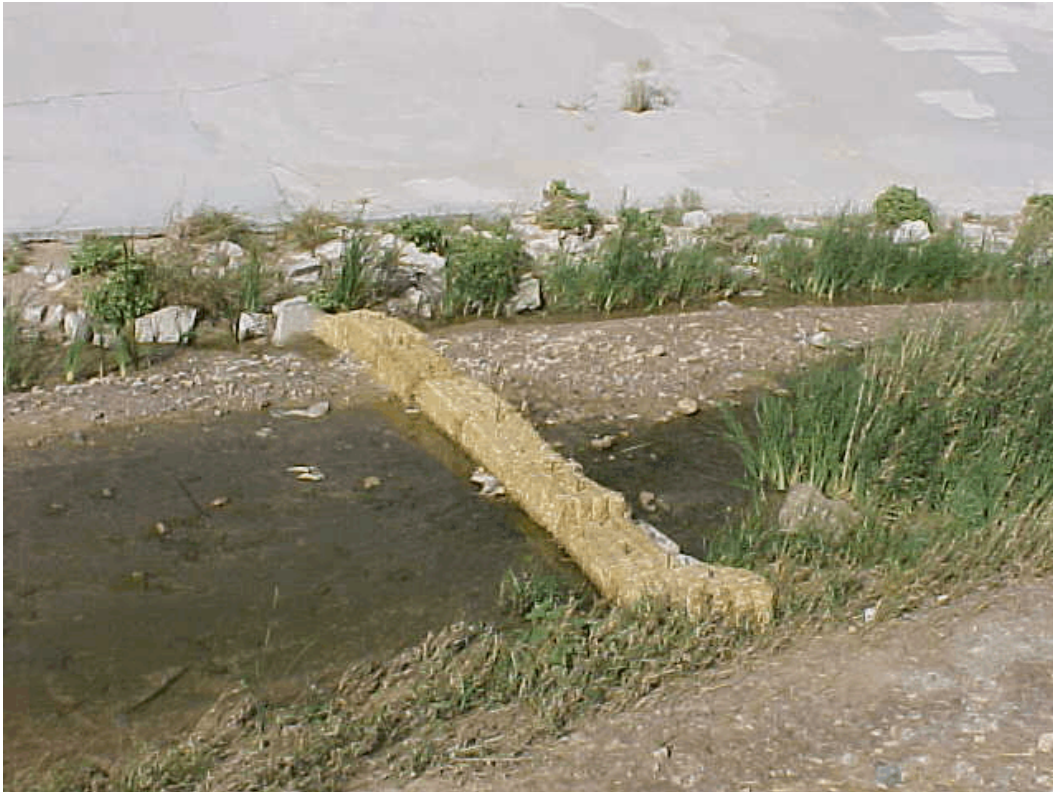
**Photo 5.** View of straw bale filter in Duck Creek Channel downstream from the construction area.

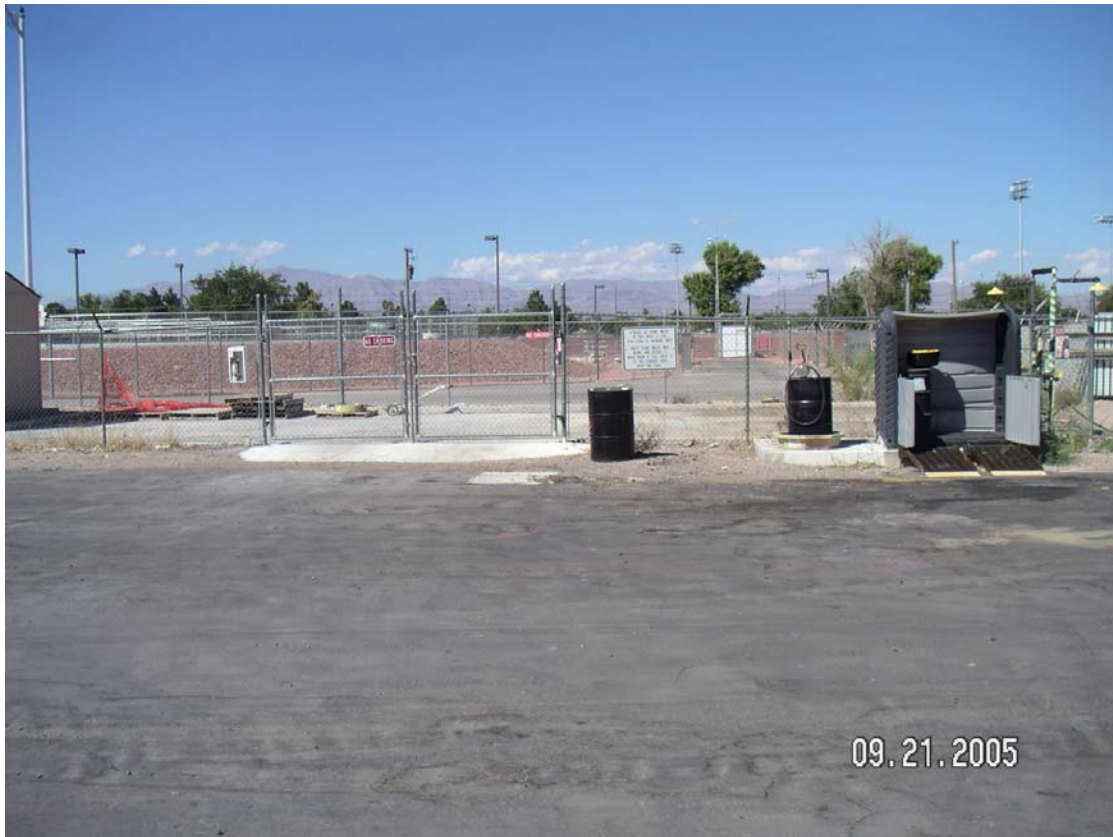
1. The filter fabric over the storm drain grate should be checked more often than twice per year. There are piles of sand, gravel, and soil nearby, and the filter fabric is the only barrier to storm water that could contain these materials.
2. The gate of the satellite accumulation area was not locked.
3. Acid appeared to have leaked from exposed and uncontained used batteries onto the concrete surface and thence to the MS4.
4. During rain events, oil, grease, and metals could leach from equipment stored in the open.
5. An NOI should be submitted under the current MS4 permit.

**Photo 5.** Satellite accumulation area.

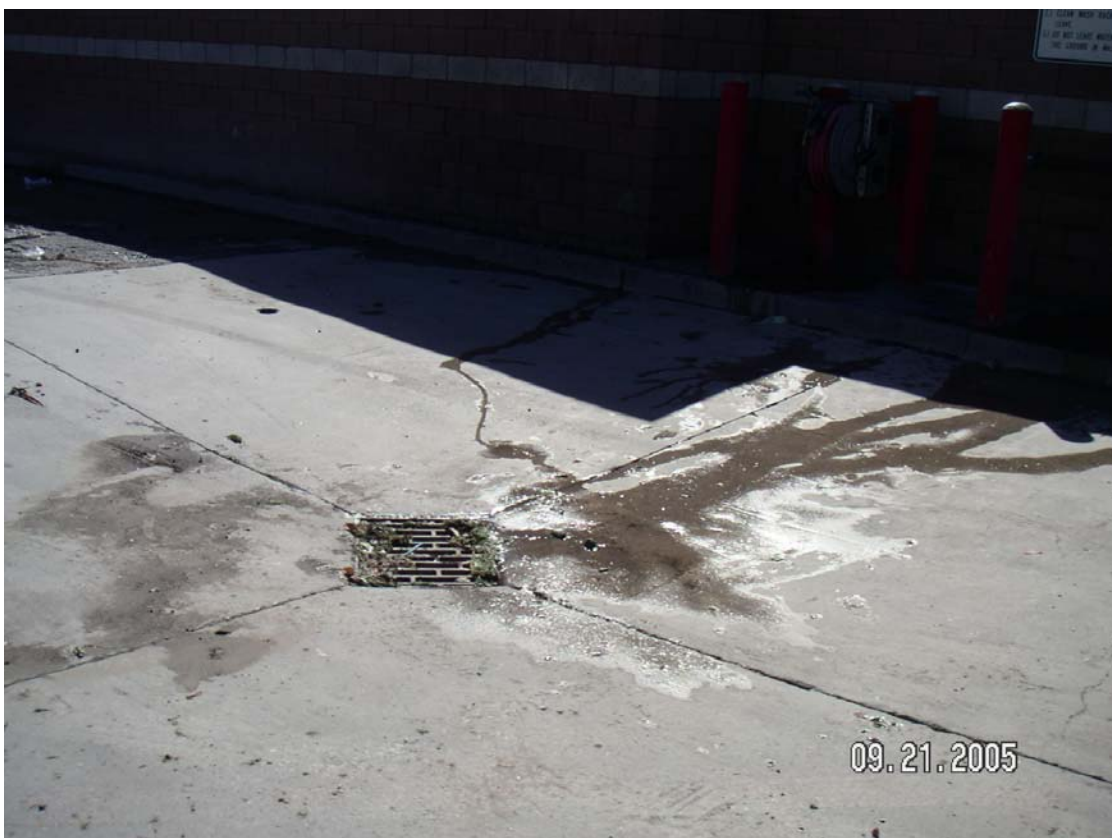
**Photo 10.** Grate over sand/oil interceptor.

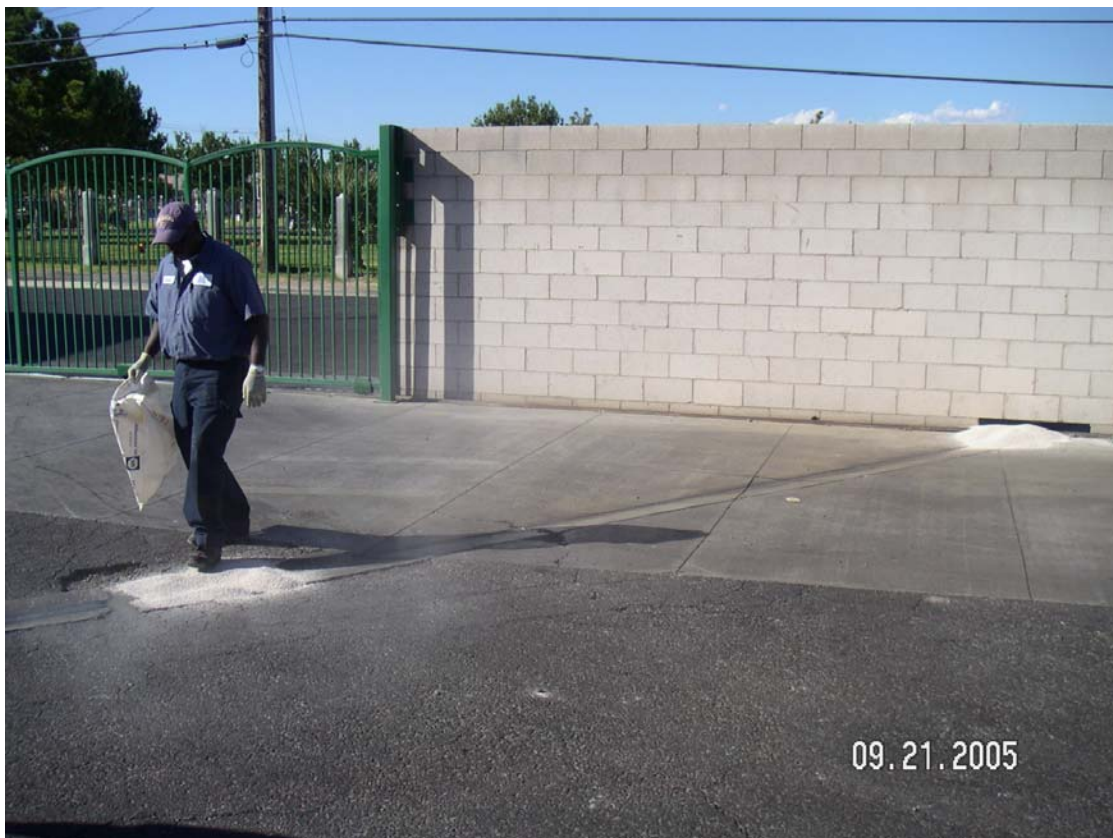
**Photo 4.** Worker spreading absorbent material.

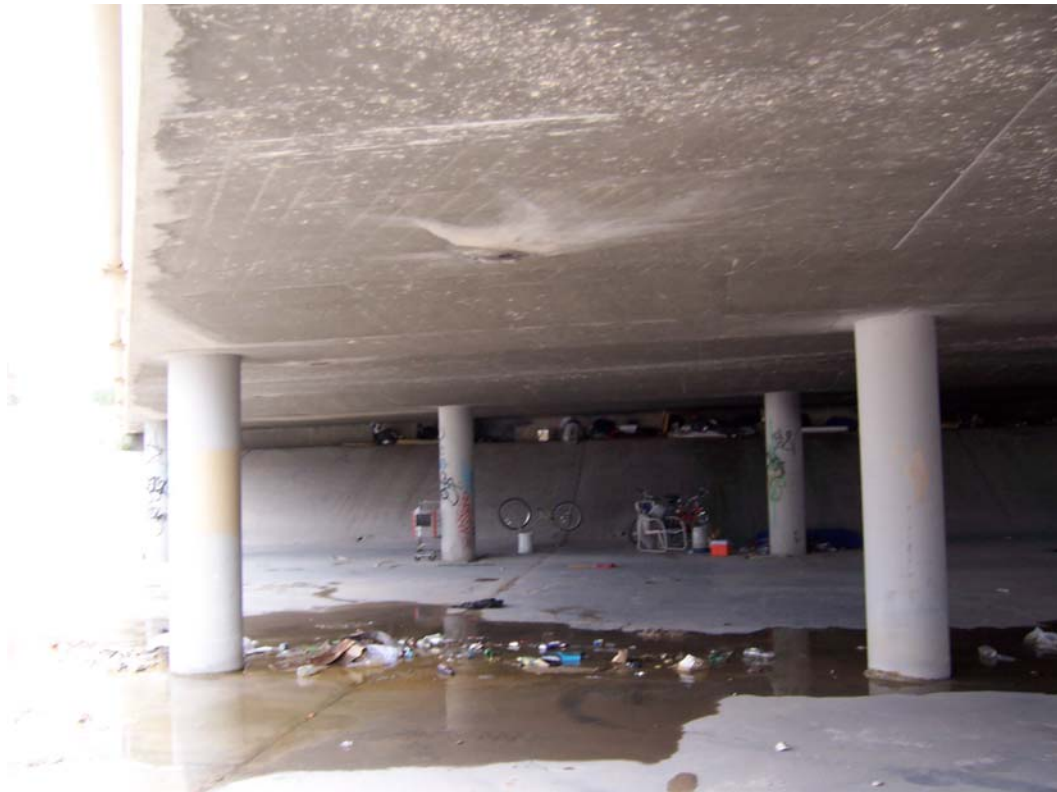
**Photo 3.** Homeless individuals living between Losse overpass roadway and upper apron of the wash. Bicycles, shopping carts, and debris in the wash are likely from these individuals.

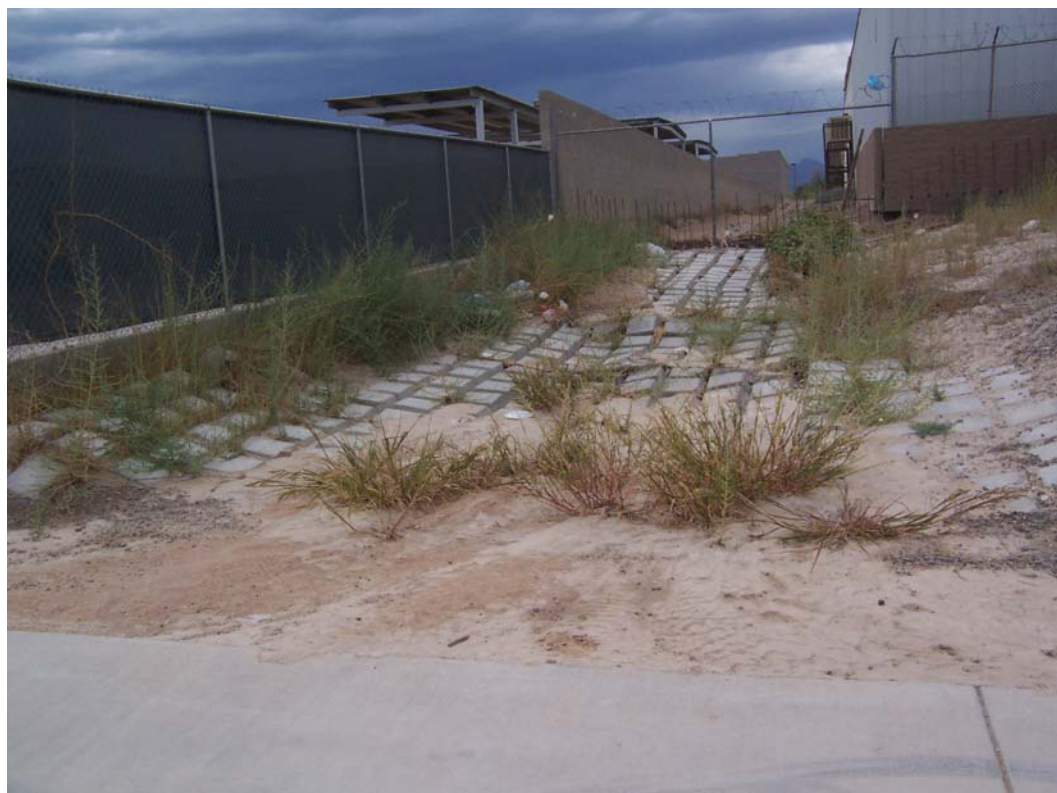
**Photo 4.** Riprap channel between commercial properties. Note lower end of channel appears to be clogged with sediment.

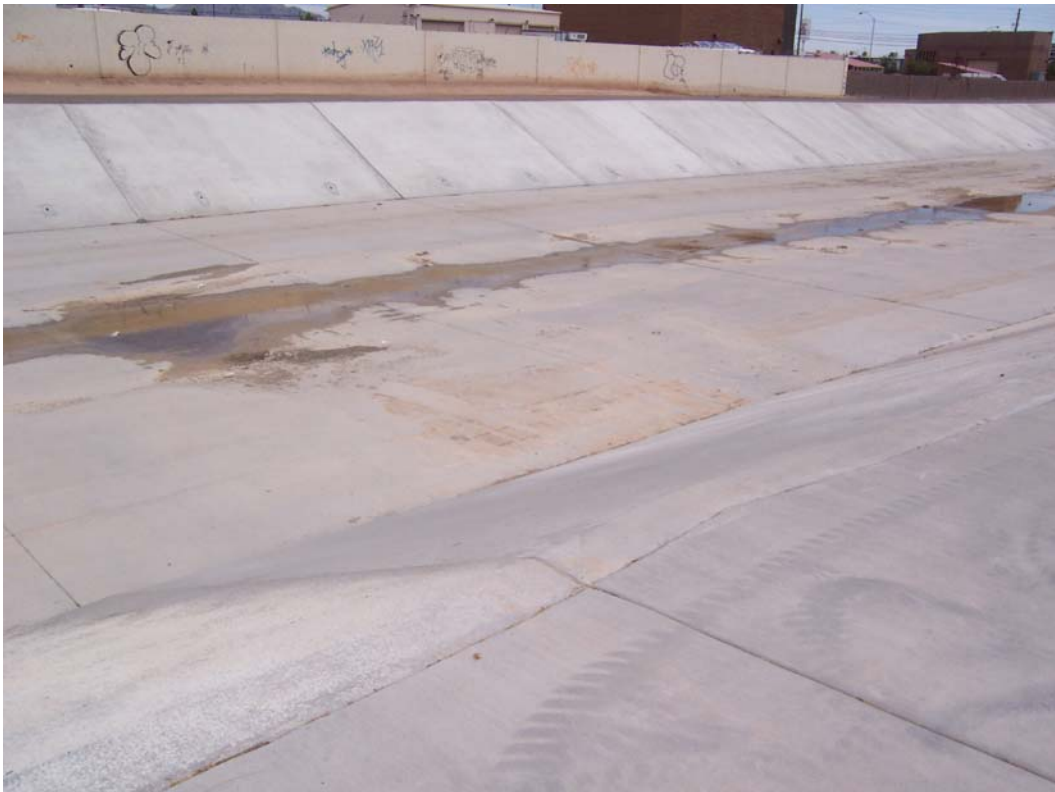
Mr. Rura did not note several areas where soil erosion appears to be entering the wash. In response to a question, he stated that soil erosion was not identified or addressed as part of the wash walks.

**Photo 5.** Portion of wash adjacent to the channel in Photo 4 where sediment appears to have entered the wash from the channel.

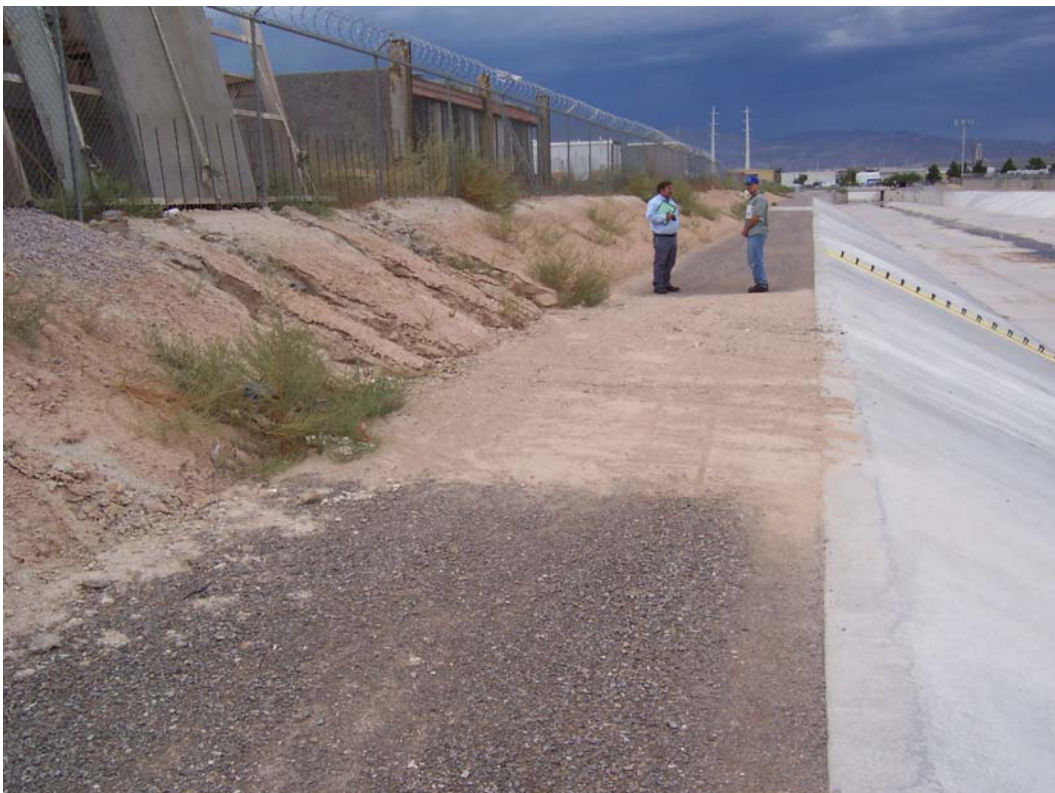
**Photo 6.** Area where soil erosion on the bank to the left of the wash appears to have entered the wash.

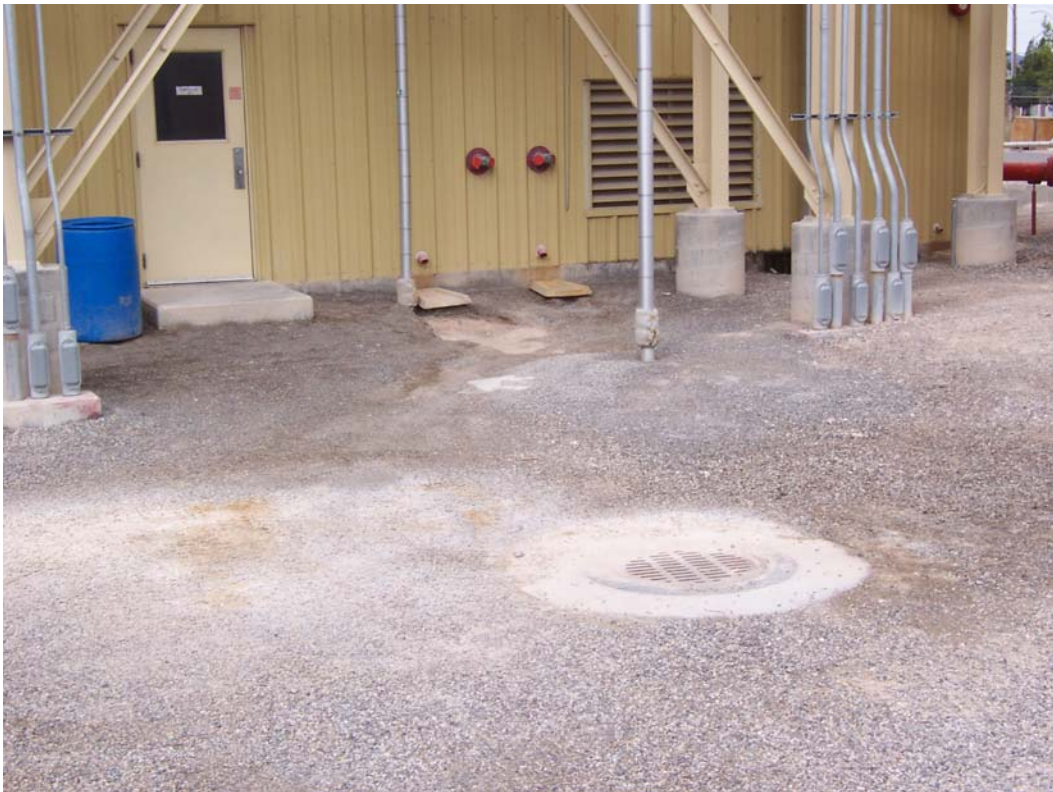
1. Mr. Rura did not note an area next to a building where a roof downspout was causing soil erosion that appeared to be going directly to a yard drain.

**Photo 1.** Inspector did not note evidence of soil erosion at roof drain discharge (to the right of the doorway) that appeared to be going directly to the area storm inlet.

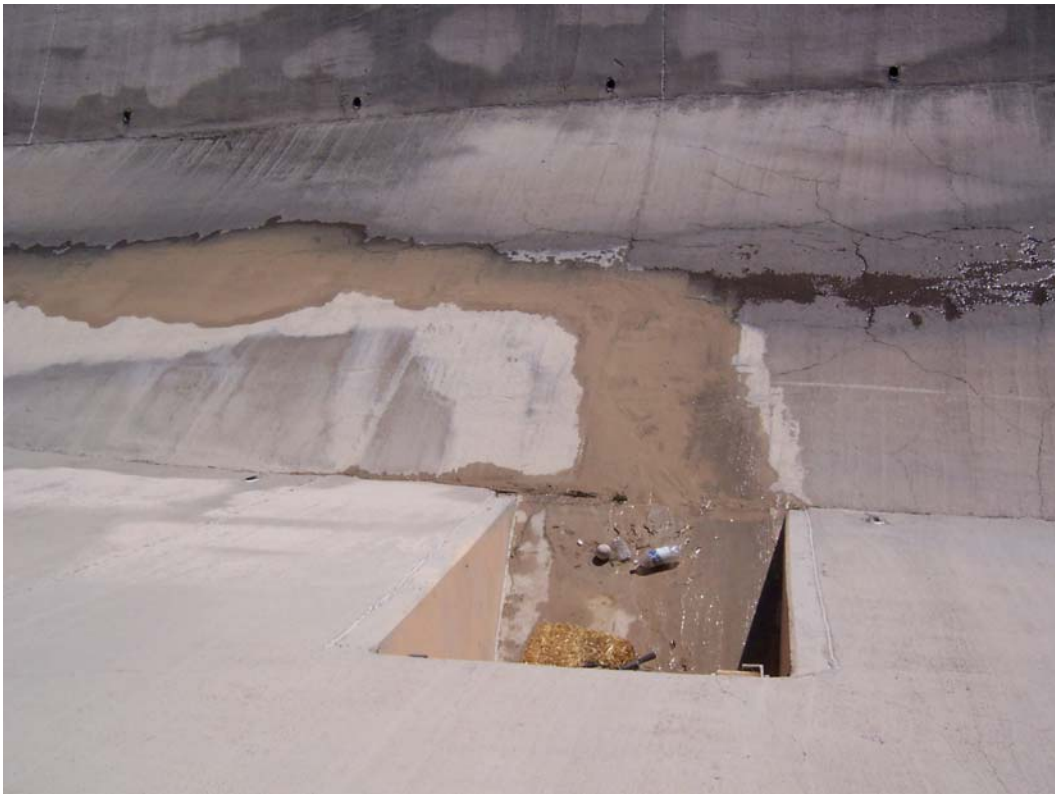
**Photo 1.** Water and sediment from the construction site entering the wash.

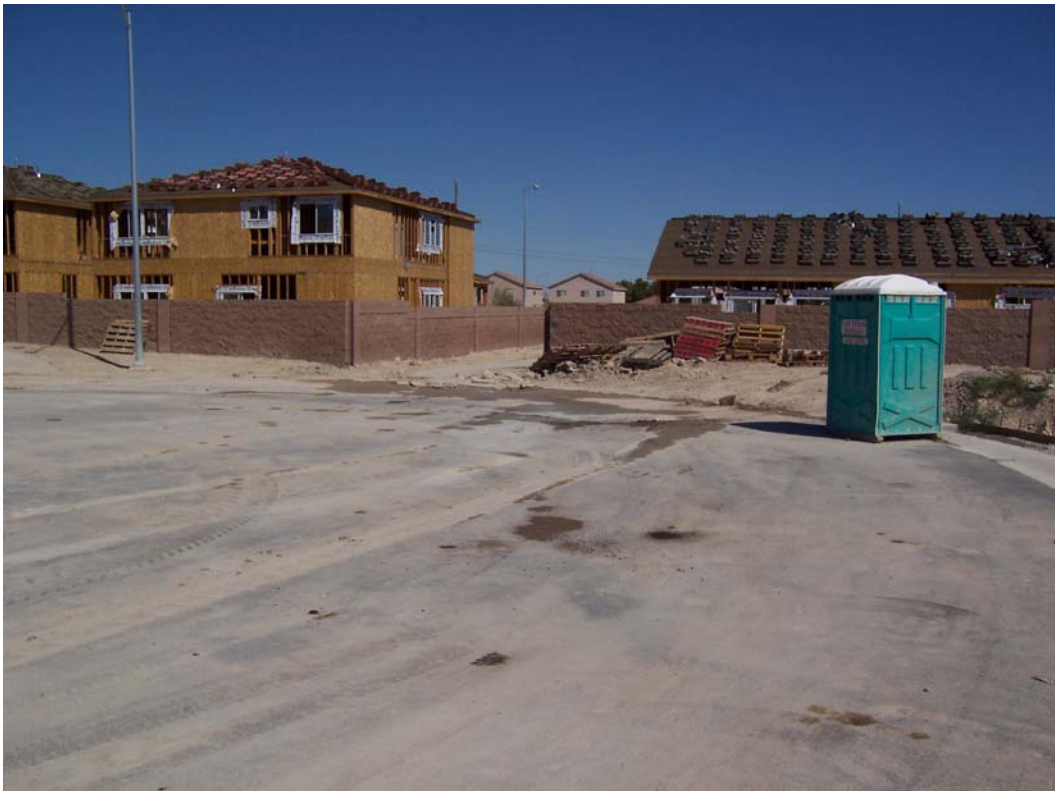
1. Mr. Melo did not note the presence of a portable toilet in the street not far from an inlet. If knocked over by a construction vehicle, it would flow directly to the storm inlet.
2. He did not note that several sand bags, which were placed at regular intervals along the curb apparently to catch sediment, were moved back several inches from the curb providing a gap for water to pass through, making them ineffective.

**Photo 4.** Portable toilet placed where spillage would go directly to storm inlet. Storm inlet is left center photo, at the end of the sidewalk to the cul-de-sac.

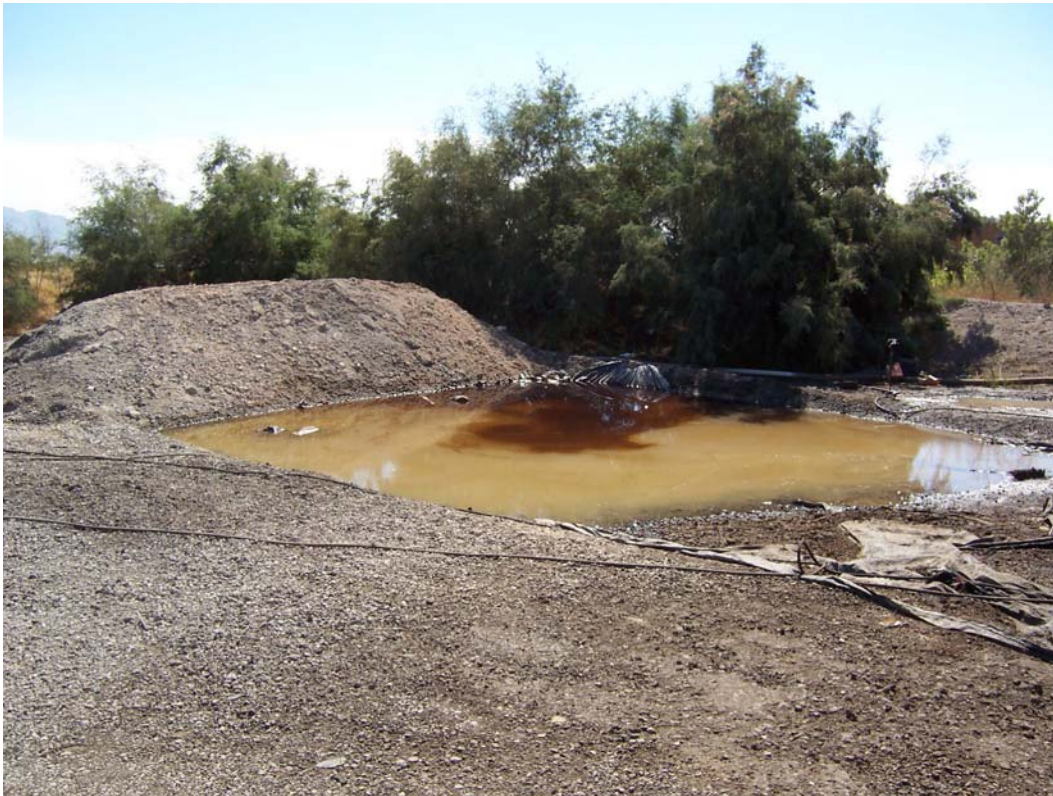
**Photo 3.** Temporary pit dug to contain wash water from equipment cleaning operation. Note floating oil on the surface of the water.

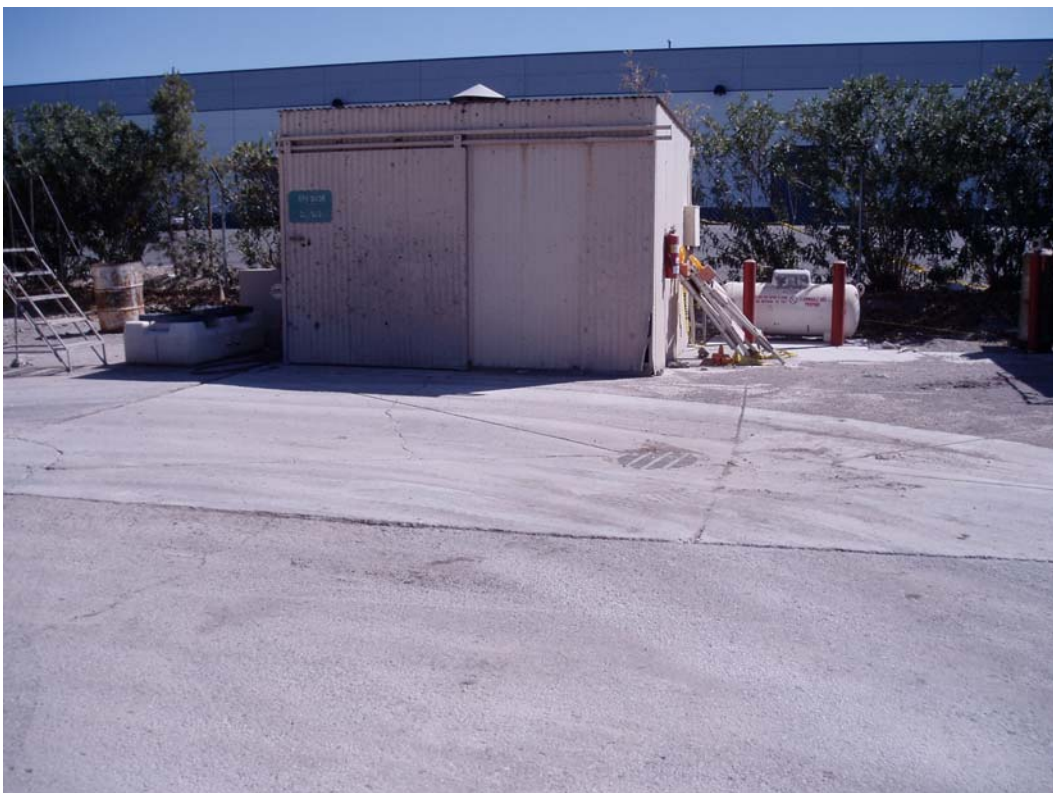
**Photo 2.** Car wash area. Drain flows to sanitary sewer.

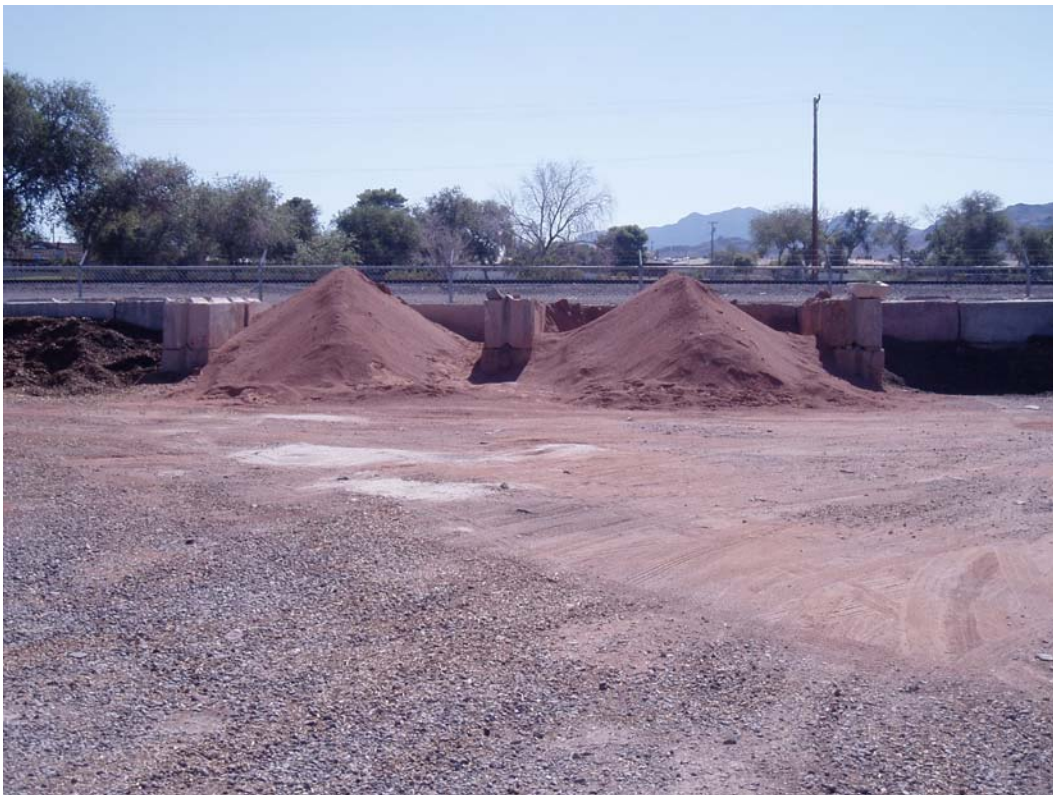
**Photo 4.** Sediment stockpiles. Grade is downhill toward the street.

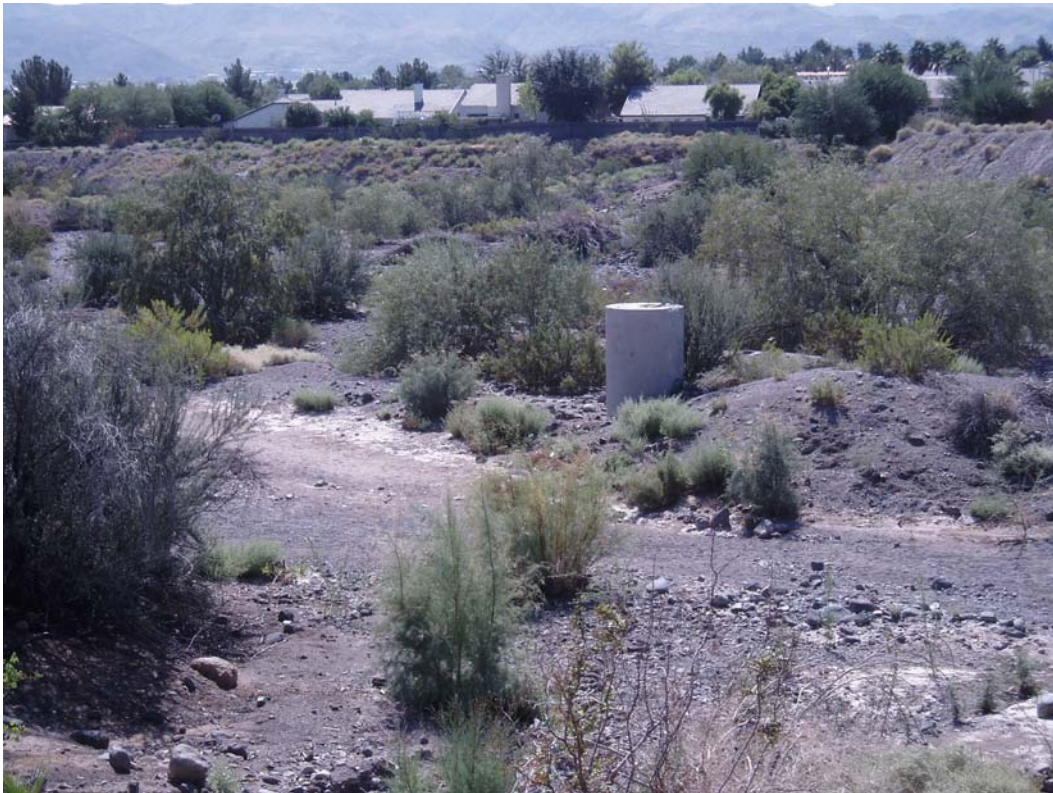
**Photo 3.** Project Green, elevated manhole in photo center.

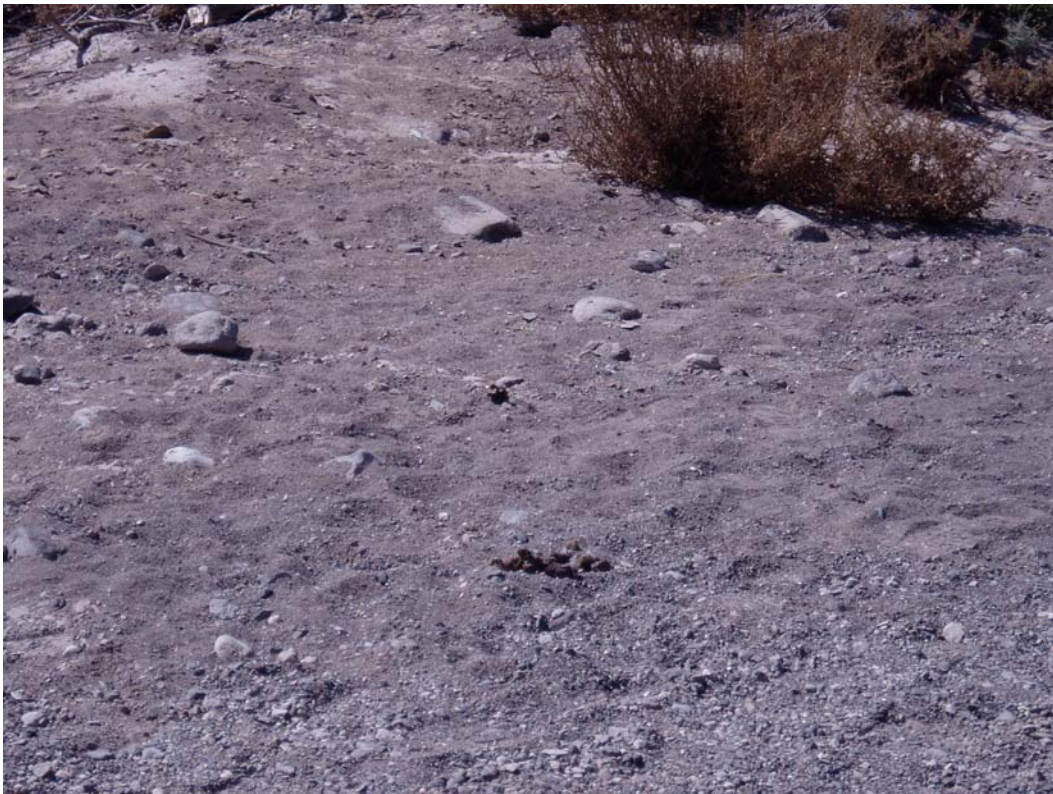
**Photo 6.** Pet waste (photo center towards the bottom) in Project Green area of Pittman Wash.

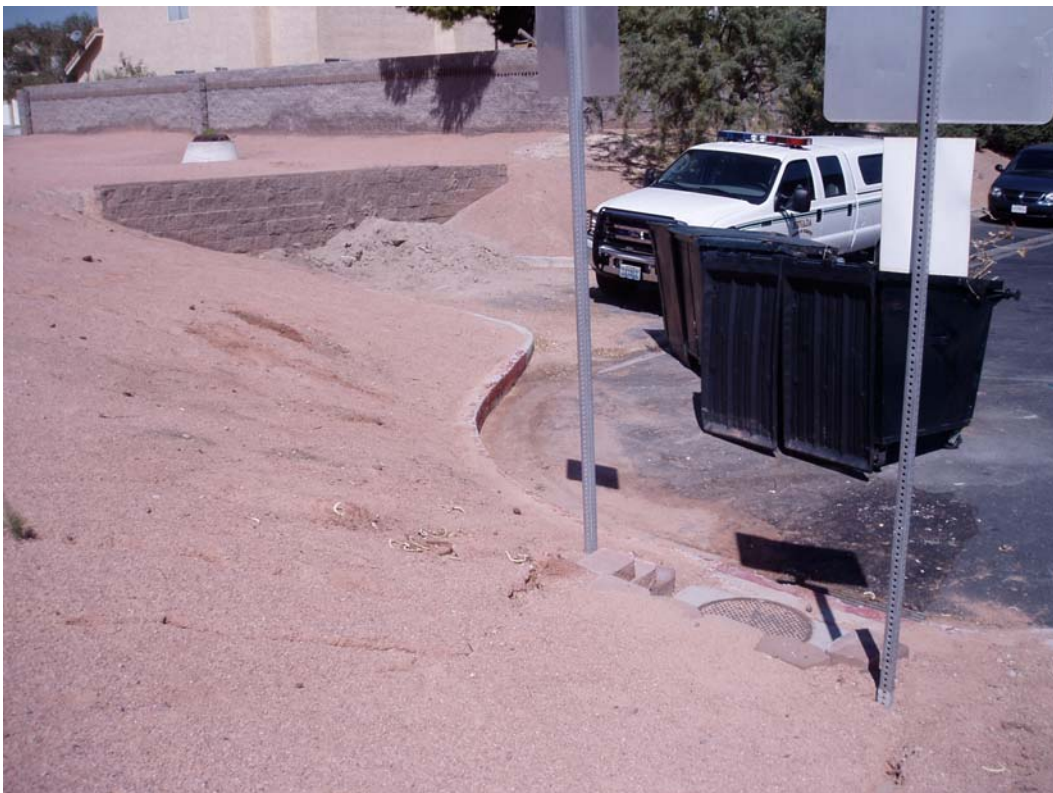
**Photo 8.** Parks and Recreation Department dirt storage. Trackout visible to inlet, which flows to outfall in Photo 7.

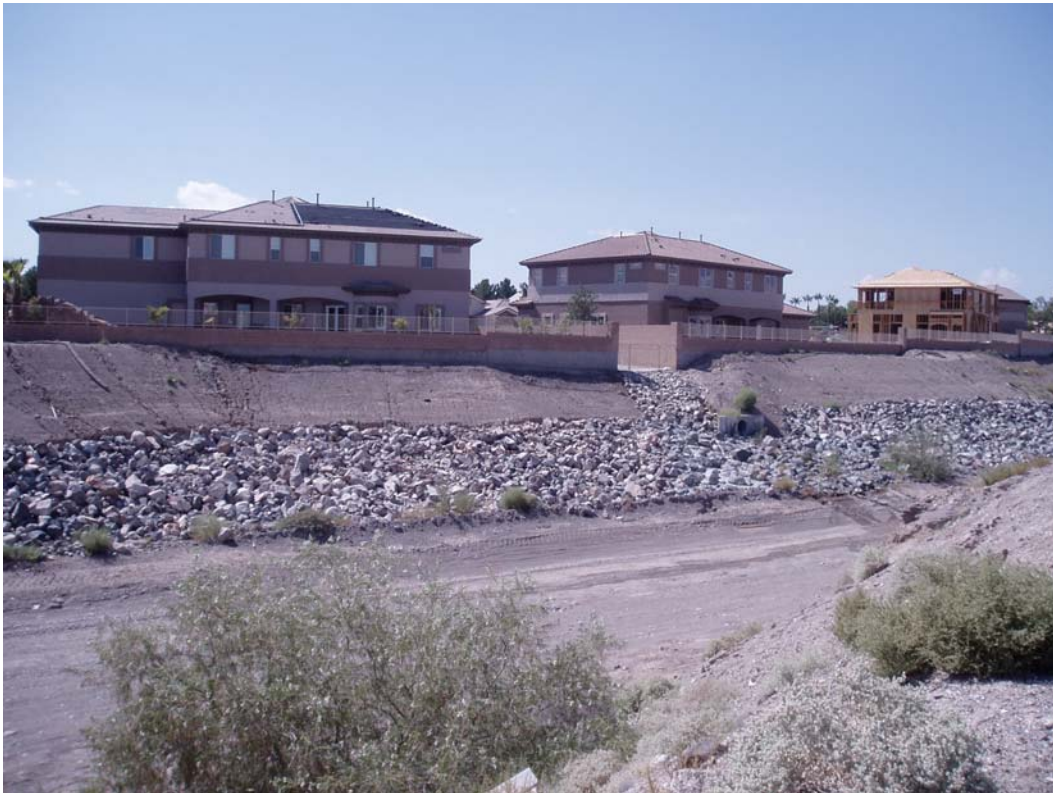
**Photo 9.** Upper Pittman Wash downstream of Project Green (flows left). Minor flow was visible from the outfall (right, center).

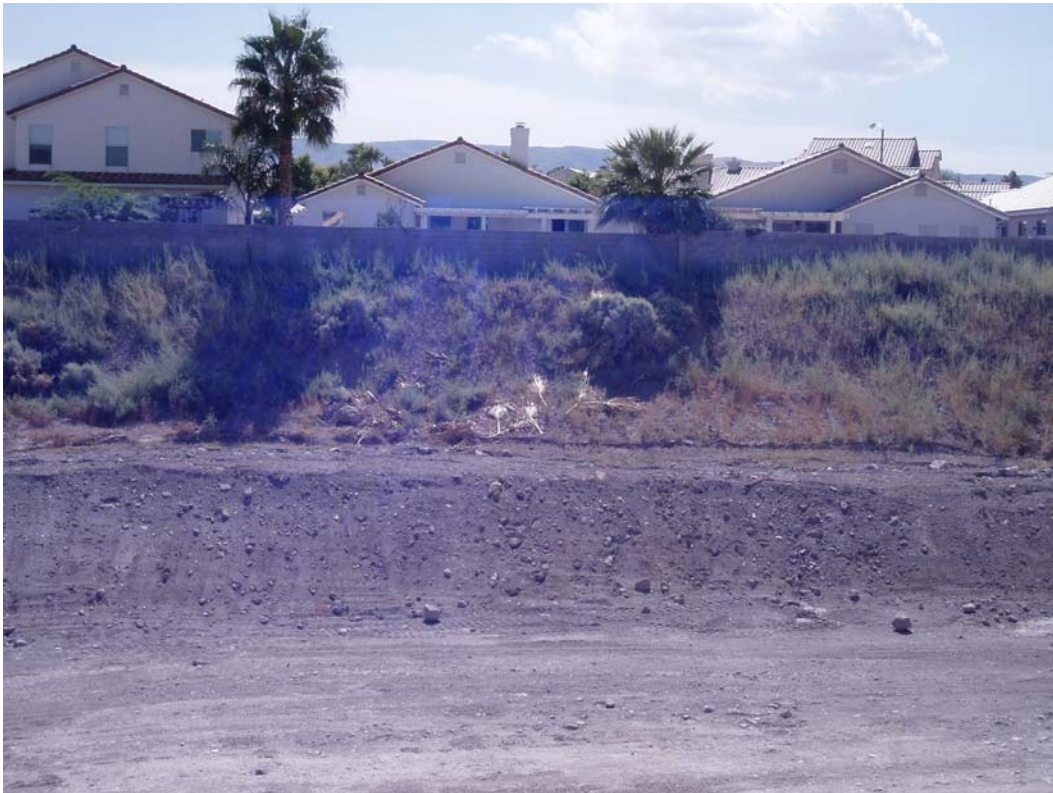
**Photo 11.** Palm fronds dumped in Upper Pittman Wash (photo center).

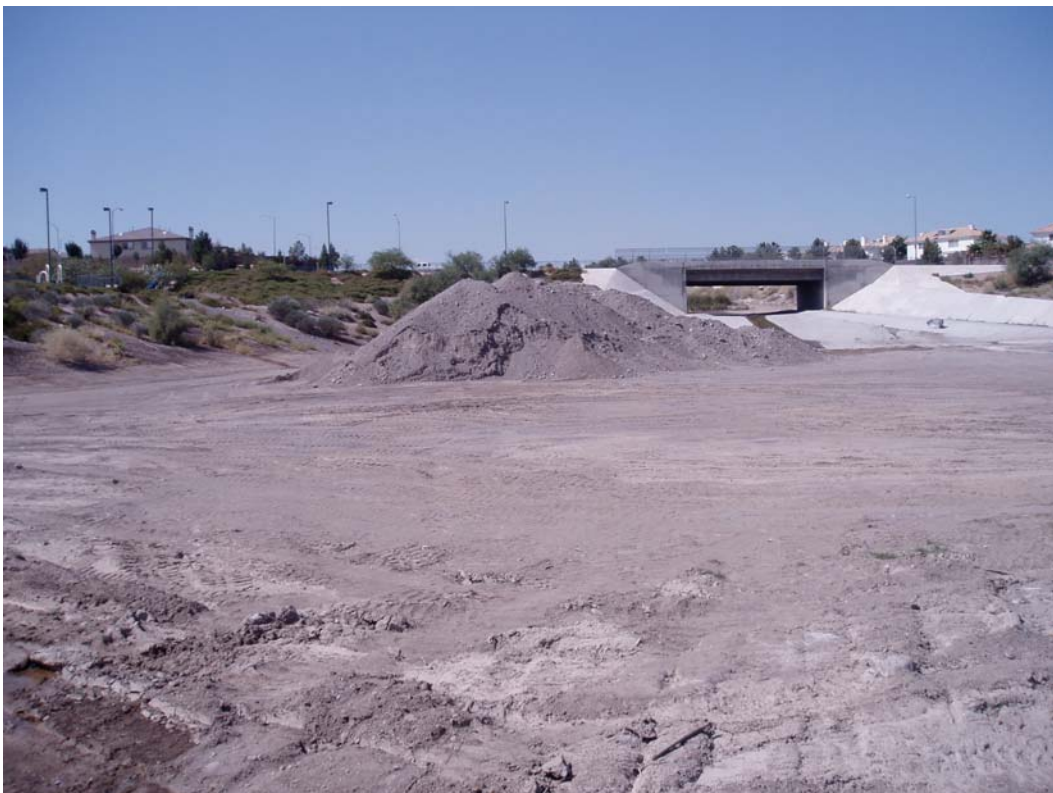
**Photo 14.** Sediment pile in Pittman Wash.

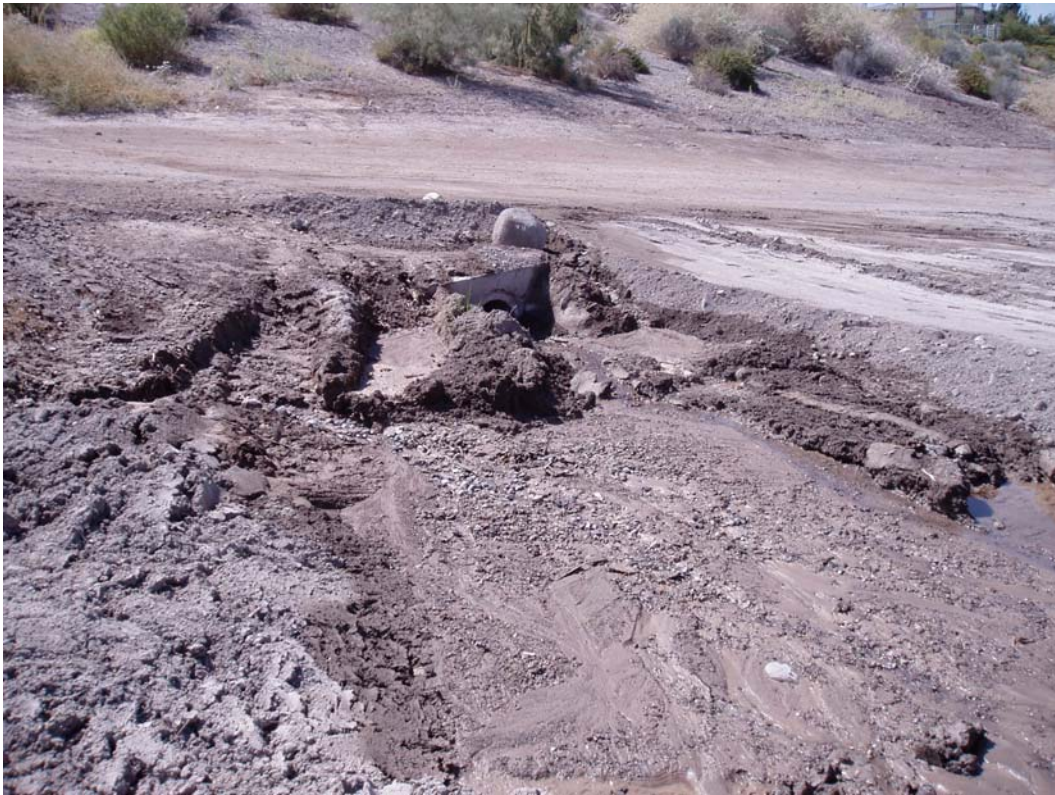
**Photo 17.** Outfall that discharges groundwater.

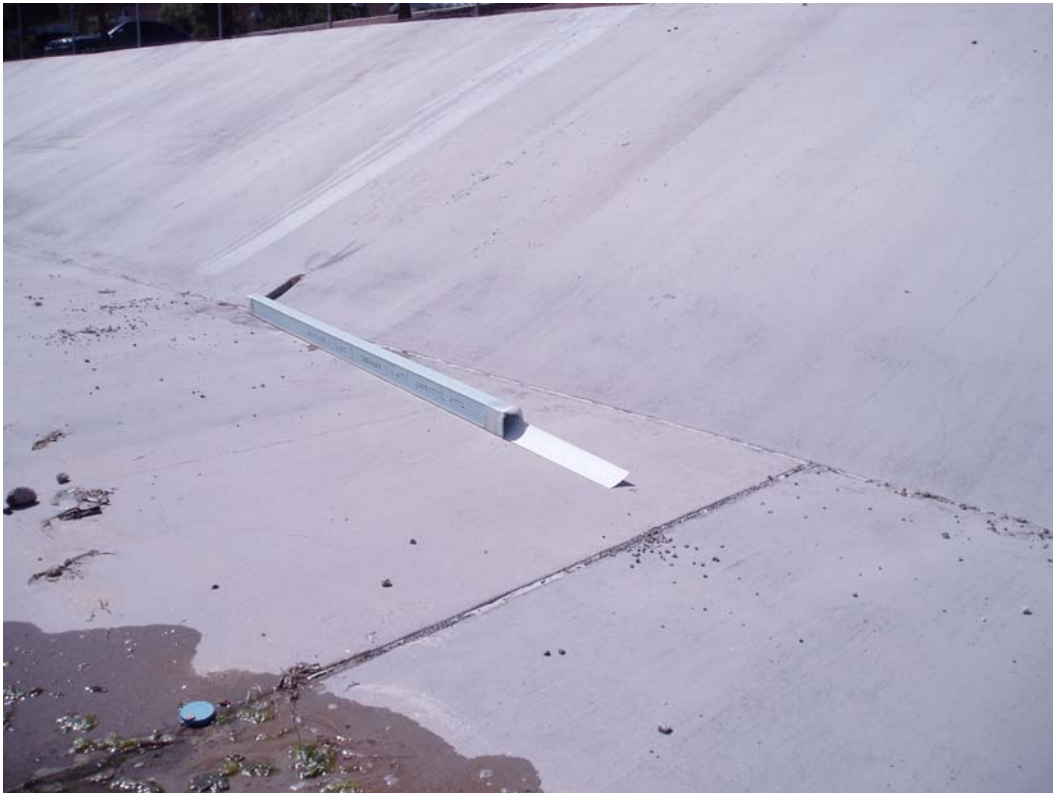
**Photo 21.** Empty box dumped in channel.

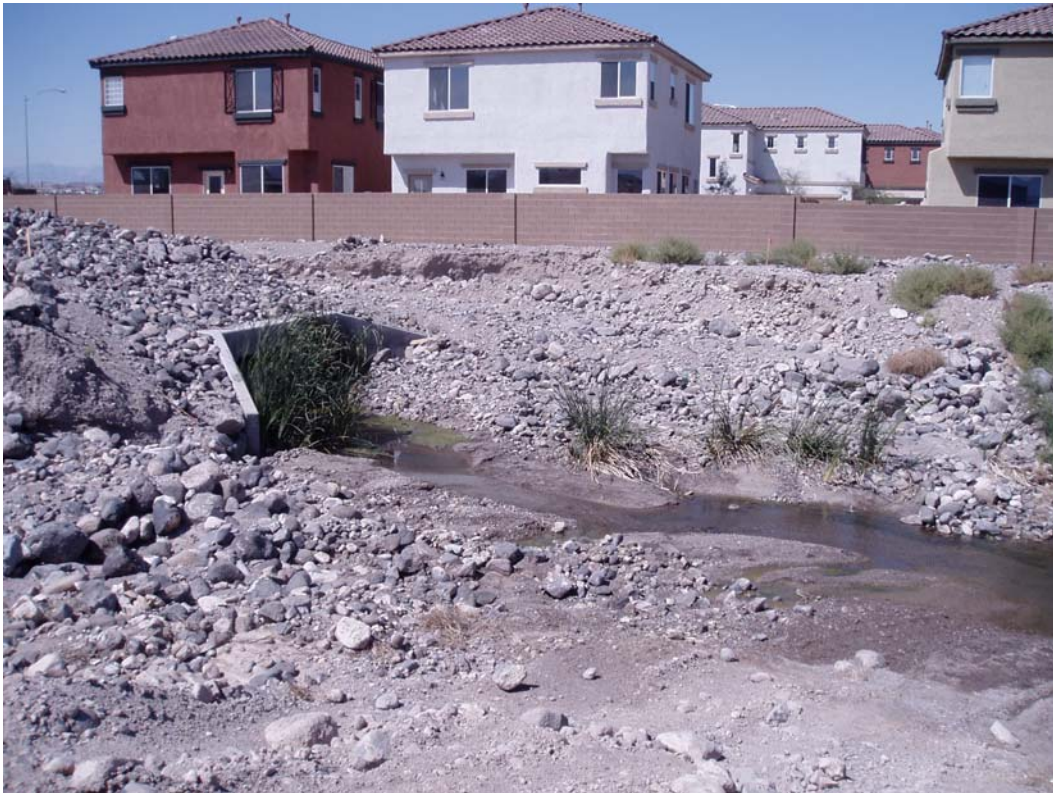
**Photo 25.** Outfall with flow.

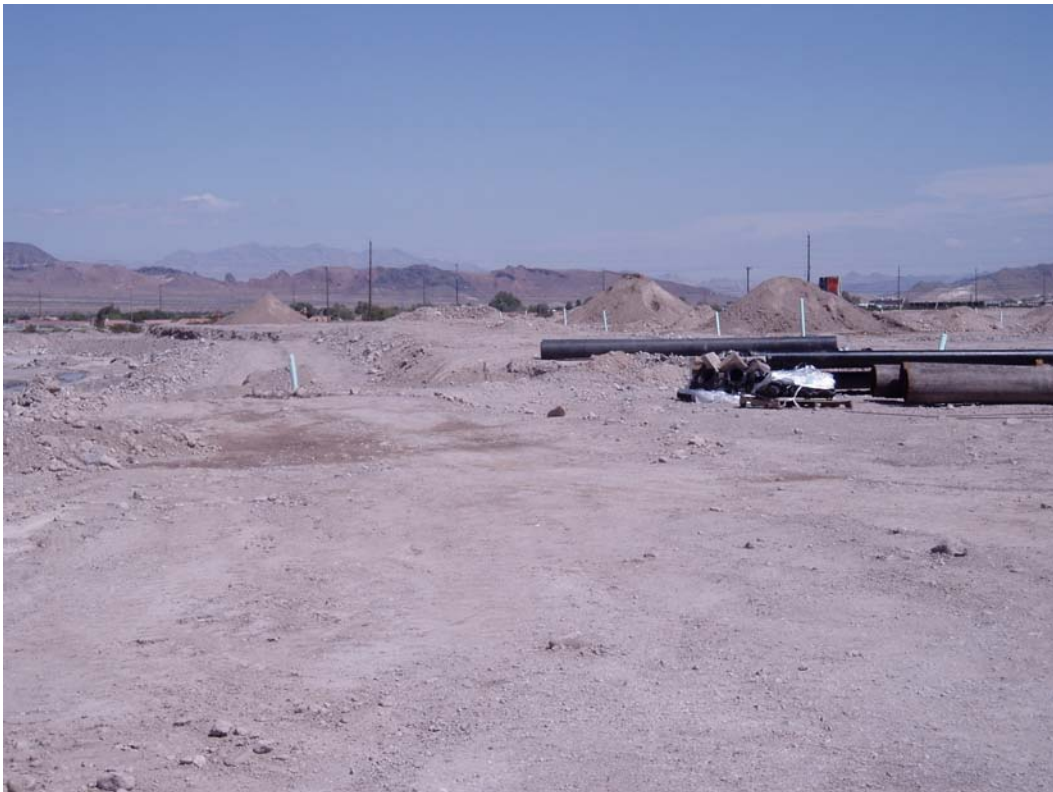
**Photo 26.** Construction and sediment piles (photo right) adjacent to Gibson Channel (photo left).
