**Appendix A**  
**Storm Water Management Plan: Comments from NDEP and Co-Permittee Response**

## Storm Water Management Plan: Comments from NDEP and Co-Permittee Response

**Appendix B**  
**Clark County**

**Appendix B.1**  
**Documentation of Findings**

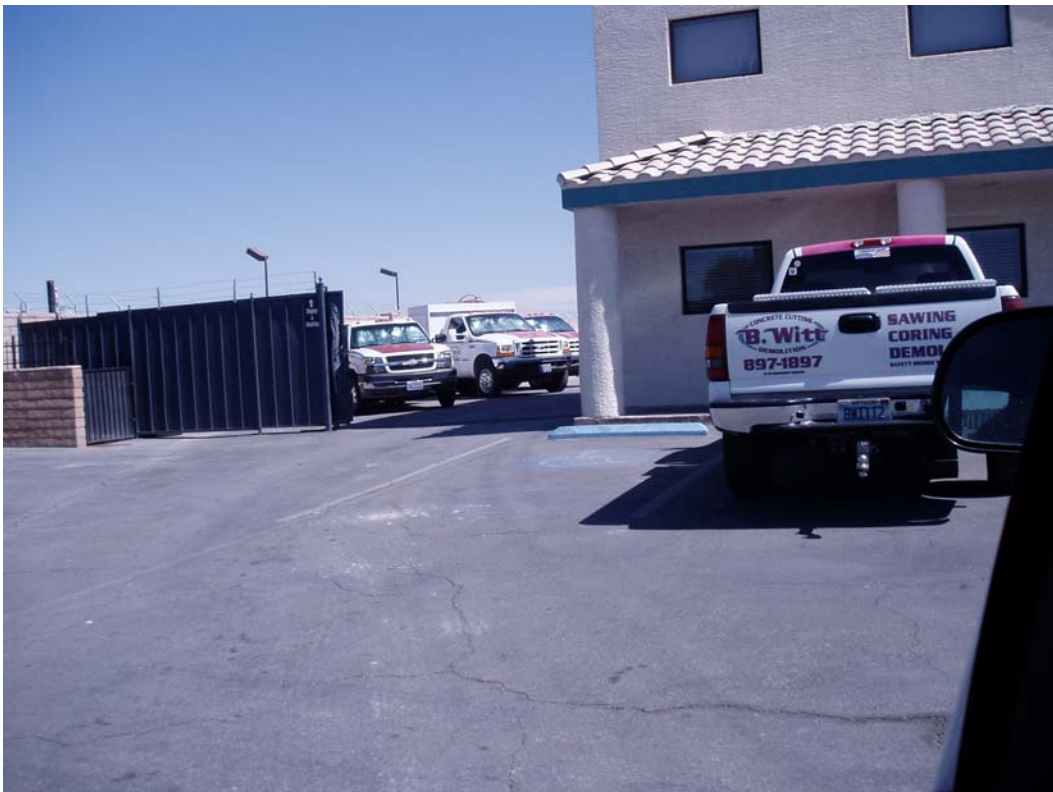
**Photo 30.** Parking lot source of discharge in Photo 29.

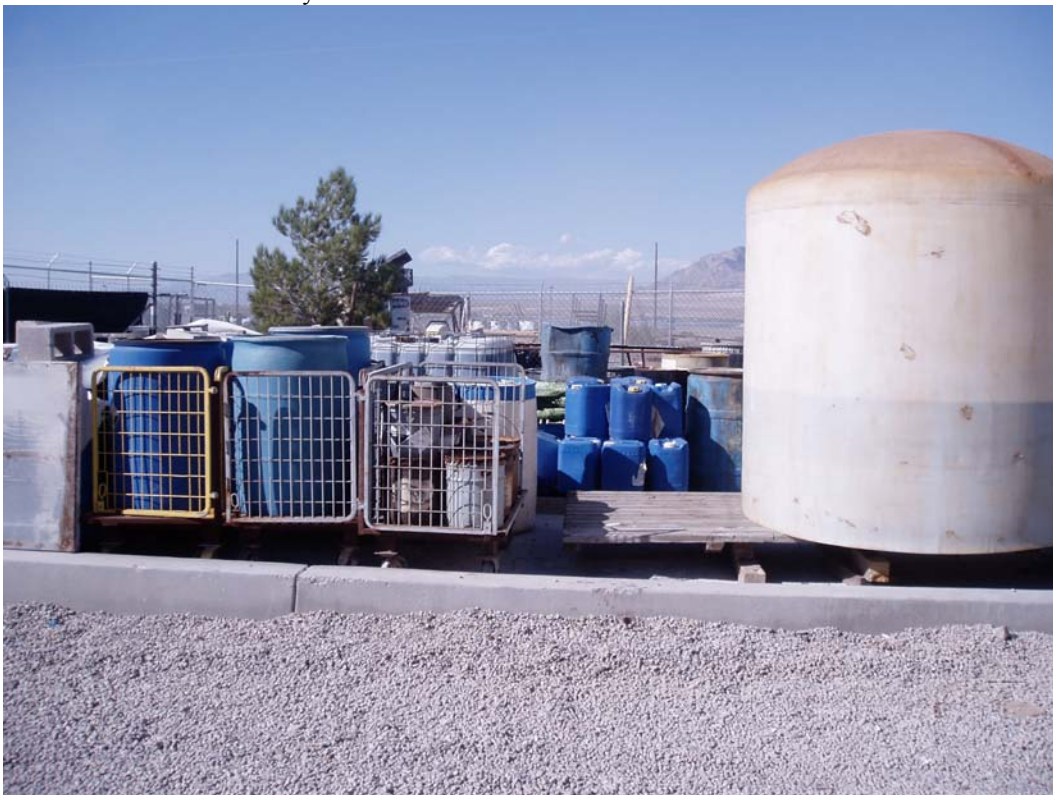
**Photo 2.** Bermed area for chemical storage.

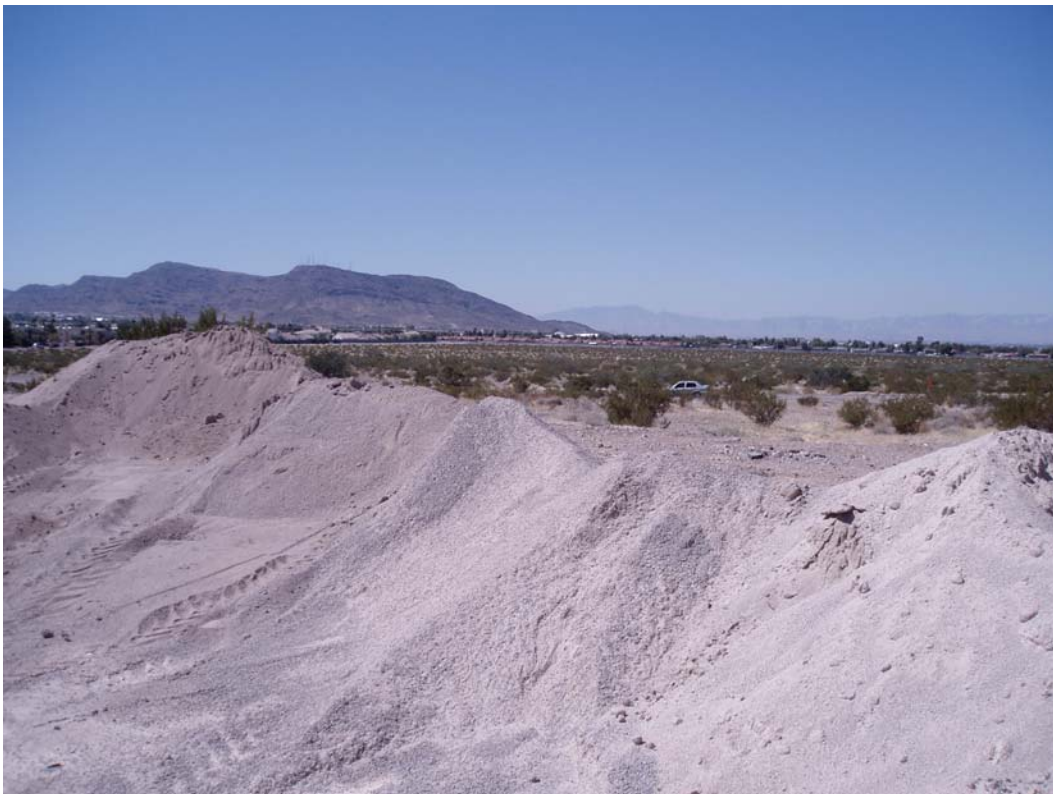
1. Mr. Ogle noted the debris at the construction site entrance.
2. Mr. Ogle noted that the soil stockpiles had the potential to runoff to the road. He said that he would ask the site superintendent to install a berm.
3. Mr. Ogle noted other construction debris throughout the site.
4. Mr. Ogle said that the site would be failed and a Notice of Violation (NOV) sent to the developer to install the berm and clean up the debris.

**Photo 2.** Sediment stockpiles. Note the ground slopes towards the road in the background.
