Westmoreland Pervious Pavers

Portland, Oregon

PROJECT SUMMARY

Project Type:	Street reconstruction with pervious pavement—demonstration project
Technologies:	Pervious pavement blocks
Major Benefits:	<ul style="list-style-type: none"> • Pervious pavement provides more natural stormwater management than a piped system, allowing stormwater to be absorbed, filtered, and cleaned before recharging groundwater. • Stormwater infiltration into the ground reduces combined sewer overflows to the Willamette River and reduces basement flooding caused by rain storms that overload sewers. • The project will provide information about how well different pavement materials, with different section geometries, manage stormwater and hold up as a street surface.
Cost:	\$412,000, with \$80,000 paid by EPA grant funds
Constructed:	2004

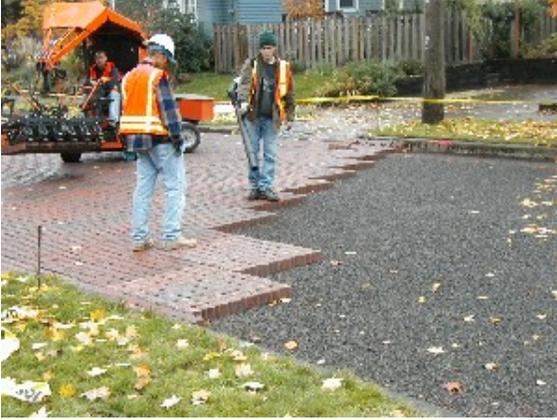
Figure 1: Project during construction

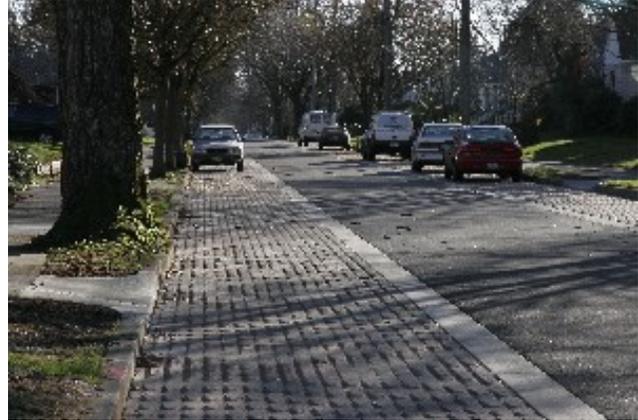
Figure 2: Pavers along parking strips only

- Two blocks (SE 21st from Knapp to Rex and SE Rex from 20th to 21st) were paved with pervious concrete paving blocks in the parking strips along each curb and with standard asphalt in the center strip. One block is crowned, and one is flat.

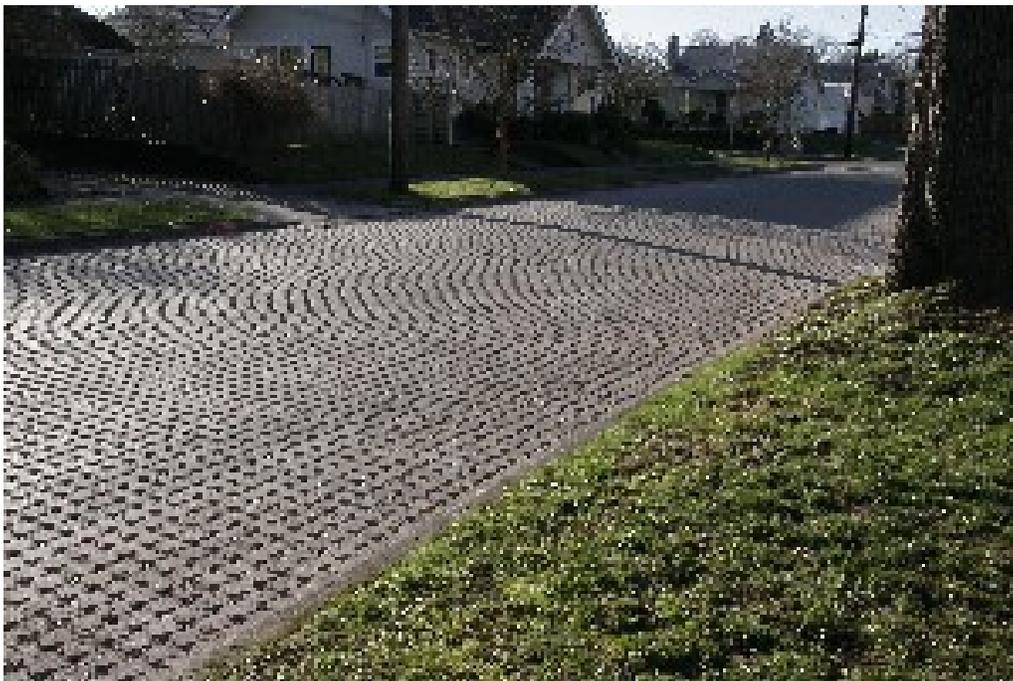
Figure 3: Pavers along the full length of the street

- The four blocks were repaved as follows:
 - One block (SE Knapp Street from 21st to 22nd avenues) was paved curb to curb with interlocking pervious concrete paving blocks. This block is crowned.
