Operation and Maintenance Plan

**Subsurface Gravel Wetland BMP Retrofit for Control of Nitrogen
in Stormwater: An EPA Green Infrastructure Demonstration and
Outreach Project for Hyannis Inner Harbor and the City of
Barnstable, MA**

**Intersection of South Street & Pleasant Street
Barnstable, MA**

BARNSTABLE, MA
NOVEMBER 2015 - CONSTRUCTION AS-BUILTS

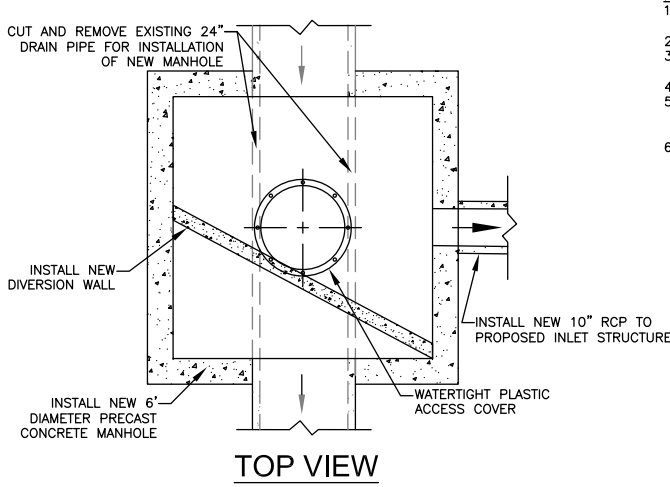
RCP INLET CONTROL STRUCTURE

TOP VIEW

ELEVATION VIEW

- NOTES**
- MANHOLE SHALL BE IN ACCORDANCE WITH SECTION 702 OF THE MA STANDARD SPECIFICATIONS
 - CIRCUMFERENTIAL STEEL REINFORCEMENT REQUIRED = 0.15 SQ. IN./LF. MINIMUM
 - STEEL REINFORCEMENT FOR BASE SECTION BOTTOM SHALL BE A MINIMUM OF 0.12 SQ. IN./LF. (BOTH WAYS)
 - ONE POUR MONOLITHIC BASE SECTION.
 - ANY NECESSARY ADJUSTMENTS DURING CONSTRUCTION WILL BE DONE BY SAW-CUTTING AND/OR CORING ONLY. NO JACKHAMMERS, HAMMERS AND CHISELS OR PNEUMATIC TOOLS WILL BE ALLOWED
 - STEPS SHALL CONFORM TO STD. 5.3.0 AND SHALL BE INSTALLED AT THE CASTING PLANT

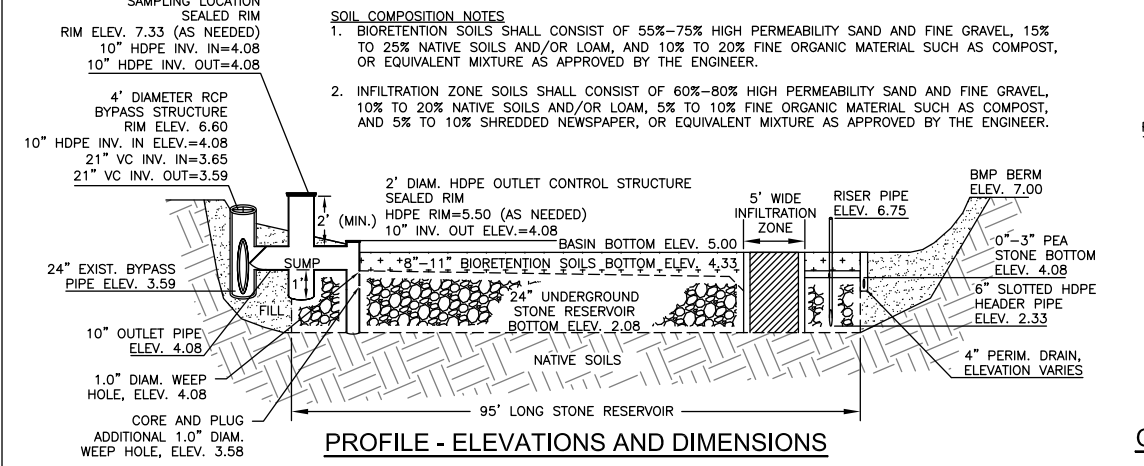
PROFILE - ELEVATIONS AND DIMENSIONS

- SOIL COMPOSITION NOTES**
- BIORETENTION SOILS SHALL CONSIST OF 55%-75% HIGH PERMEABILITY SAND AND FINE GRAVEL, 15% TO 25% NATIVE SOILS AND/OR LOAM, AND 10% TO 20% FINE ORGANIC MATERIAL SUCH AS COMPOST, OR EQUIVALENT MIXTURE AS APPROVED BY THE ENGINEER.
 - INFILTRATION ZONE SOILS SHALL CONSIST OF 60%-80% HIGH PERMEABILITY SAND AND FINE GRAVEL, 10% TO 20% NATIVE SOILS AND/OR LOAM, 5% TO 10% FINE ORGANIC MATERIAL SUCH AS COMPOST, AND 5% TO 10% SHREDDED NEWSPAPER, OR EQUIVALENT MIXTURE AS APPROVED BY THE ENGINEER.

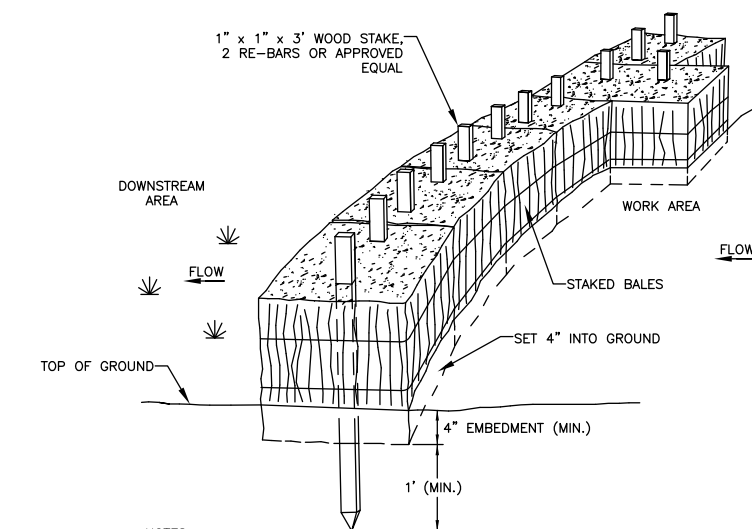
PERIMETER EROSION CONTROLS

NOTES
1. PUT ONE HAYBALE PERPENDICULAR ALONG HAYBALE BARRIER (100' O.C.)

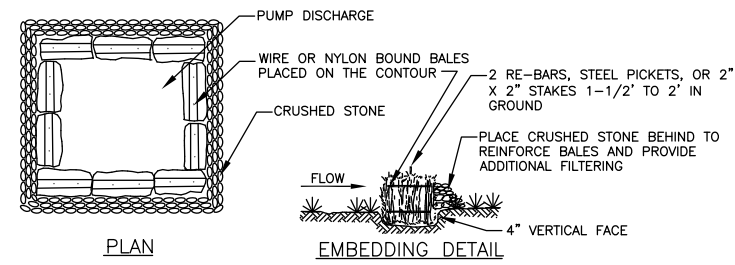
PUMPING DE-WATERING DISCHARGE AREA, HAY BALES

STRAW BALE BARRIER CONSTRUCTION SPECIFICATIONS

1. BALES SHALL BE PLACED IN A ROW WITH ENDS TIGHTLY BUTTED.
2. EACH BALE SHALL BE EMBEDDED IN THE SOIL A MINIMUM OF 4\".
3. BALES SHALL BE SECURELY ANCHORED IN PLACE BY STAKES OR RE-BARS DRIVEN THROUGH THE BALES. THE FIRST STAKE IN EACH BALE SHALL BE ANGLED TOWARD PREVIOUSLY LAID BALE TO FORCE BALES TOGETHER.
4. INSPECTION SHALL BE FREQUENT AND REPAIR OR REPLACEMENT SHALL BE MADE PROMPTLY AS NEEDED.

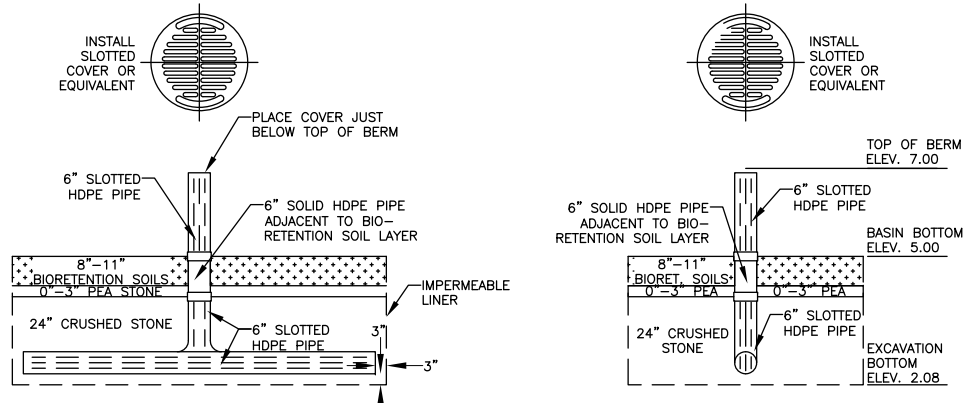
SLOTTED RISER PIPE DETAIL

CROSS-SECTION VIEW ELEVATION VIEW

SLOTTED PIPE SPECIFICATIONS
1. SLOTS SHALL BE A MINIMUM OF 0.040 INCHES WIDE SPACED EVERY 0.25\".

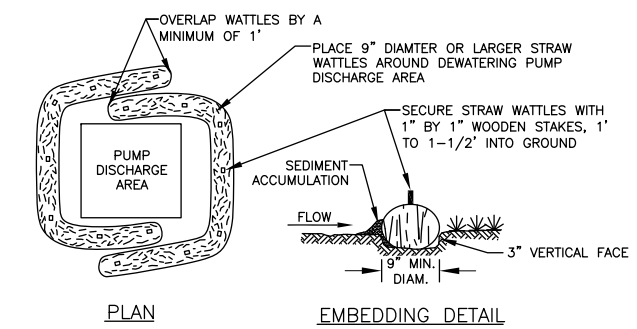
STRAW WATTLE DEWATERING AREA CONSTRUCTION SPECIFICATIONS

1. WATTLES SHALL BE PLACED IN A ROW WITH ENDS OVERLAPPING A MINIMUM OF 1\".
2. EACH WATTLE SHALL BE EMBEDDED IN THE SOIL A MINIMUM OF 3\".
3. WATTLES SHALL BE SECURELY ANCHORED IN PLACE BY STAKES OR RE-BARS INSTALLED AT A MINIMUM EVERY 3' ON-CENTER.
4. INSPECTION SHALL BE FREQUENT AND REPAIR OR REPLACEMENT SHALL BE MADE PROMPTLY AS NEEDED.
5. SEDIMENT SHALL BE REMOVED WHEN THE HEIGHT REACHES THE HALFWAY POINT ON THE STRAW WATTLE.
