**ENFORCEMENT CONFIDENTIAL
NEIC WORK PRODUCT NO. VP0989E01**

**INSPECTION AND SANITARY SURVEY REPORT
FOR THE
GUAM WATERWORKS AUTHORITY
PUBLIC WATER SYSTEM
Guam, United States Territory
April 23 – May 4, 2012**

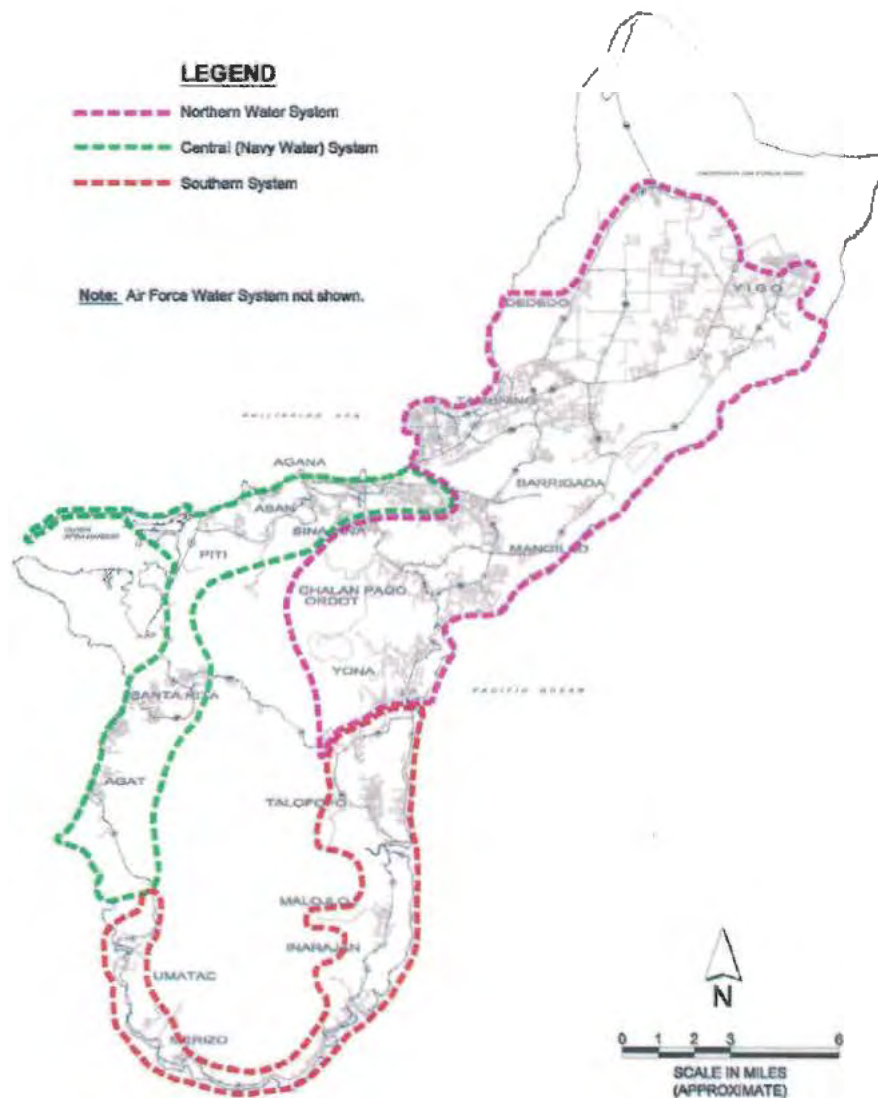
Figure 2 illustrates the boundaries among the GWA Northern, Central and Southern PWS. Note that the boundaries illustrated in Figure 2 are inexact insofar as the three GWA PWS have potential overlaps of service areas that result from the utilization of different sources over time. More information concerning service overlaps can be found in the GWA Master Plan.

Figure 2. GWA PWS Boundaries
Project Name
Location
Source: GWA Master Plan
