NPDES Industrial Storm Water Investigation and Case Development Worksheet

Facility Location Information				
Name/Location/ Mailing Address	Guam Shipyard Building 20 Sumay Drive Sumay Cove Santa Rita, GU 96915			
GPS Coordinates (as measured in Google Earth Pro)	Latitude	133°26'20.21" N	Longitude	144 39' 49.08" E
Receiving Water(s)	Apra Harbor			
	Name		Telephone	
Owner	U.S. Navy owns the property and subleases it to the Guam Economic Development and Commerce Authority, which subleases the land to Guam Shipyard.			
Operator	Mathew Pothen, President and CEO		(671) 339-1637/58

Guam Shipyard (facility) is located at Point Orote across the entrance into Apra Inner Harbor from Polaris Point in the Territory of Guam. Storm water runoff discharges into Inner and Outer Apra Harbor through a network of storm drains and outfalls. The facility covers approximately 100 acres of land with an offshore floating drydock on which Guam Shipyard performs overhaul, repair and alteration work on a variety of marine vessels.

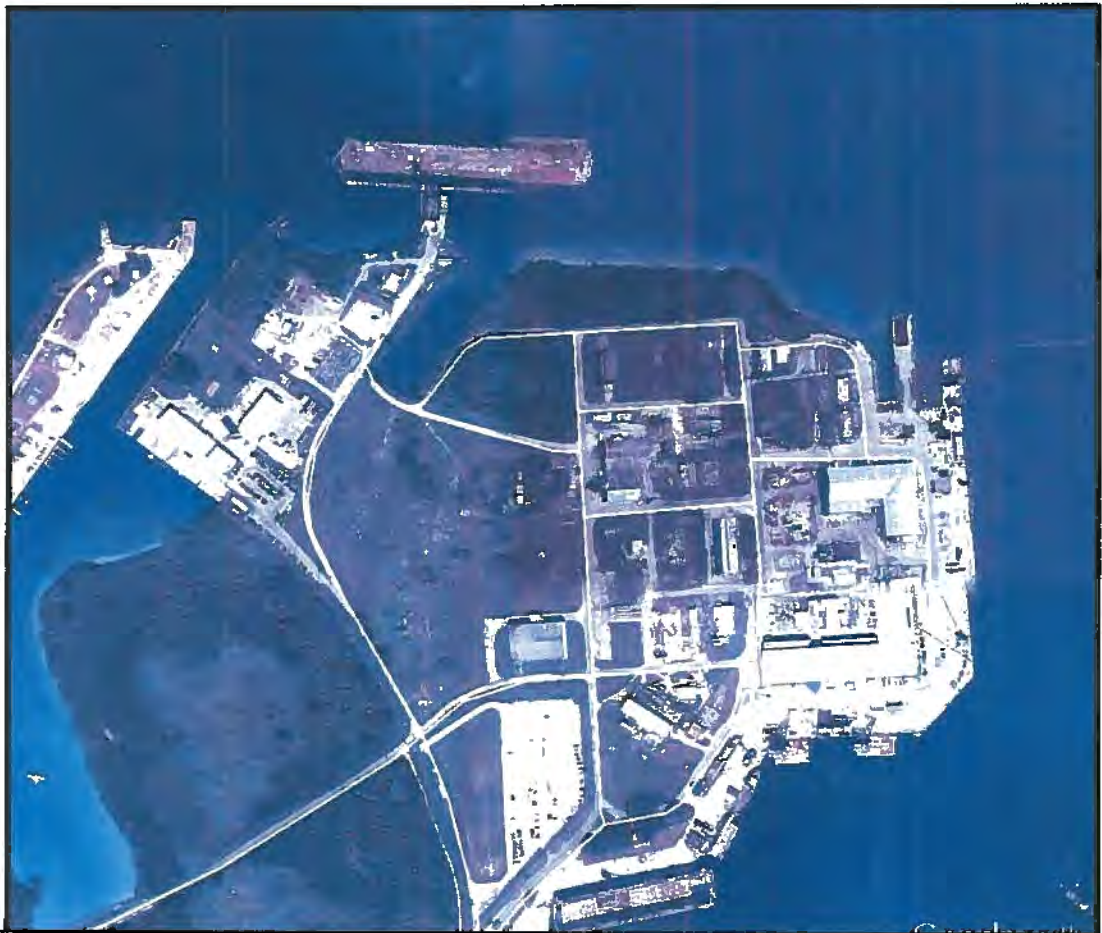
Below is a Google Earth Pro aerial photograph of the Guam Shipyard. This aerial was taken March 27, 2013. A site map of the facility has been included in Attachment 4.
