# Section 319 NONPOINT SOURCE PROGRAM SUCCESS STORY

# Installing Upland and Stream Restoration Practices Reduces Sediment in German Valley Branch

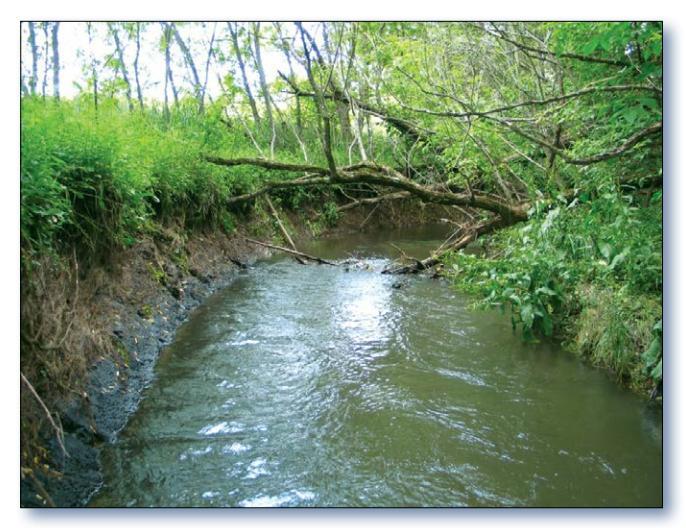
Figure 1. Before restoration, German Valley Branch was deeply entrenched and had highly eroding banks.

Over many years, sediment from cropland and streambank erosion degraded the in-stream habitat for aquatic life in German Valley Branch (Figure 1). Fisheries and habitat surveys conducted in the mid-1990s indicated that the stream was dominated by fish species tolerant of disturbed habitat and that the overall habitat condition was only "fair." The stream's cold-water fish Index of Biotic Integrity (IBI) scores (based on several metrics used to assess the fish community) ranged from zero (very poor) to 40 (fair), and the macroinvertebrate IBI scores were as low as 2.4 (poor). Quantitative habitat surveys, which factor in stream width, bank erosion, width-to-depth ratio, riffle and/or pool ratio, percent soft sediment, and fish cover, resulted in scores ranging from 25 (fair) to 63 (good) before rehabilitation efforts. These data indicated that the stream was not supporting its aquatic life designated use. On the basis of the data, the state added the 7-mile-long German Valley Branch to its CWA section 303(d) list of impaired waters in 1998 because of excessive sediment from agricultural nonpoint source pollution.

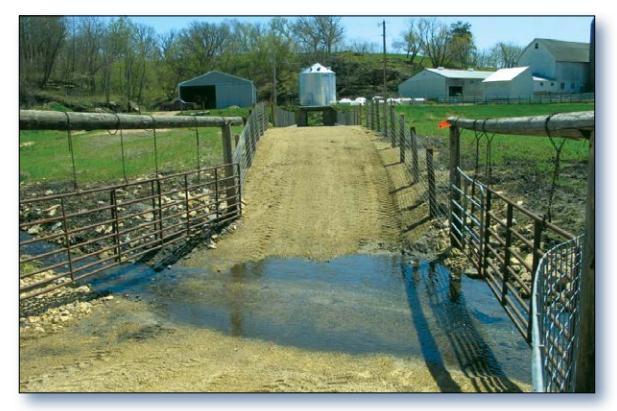
Figure 2. Project partners worked with a local farmer to install a fenced cattle crossing to limit livestock access to the stream.

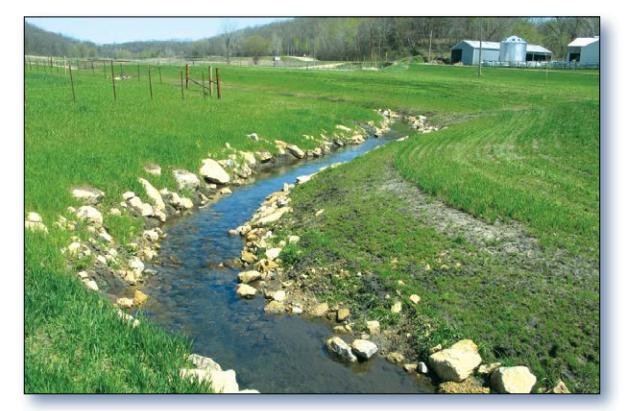
Figure 3. Project partners installed livestock exclusion fencing and restored the stream channel and its natural meanders.

Dane County LCD continued restoration efforts from 2004 to 2006, supported by the Wisconsin Department of Natural Resources' (WDNR) Targeted Runoff Management (TRM) Grant Program and Dane County cost-share funds. The county worked with eight landowners to implement three TRM projects that rehabilitated the stream corridor and improved fish habitat. The projects included restoring streambanks, stabilizing critical areas, adding wastewater treatment strips (vegetated buffers) near livestock holding areas, installing waterway systems (vegetated waterways that convey excess runoff across fields), and installing livestock exclusion fencing (Figures 2 and 3). Project partners improved fish habitat in the stream by placing rock and log weirs (channel-spanning rock structures that protect streambanks by redirecting stream flow), as well as lunker structures (cells of heavy wooden planks and blocks installed along streambanks to improve aquatic life habitat and minimize bank erosion). In total, watershed efforts restored more than four miles of stream habitat, which significantly improved water quality and habitat. In addition, all landowners in the stream restoration area provided public access easements to allow people to fish and hike.
