## Re: June 30, 2009 Clean Water Act Inspection

# NPDES COMPLIANCE EVALUATION INSPECTION REPORT

Facility:	Guam Shipyard Naval Base Guam
NPDES Permit No.:	GU0020362
US EPA Representative:	Jeremy Johnstone Senior Environmental Engineer
GSY Representatives:	Mathews Pothens, President and CEO Keith Carter, Shipyard Manager Sonne Alston, Environmental and Safety Manager
US Navy Representatives:	Maria Lewis, EPS, NAVFACMAR EVBL Blaise Koki, NAVFACMAR EVBL Danny Dungca, Utility Worker, NAVFACMAR EVBL
Guam EPA Representatives:	Manny Minas, Supervising Engineer Maricar Quezon, Engineer II Noel Cruz, Engineer II
Date of Inspection:	30 June 2009
Report Prepared by:	Jeremy Johnstone

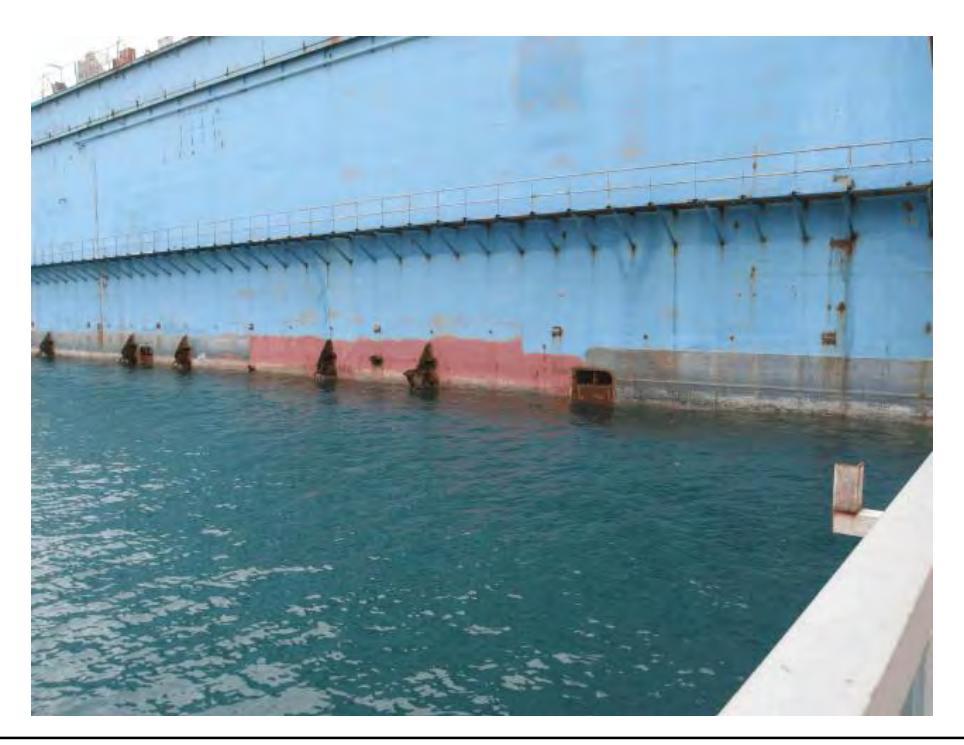
Photo 1 - Port side view of Guam Shipyard's Drydock AFDB-8. Outfall No. 004 is depicted at the right side juncture of the red and gray painted areas.

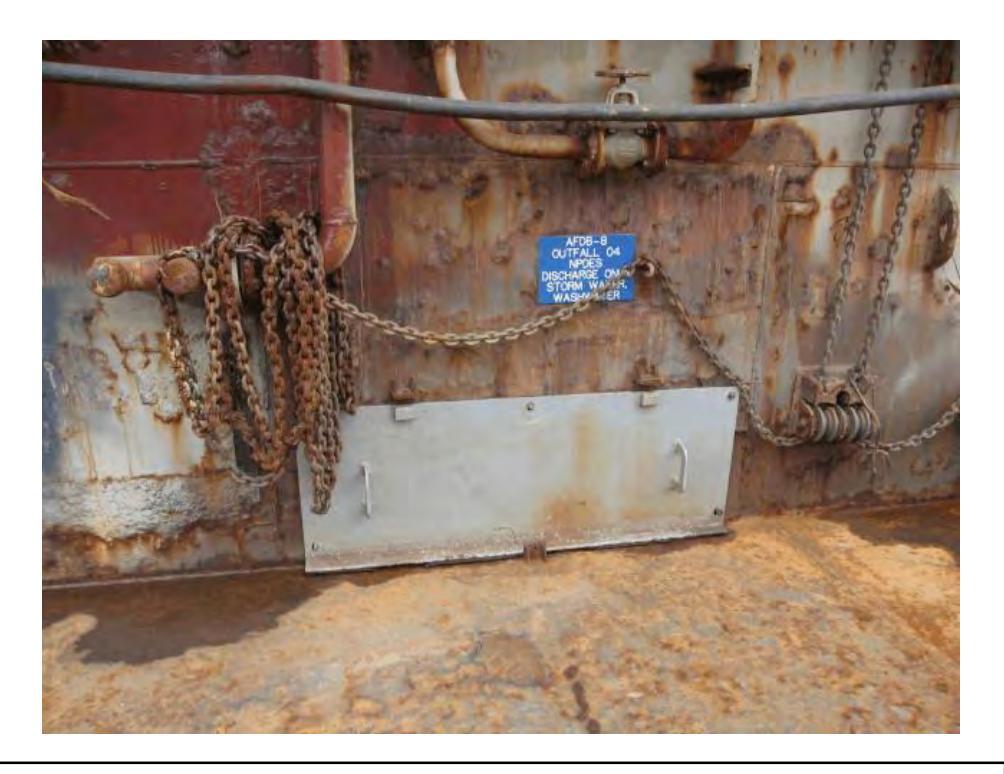
Photo 2 - View of Outfall No. 4 inlet on from inside drydock. Note metal plate used to prevent discharges during normal operations.

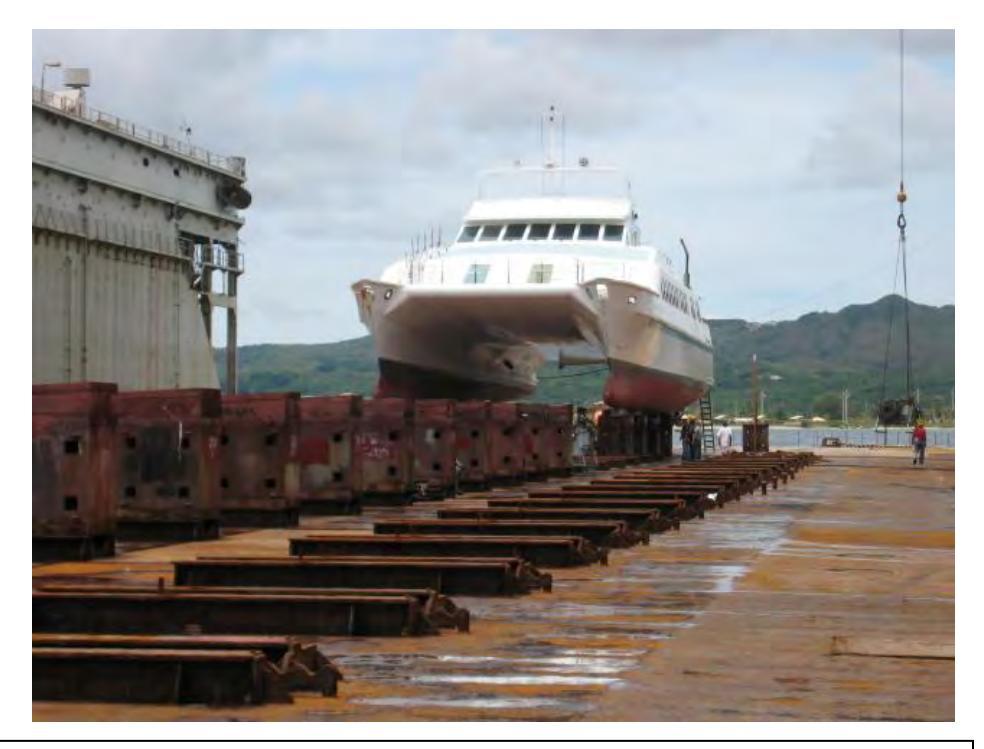
- 1. Work on the vessel Micronesian Dream was occurring at the time of the inspection. No BMPs were in evidence, in particular plastic sheeting had not been deployed beneath the vessel and no spill kits were onboard the drydock. Both of these BMPs are specified in the facility SWPPP.

Photo 3 – The Micronesian Dream in drydock

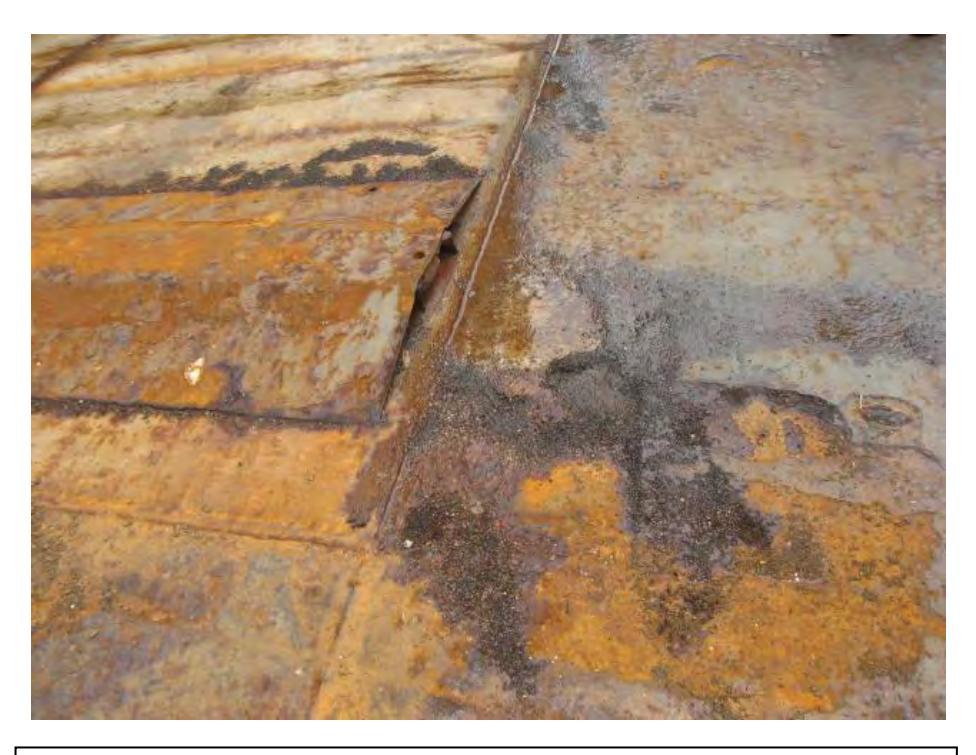
- 2. Accumulations of solids on the drydock deck were noted. See Photo 4 attached. A mandatory BMP under the permit is for the drydock to be swept several times per day and at the end of each workday.

Photo 4 – Accumulated solids on drydock deck

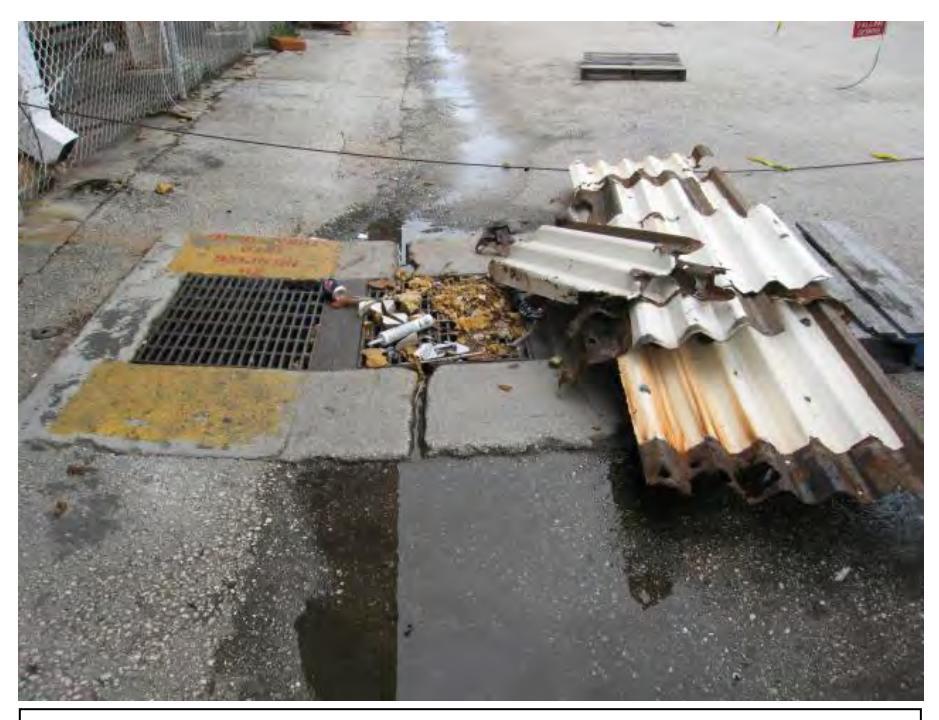
- 15. Poor housekeeping practices were observed at various locations, including outside the Electrical Shop. See Photo 5 attached. At the oil storage area some drums were observed to be stored outside of containment and/or cover. See Photo 6 attached.

Photo 5 – Accumulated debris on top of drain inlet located outside of electrical shop

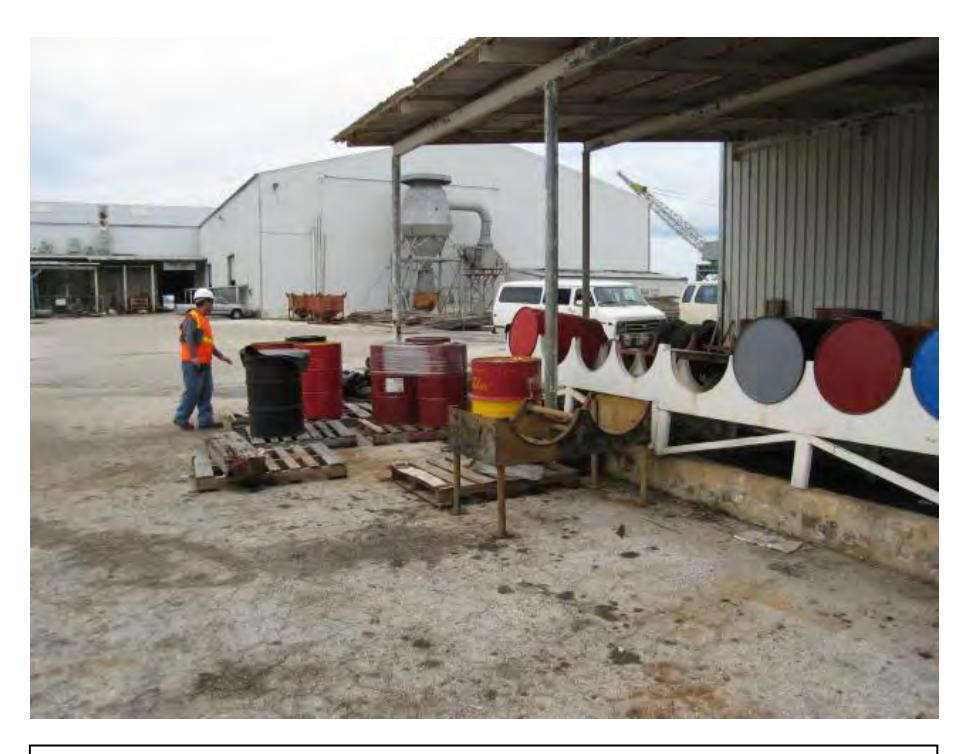
Photo 6 – Drums stored outside of containment and cover at the oil storage area

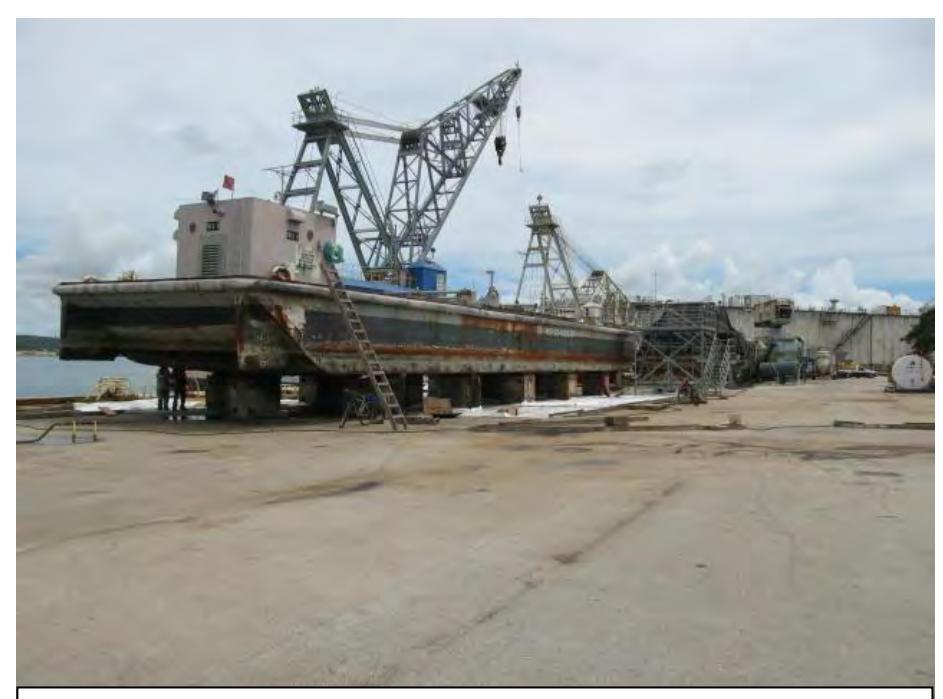
- 13. A barge had been hoisted onto land and was being worked upon at the time of the inspection. Hosing and a pump for hull washing had been set up, but nearby outfall scuppers had not been blocked. There was evidence of a discharge from this operation to harbor waters. See Photos 7 and 8 attached. Discharges of hull washwater or any other non-stormwater discharges are not authorized under any NPDES permit issued to GSY.

Photo 7 – Barge undergoing work Shoreside. Note hosing to left and puddled water nearby.

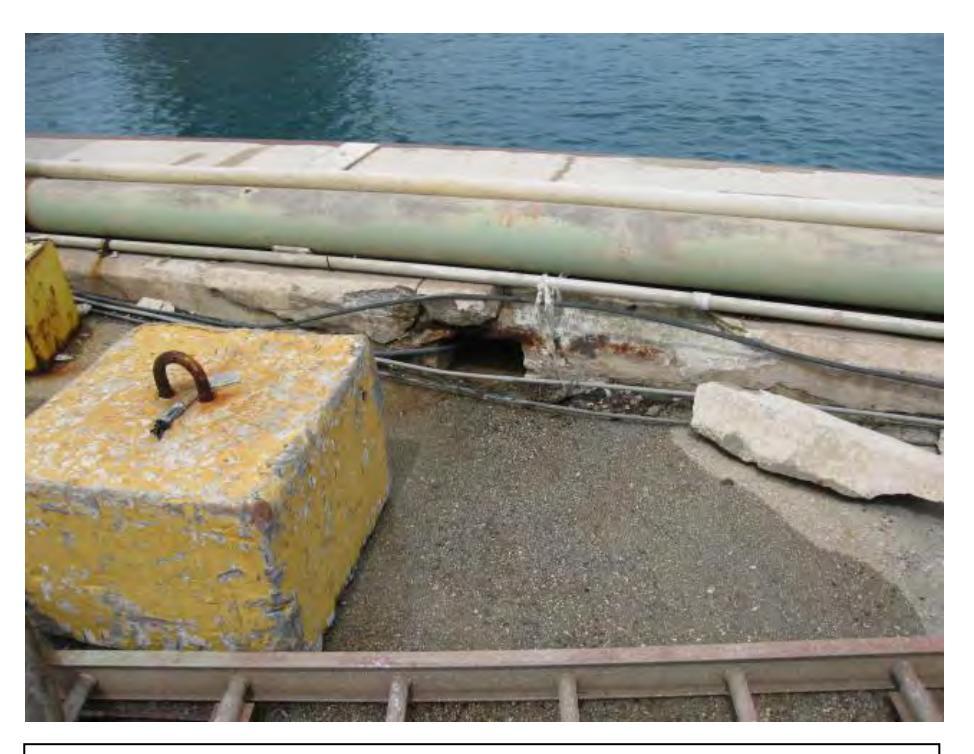
Photo 8 – Evidence of discharge of non-stormwater to harbor from a scupper immediately adjacent to the where a barge was undergoing work onshore.
