**Optimization Review
Palermo Wellfield Superfund Site**

City of Tumwater, Thurston County, Washington

Report of the Optimization Review
Site Visit Conducted at the Palermo Wellfield Superfund Site on
August 25, 2011

December 14, 2011

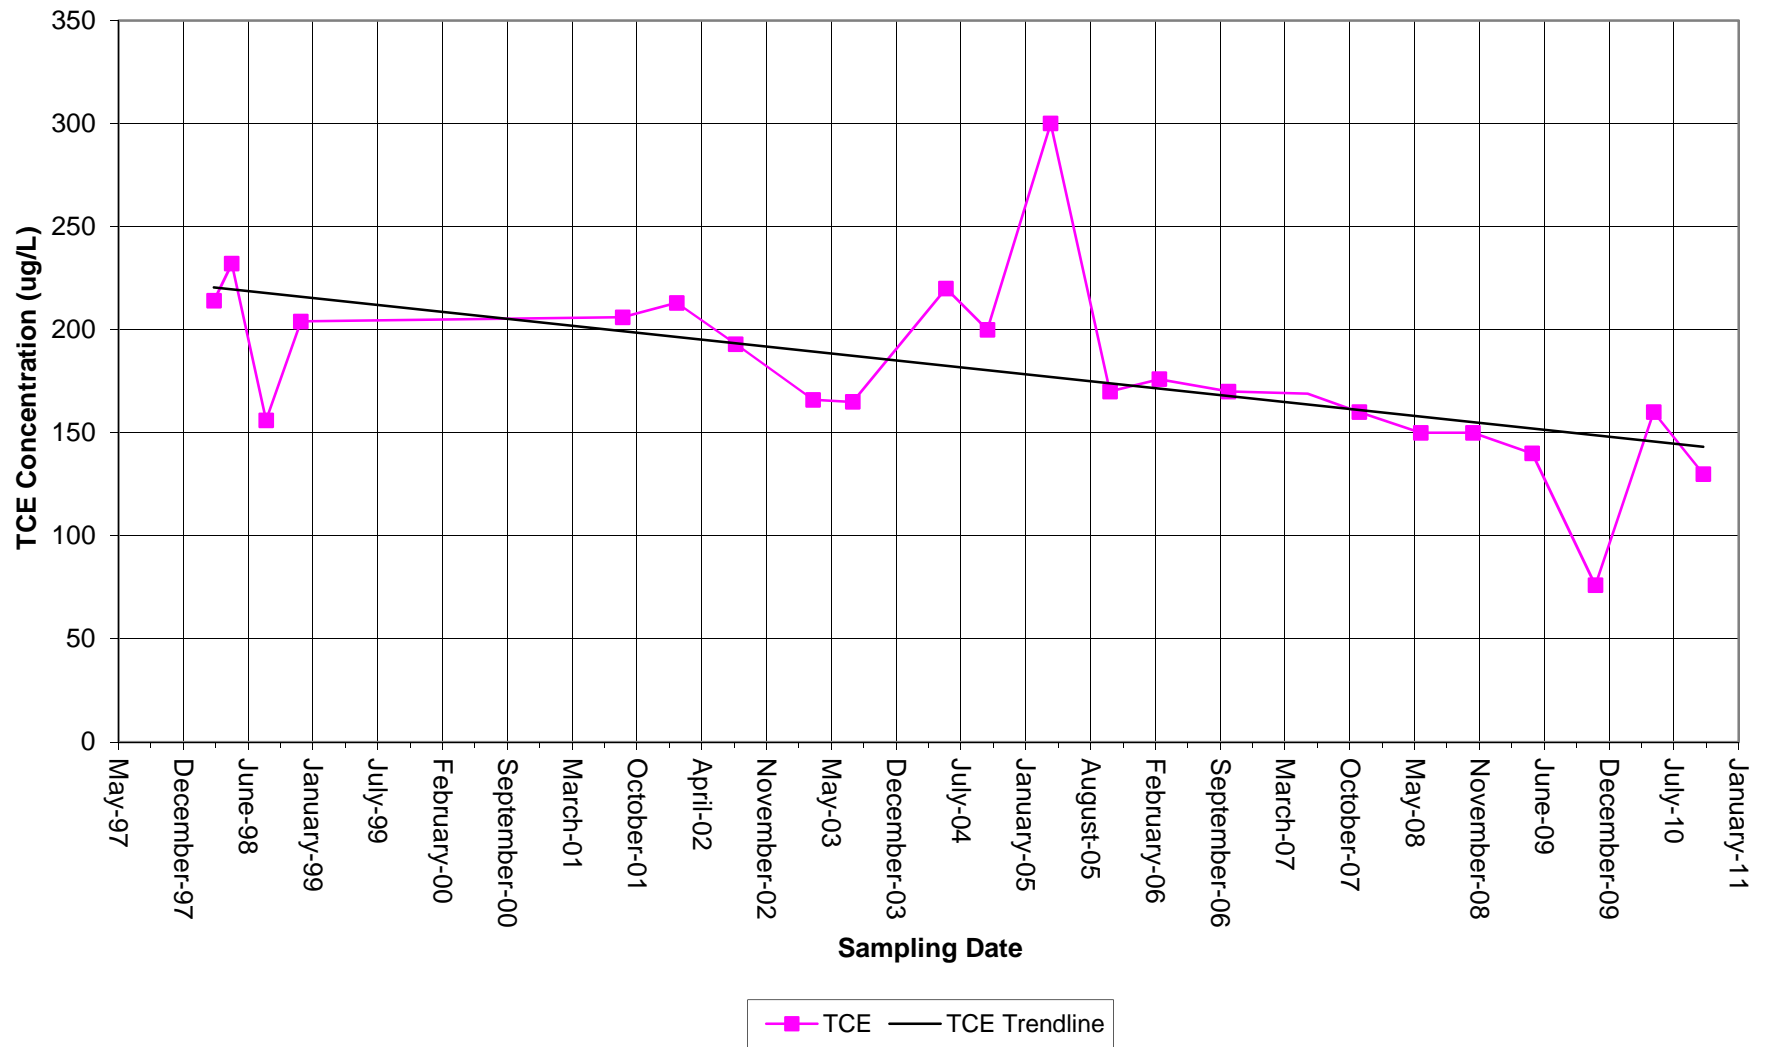
MW-ES-09 TCE Concentration Time-Trend Plot

TCE concentrations at MW-ES-09 are currently the highest observed TCE concentrations at the Site and concentrations are declining slowly, indicating it will take many decades to reach MCLs in this area with the current remedial approach, even if upland sources have been removed. In addition, the higher concentrations at shallower depths (compared to wellfield pumping at deeper depths) and the position of the Palermo Wellfield south of the plume core increases likelihood that the wellfield may not provide full capture (plume capture is further discussed in Section 5.2.2).

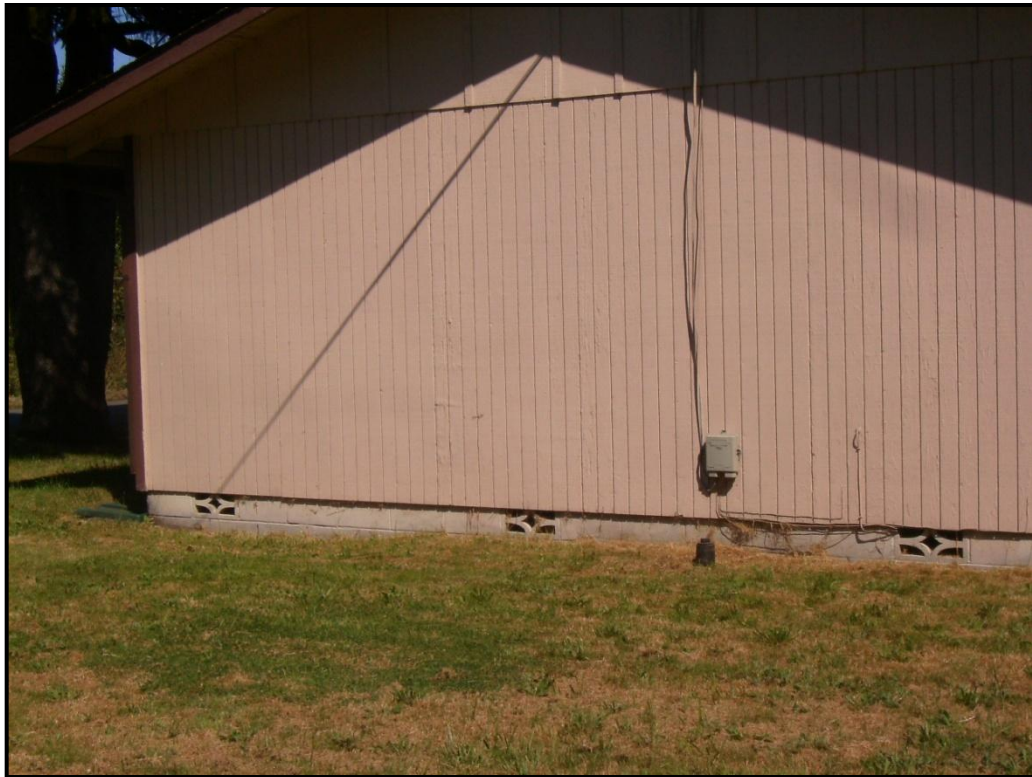
PHOTO 20: Typical residential perimeter foundation with crawl space; note crawl space ventilation.

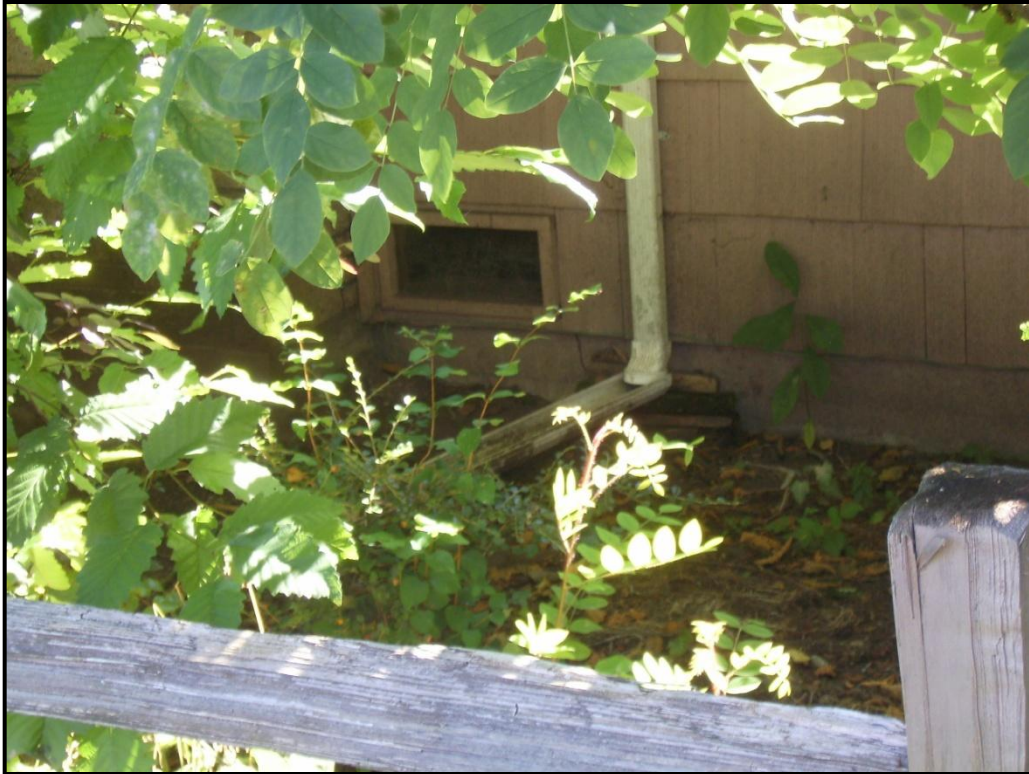
PHOTO 21: Close-up of residential foundation showing crawlspace ventilation.

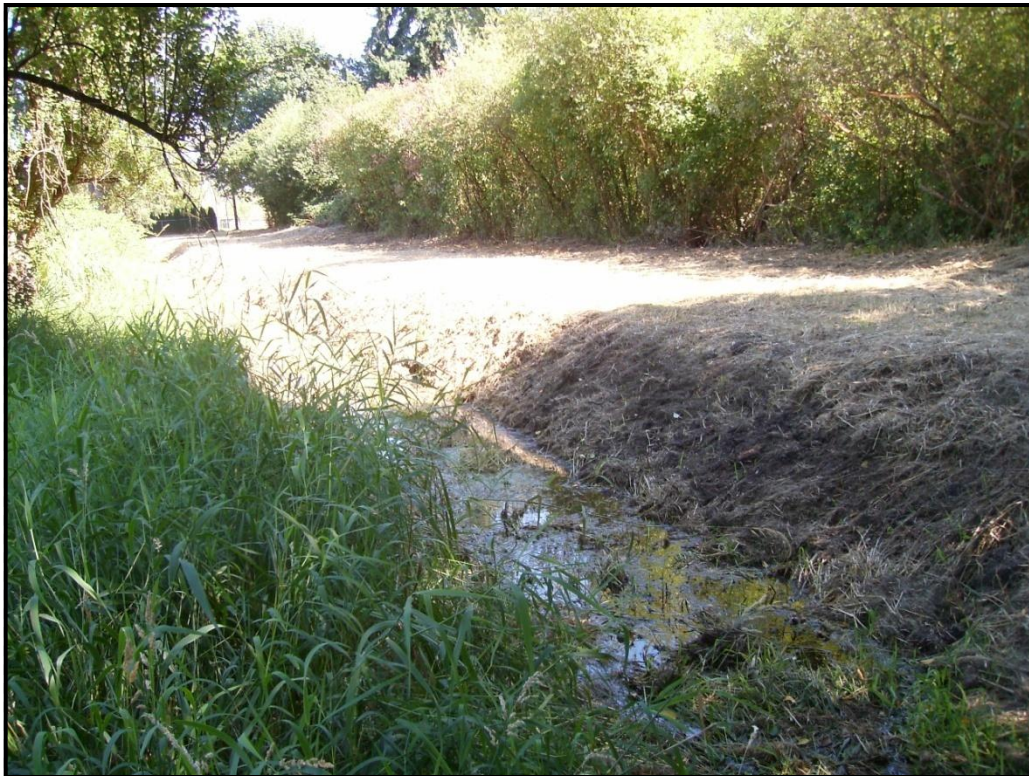
PHOTO 22: Seep drainage feature oriented west-east, south of House #6 at the southwest corner of the neighborhood, looking southeast.

During the Site visit, the project team encountered what appeared to be a surface water expression of shallow groundwater emanating from the Palermo Bluff. Flowing surface water was identified in a trench beginning at the base of the bluff in the southwest corner of the Palermo neighborhood and extending east along the southern edge of the neighborhood down to the Palermo Wellfield. In addition, while walking along the base of the bluff to the west side of the Palermo neighborhood, the team noted several interesting surface features including a 6" polyvinyl chloride (PVC) pipe extending down from the parking areas on top of the bluff to within a few feet of the base of the bluff and another surface water feature (low lying swamp area) just east of the PVC pipe. These features are illustrated in Attachment E. The seeps and the drainage water from the PVC pipe have not been sampled. These features are shown in the attached Photolog (Attachment F).

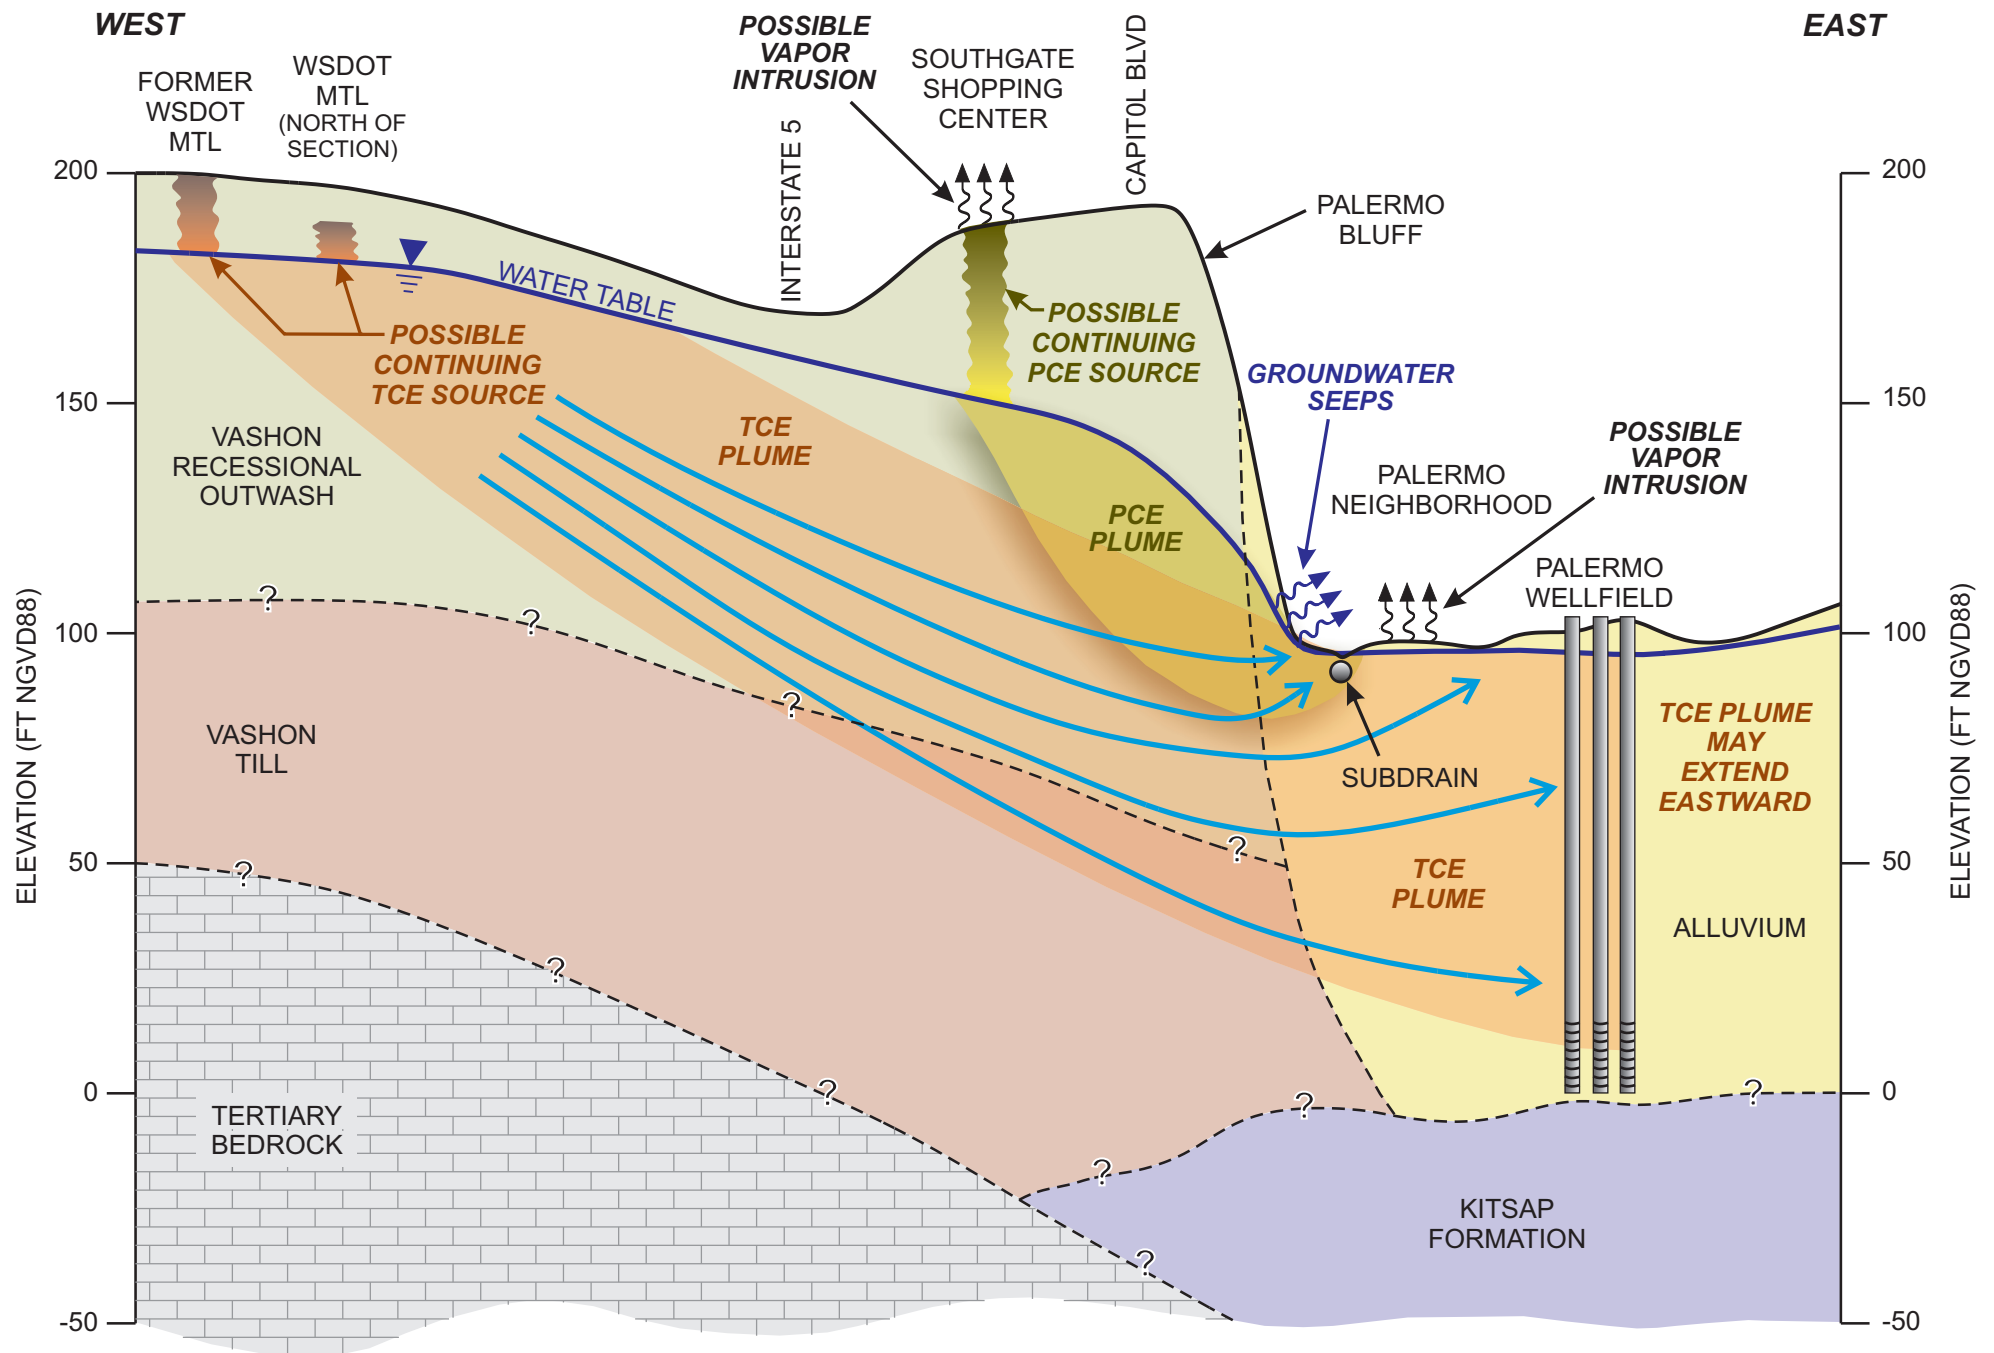
FIGURE 1
 CROSS SECTION ILLUSTRATION OF SITE CONCEPTUAL MODEL
 Palermo Wellfield Superfund Site

Figure 1 is a cross-section illustration that summarizes the CSM. Volatile organic compound (VOC) contamination released at the surface and/or in the shallow subsurface from the Southgate Dry Cleaners and both the current and former WSDOT MTL facilities has impacted groundwater at the Site. The soils are relatively permeable (described as sands) and low in organic carbon. In addition, the releases in some cases may have occurred approximately 25 years before remedial investigation (RI) sampling occurred. These factors contributed to relatively low soil concentrations observed during the RI and may have resulted in relatively weak continuing sources of dissolved groundwater contamination in 2010 at these previously identified sources. The relatively high groundwater flow rates and low organic carbon have contributed to contaminant flushing over the period of three to four decades from the time of the original releases until present. As a result, the majority of contamination associated with the original releases appears to have migrated away from the source areas and is now present in the vicinity of the Palermo neighborhood. However, one or more of the historic source areas may be continuing to impact groundwater.

VOC contamination released at the surface and/or in the shallow subsurface from the Southgate Dry Cleaners and both the current and former WSDOT MTL facilities has impacted groundwater at the site. The soils are relatively permeable (described as sands) and low in organic carbon. In addition, the releases in some cases may have occurred approximately 25 years before the RI sampling occurred. These factors contributed to relatively low soil concentrations observed during the RI and may have resulted in relatively weak continuing sources of dissolved groundwater contamination measured in 2010 at these previously identified sources.
