# NONPOINT SOURCE PROGRAM SUCCESS STORY

# Wyoming

## Stakeholders Collaborated to Reduce Sediment in Creek

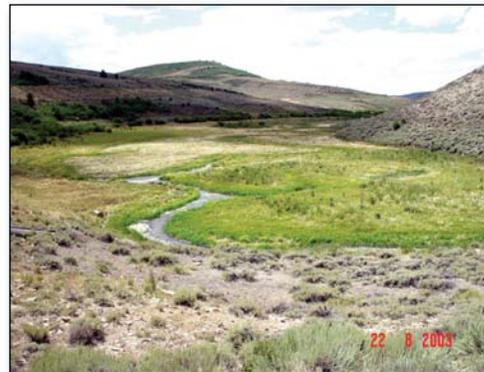
Figure 1. Photo of lower Sage Creek near the confluence with the North Platte River.

Sage Creek is in the North Platte River Basin of southeastern Wyoming. The creek's headwaters are along the continental divide in the northern foothills of the Sierra Madre at an elevation of approximately 8,400 feet. The 263-square-mile Sage Creek watershed drains into the North Platte River near the town of Saratoga (Figure 1). WDEQ classifies Sage Creek as waterbody type 2AB; thus, it is protected for the designated uses of drinking water, coldwater game and nongame fisheries, fish consumption, aquatic life, recreation, wildlife, industry, agriculture and scenic value. The Sage Creek watershed produces naturally high sediment loads because of its highly erodible soils. Dam failures, road construction and historic livestock grazing practices have exacerbated the erosion, especially during precipitation events and the spring snowmelt runoff period (Figure 2).

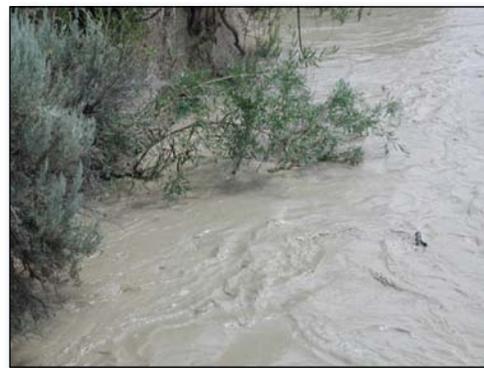
Figure 2. Photo showing a high sediment load in Sage Creek after a storm event.
