Section 319

NONPOINT SOURCE PROGRAM SUCCESS STORY

Removing Sources of Fecal Coliform Improves Water Quality

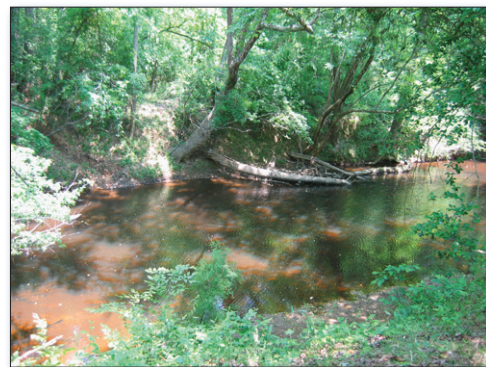
Figure 1. Thompson Creek flows through portions of North and South Carolina before emptying into South Carolina's Pee Dee River.

The Thompson Creek Watershed drains parts of South Carolina's Chesterfield County (100 square miles) and North Carolina's Anson County (49.8 square miles), before emptying into South Carolina's Pee Dee River (Figure 1). Major land uses in the watershed are forest (65.5 percent) and agriculture (22.3 percent).

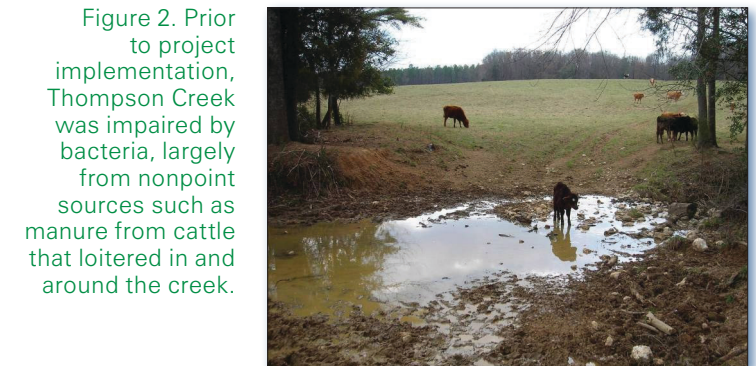
Figure 2. Prior to project implementation, Thompson Creek was impaired by bacteria, largely from nonpoint sources such as manure from cattle that loitered in and around the creek.

On the basis of the data, DHEC placed two segments (PD-246 and PD-247) of Thompson Creek on South Carolina's 2002 CWA section 303(d) list of impaired waters for not meeting the state's fecal coliform bacteria water quality standard. DHEC attributed the impairment primarily to nonpoint source pollution (Figure 2).

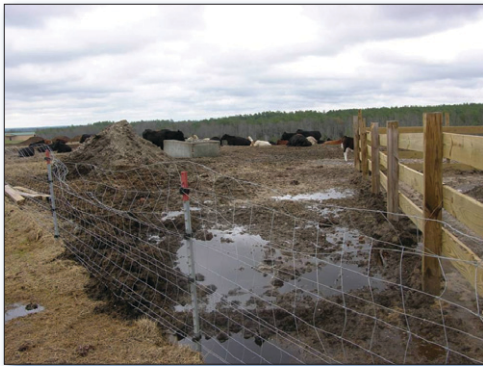
Figure 3. Prior to project implementation, runoff from this muddy cattle feeding area flowed downhill into Thompson Creek.

974 acres of conservation tillage, 2 waste storage facilities, 3 acres of critical area planting, 24,899 square feet of heavy use area protection (Figures 3 and 4), 34 acres of forest site preparation, 26 acres of pasture and hayland planting, and 106 acres of tree and shrub planting. Homeowners also repaired/replaced 34 septic systems. Collectively, the BMPs have significantly improved water quality in the watershed.

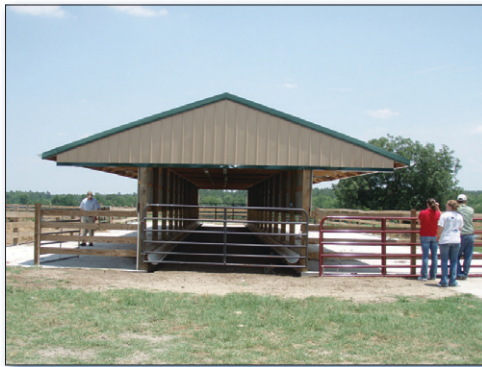
Figure 4. To address the runoff from the heavy use feeding area, the landowner built a structure that keeps the cows dry during feeding and allows for easy clean up of manure.
