PG&E and the New Breaker SF₆ Leak Study

Sven Thesen, PG&E

Abstract:

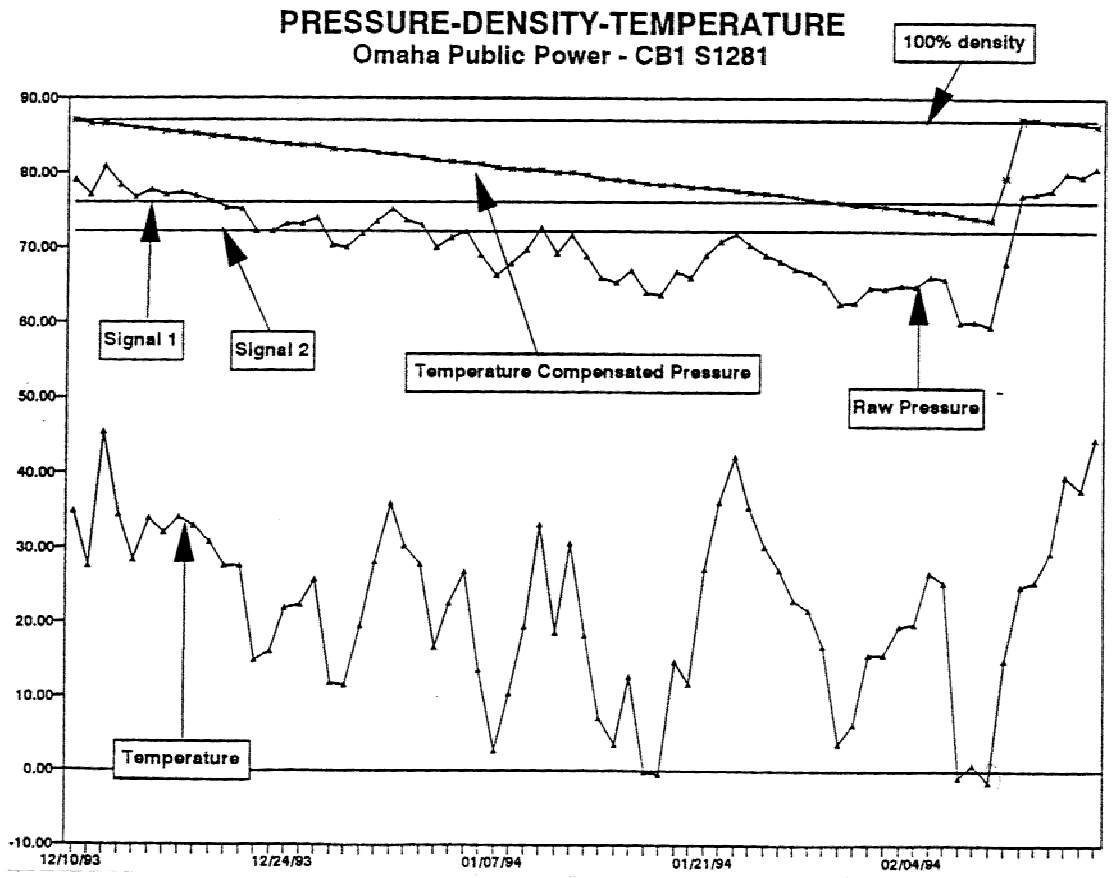
In addition to the above, other utilities may define a SF₆ leak as a 10 percent decrease in SF₆ density as compared to the density of the fully charged breaker at installation. The same density monitor discussed above is used to determine leaks by measuring actual breaker internal pressure and temperature, compensating for the measured temperature and calculating the breaker current compensated pressure. This value is compared to the reference standard of the fully charged breaker to calculate a percentage; 100% representing a full breaker. Should this value fall by more than 10 percent, an alarm is sounded. Figure 1 illustrates this scenario by detailing the drop in temperature compensated pressure as the result of a breaker's slow leak.

PG&E defines a SF₆ leak as an SF₆ pressure drop of more than 10 psi from a fully charged breaker at installation with a base pressure of 80 psi. A breaker density monitor is used to monitor for and determine SF₆ leaks by measuring the breaker internal pressure and temperature. The monitor then "compensates" for the difference between the measured temperature and the reference standard of a fully charged breaker defined at installation and calculates the temperature compensated pressure. Should the compensated pressure inside the breaker fall by more than 10 psi, an alarm is sounded. It is understood that the most density monitors are rated at ± 2 psi.

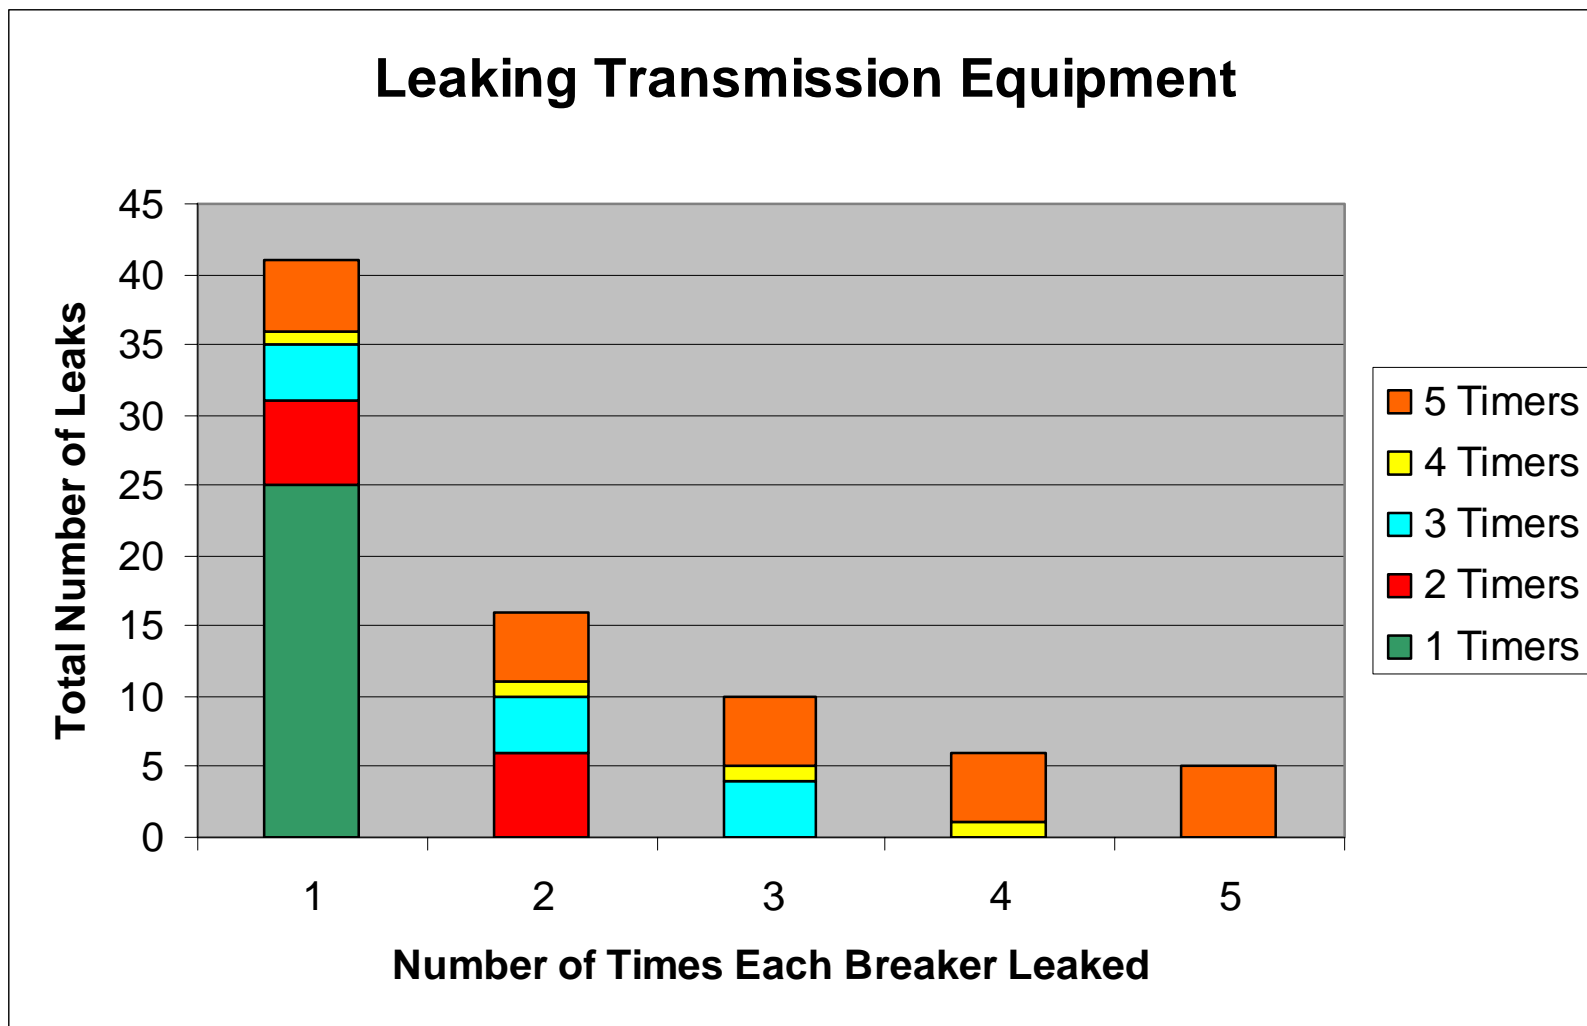
Figure 2

From the pool of "new" breakers, PG&E collected and reviewed the SF₆ leak alarm data. Of the 537 new breakers, 41 experienced a SF₆ alarm between their installation and the Spring of 2004. As illustrated by Figure 2, of those 41 breakers that experienced the first alarm, 16 experienced a second alarm, 10 experienced a third alarm and 6 have experienced four or more alarms since installation.

This data indicates that only a small proportion, approximately 8 percent of PG&E's new breakers leak. However, it also indicates that some leaks can be difficult to repair or that some breakers may be particularly susceptible to leaks.
