NONPOINT SOURCE SUCCESS STORY

Renovation of Big Springs Community Lake Restores Beneficial Use

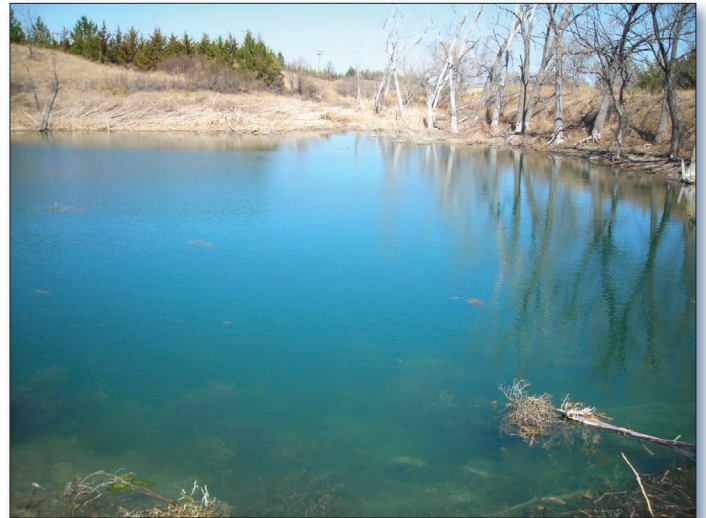
Figure 1. Big Springs Community Lake, before renovation.

Big Springs Community Lake is a 1-acre pond in the community of Big Springs in southwest Nebraska's Deuel County. The pond was the centerpiece of a small community park adjacent to South Platte High School in Big Springs. Age and historic management practices in the watershed took a toll on the pond since its construction in 1927. Sediment accumulated from shoreline erosion left the pond with shallow, stagnant water and steep banks.

The NDEQ listed the pond (waterbody ID SP1-L0095) for aesthetic use impairment in the Nebraska 2012 Water Quality Integrated Report. Current sediment inputs from the watershed were considered fully controlled. Other sources of impairment to the pond, such as woody debris, were considered natural. Restoration of the aesthetic use benefit required removal of the accumulated sediment and woody debris.

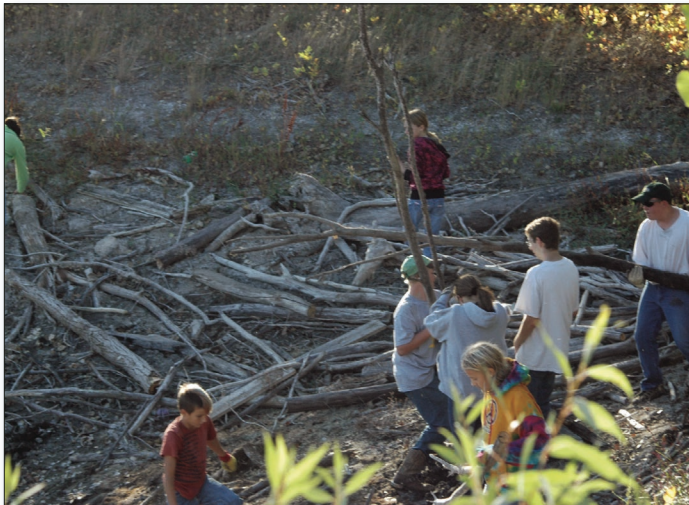
Figure 2. Community partners remove woody debris from the lake area.

The community of Big Springs requested assistance from the NDEQ's Community Lakes Enhancement and Restoration (CLEAR) program to restore the community pond. CLEAR Team members from NDEQ, Nebraska Game and Parks Commission, and University of Nebraska Extension visited the site and helped the community develop a renovation plan and a funding package. Restoration of the pond was completed in 2010–2011. Woody debris was removed; 2,500 cubic yards of sediment was excavated; the shoreline was reshaped, armored and re-vegetated; a pond liner was

installed to reduce leakage; and habitat structures were installed to enhance the fishery (Figure 2). The depth of the pond was increased from a maximum of 5 feet to an average depth of greater than 10 feet over 25 percent of the surface area, which will allow the pond to sustain a warm water fishery year-round (Figure 3). Grading and stabilizing the shoreline improved ease and safety of access and provided protection from shoreline erosion. To complete the project, the Nebraska Game and Parks Commission restocked the pond with bluegill, largemouth bass and channel catfish of catchable size. The community installed picnic tables and other amenities to attract park users. The adjacent school developed activities to enhance outdoor classroom experiences for students.

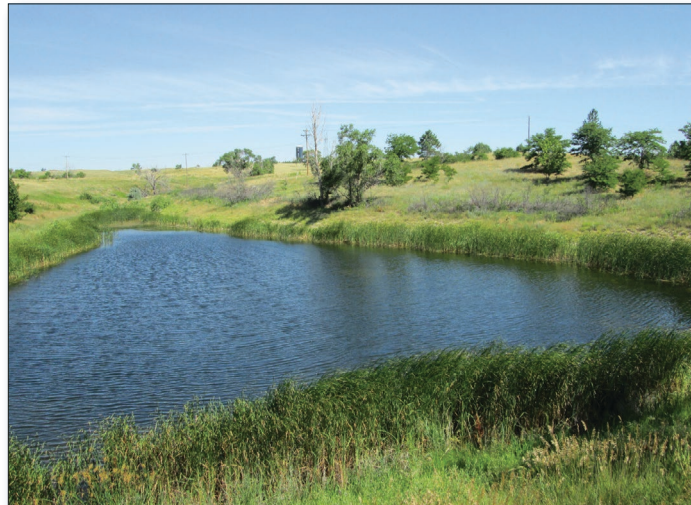
Figure 3. Big Springs Community Lake, after community partners completed renovation.

Today the pond is again a destination for community activities and recreation. The renovation project removed 2,169 tons of sediment, 1,800 pounds of phosphorus and 1,041 pounds of nitrogen from the pond. Outdoor classroom activities bring students from the adjacent school to learn about water quality and other natural resources issues. The pond supports a vigorous fishery with water clarity exceeding 3 feet. Inspection of the pond in 2015 confirmed that restoration had removed the aesthetic impairment. Big Springs Community Lake was removed from the 2014 CWA section 303(d) list of impaired waters.
