**US Army Corps of Engineers
New England District
Total Environmental Restoration Contract
USACE Contract Number: DACW33-03-D-0006
Task Order No. 0008**

**FINAL
TECHNICAL MEMORANDUM
SUMMARY OF FINDINGS
New Bedford Harbor Superfund Site
2012 Near-Shore Boring Program Adjacent to the Former Aerovox Property
740 Belleville Avenue
New Bedford, MA**

April 2013

**Prepared by
Jacobs Engineering Group
103 Sawyer Street
New Bedford, MA 02746**

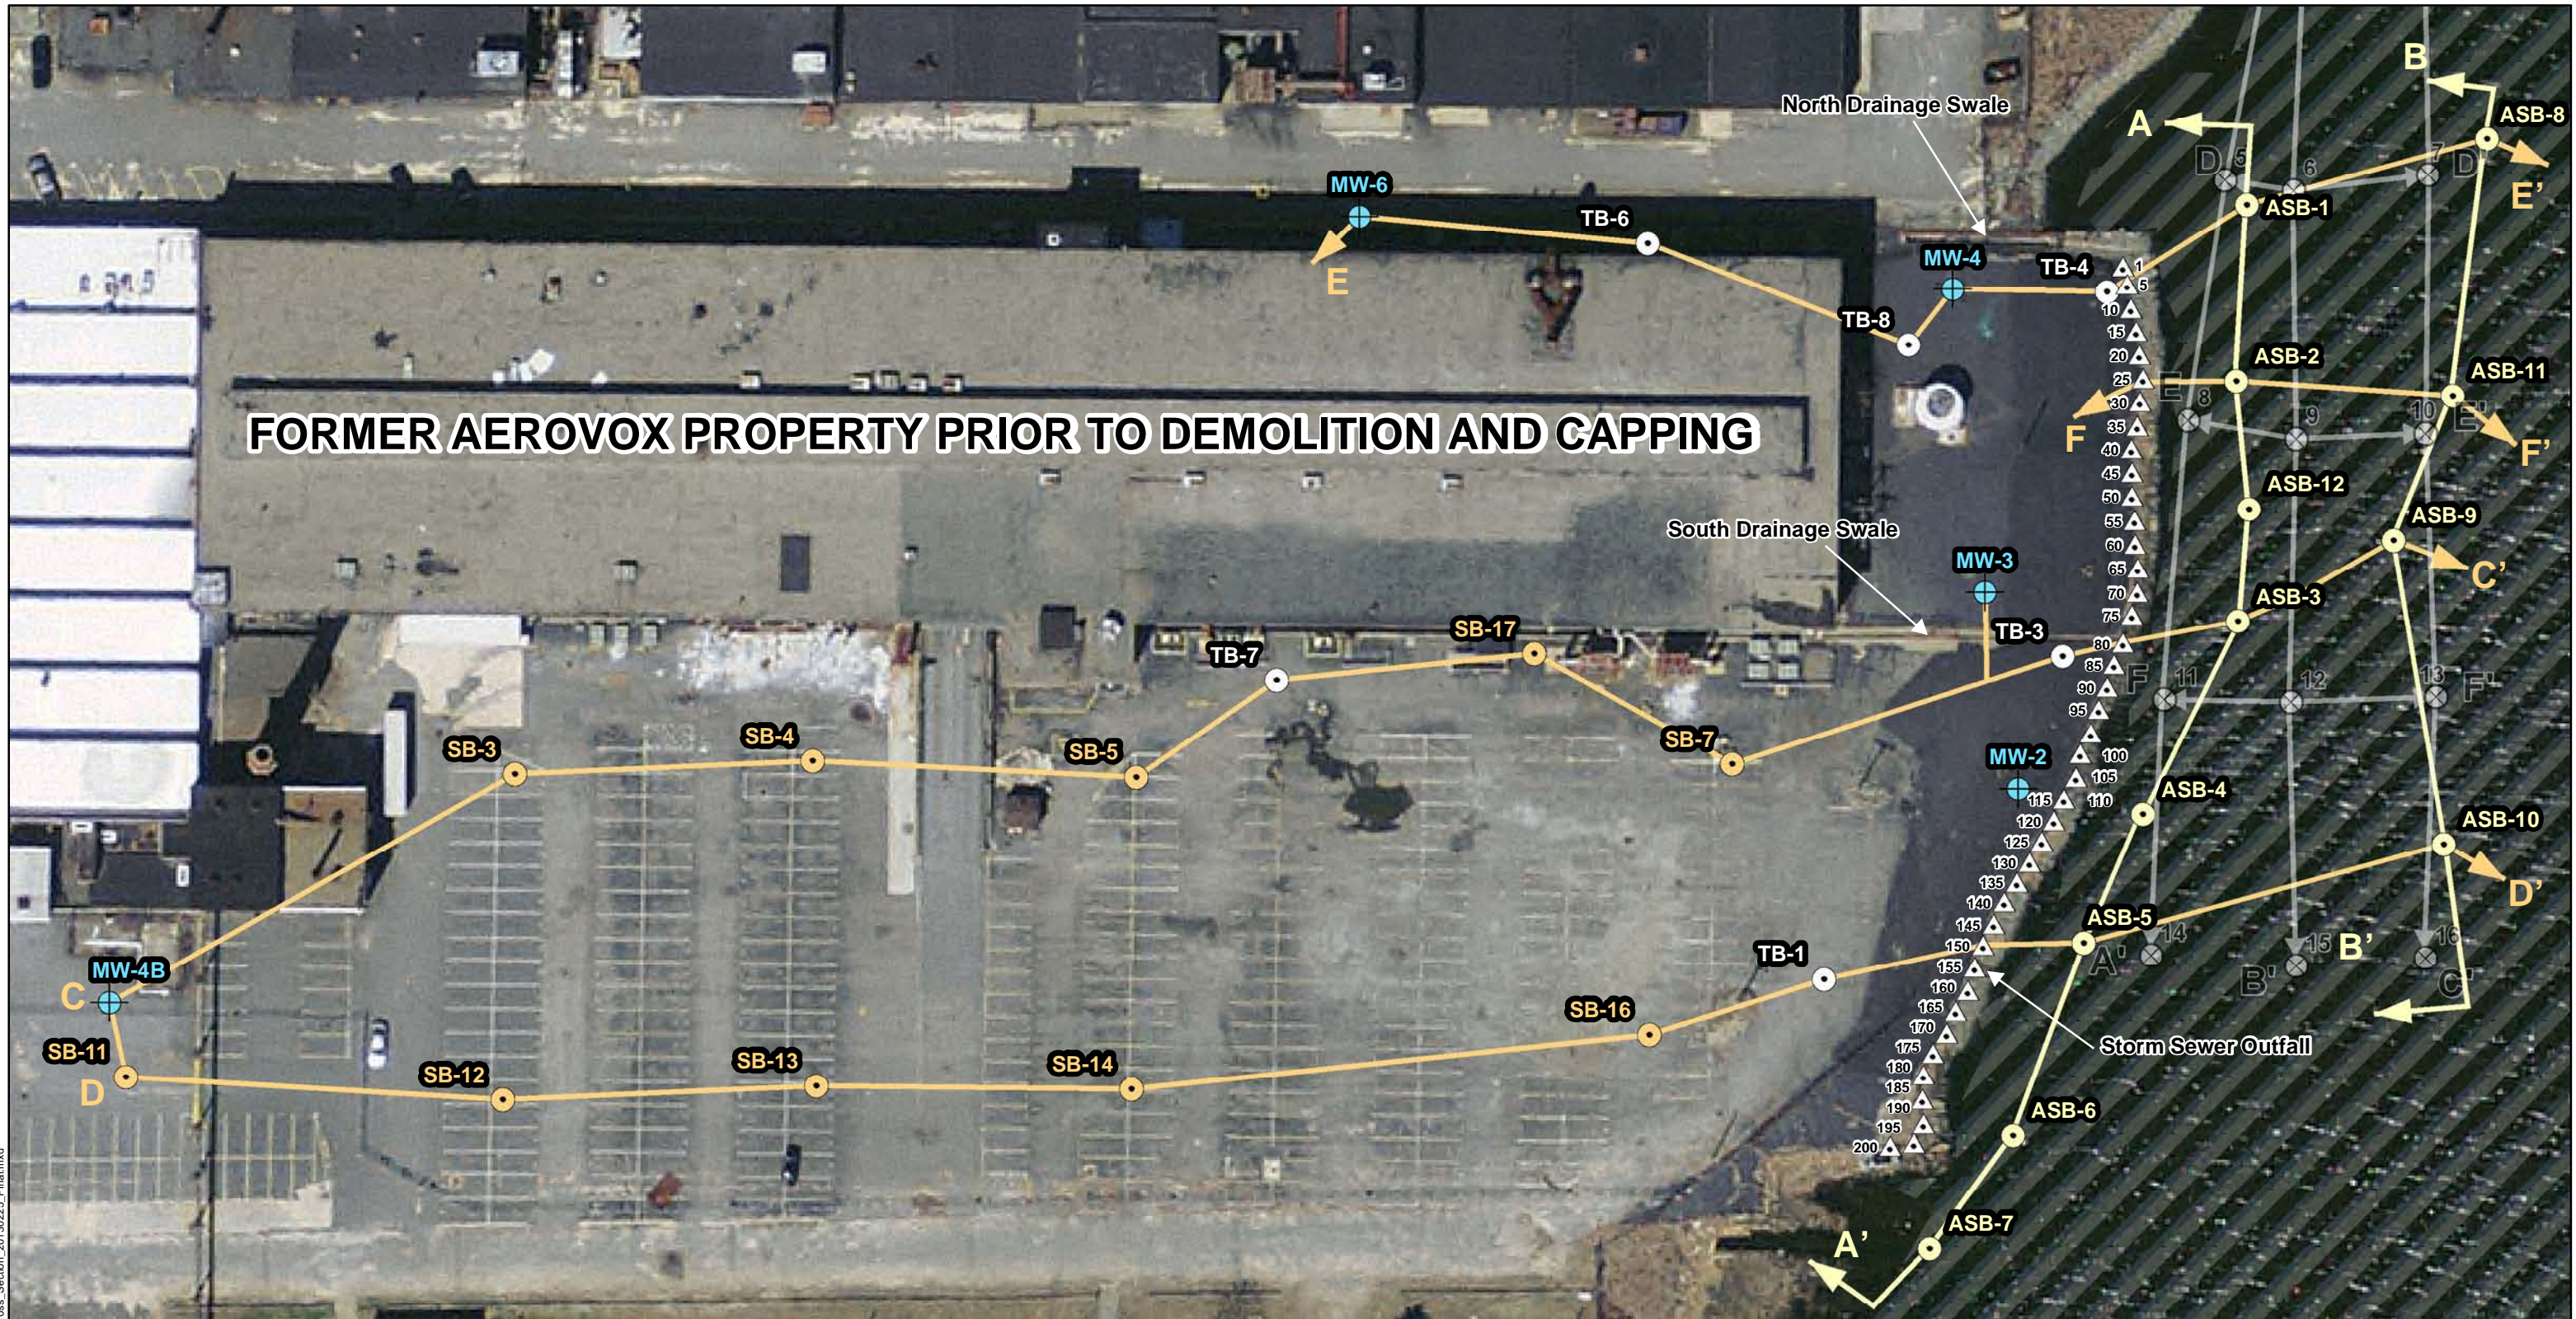
FORMER AEROVOX PROPERTY PRIOR TO DEMOLITION AND CAPPING

The highest concentrations of PCBs are found along the A-A' transect from the 2012 Aerovox shoreline investigation (WHG 2013). This cross-section is oriented north to south and parallels the shoreline with all borings located within 40 feet of the defined shoreline (Figure 2-1). Parts of this area have been previously dredged for mass removal as recently as 2008, with the exception of the southern portion (ASB-7) which was dredged in 2011. Based on comparison to 1991 elevations, up to 6 feet of material has been removed in some areas since active dredging began (Figure 2-2). The orientation of cross-section A-A' reflects a groundwater flow path that generally runs perpendicular to and into the page indicating a flow from west to east. The highest PCB concentrations are found in borings ASB-1 and ASB-3 (Figures 3-1 and 3-2). The location of the two main concentration centers (borings ASB-1 and ASB-3) align with the two drainage swales or trenches that paralleled the north and south sides of the former Aerovox building east to the harbor (Figure 2-1).
