EPA 909B-00-003
May 2001
www.epa.gov/region09

A Guide for School Administrators

Removing PCBs from Light Fixtures: Protecting Students from Hidden Dangers

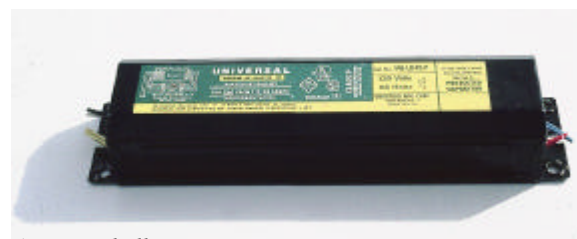
An intact ballast.

Many schools in the U.S. have light ballasts containing PCBs. The PCBs are contained within the light ballasts' capacitors and in the ballasts' potting material, which is used for insulation. Until the late 1970s, PCBs were commonly used as insulators in electrical equipment because they have high tolerance to heat, do not burn easily, and are non-explosive.

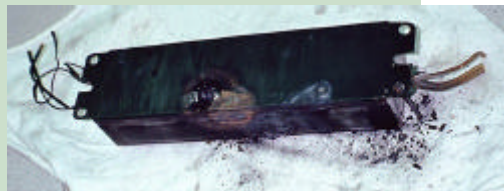
This ballast sparked a fire at a Southern California school in 1999.
