**Preliminary Assessment/Site Inspection Report  
Santa Susana Field Laboratory  
Simi Valley, California**

**EPA ID No.: CAN000908498  
USACE Contract No.: W91238-06-F-0083  
Document Control No.: 12767.063.419.1650**

**November 30, 2007**

**Prepared by:  
Weston Solutions, Inc.  
1575 Treat Blvd, Suite 212  
Walnut Creek, CA 94598**

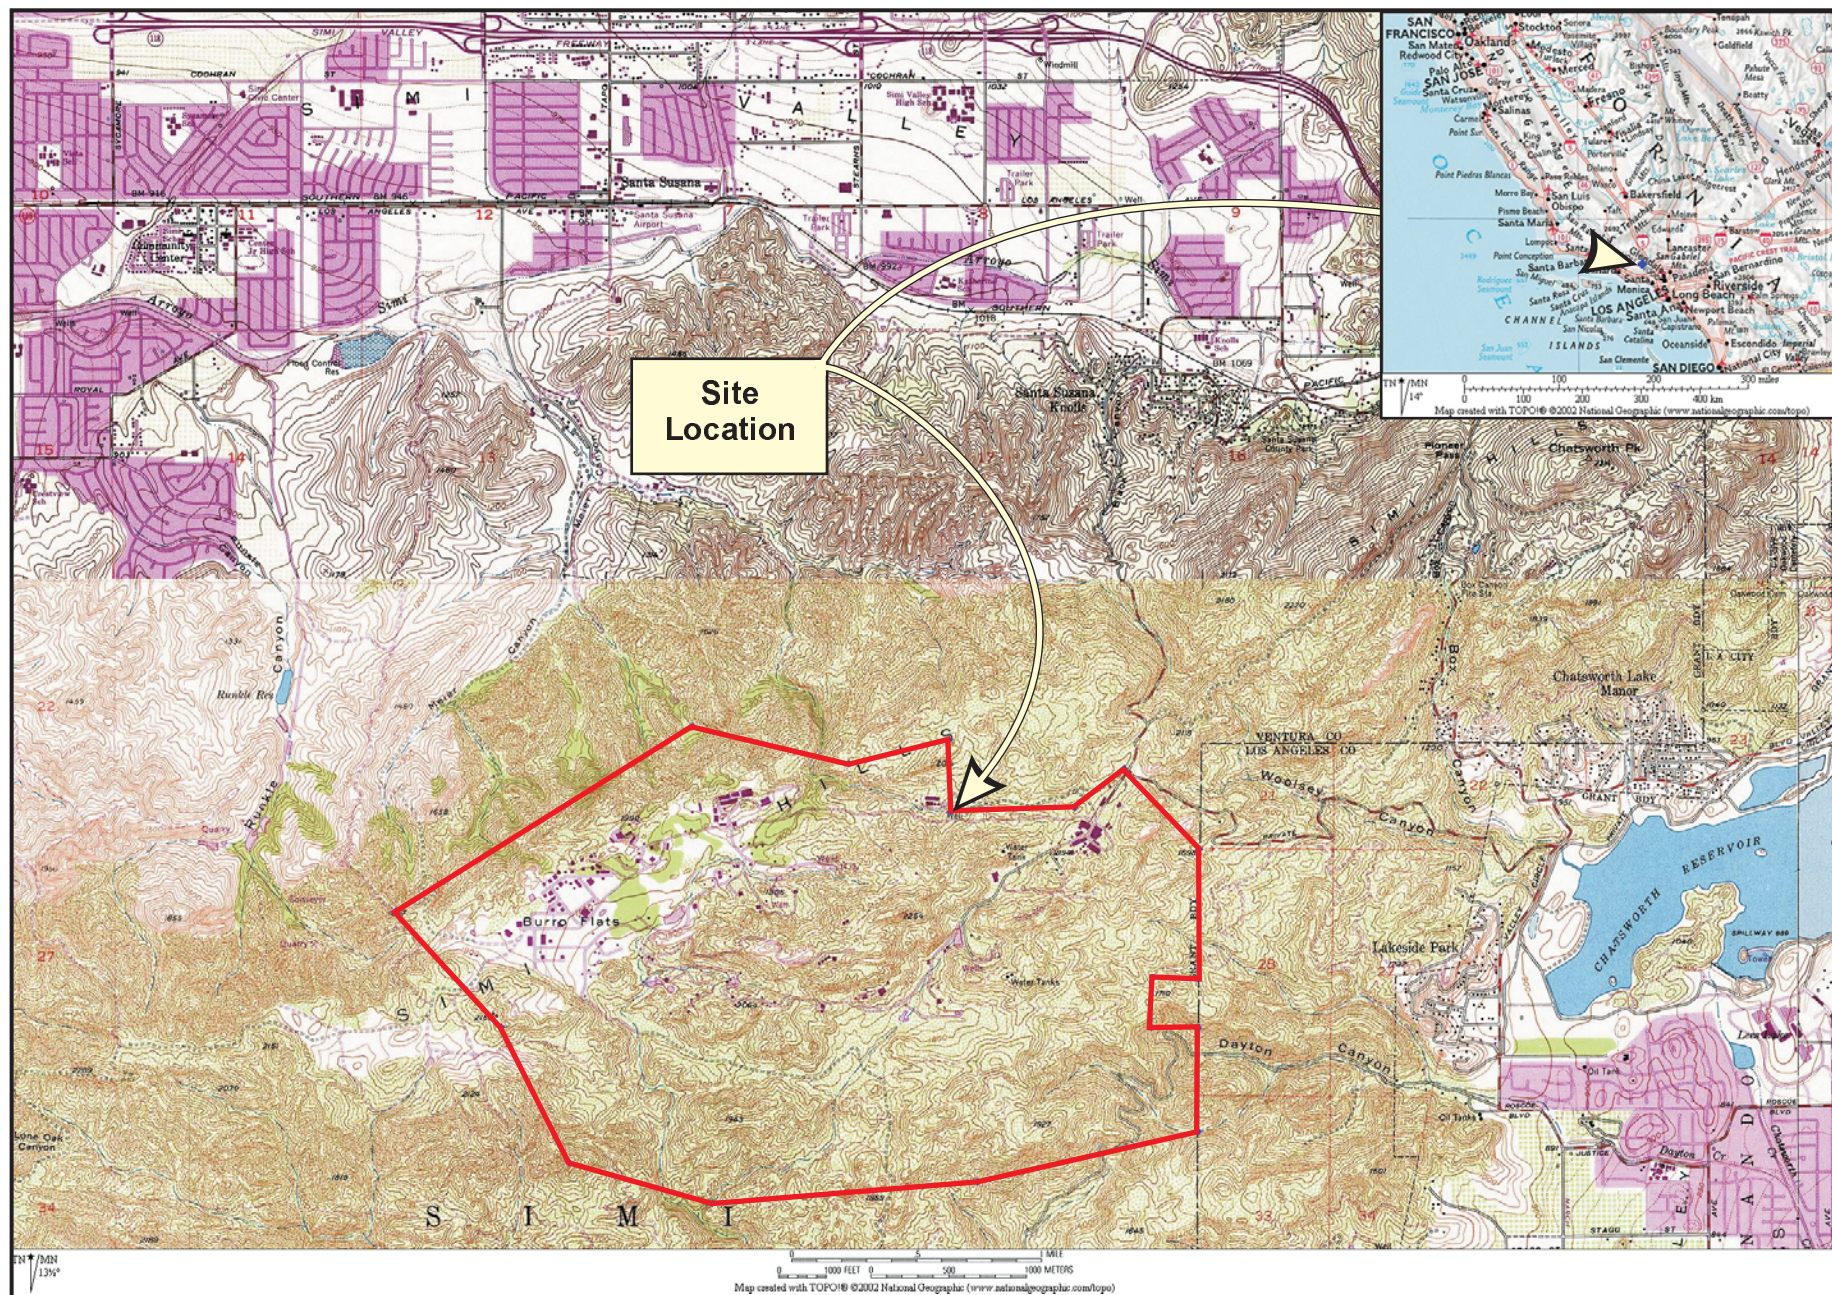
Site Location Map  
 Santa Susana Field Laboratory  
 Ventura County, California

The SSFL is located approximately 2 miles south of the City of Simi Valley and 29 miles northwest of downtown Los Angeles, California, in the southeast corner of Ventura County. The approximate geographic coordinates for the center of the site are 34° 13' 35" north latitude and 118° 41' 30" west longitude. The location of the site is shown in Figure 2-1.

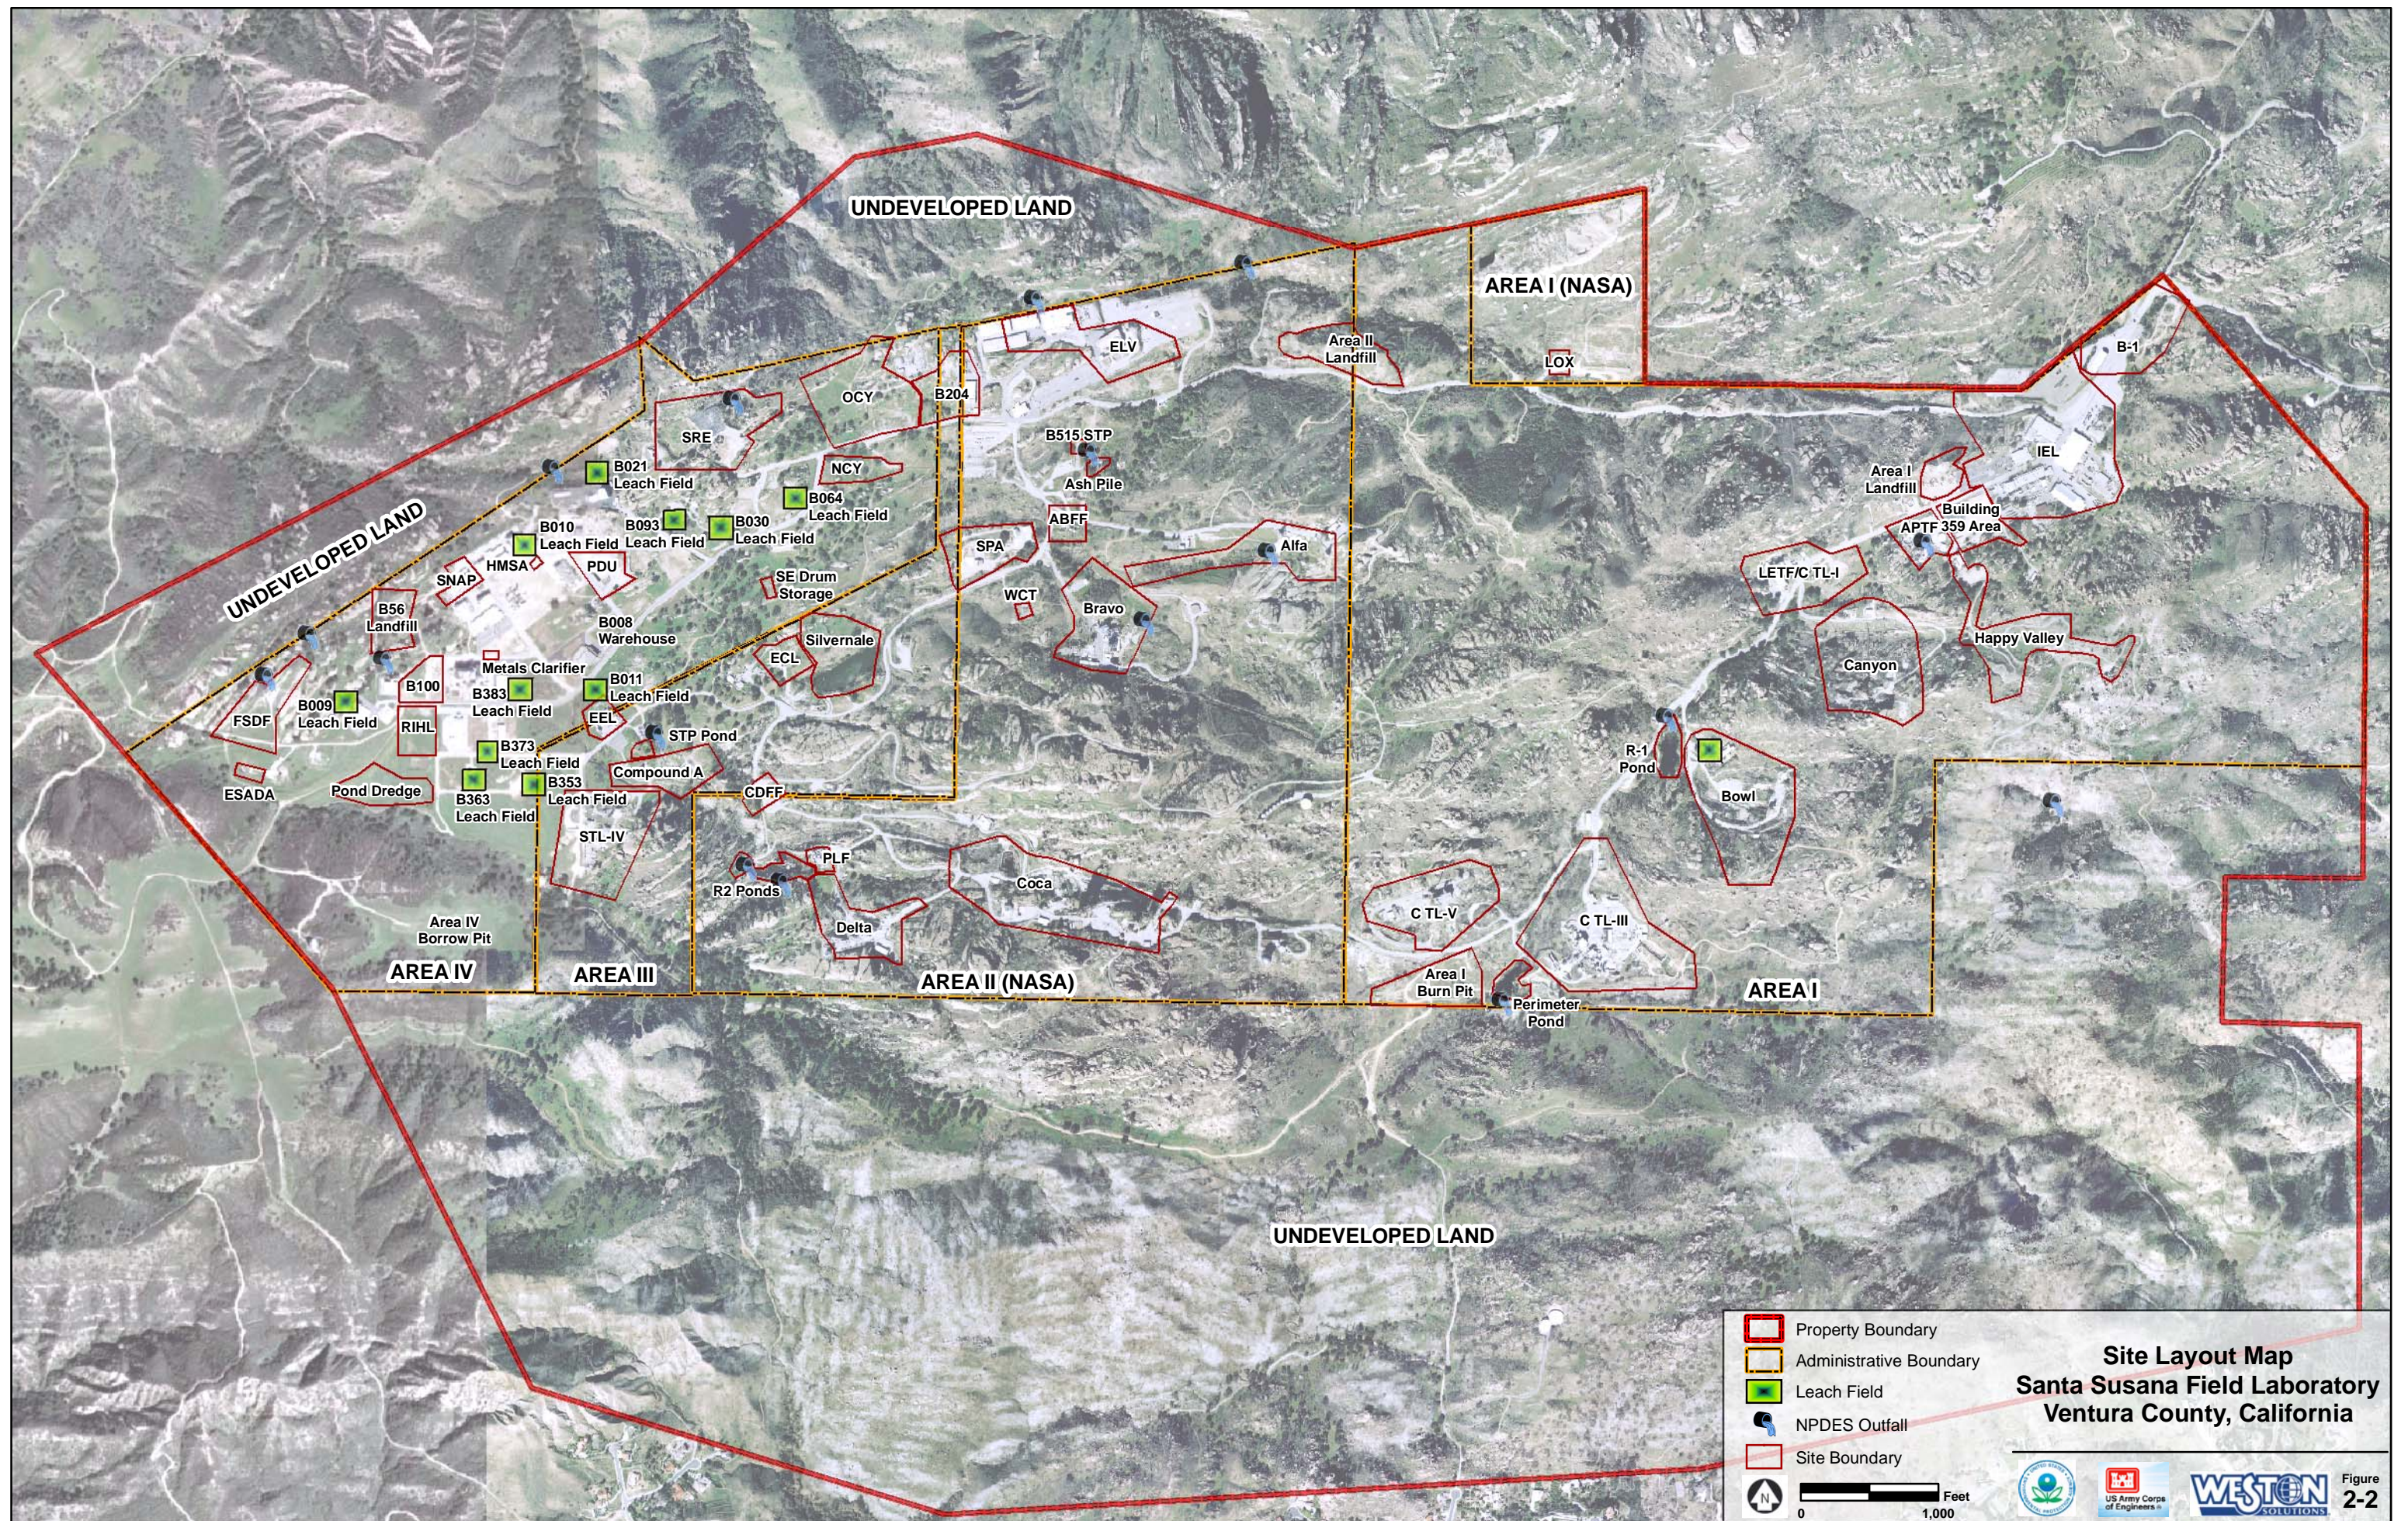
The SSFL site is divided into four administrative areas (Areas I, II, III, and IV), with undeveloped land acting as buffer zones to the northwest and south, as shown in Figure 2-2. The size, location, and current ownership of these areas are as follows:
