# **Romic Environmental Technologies Corp.**

**AZD 009015389**

Chandler, Arizona  
TSD Facility

### **Introduction and Facility Description**

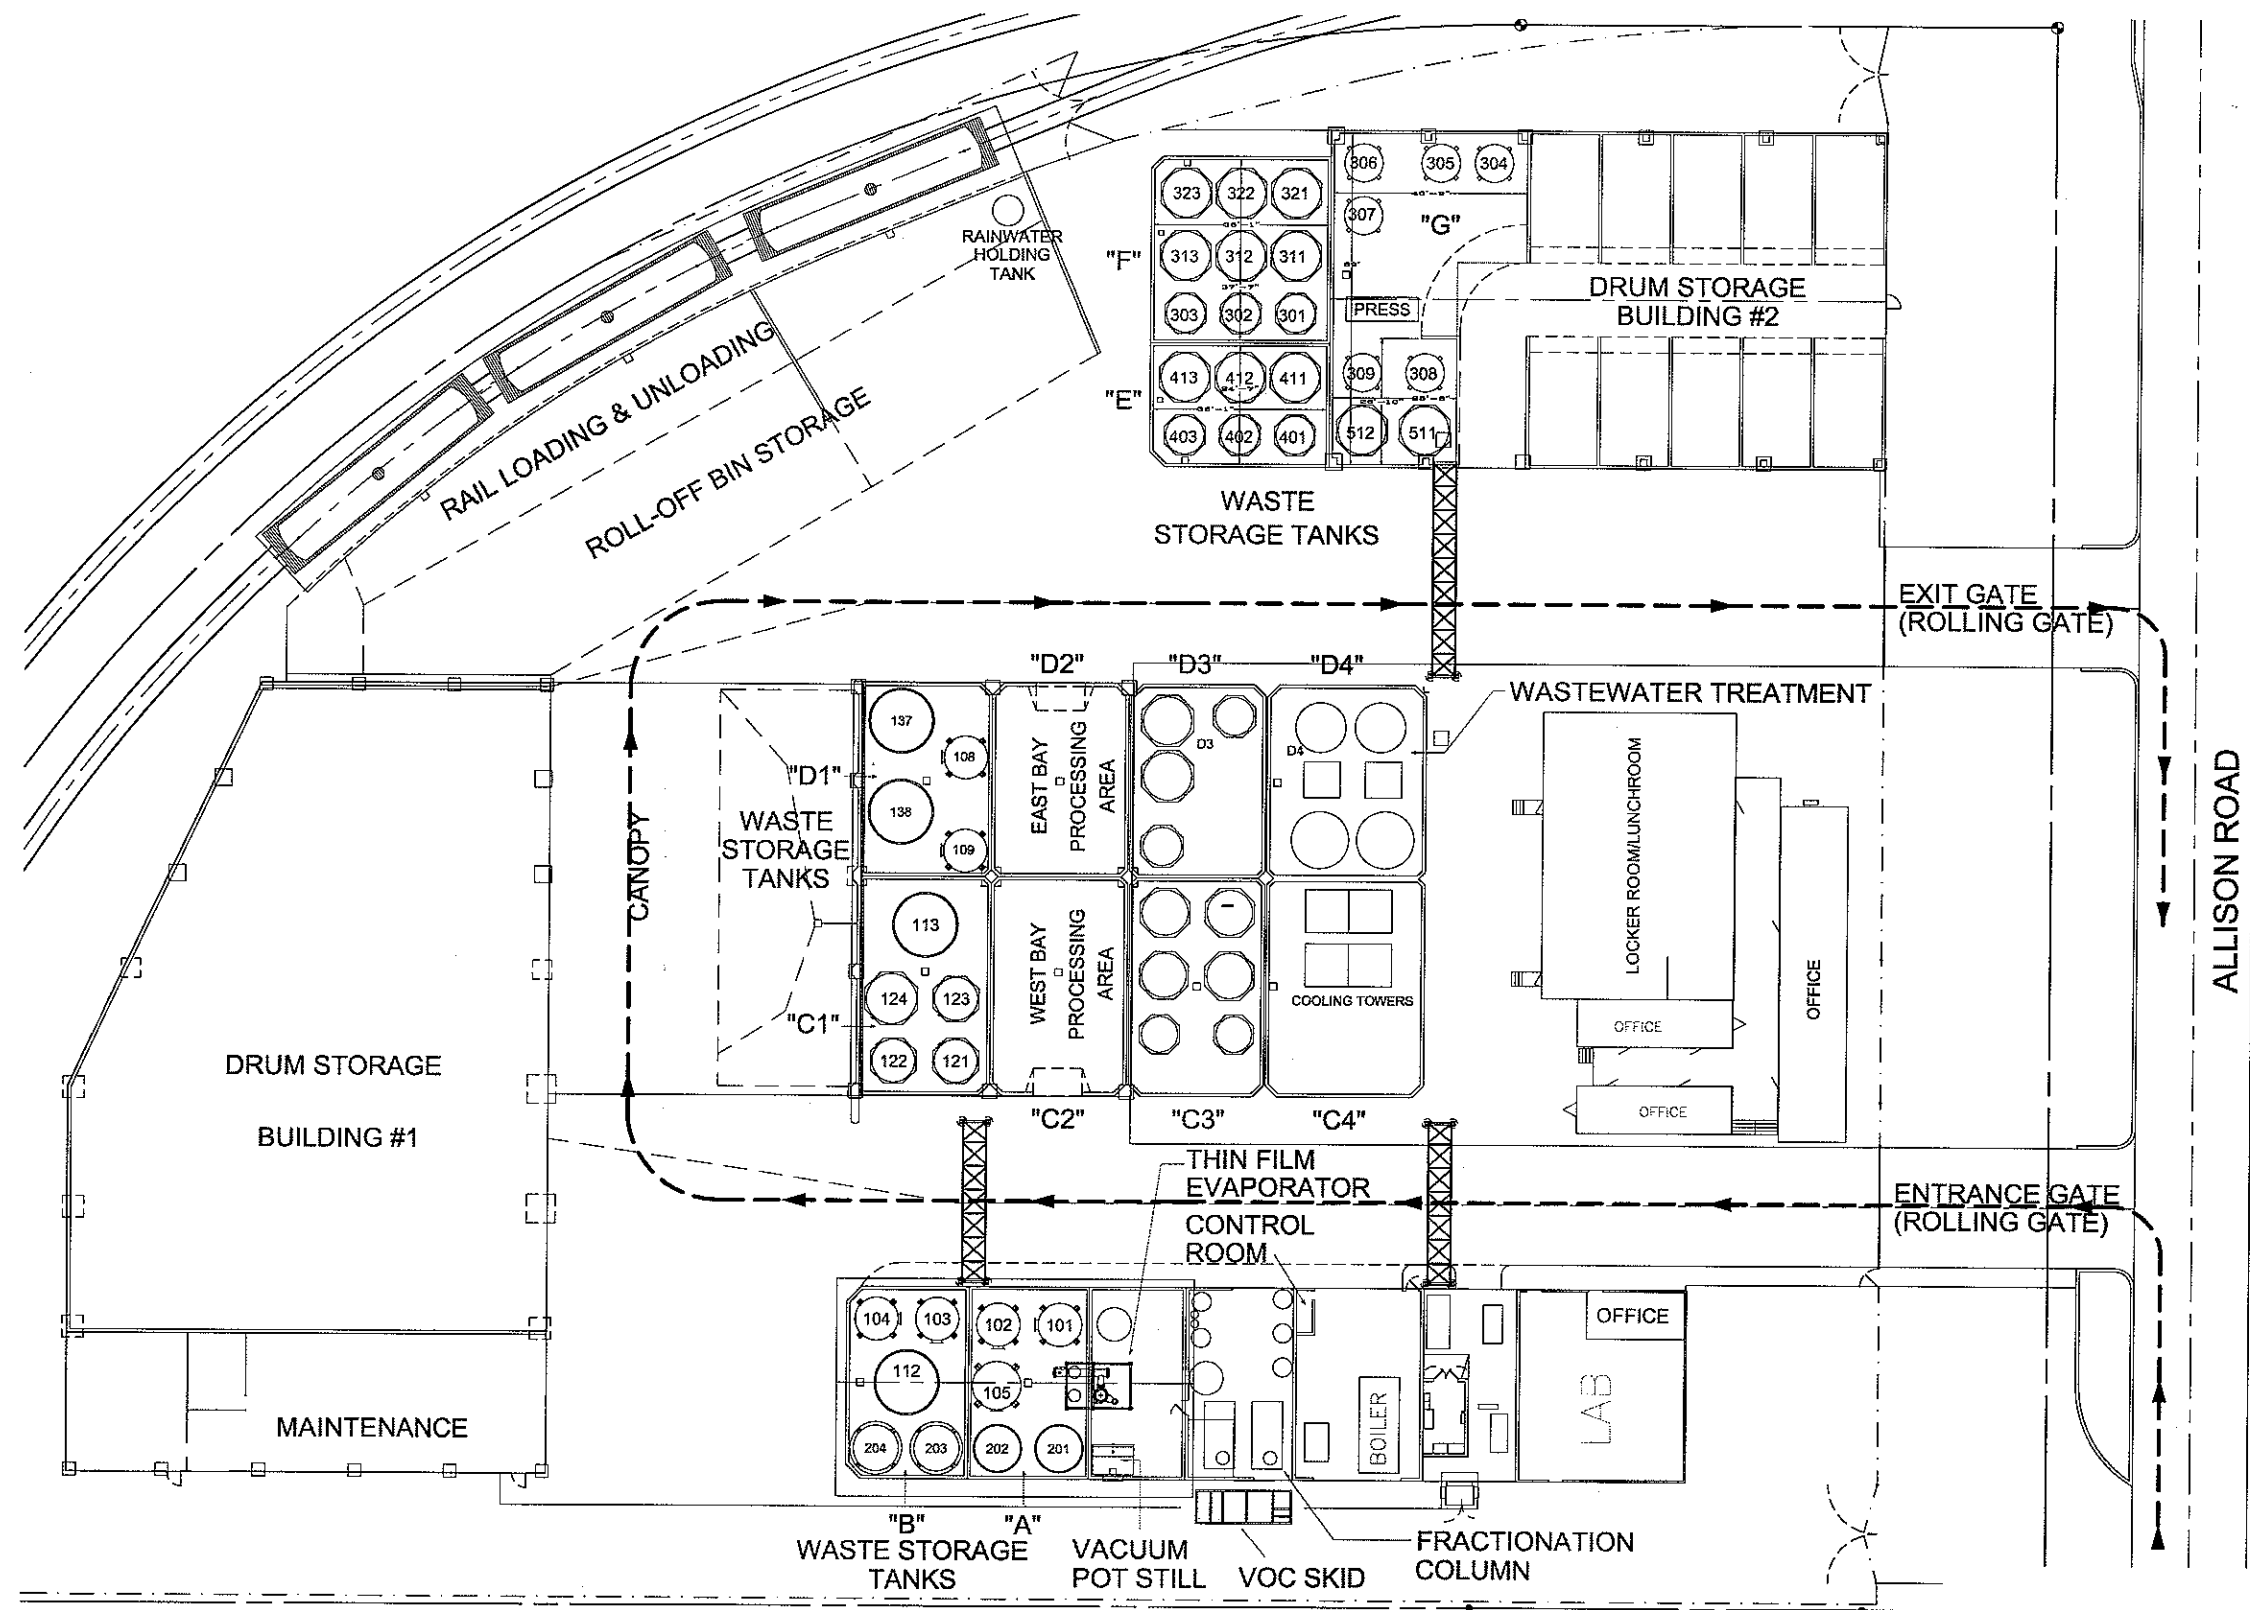
Figure B-7

**Traffic Patterns on Site**  
Romic - Southwest  
Chandler, Arizona
