**Re: May 6, 2010 Storm Water Inspection**

**NPDES MSGP STORMWATER COMPLIANCE INSPECTION**

**Report No. 2**

Facilities: Apra Harbor Naval Waterfront

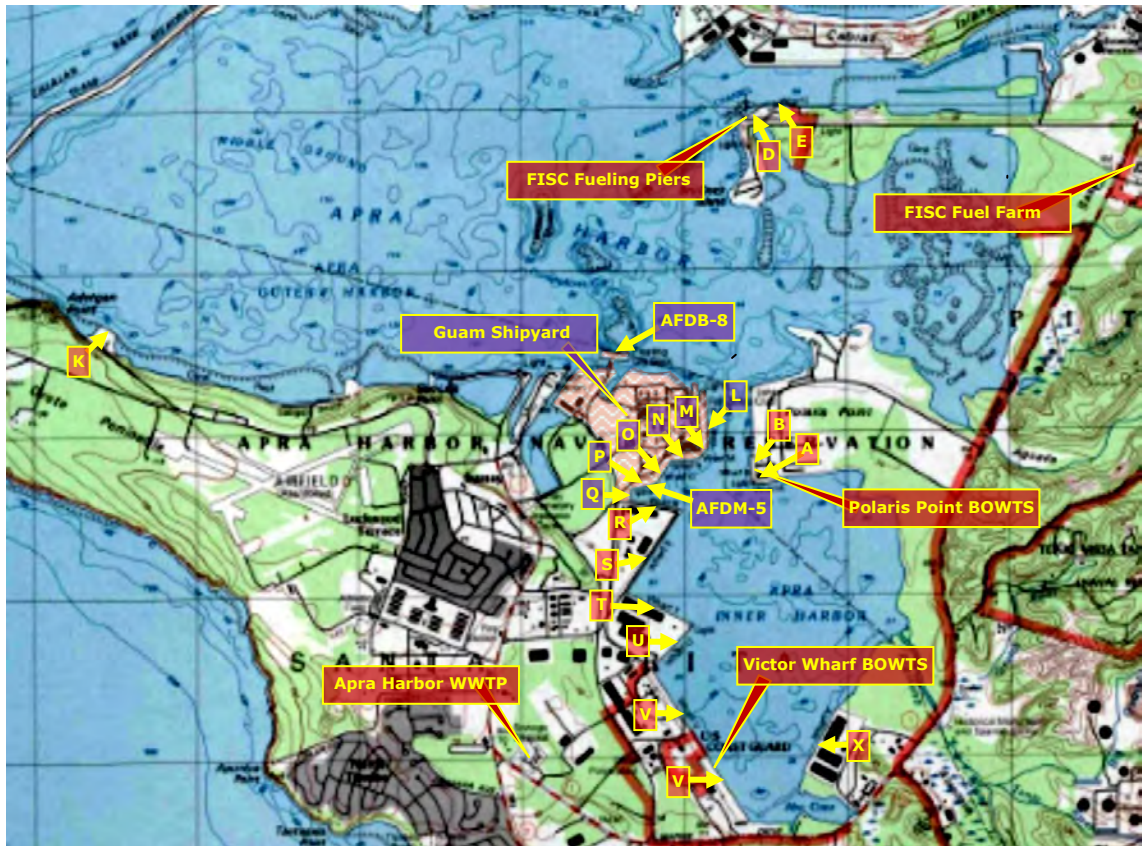
**Figure 1.3**  
Apra Harbor Naval Ports – Wharf and Pier Locations

Location - The Apra Harbor naval port operations consist of wharves and piers located at Orote Point, Polaris Point, the Fueling Depot, and the former Naval Ship Repair Facility.

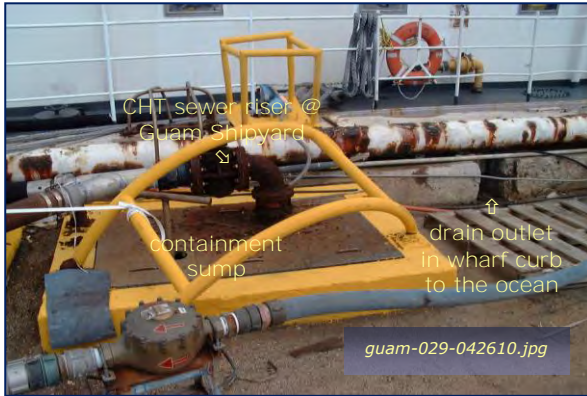
Photo #3-1: Oscar Wharf - CHT Sewer Riser  
Taken By: Greg V. Arthur  
Date: 04/26/10

Guam Shipyard – Guam Shipyard’s Pier Services Department connects and disconnects the CHT hoses on and off the shipyard sewer system risers under the lease contract with the Navy. Guam Shipyard does not have written operating procedures covering the CHT. The CHT risers operated by the Guam Shipyard included those found to be disabled (Lima), functioning in near disrepair (Oscar), and functioning in good condition (November). See Photos #3-1 and #3-2 in Section 3.4 of this report on page 15.

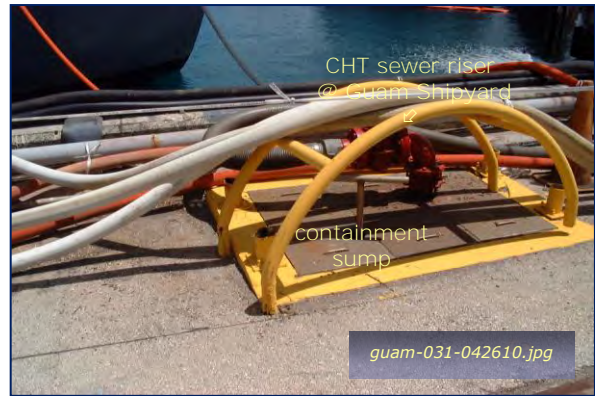
Photo #3-2: November Wharf - CHT Sewer Riser  
Taken By: Greg V. Arthur  
Date: 04/26/10

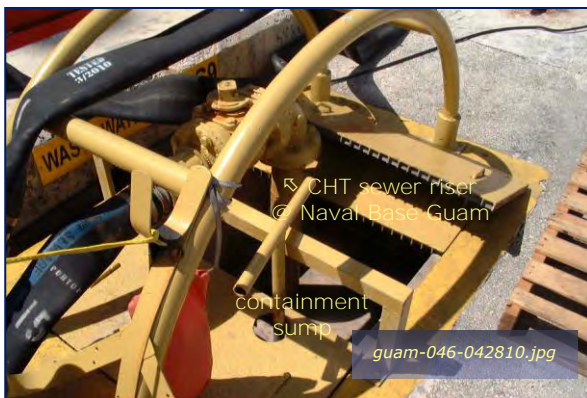
Photo #3-3: Sierra Wharf - CHT Sewer Riser  
Taken By: Greg V. Arthur  
Date: 04/28/10

Naval Base Guam – Navy Port Operations (through DZSP21, a base support contractor) connect and disconnect the CHT hoses to the Naval Base Guam sewer system risers including those for the tenants at the Victor and X-ray Wharves. DZSP21 uses Annex 0600 Instruction POP-I-0026 covering the CHT systems. Ships personnel connect, fresh water flush, and disconnect the hoses on and off the ship’s risers. The flush just before disconnection lasts for around 10 minutes at full pressure according to the NAVFAC MO-340 Ship-to-Shore Hose Handling Operations Manual. The CHT risers operated by the Naval Base Guam included those found to be disabled (Uniform), and functioning in good condition (Alpha, Bravo, Delta, Echo, Victor, Sierra, Tango). See Photos #3-3 and #3-4 in Section 3.4 of this report on page 15.

General Waterfront – Listed below are the effective storm water control measures (+) and ineffective, improvable, or missing control measures (-) observed during this inspection of the waterfront. See Photos #3-3 and #3-6 in Section 3.4 of this report on page 15.

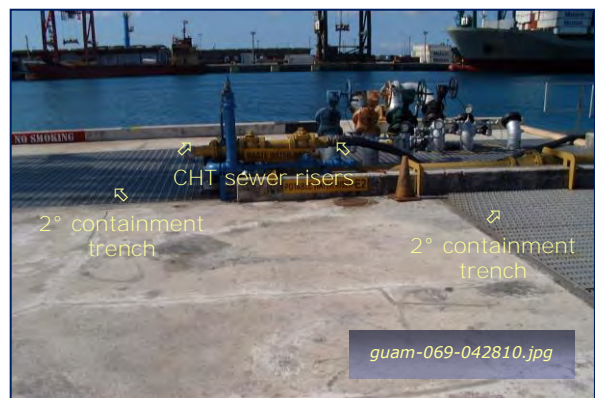
Photo #3-4: Echo Fueling Pier - CHT Sewer Riser  
Taken By: Greg V. Arthur  
Date: 04/28/10

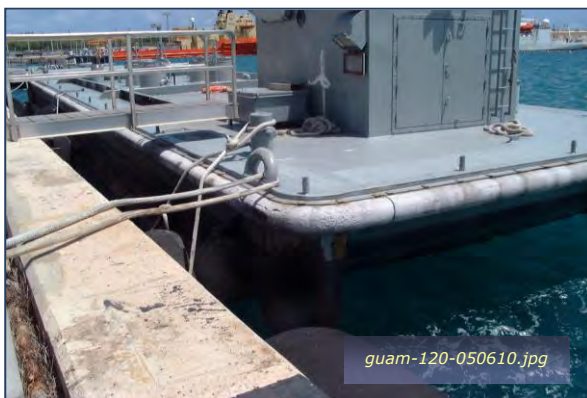
Photo #3-5: Victor Wharf - SWOB Bilge Barge  
Taken By: Greg V. Arthur  
Date: 05/06/10

Naval Base Guam, Point Orote – The Navy Port Operations (through DZSP21, a base support contractor) off-loads bilge water from most of the berthed ships to SWOB barges or tanker trucks, and suction out the barges and tankers to the Victor Wharf BOWTS under Annex 0600 Instruction POP-I-0015. The 55,000 gallon capacity SWOB barges are floated to the Victor Wharf to be pumped out through pump station risers on the wharf which feed by underground pipe into the BOWTS. Tanker trucks are pumped out by hose directly into the BOWTS. See Photos #3-5 and #3-6 in Section 3.4 of this report on page 15.

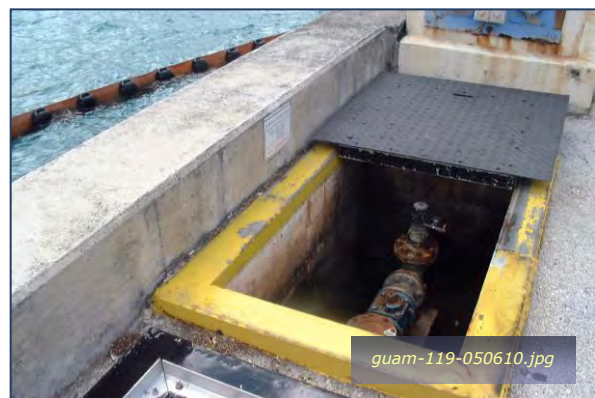
Photo #3-6: Victor Wharf - Bilge Pump Station Riser  
Taken By: Greg V. Arthur  
Date: 05/06/10

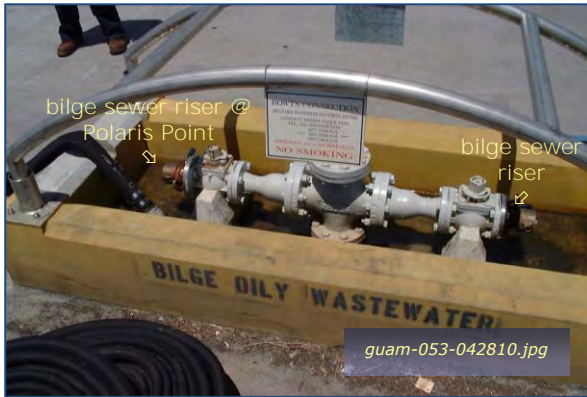
Photo #3-7: Bravo Wharf - Bilge Sewer Riser  
Taken By: Greg V. Arthur  
Date: 04/28/10

Naval Base Guam, Polaris Point – The Alpha and Bravo Wharves have parallel bilge and CHT sewers. The bilge sewers include seven riser stations that feed to the Polaris Point BOWTS. The Navy Port Operations (through DZSP21) connect and disconnect bilge hoses to the waterfront bilge risers. See Photo #3-7 in Section 3.4 of this report on page 16.

Polaris Point – Submarines were observed at berth during the April 28th inspection of the Polaris Point BOWTS, but all had departed by the May 6th inspection of the waterfront. As a result, there were no waterfront activities observed during this inspection and thus no control measures were needed or deployed. See Photos #3-7, #3-13 in Section 3.4 of this report on pages 16 and 17.

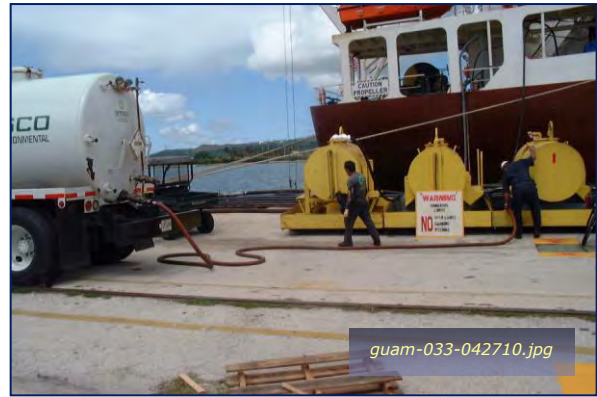
Photo #3-8: Lima Wharf - Bilge to Holding to Tanker  
Taken By: Greg V. Arthur  
Date: 04/27/10

Guam Shipyard, Papa Wharf – The Guam Shipyard’s Pier Services Department off-loads bilge from berthed or dry docked ships to truck tankers or on-shore tanks for delivery either to the Papa Wharf oil water separator or to off-site disposal by Gresco or Unitek. The Guam Shipyard SWPPP has specific BMPs for the waterfront. See Photos #3-8 and #3-9 in Section 3.4 of this report on page 16.

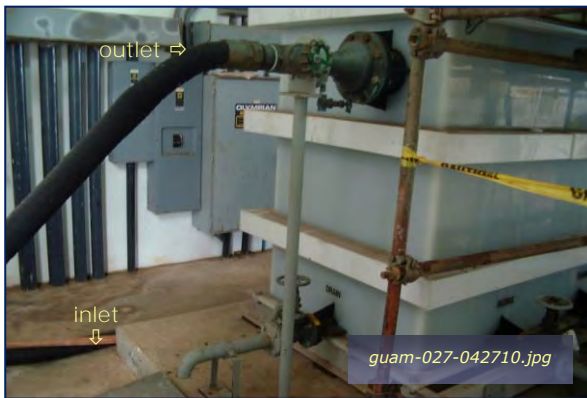
Photo #3-9: Papa Wharf - Bilge Oily Water Separator  
Taken By: Greg V. Arthur  
Date: 04/27/10

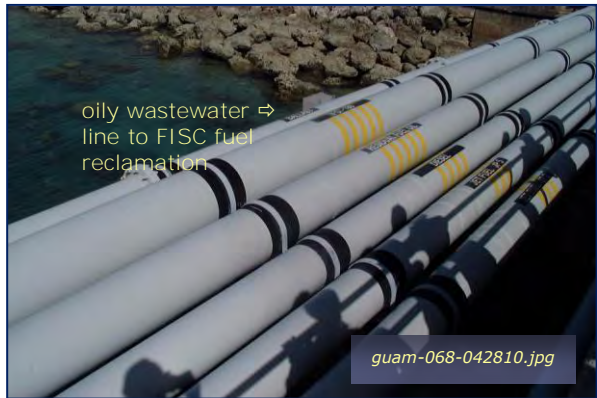
Photo #3-10: Fueling Piers - Bilge and Ballast Line  
Taken By: Greg V. Arthur  
Date: 04/28/10

Naval Base Guam, Fueling Piers – The FISC fueling piers are constructed with containment pits built into the piers and located beneath the pumps and valving used in the off- and on-loading of fuel to and from ships at berth. Drainages, captured contamination, and off-loaded bilge all are conveyed by the dedicated „ballast’ pipeline to the fuel reclamation system. The Navy Port Operations have a specific SWPPP covering the operation of the fueling piers including the handling of bilge waters and drainages, and the deployment of booming. See Photo #3-10 in Section 3.4 of this report on page 16.

Fueling Piers – There were no fueling operations observed during the April 28th inspection of the fueling piers, fuel farm, and fuel reclamation unit. Nevertheless, a number of effective control measures were observed in-place and in operation. See Photos #3-4, #3-10, #3-12, and #3-14 in Section 3.4 of this report on pages 15, 16, and 17.

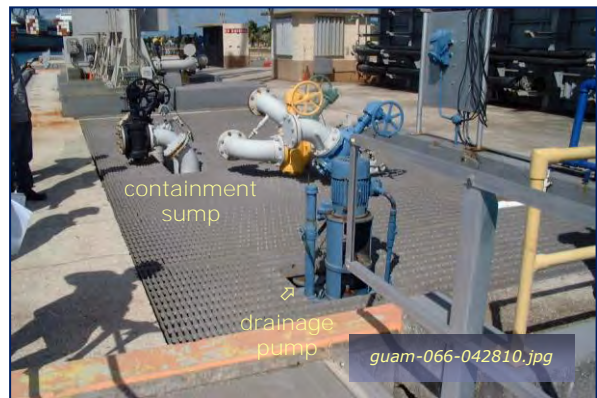
Photo #3-12: Delta Fueling Pier - Containment Sumps  
Taken By: Greg V. Arthur  
Date: 04/28/10

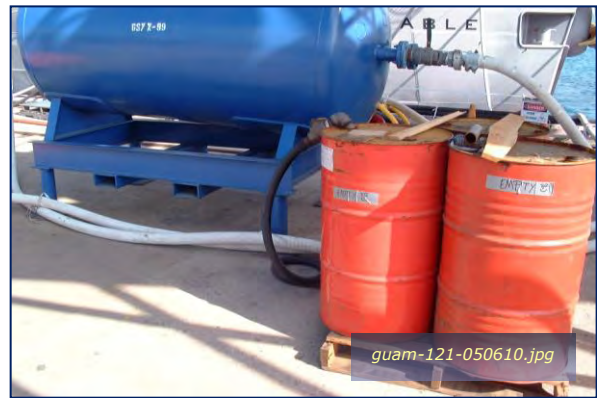
*Photo #3-16: November Wharf – Condensate Capture  
Taken By: Greg V. Arthur  
Date: 05/06/10*

Shipyard Control Measures - The Guam Shipyard waterfront qualifies for MSGP regulation under Sector R for Ship and Boat Building and Repair. There were ships berthed at the Lima, Mike, November, and Oscar Wharves, and a floating dry dock at the Papa Wharf. Listed below are the effective storm water control measures (+) and ineffective, improvable, or missing control measures (-) observed during this inspection of the water-front. See Photos #3-11, #3-15, #3-16, #3-17 and #3-18 in Section 3.4 of this report on pages 16 and 17.

- + Air compressor condensate is drained from the lines and collected to drums.
- + Portable bilge oily water storage tanks were deployed within secondary containment.
- Guam Shipyard does not have written operating procedures covering the CHT.
- Not all CHT ships sanitary risers were found in good condition.
- + Drain lines from the CHT riser boxes are closed when the CHT risers are in use.
- Piers scupper are not sandbagged during the transfer of bilge to tankers, or during CHT ships sanitary riser use.
- Observed fire pump and fresh water line leaks can carry contamination into the harbor through the storm water drains.

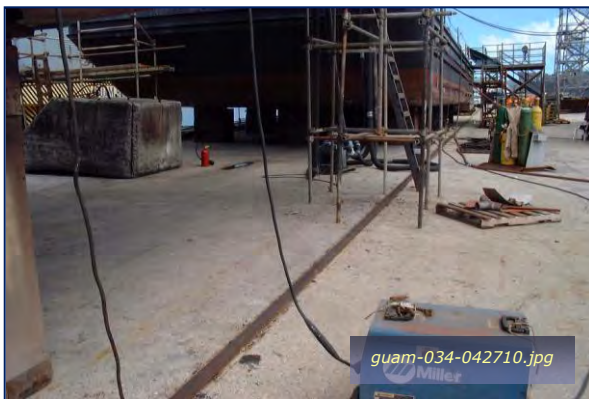
*Photo #3-17: Lima Wharf – Swept Outside Rails  
Taken By: Greg V. Arthur  
Date: 04/27/10*

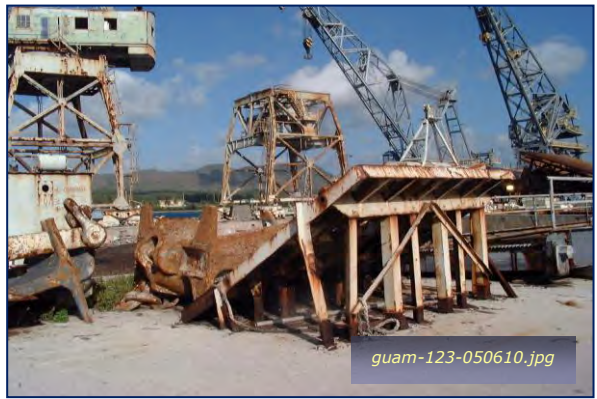
*Photo #3-18: Finger Pier – Scrapyard  
Taken By: Greg V. Arthur  
Date: 05/06/10*

- + The SWPPP is detailed, up to date, with the control measures well understood, and the procedures clearly described.
- + Inland storm drains are covered during ship building and repair activities.
- + Storm water drain inlets have stenciled information signs.
- + Walk-throughs are performed weekly to identify the need to deploy control measures.
- + Debris on the waterfront is swept weekly to the center point between the crane rails.
- + Spill containment kits were deployed and ready for use.
- + No oily debris, oil staining, or oil sheen on the water was observed.
- Debris haul-off is on a weekly schedule but rusty debris was found on the wharves.
- Piers scupper are not sandbagged during ship repair activities.
- Recyclable materials have remained staged for off-hauling and thus exposed to storm water contact for long periods of time.
