# Assessment Report on Tetra Tech's Support of California's Industrial Stormwater Program

Produced for:  
U.S. EPA Region IX

Produced by:  
Tetra Tech, Inc.  
[www.ttwater.com](http://www.ttwater.com)

July 12, 2006

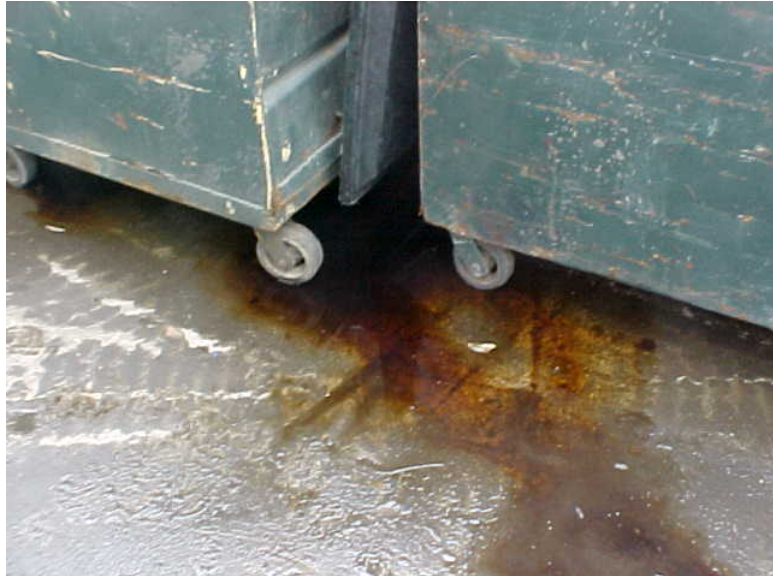
Implementation of stormwater BMPs is critical to maintaining the quality of stormwater at the facility boundary or discharge point. BMPs are either structural or nonstructural; Tetra Tech did not collect quantitative data regarding implementation of structural versus nonstructural BMPs.

Anecdotal information suggests that facilities rely on nonstructural BMPs

(e.g., good housekeeping, spill cleanup) until it becomes clear (through an inspection, for example) that benchmark values cannot be attained without the implementing structural BMPs. In addition, structural BMP implementation appears to be positively correlated with facility size and market capitalization.

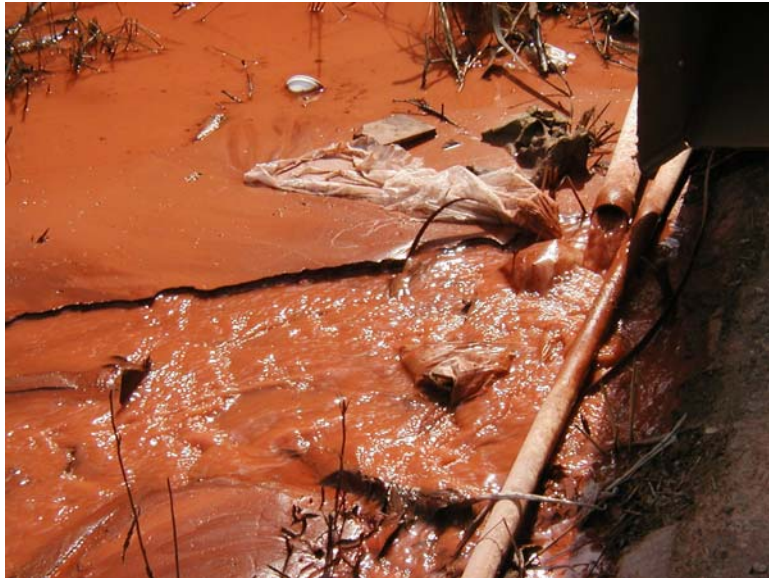
Detailed data analysis is not presented for observed unauthorized non-stormwater discharges. The inspectors observed 158 facilities with unauthorized non-stormwater discharges, fewer than 10 percent of the facilities inspected. In these cases, the facilities were directed to “cease and desist” and the Water Board was immediately notified.

Of these 158 facilities, 1 facility in the Los Angeles Water Board was assessed the largest financial penalty associated with a Tetra Tech industrial stormwater inspection. Cemex Construction Materials, L.P., was assessed a penalty of \$86,500 for unauthorized non-stormwater discharge (Complaint No. R4-2004-0068); however, the calculated potential maximum penalty was \$4,360,000 based on the number of days between the NOI

submittal and the date the illicit drain was sealed (436 days x \$10,000 per day).<sup>7</sup> Tetra Tech employee Steve Hruby conducted the initial inspection on December 18, 2003, and Jonathon Bishop (Interim Executive Director) signed the complaint on July 2, 2004.

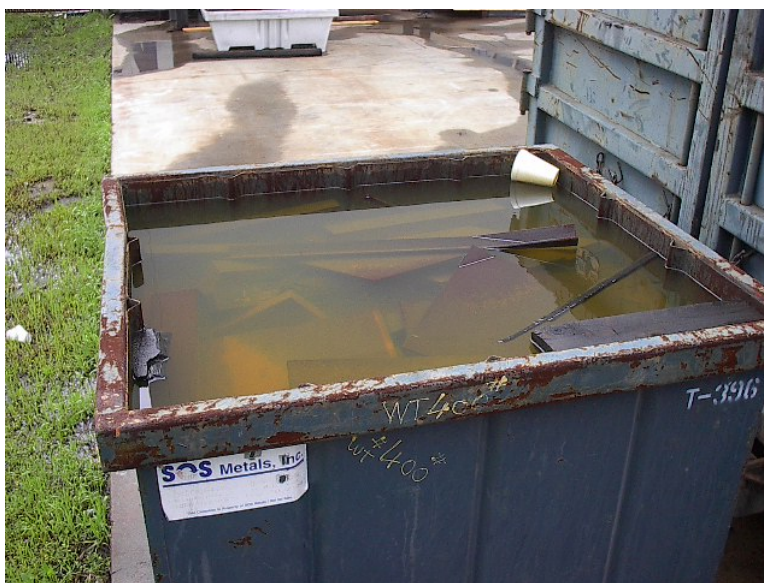
At the request of the Los Angeles Water Board, Tetra Tech and Water Board inspectors evaluated BMPs frequently implemented for stormwater control at motor freight transportation facilities (SIC code 42XX – Motor Freight Transportation and Warehousing). The inspections occurred during the week of February 21, 2005, immediately following a heavy storm cycle that raised the rainfall total for the season in downtown Los Angeles to 33.9 inches. Inspections were done in accordance with standard industrial inspections, with the exception of having a focus on the effectiveness of

particular BMPs common to the trucking industry. BMP analysis was based on visual inspection; historical stormwater sampling data were not evaluated.
