Airborne Thermal Infrared Remote Sensing Eel River, CA

Survey Date: August 11-12 2005
Draft Report Date: October 15, 2005

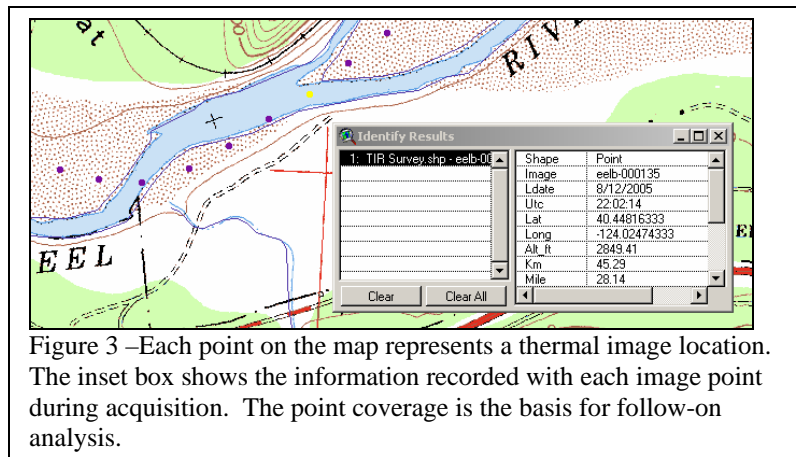
Geo-referencing: The images are tagged with a GPS position at the time they are acquired. Since the TIR camera is maintained at vertical down-look angles, the geographic coordinates provide an accurate index to the location of the image scene. In order to provide further spatial reference, the TIR images were assigned a river mile based on a routed stream layer (Figure 3).

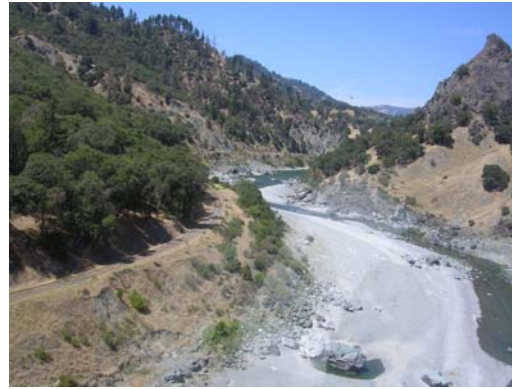
Weather conditions were considered ideal with clear skies, air temperatures in the mid 90's (°F), low humidity, and calm winds.

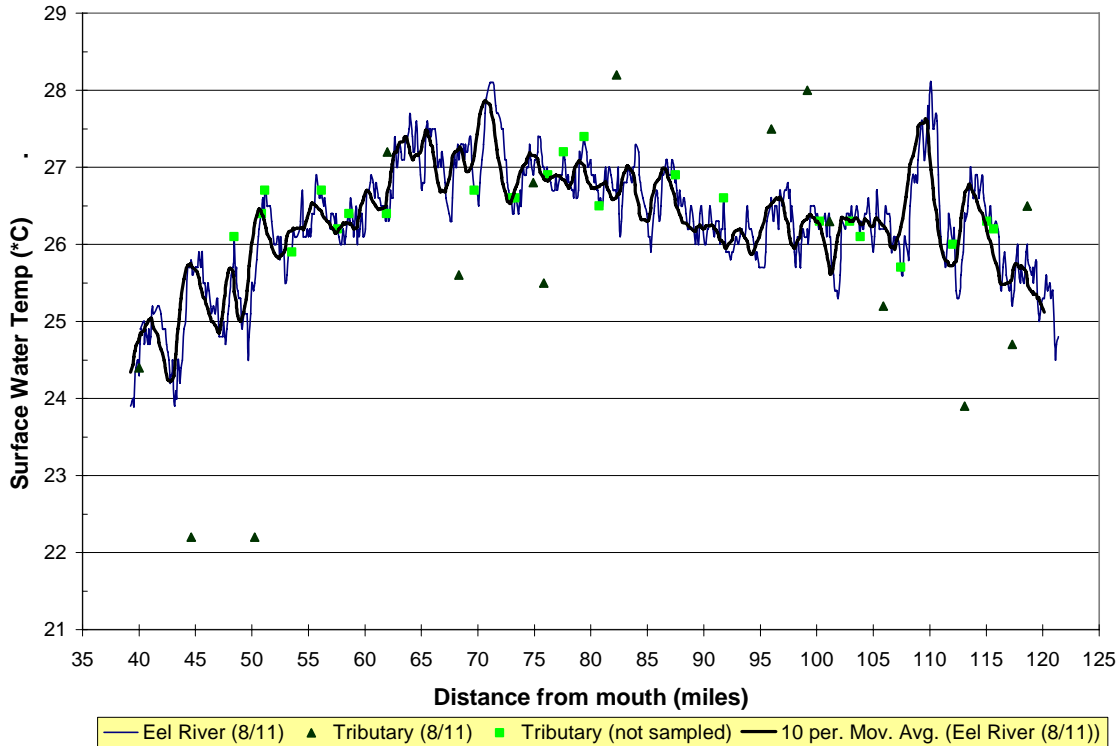
Figure 7 - Longitudinal profile with both sampled and detected (not sampled) tributaries along Middle Main Eel River. The plot also shows a moving average trend line derived from the sampled data.

Radiant water temperatures in the Middle Main Eel River ranged from 23.9°C to 28.2°C over the 82-mile survey extent (Figure 7). A total of 15 tributaries were sampled during the analysis, of which 7 contributed cooler water to the main stem. A number of other tributaries were detected, but were too small (*relative to pixel size*) to obtain an accurate temperature sample. In some cases, surface flow was detected within the tributary channel, but disappeared in the alluvial floodplain prior to reaching the active channel.

Inspection of the longitudinal profile shows two prominent spikes between miles 110.8-108.3 and miles 72.2-70.5 where radiant temperatures reached maximums of greater than 28°C. Inspection of the TIR imagery did not show any evidence of thermal stratification or other artifacts of remote sensing that would account for these gains. Such rapid longitudinal heating is often observed in smaller streams where surface flow is lost (*e.g. withdrawal or to the sub-surface*) or in the absence of a buffering source (*e.g. hyporheic discharge*). Review of the imagery between river mile 110.8 and 108.3 shows small seeps along a gravel bar (mile 110.3) and cooler water from a side channel at mile 109.7. The spatial temperature pattern at these locations suggest that surface flow is lost, resulting in a lower surface flow volume and increased downstream heating followed by discharge back into the channel and subsequent cooling.

In order to highlight reach scale patterns, a trend line (10-sample moving average) was generated from the sample points (Figure 7). The trend line shows that in addition to the local variability, general temperature patterns were also observed in the Middle Main Eel River. At the upstream end of the survey near Dos Rios, water temperatures were ~25.0°C and showed a general warming trend, reaching ~27.4°C at mile 62.7. Moving downstream, water temperatures exhibited a general cooling trend reaching ~24.3°C at the South Fork confluence. The reason for this cooling trend was not directly apparent from the imagery. However, this trend has been observed on other coastal streams in Northern California (*Redwood Creek, Mattole River*). The trend is presumably due to morning fog and generally cooler air temperatures as the river moves closer to the coast.
