**U.S. Environmental Protection Agency  
Region IX**

**Van Duzen River and Yager Creek  
Total Maximum Daily Load  
for Sediment**

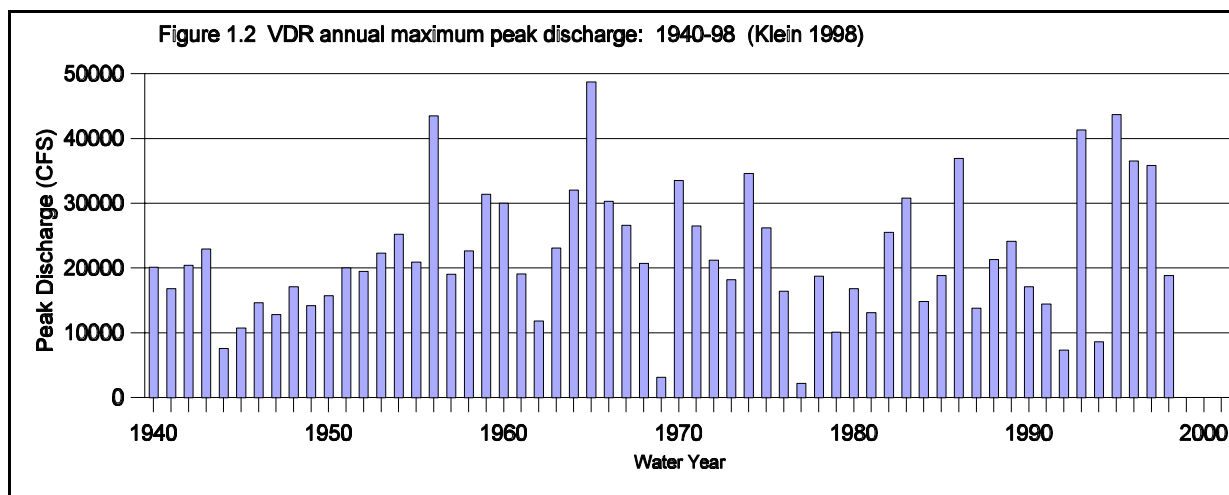
The quantity and duration of rainfall during storm events is a major factor influencing geomorphic processes in the VDR. The VDR basin receives 50-100 inches of precipitation annually, which occurs almost entirely from October through April, including a small fraction of snowfall. Between two and six intense rainstorms typically occur each winter. Summer fog provides cooler temperatures in the lower basin while the middle and upper basins are drier and warmer during the summer months. High magnitude, infrequent storms cause widespread flooding and modification of channel characteristics in the VDR. Multiple layers of roots on old redwood trees growing in floodplains are evidence of silt deposition due to prehistoric flooding (Stone and Vasey 1968). Floods in 1861, 1955 and 1964 are considered the largest floods of record in the Van Duzen (Kelsey 1977). Figure 1.2 illustrates the wide variability in the annual maximum peak discharge in water years from 1940 through 1998.

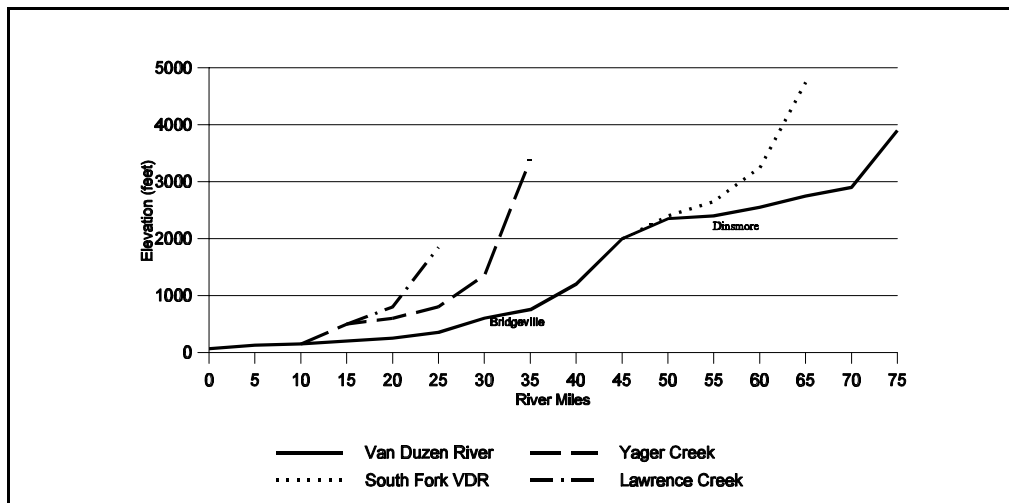
Figure 1.3 Longitudinal profile of VDR (adapted from Kelsey and Allwardt 1975).

The VDR's sediment transport mechanisms encompass a range of channel types including: 1) depositional reaches (strongly alluvial, low gradient, low confinement, able to meander relatively freely); 2) transport reaches (weakly or non-alluvial, steeper gradient, more confined, coarse textured sediments); and 3) source reaches (steep headwater swales). A longitudinal profile of the VDR adapted from Kelsey and Allwardt (1975) illustrates the changes in gradient from the lower floodplains to upper Yager Creek and VDR (Figure 1.3).

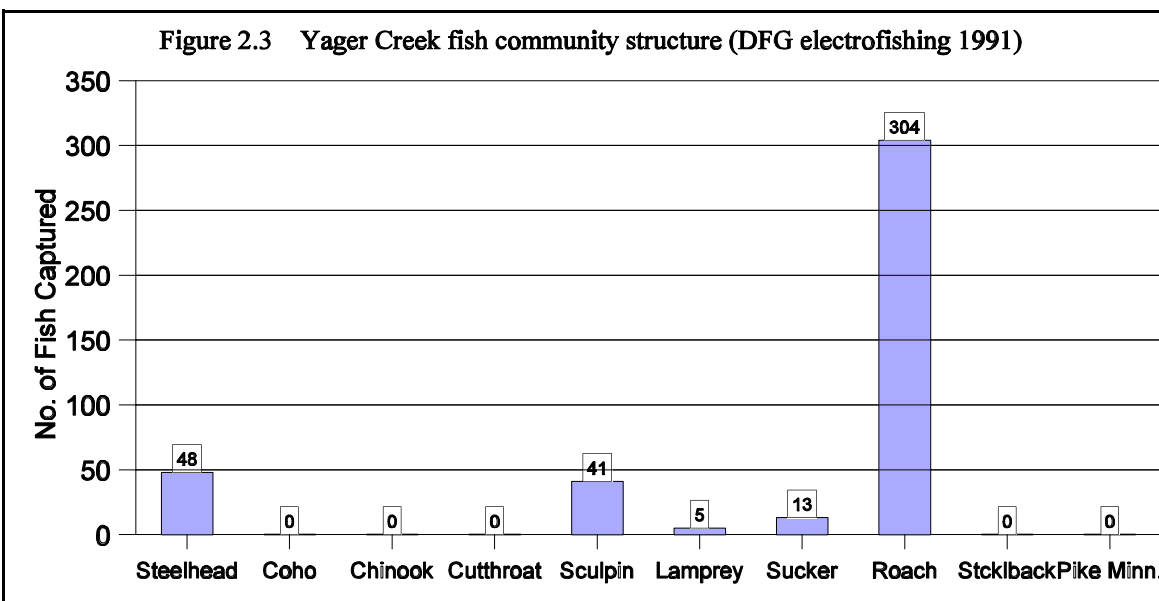
The fish community structure in Yager Creek in 1991, as measured by DFG, was much different than the 1951 account. As illustrated in Figure 2.3, Yager Creek contained a higher ratio of roach compared to steelhead. The presence of western roach and Sacramento pike minnow, both introduced species in much of the lower mainstem VDR and to some extent lower gradient tributaries, may be causing mortality to juvenile salmonids and forcing them to use less suitable habitat. Both species appear to thrive in aggraded channel conditions (described below) and warmer stream temperatures that have persisted since the 1964 flood. DFG (1991) found higher numbers of steelhead in tributaries to Lawrence Creek in 1991 but very few coho or chinook salmon.

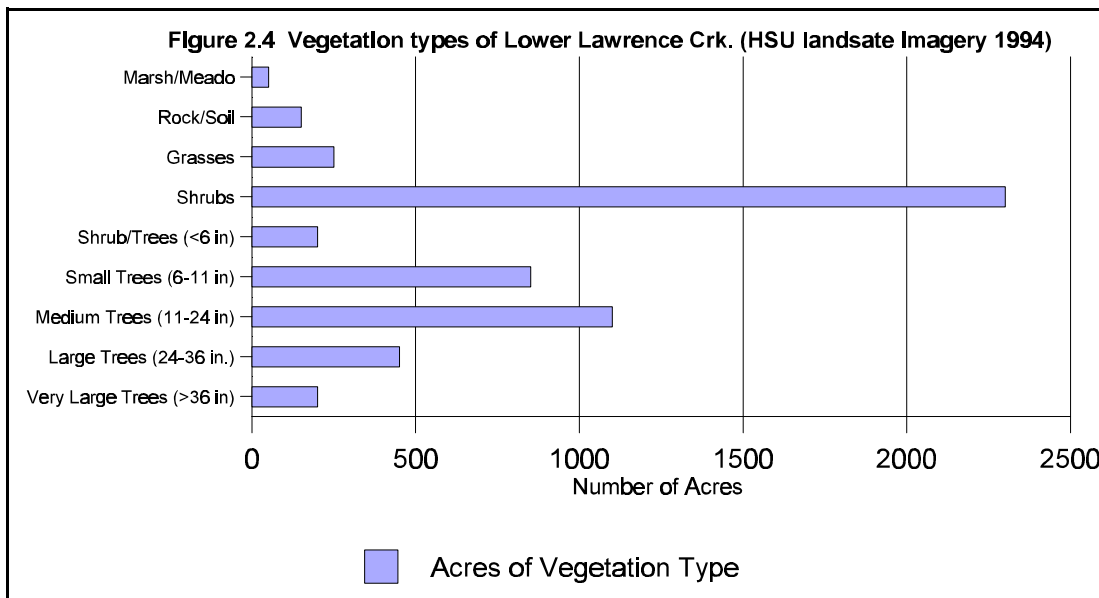
Portions of the lower basin have been heavily harvested within the last decade, thereby increasing sediment delivery risks to watercourses particularly in critical spawning and rearing subwatersheds, such as Lawrence Creek and associated tributaries. For example, 44% of the Yager Creek area under industrial timber management is dominated by a “young” forest type, indicating a high percentage of relatively recent (within last decade) harvesting and associated soil disturbance (PL 1998). Figure 2.4 displays the timber and vegetation types created from a 1994 Landsat image by the Humboldt State University spatial Analysis Laboratory.

The relatively large acreages of shrub and small tree classes in figure 2.4 are indicative of clear cut or heavy selection logging conducted prior to 1994. Intensive timber harvesting can affect several physical and biological watershed processes including: hydrology (water yield, evapotranspiration, peak flows, timing of runoff, etc.), sediment transport, canopy cover and stream temperatures, large woody debris recruitment rates, etc. as described by Spence et al. (1996). Intensive management on steep streamside slopes, unstable areas and riparian zones can especially affect sediment delivery rates. PWA determined that 20% of the total historic sediment delivery in the lower basin was associated with timber harvest activities, as discussed more thoroughly in Chapter 4.

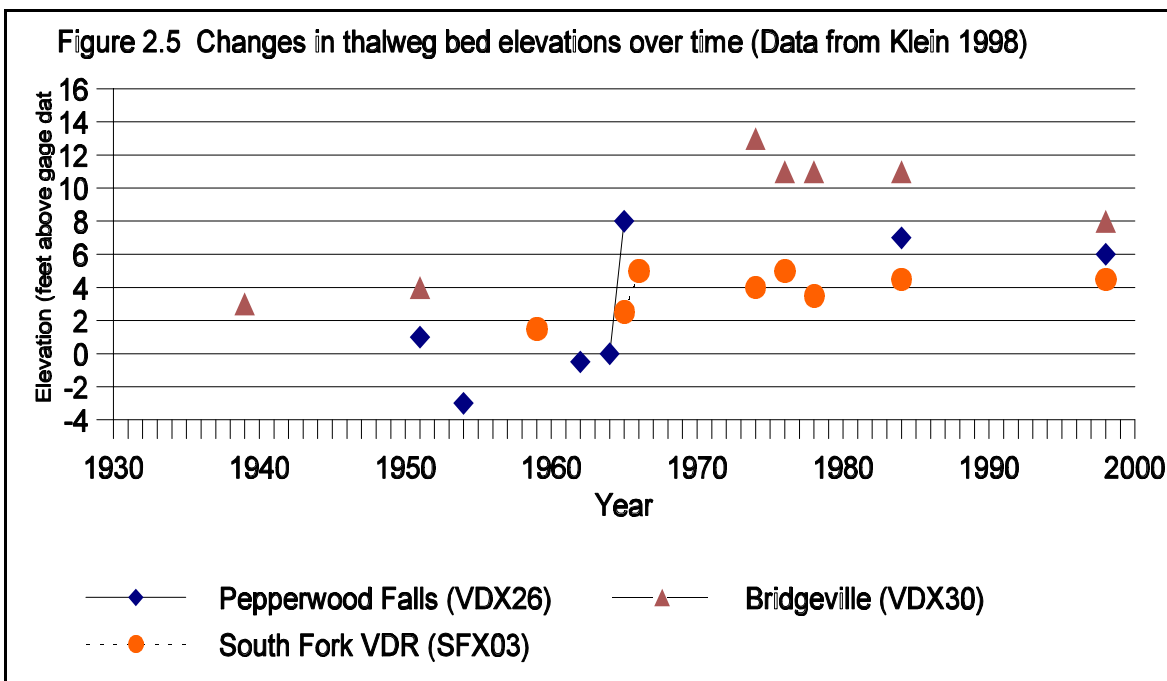
The low gradient reach between Bridgeville and Little Larabee Creek in the middle basin was dramatically altered by aggradation due to the 1964 event (Kelsey 1977). This reach of the middle mainstem VDR appears to be recovering toward pre-1964 levels, based on more recent channel cross-sections survey data (Klein 1998). Figure 2.5 illustrates the change in thalweg elevation (deepest point) of cross section measured at three points on the VDR including: the former US Geologic Survey (USGS) gaging station at Pepperwood Falls, the old Highway 36 bridge at Bridgeville, and the former USGS gaging station on the South Fork VDR. Channel downcutting and pool development in the middle mainstem reach between Bridgeville and Baker Creek is particularly beneficial for spawning and rearing of chinook and steelhead.

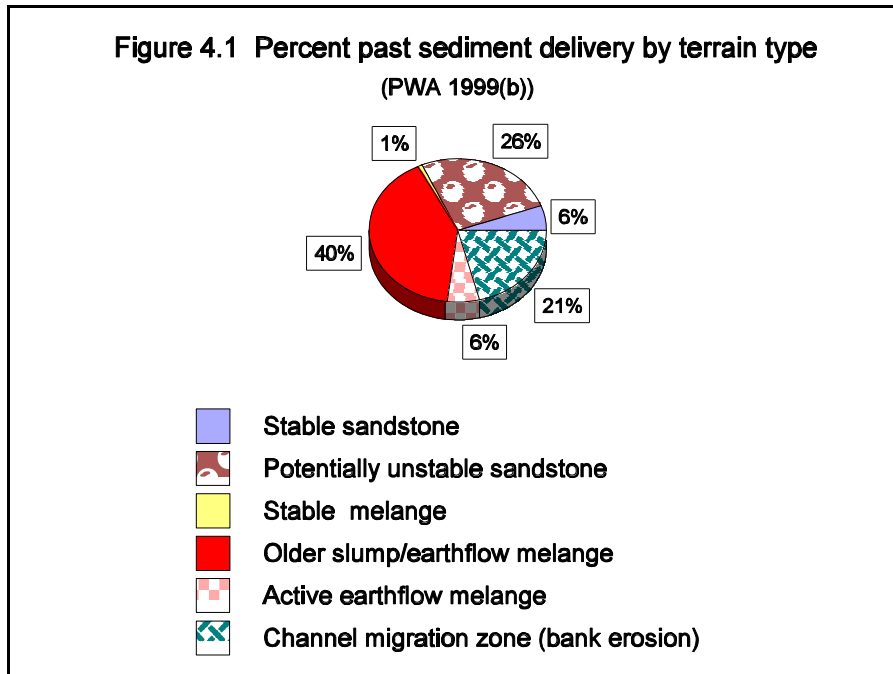
Estimated sediment yield determined by PWA (1999(b)) conforms fairly well to the expected relative importance of sediment yield (derived from Kelsey 1977). PWA (1999(b)) provides a full discussion of the comparison between PWA's erosion estimates and Kelsey's original projections.

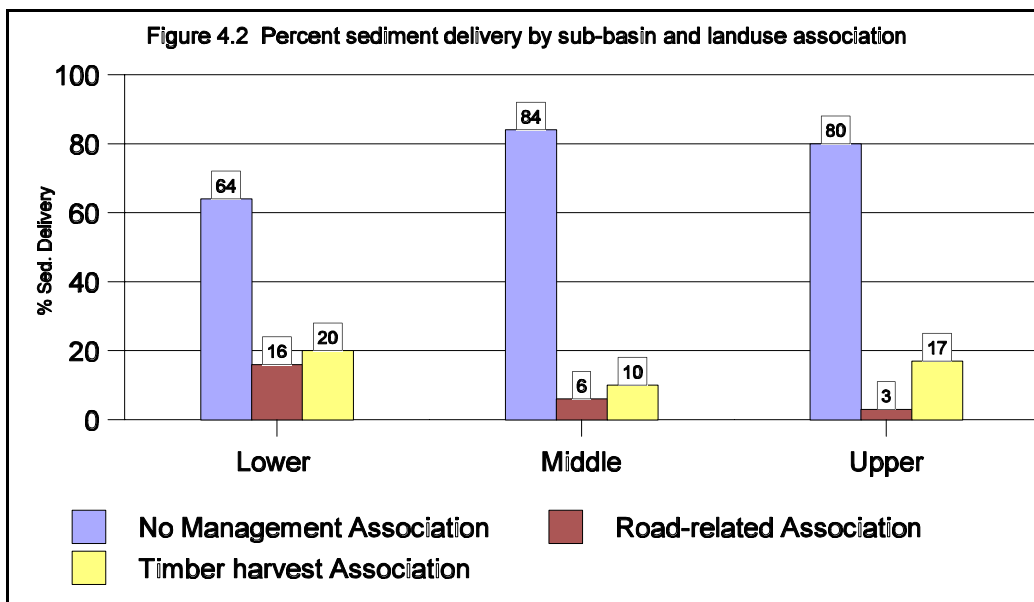
Within the middle basin, management-associated sediment yield associated with tractor harvested areas reflect a low percentage of cable harvesting over the previous three decades. While natural volumes (and rates) of sediment yield are highest in the middle watershed, management-associated sources account for 293 yds<sup>3</sup>/mi<sup>2</sup>/year.

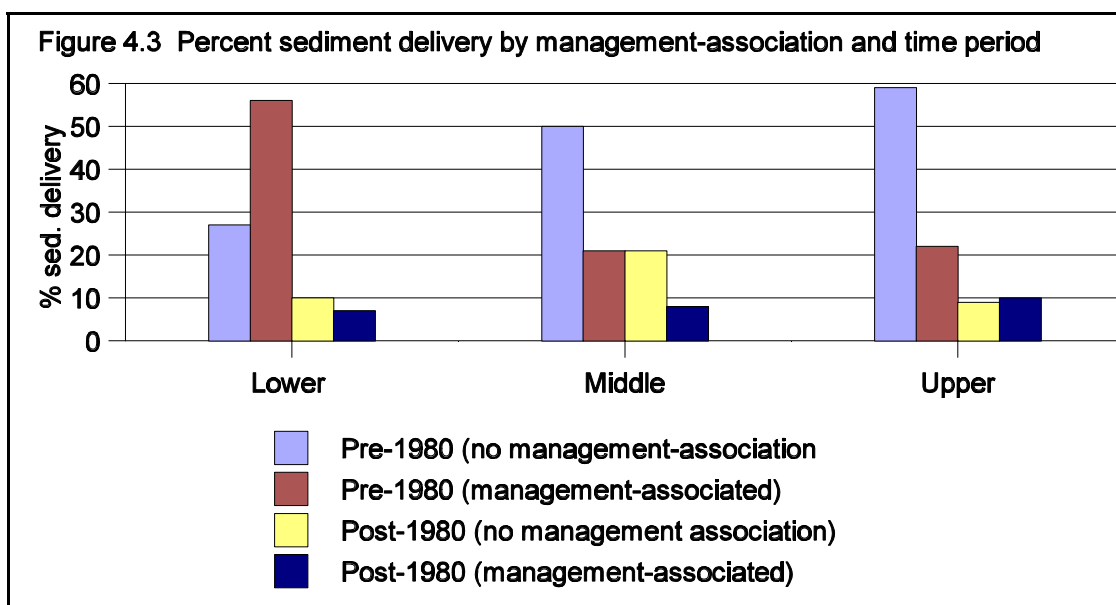
Sub-watershed		Total by Time Period for Management Sediment Yield (yds <sup>3</sup> ) & (%)	Total by Time Period for Non-Management Sediment Yield (yds <sup>3</sup> ) & (%)
Upper Basin	Pre-1980	394,400 (22%)	1,054,400 (59%)
	Post-1980	176,900 (10%)	167,000 (9%)
	Subtotals	574,300 (32%)	1,222,100 (68%)
Middle Basin	Pre-1980	796,300 (21%)	1,862,500 (50%)
	Post-1980	303,600 (8%)	775,700 (21%)
	Subtotals	1,099,900 (29%)	2,638,200 (71%)
Lower Basin	Pre-1980	1,049,600 (56%)	494,200 (27%)
	Post-1980	136,100 (7%)	183,600 (10%)
	Subtotals	1,185,700 (63%)	677,800 (37%)
<b>Totals for whole basin</b>		<b>2,859,900 (39%)</b>	<b>4,538,100 (61%)</b>
