Leak Detection & Repair

COMMONWEALTH UTILITIES CORPORATION WATER DIVISION

Leak Detection and Repair Phase II

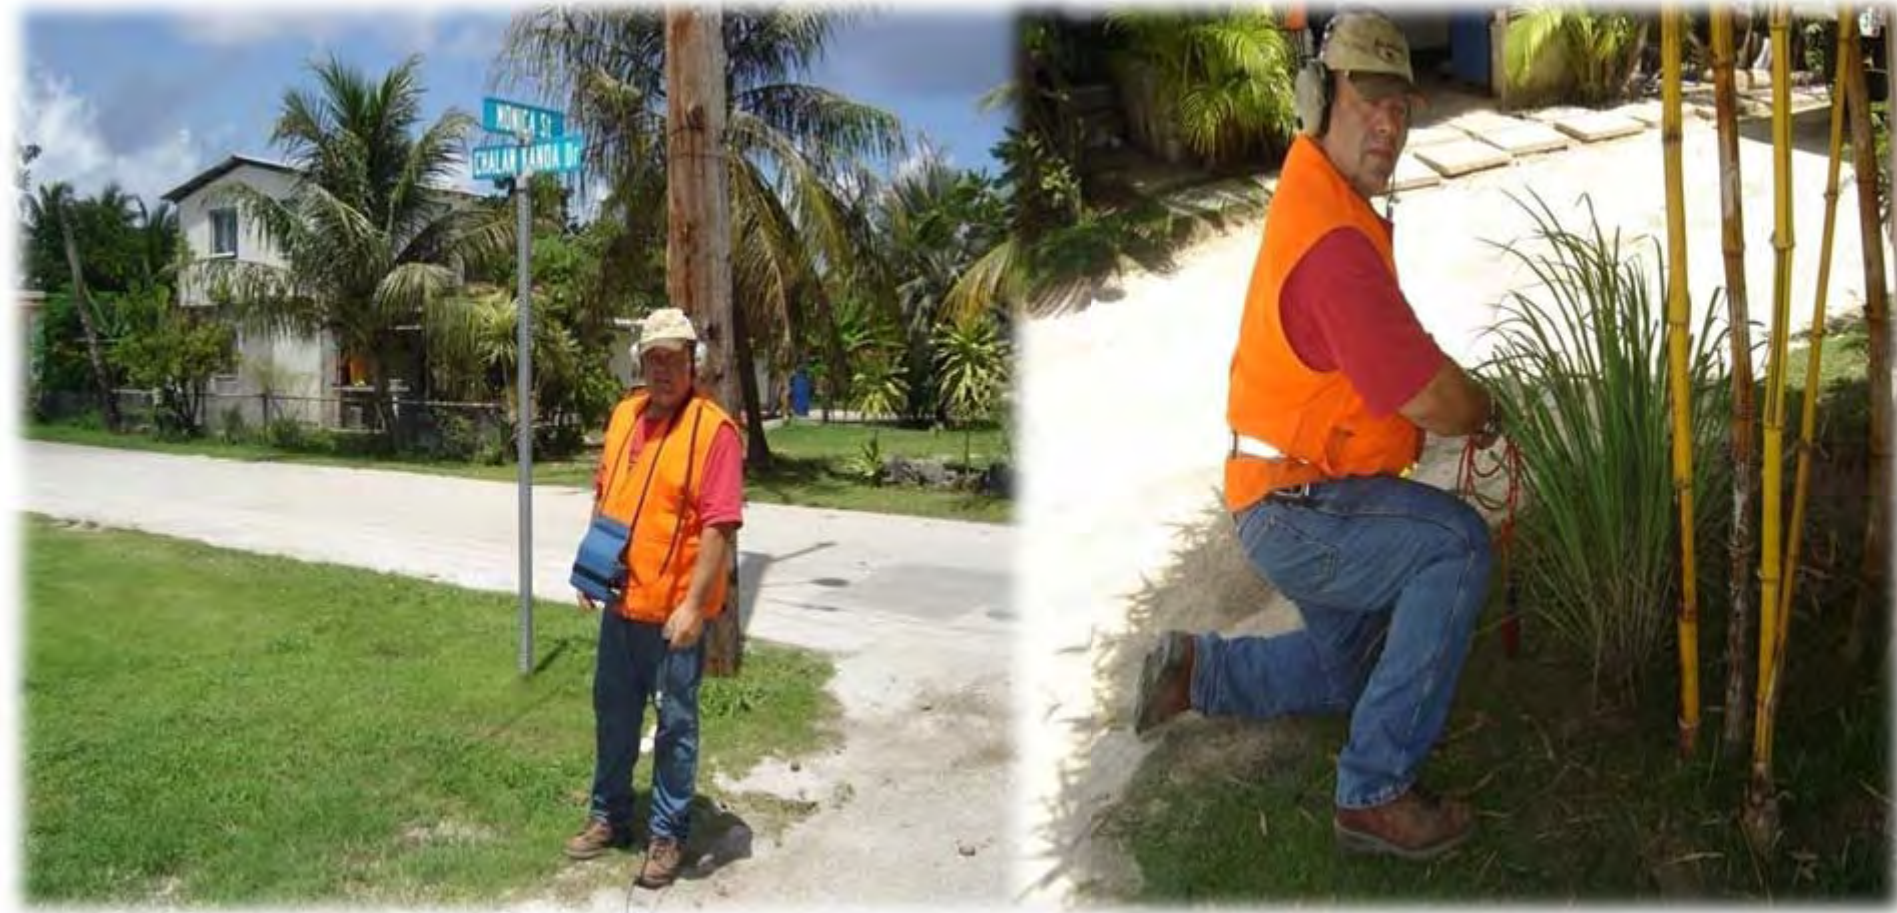
Chalan Kanoa

Leak Detection and Survey (Point to Point)

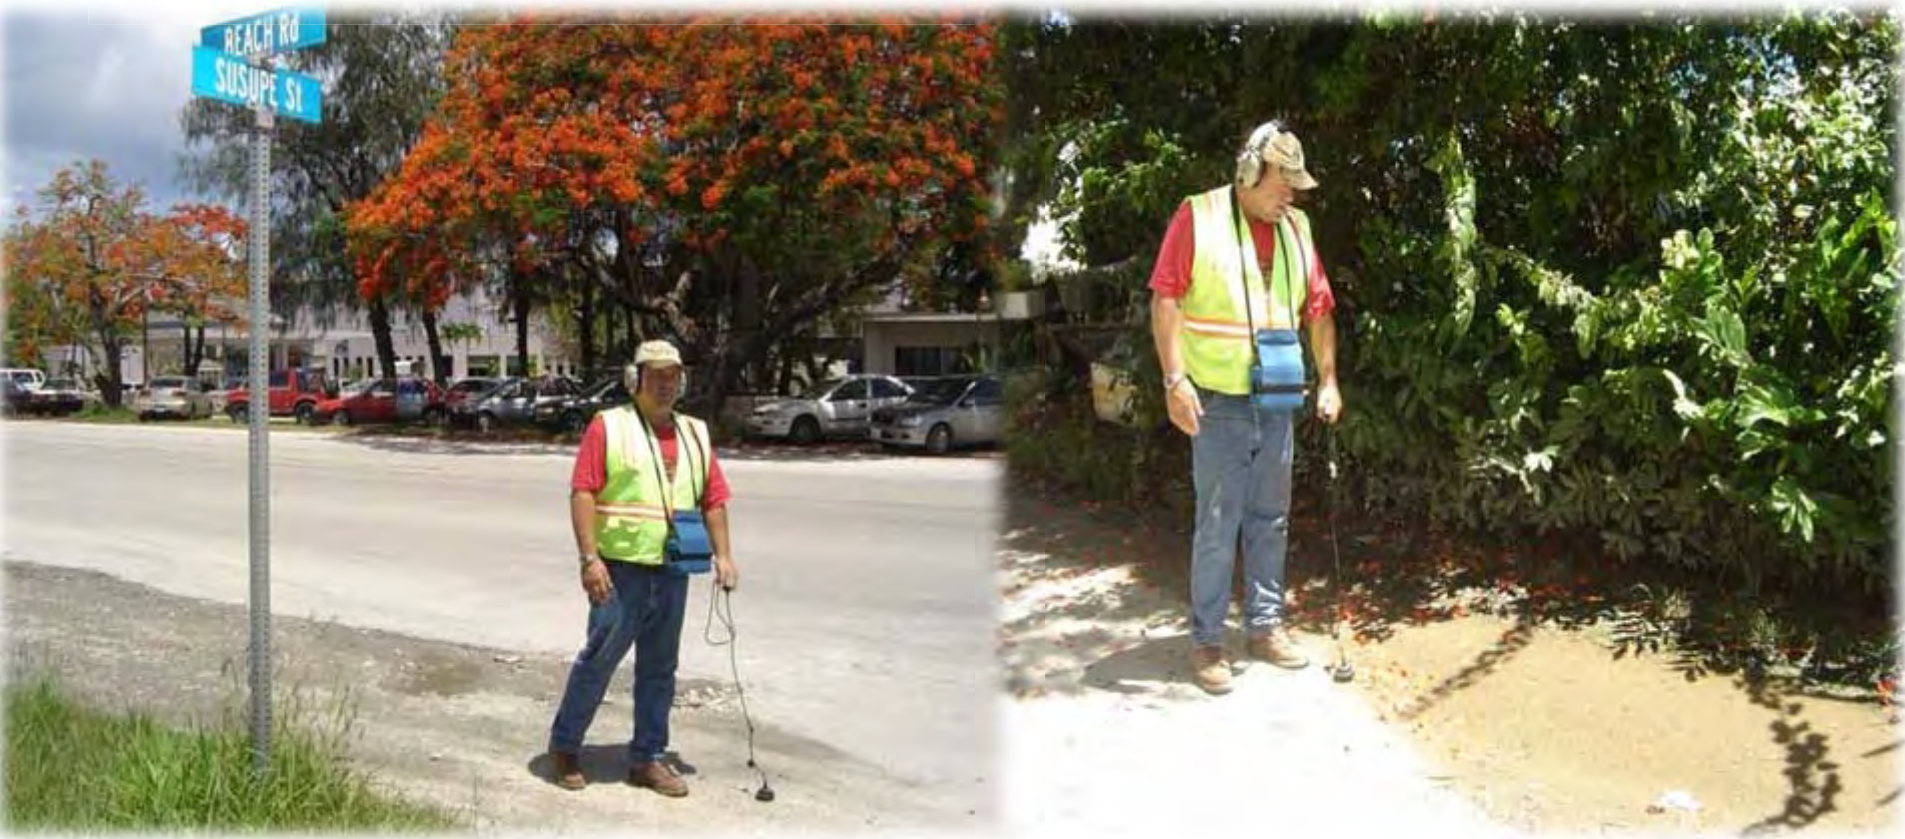
Susupe

Leak Detection and Survey (Ground Microphone)
