## **Appendix D**

# **Construction Program Site Visit Reports**

**Site Visit No. 1**

**Thomes Creek Bridge Project**  
**Site Visit Date: 10/13/2009**

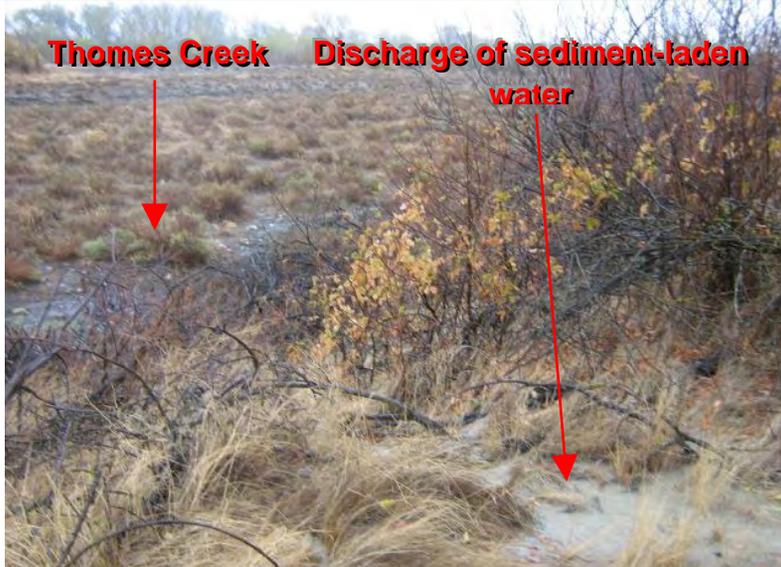
Prohibition A.1 of the Permit states the “discharge of runoff from construction sites containing pollutants which have not been reduced using BAT for toxic pollutants and BCT for conventional pollutants to waters of the United States is prohibited.” Adequate BMPs were not implemented for the contractor’s staging and material storage areas located up-gradient and adjacent to Thomes Creek. Specifically, adequate BMPs or perimeter controls had not been implemented for the areas of disturbance associated with the contractor staging and material storage areas. For example, a concrete washout was improperly implemented and lined with plastic that had been torn and badly deteriorated (see Photographs 1 and 2), and uncontained concrete waste was observed on the ground surface directly adjacent to the concrete washout (see Photograph 3). Jeff Blin (Caltrans District 2, Resident Engineer), explained that the concrete washout area had been present for a long period of time and was not identified in the project SWPPP. Moreover, a visible discharge of sediment and/or other pollutants was observed leading from the contractor staging and material storage areas to Thomes Creek (see Photographs 4 through 7).

Photograph 5— Discharge of pollutants from the contractor staging and material storage areas to Thomes Creek

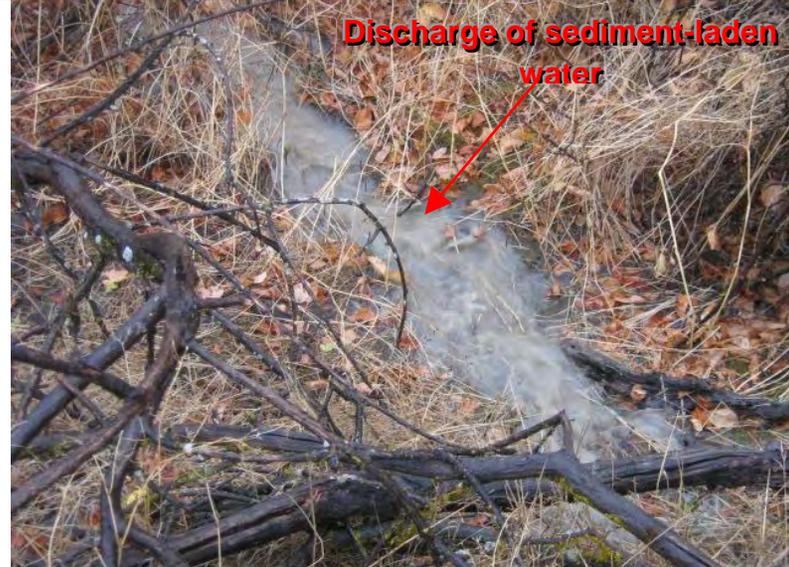
Photograph 6 – Close-up of Photograph 5 depicting the discharge of pollutants flowing to Thomes Creek

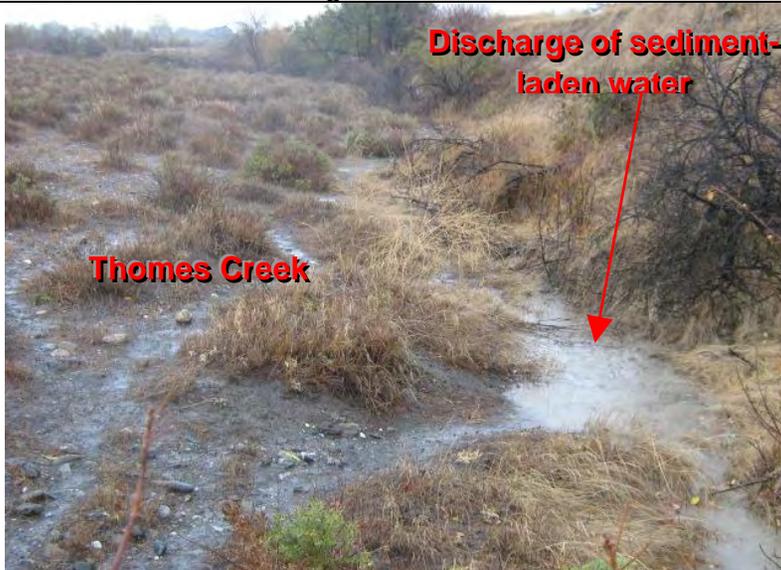
Photograph 7—Discharge of pollutants entering the receiving water, Thomes Creek

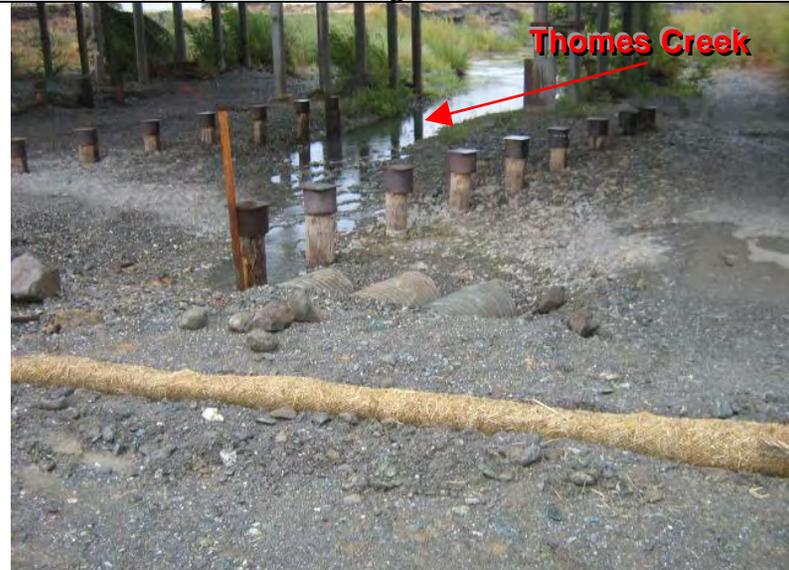
Additionally, adequate BMPs had not been implemented for areas of disturbance located directly adjacent to the flowing Thomes Creek. Although erosion log BMPs had been implemented, the erosion logs were not staked and a discharge of sediment was observed bypassing the BMPs and leading to Thomes Creek (see Photographs 8 and 9).

Photograph 8 – Erosion log BMPs were not adequately installed (e.g., not properly staked) adjacent to the flowing Thomes Creek

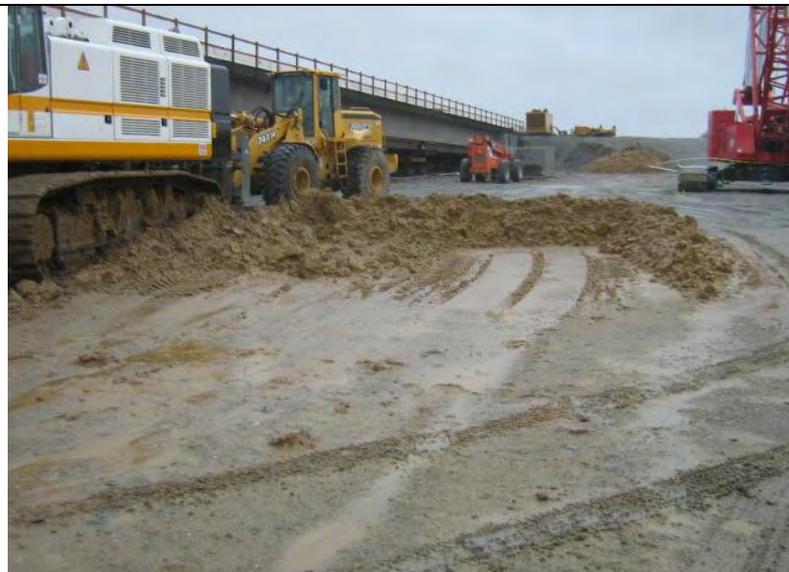
Photograph 10 – Unconsolidated soils without BMPs

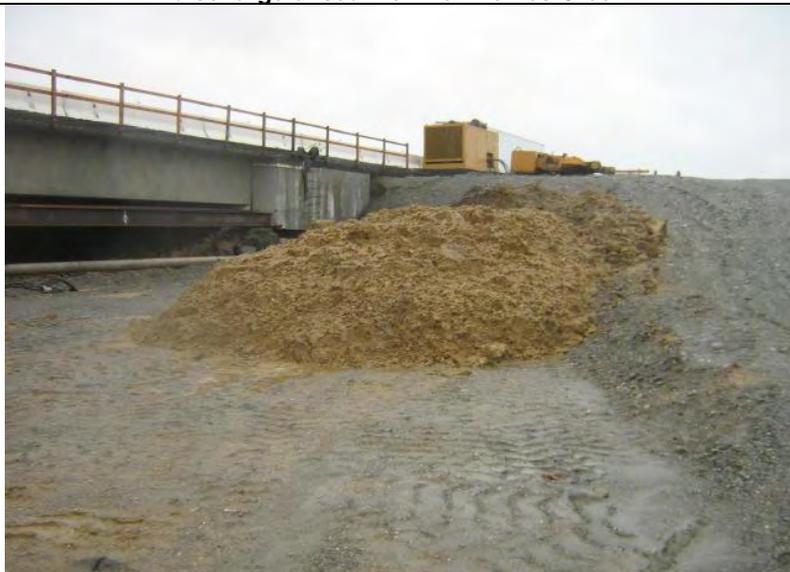
Photograph 11— Soil stockpile without BMPs

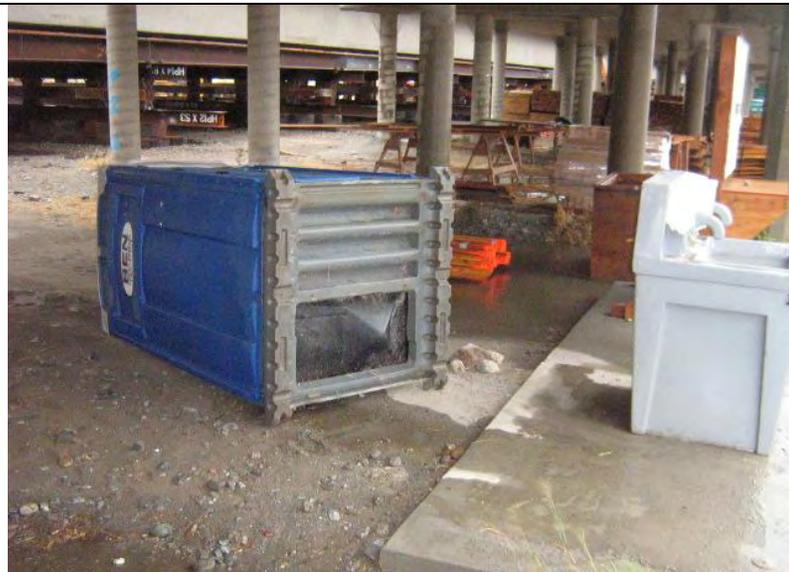
Photograph 12 – View of portable toilet blown over under Thomes Creek bridge

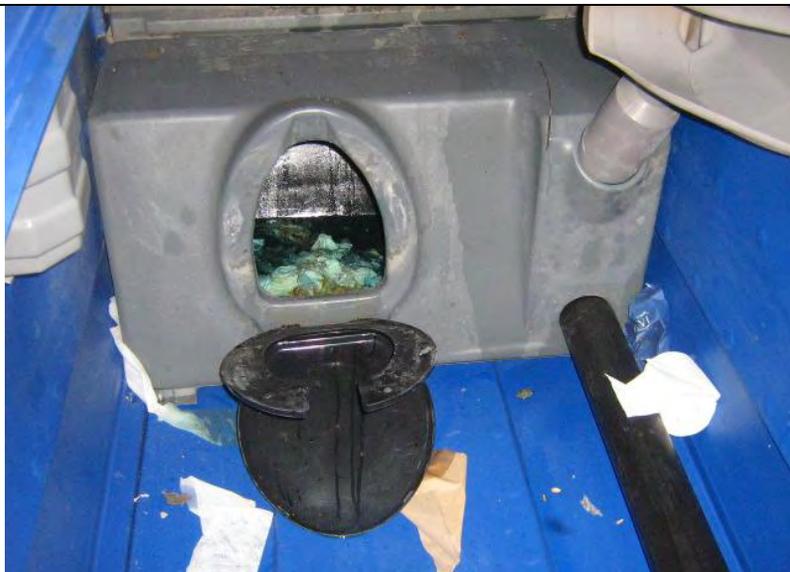
Photograph 13—View inside of overturned portable toilet with visible chemical and sanitary waste present

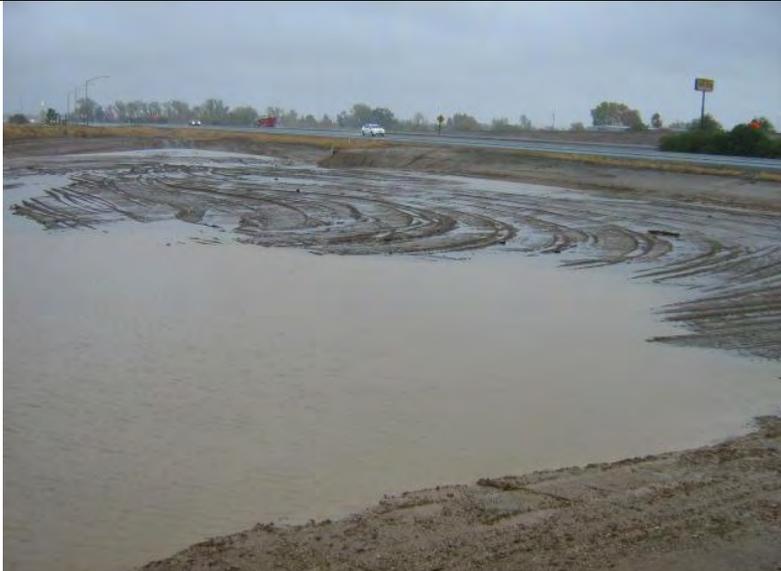
Photograph 1 – View of unstabilized sediment basin and embankment slopes

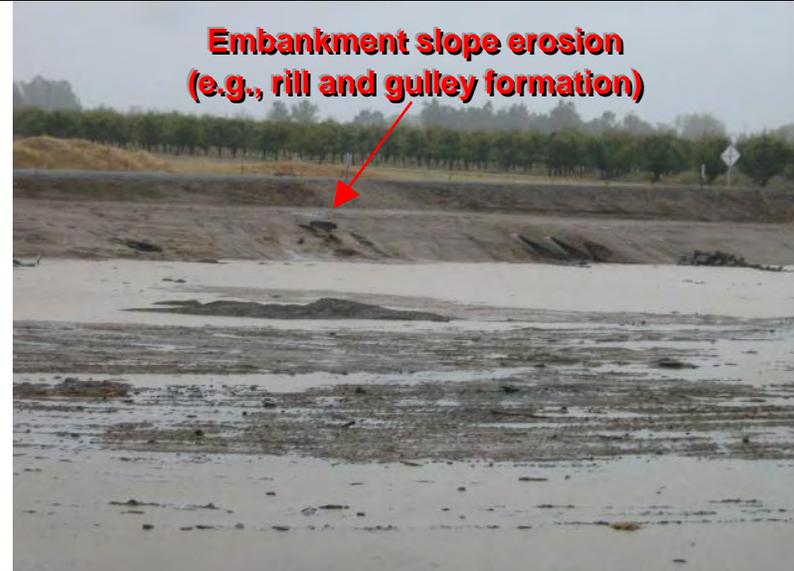
**Embankment slope erosion  
(e.g., rill and gully formation)**

Photograph 2 – Erosion of unstabilized sediment basin and associated embankment slopes

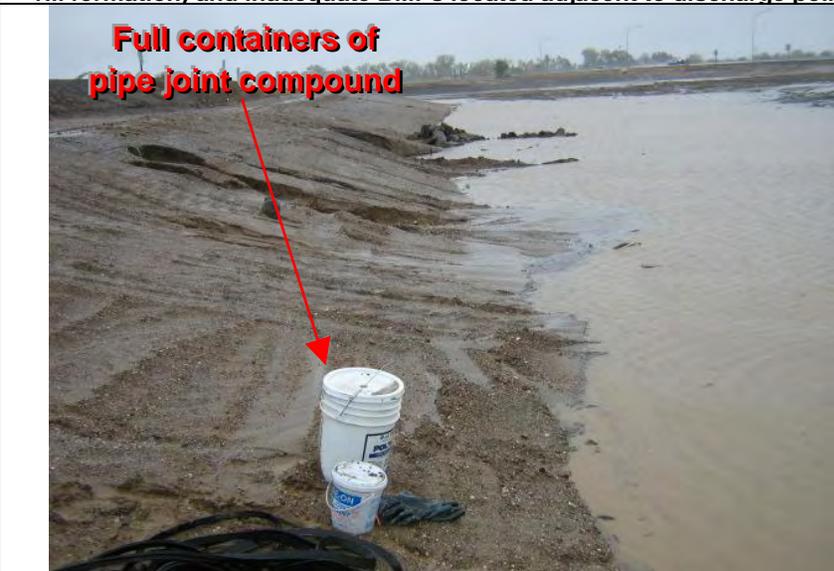
Adequate structural and non-structural BMPs also had not been implemented for material storage. Specifically, full containers of pipe joint compound were observed adjacent to the standing water in the eastern sediment basin (see Photographs 7 and 8). As a result, there was a potential for the contribution of pollutants to storm water runoff.

Photograph 7—Pipe joint compound located in the eastern sediment basin

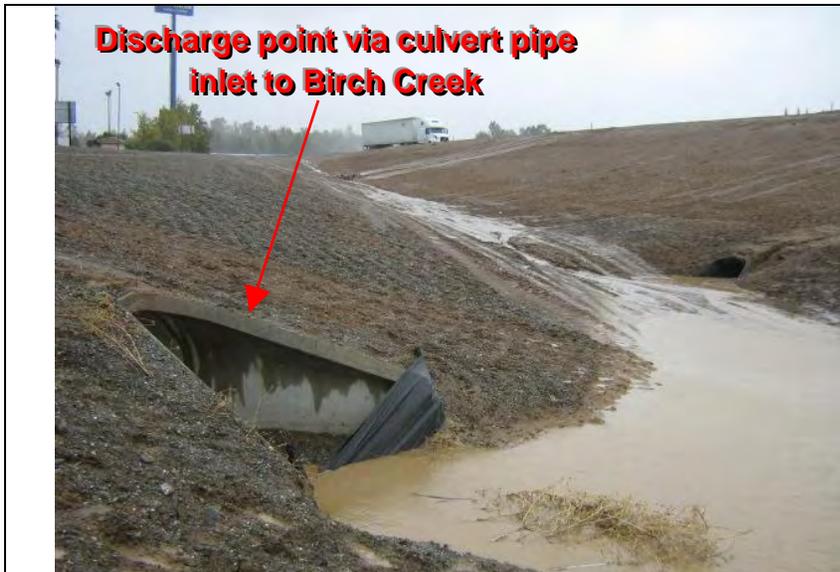
Photograph 9—Discharge point, culvert inlet and drainage pipe leading to Birch Creek

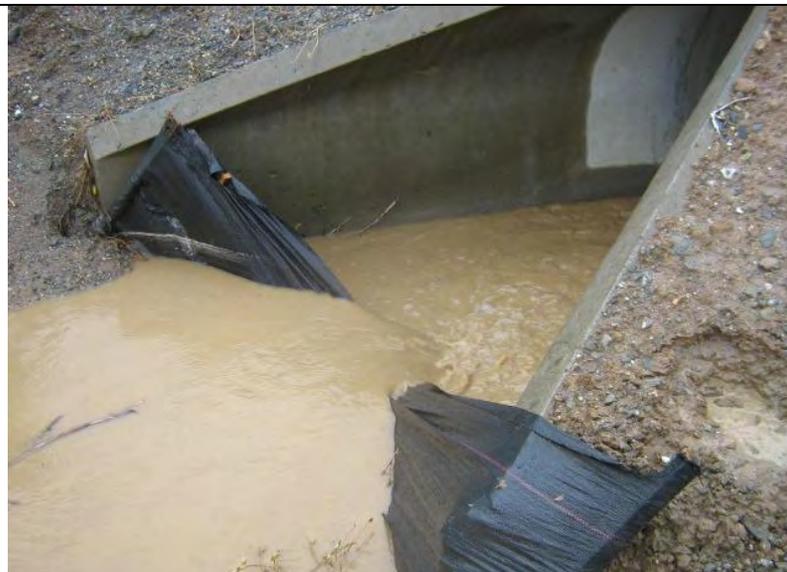
Photograph 10 – Inappropriate BMP selection (e.g., silt fence implemented in area of concentrated flow) and discharge of sediment laden runoff

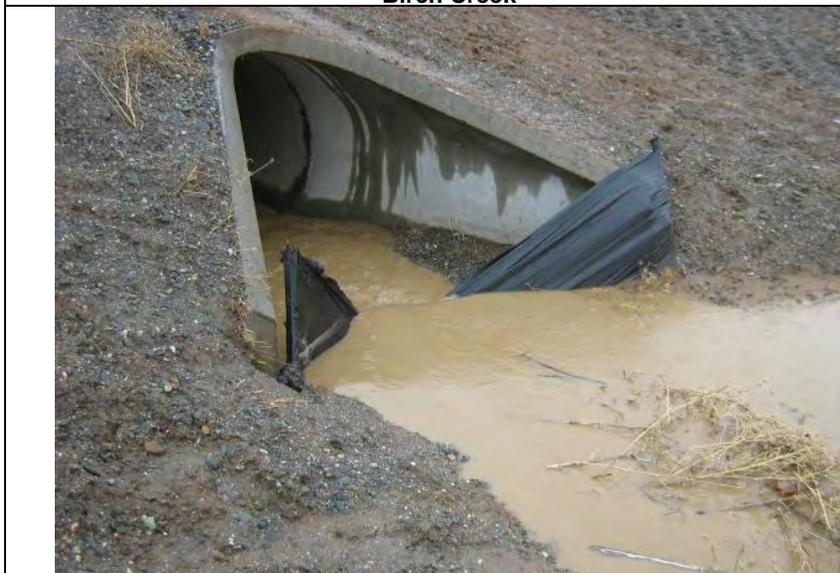
Photograph 11— Collapsed silt fence BMP and discharge of sediment laden runoff

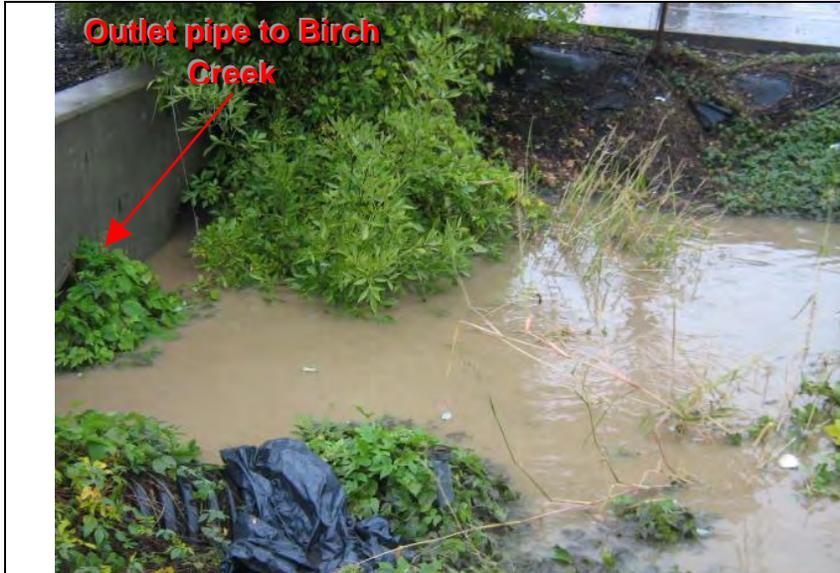
Additionally, inappropriate and inadequate BMPs had been implemented for the interconnected sediment basin discharge point, a culvert pipe inlet and drainage pipe leading to Birch Creek. Specifically, a silt fence BMP had been implemented in an area of concentrated flow at the culvert inlet, and had therefore collapsed (see Photographs 9 through 11). As a result, there was a discharge of sediment from the unstabilized up-gradient areas (e.g., sediment basins and disturbed slope areas) to the culvert pipe inlet and discharge pipe which ultimately flows to Birch Creek (see Photographs 12 through 14).

Photograph 13—Evidence of the discharge of sediment leading to Birch Creek

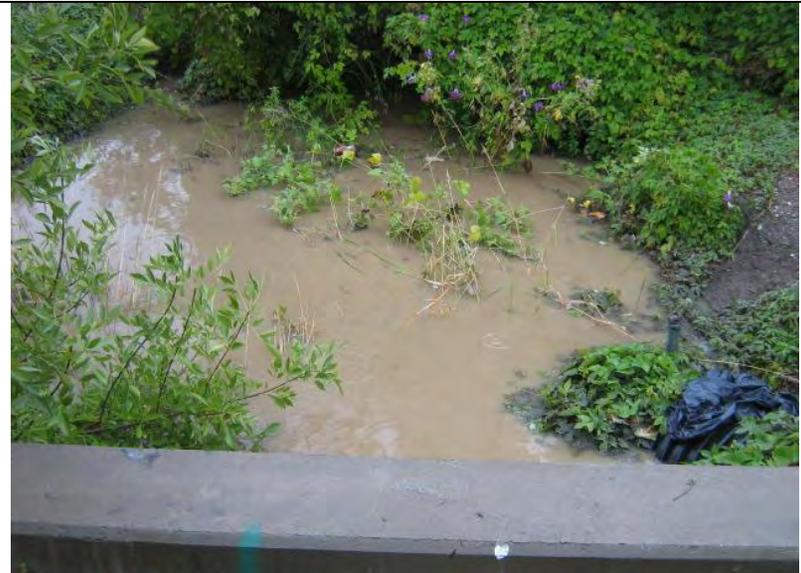
Photograph 14 – Evidence of the discharge of sediment leading to Birch Creek

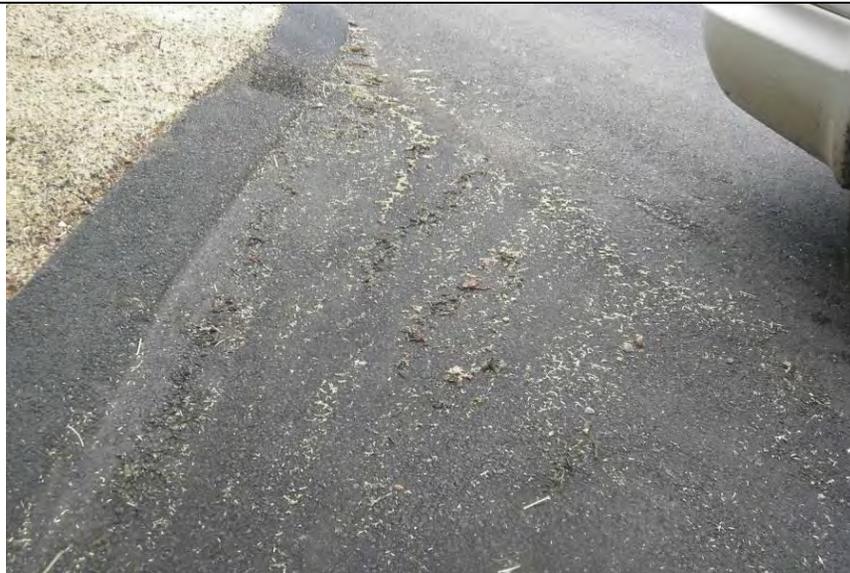
Specifically, BMPs were not adequately implemented and maintained along the perimeter of the disturbed area associated with the former construction site staging area. The Audit Team observed a visible flow path and erosion causing sediment and debris accumulation to surpass the straw wattles utilized along the southern perimeter of the former staging area (see Photograph 1). Erosion had caused the discharge of sediment and debris from several portions of the roadway drainage area adjacent to the sound wall into a storm drain inlet located along the west side of the highway shoulder (see Photographs 2, 3, and 4).

Photograph 3 – Sediment and debris from Photograph 2

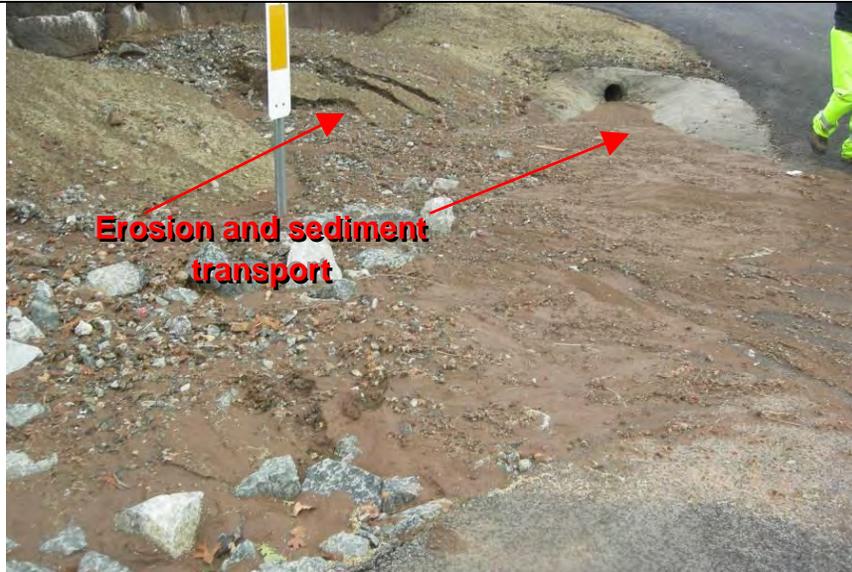
In addition, BMPs were not adequately implemented on the disturbed slope along the south side of the sound wall to prevent sediment discharge (see Photographs 5 and 6). Furthermore, sediment accumulation was observed along the flow path of a rock lined drainage swale leading to a down-gradient drainage pipe (see Photographs 7 and 8). The straw wattles utilized at the down-gradient drainage pipe inlet were not adequately maintained.

**Erosion and sediment transport**

Photograph 5 – Lack of adequate BMPs to prevent discharge of sediment to the roadway

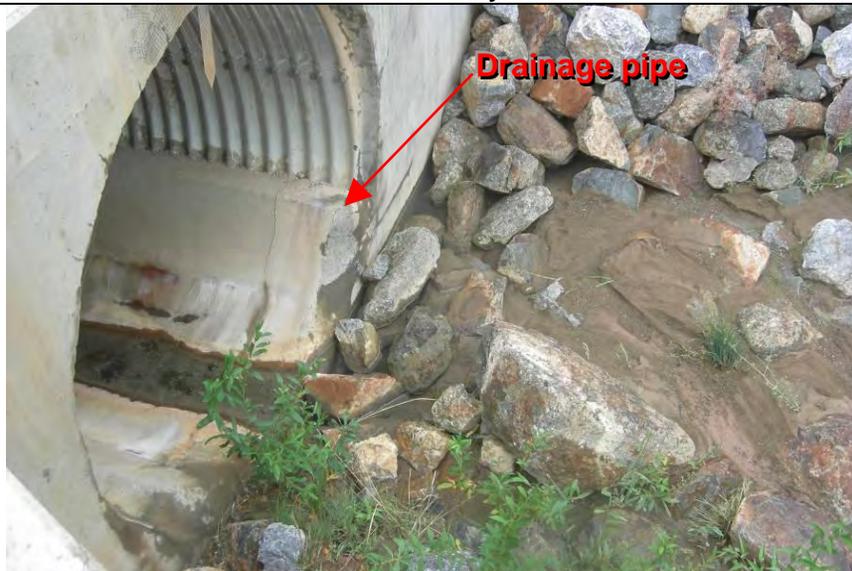
**Drainage pipe**

Photograph 7 – Sediment accumulation at down-gradient drainage pipe inlet

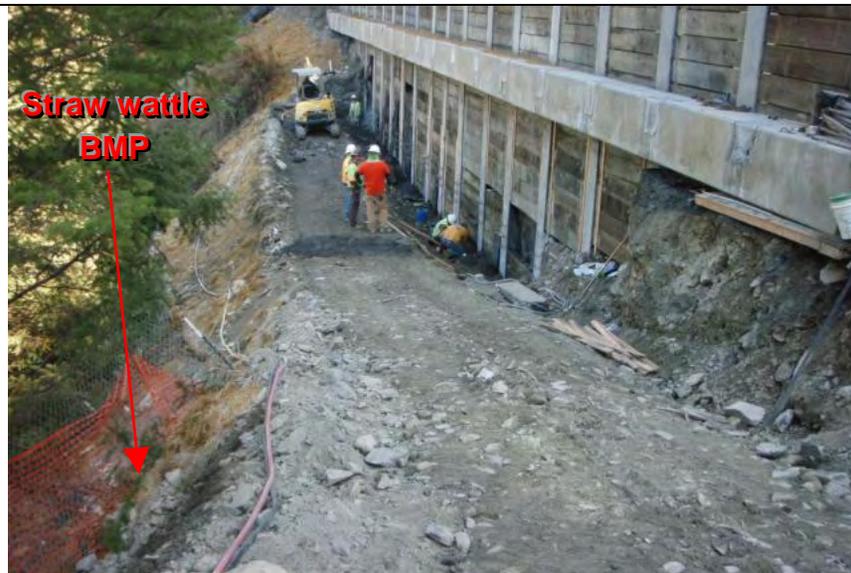
Photograph 2 – Example of straw wattle BMP implemented down-gradient of disturbance and retaining wall construction

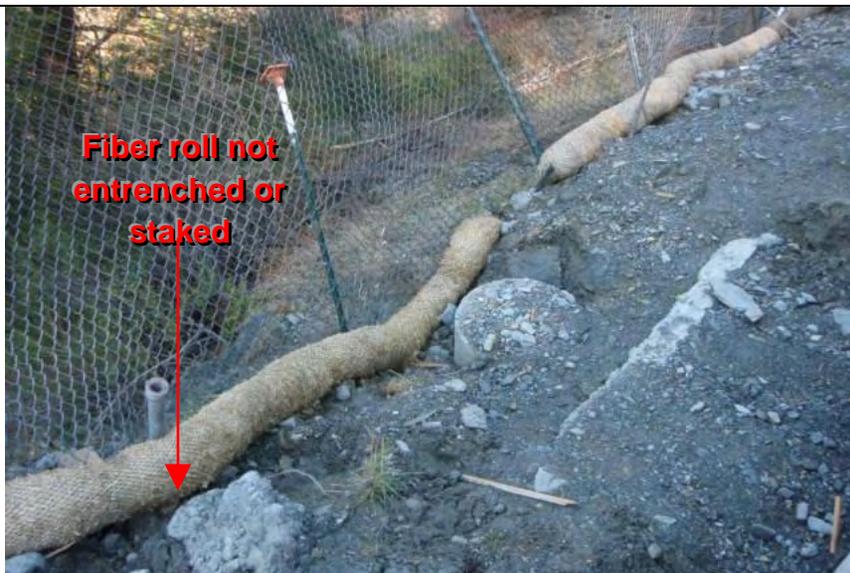
Photograph 3 – Example of fiber roll not entrenched or staked into the ground

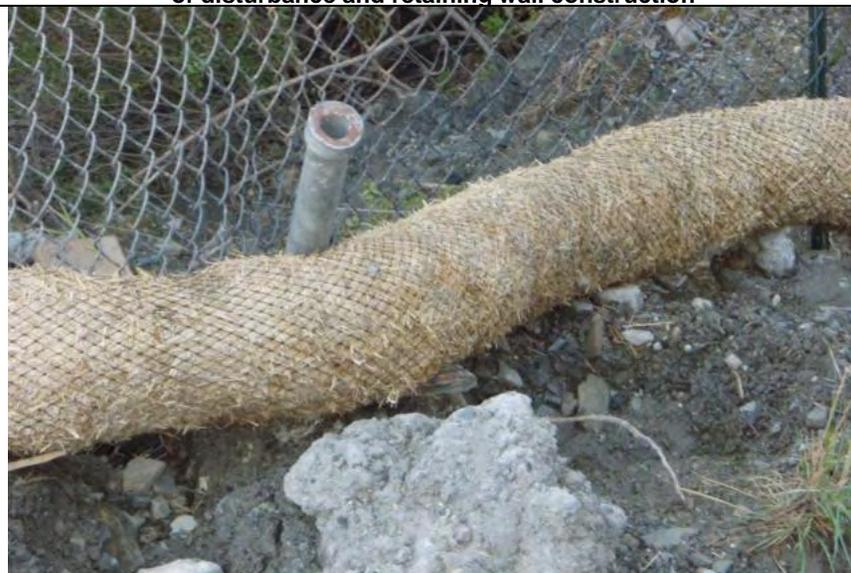
Photograph 4 – Close-up view of fiber roll not entrenched or staked into the ground

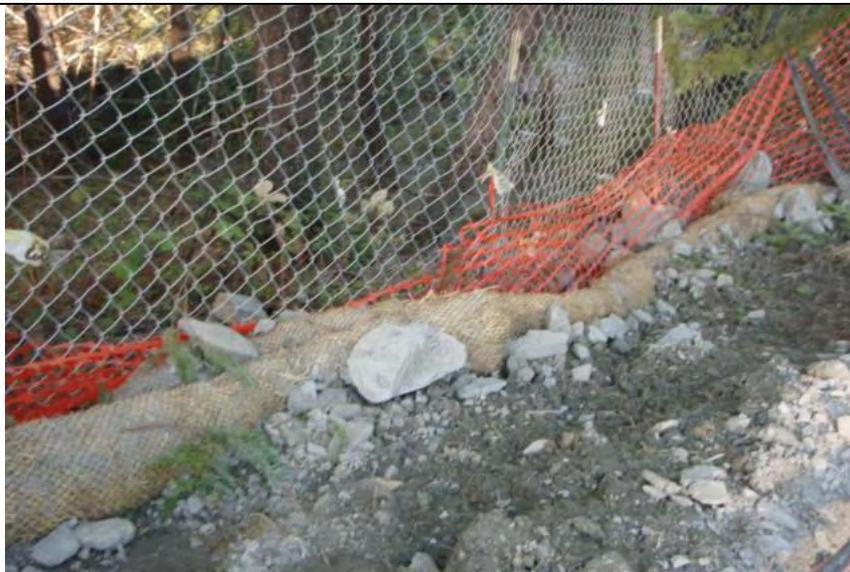
Photograph 5— Example of sediment and debris accumulation against straw wattle BMP

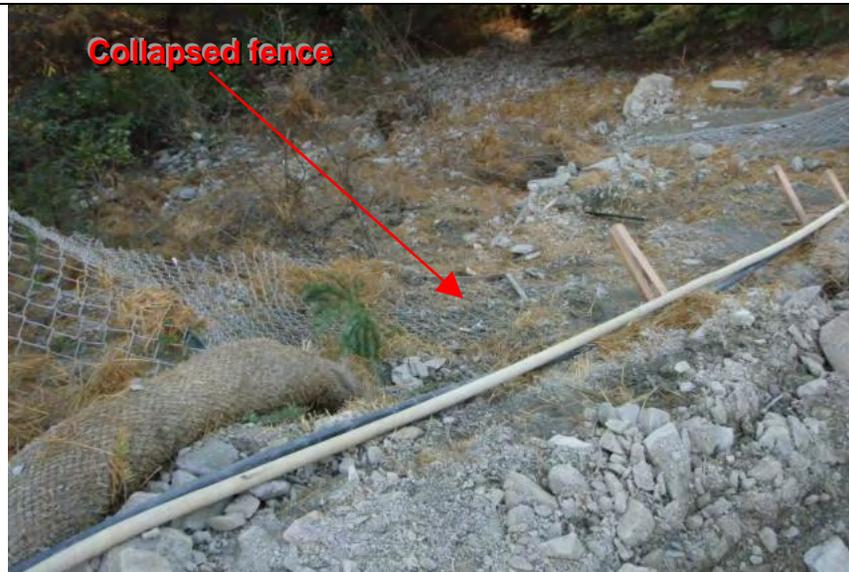
Photograph 6 – Example of collapsed section of metal fence

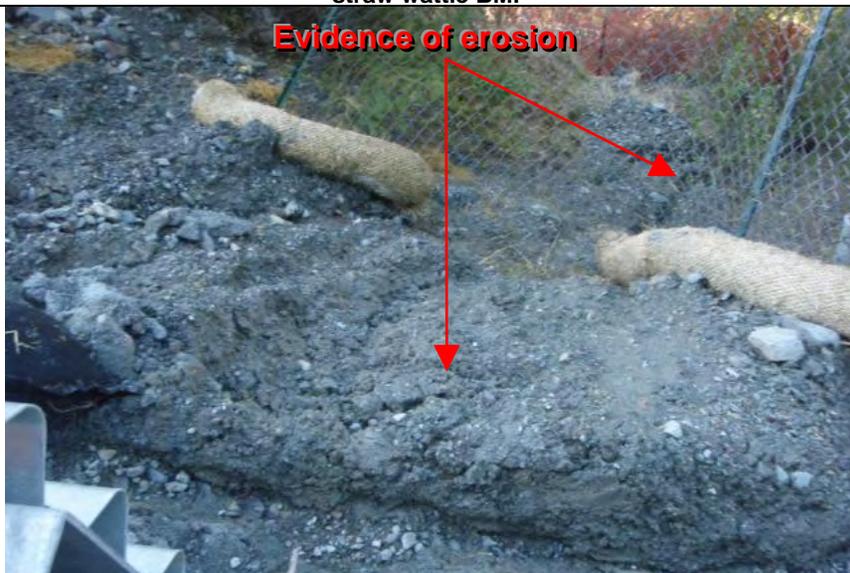
Photograph 7— Undercut section of straw wattle BMP and evidence of erosion

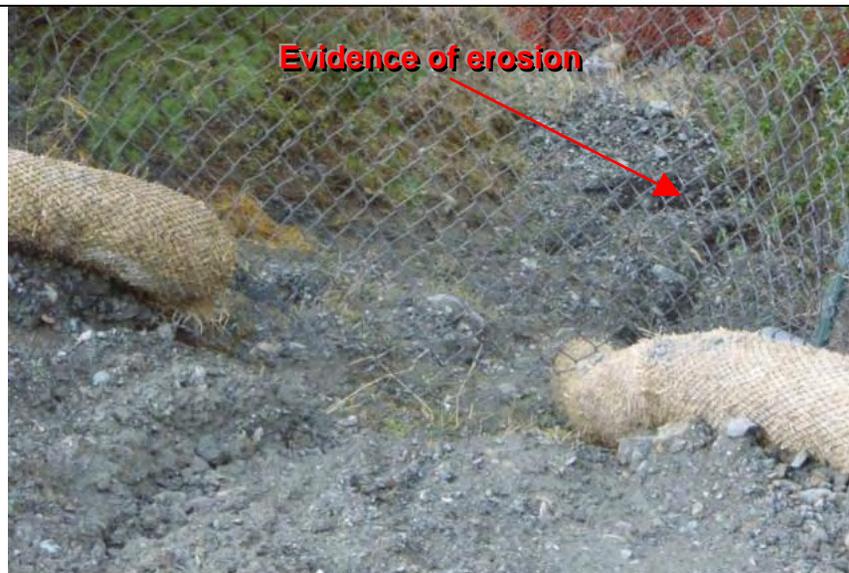
Photograph 8 – Closer view of straw wattle and erosion pictured in Photograph 7

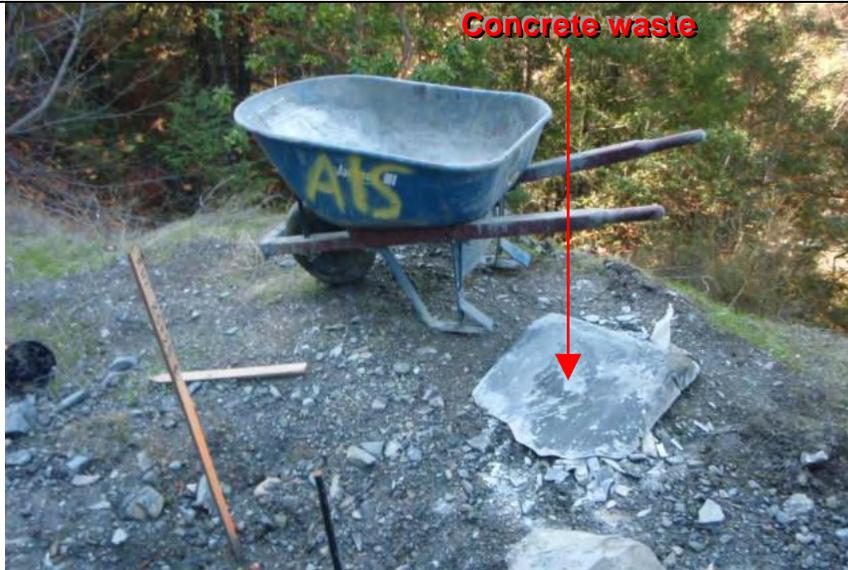
Photograph 9— Concrete waste on ground surface adjacent to steep slope

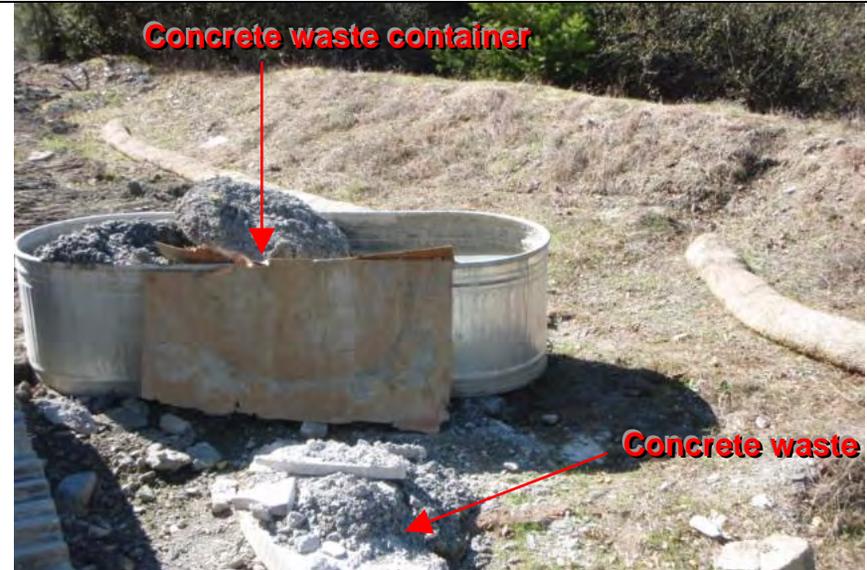
Photograph 10— Concrete waste and container in staging area (Note: Straw wattle BMP not staked or entrenched into ground)

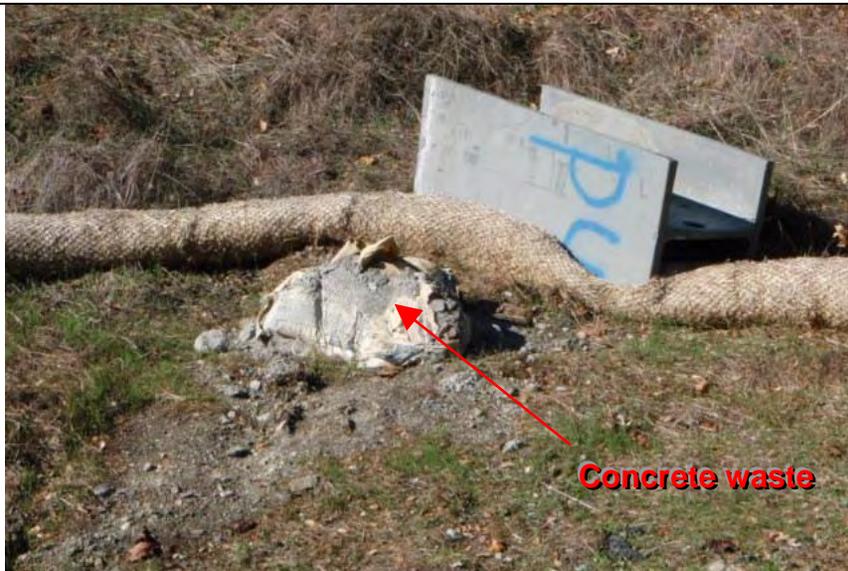
Photograph 11— Concrete waste near concrete waste container in staging area (Note: Straw wattle BMP not staked or entrenched into ground)

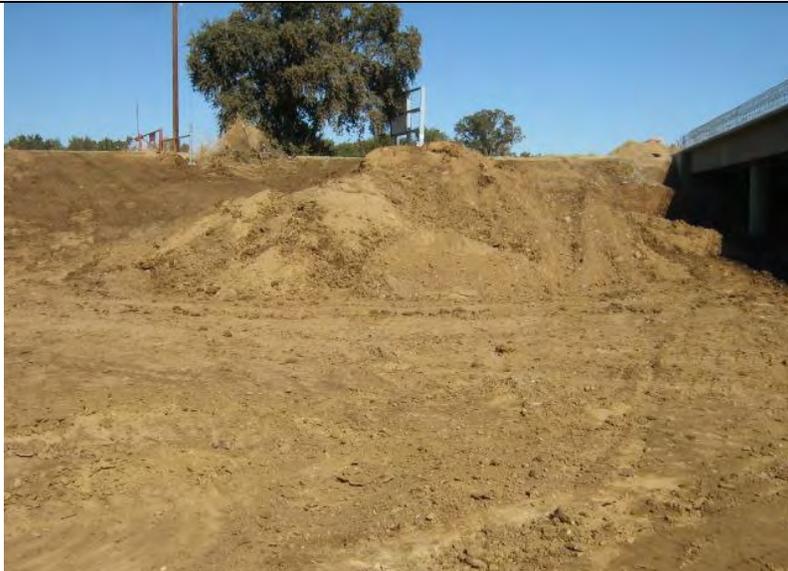
Photograph 5 – Soil stockpile with no perimeter controls or temporary stabilization located just upgradient of Bear River crossing.

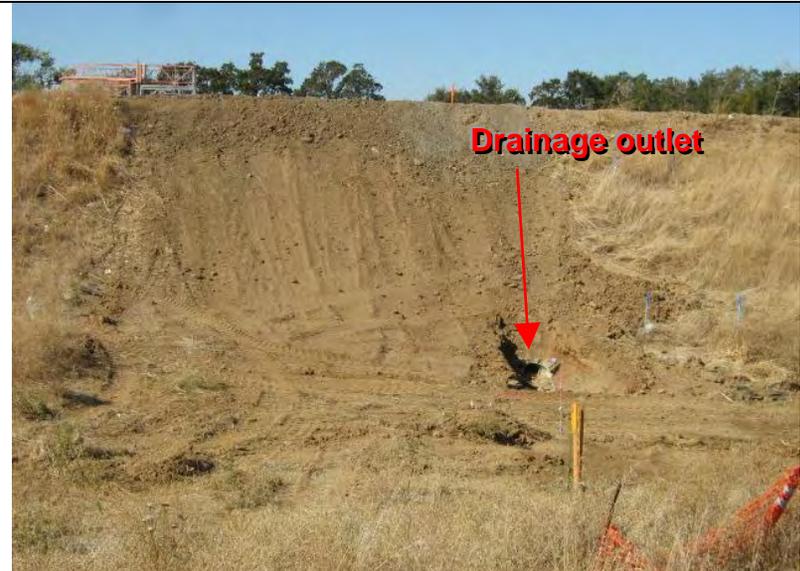
Photograph 6 – Drainage outlet below unstabilized embankment slope adjacent to the highway.

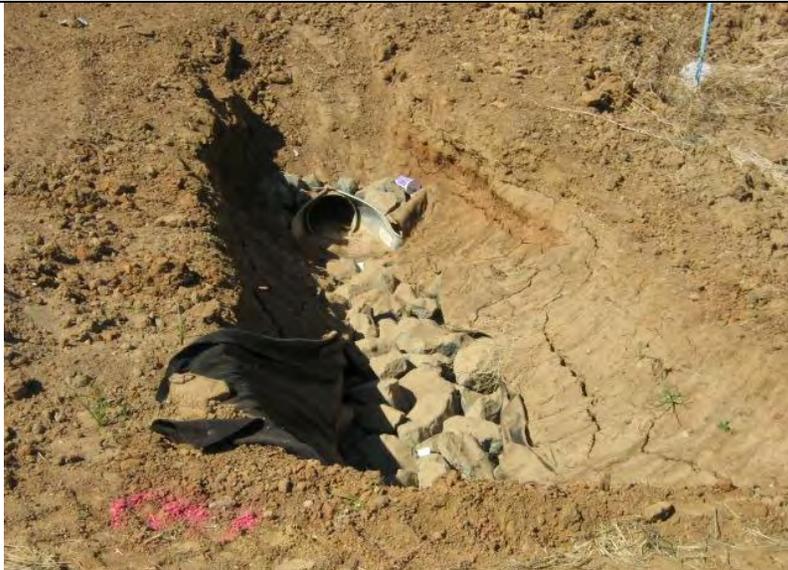
Photograph 7 – Drainage outlet at base of unstabilized slope shown in Photograph 6.

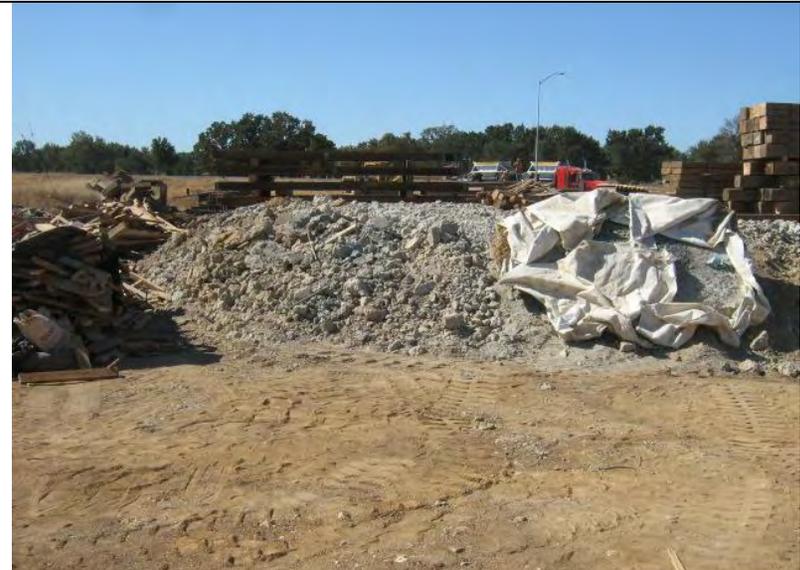
Photograph 8 – Uncontrolled/uncontained concrete waste

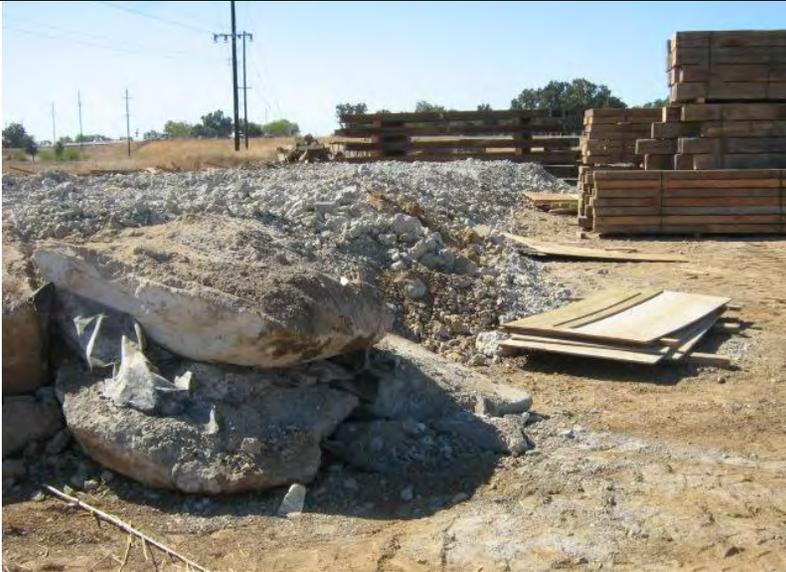
**Photograph 9 – Uncontrolled/uncontained concrete waste**

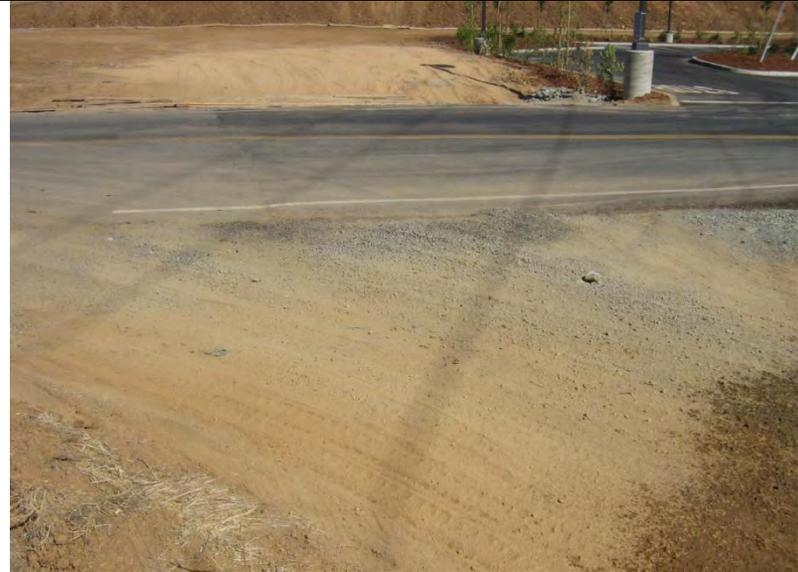
**Photograph 10 – Tracking control BMPs not adequately maintained (e.g., sediment in rock pad and rock sparse in areas)**

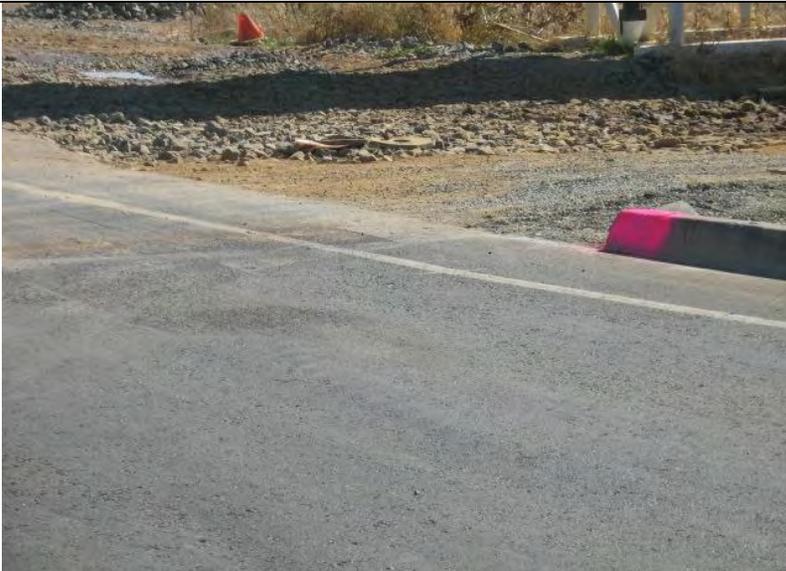
**Photograph 11 – Tracking control BMPs not adequately maintained (e.g., sediment in rock pad and rock sparse in areas)**

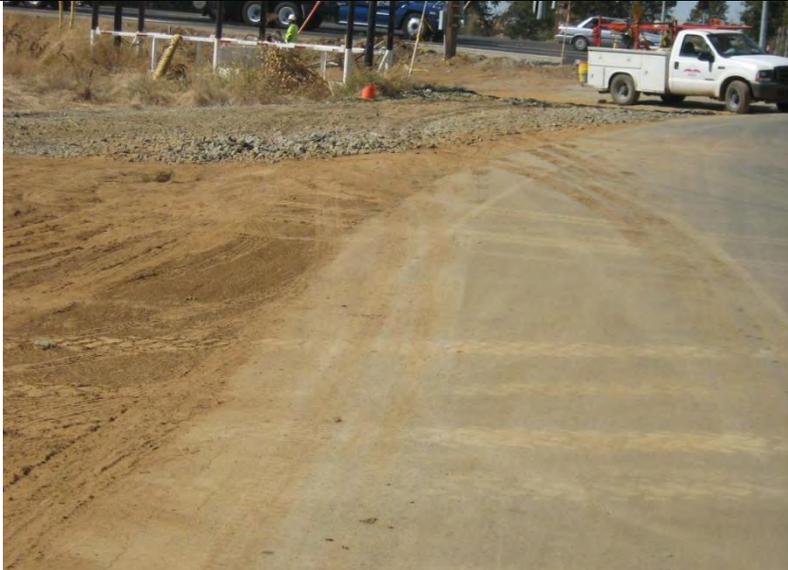
**Photograph 13 – Sediment transport from areas of disturbance onto Feather River Boulevard, a public roadway.**

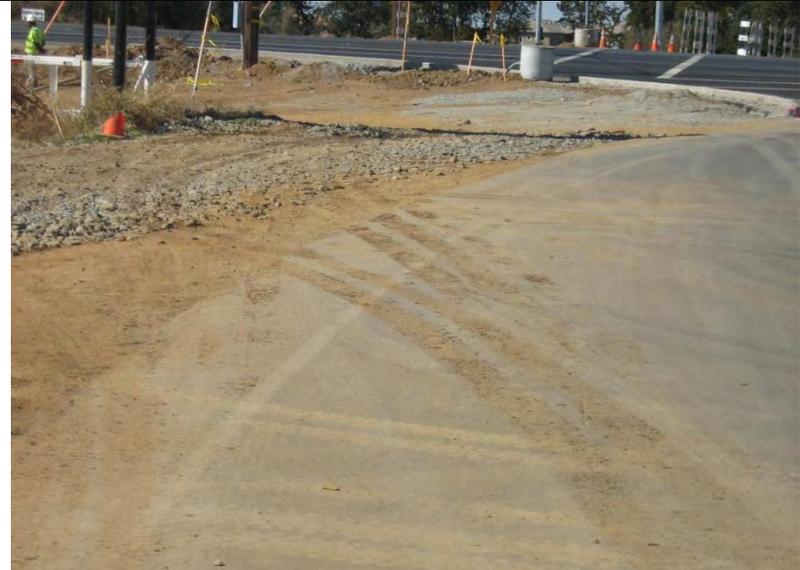
**Photograph 14 – Sediment transport from areas of disturbance onto Feather River Boulevard, a public roadway.**

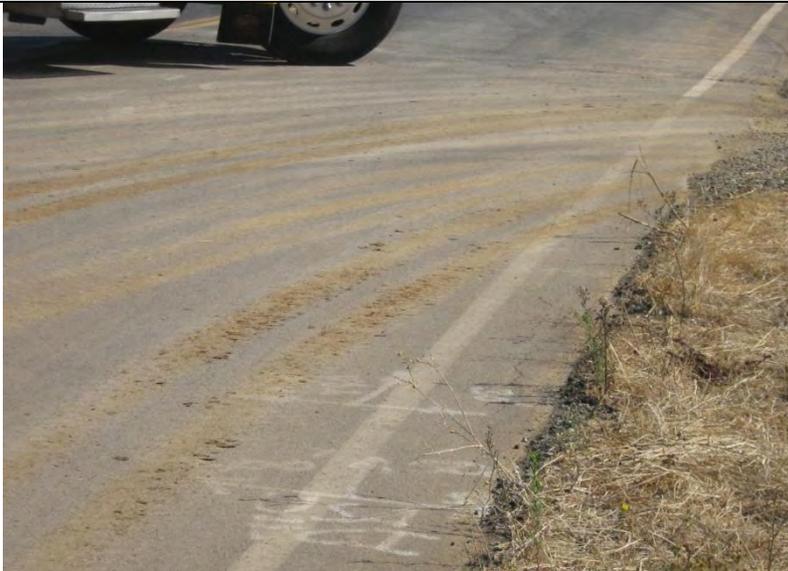
**Photograph 15 – Sediment transport from areas of disturbance onto Feather River Boulevard, a public roadway.**

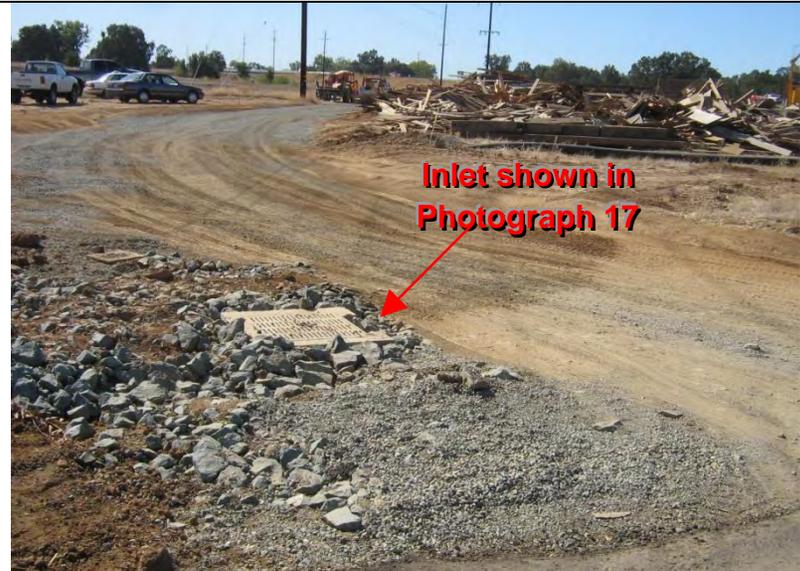
**Photographs 16 – Adequate inlet protection and vehicle tracking control BMPs had not been implemented adj. to entrance off Feather River Blvd.**

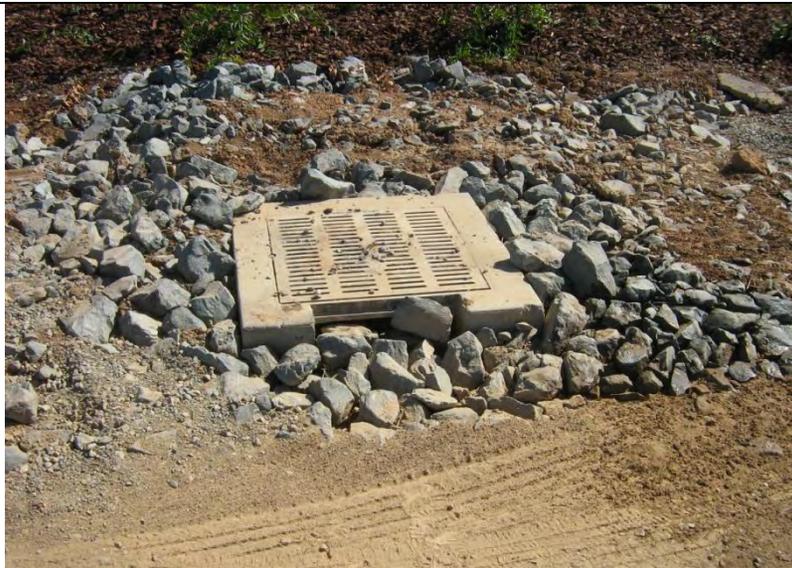
Photograph 17 – Close-up of Photograph 16. Adequate inlet protection had not been implemented.

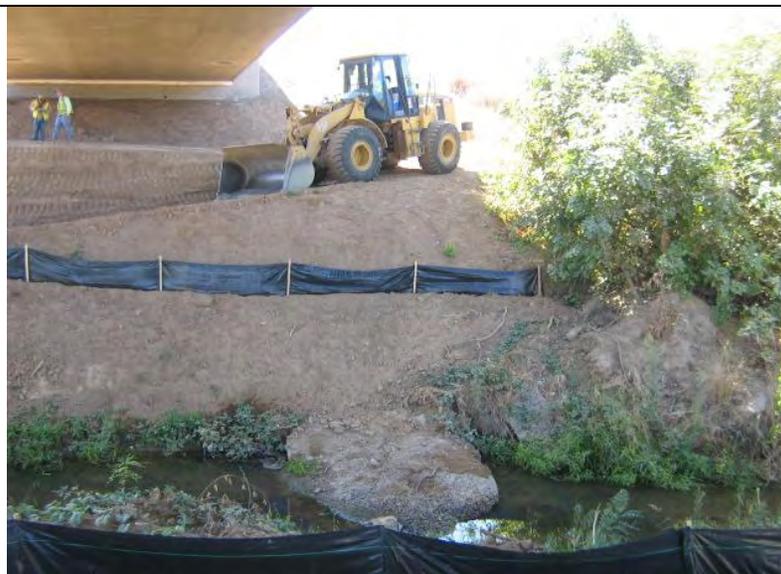
Adequate BMPs were not implemented to prevent the discharge of sediment from disturbed slope areas adjacent to Yankee Slough waterway. Specifically, BMPs had not been implemented for disturbed slope areas adjacent to Yankee Slough (see Photographs 19 and 20), and silt fence BMPs implemented at the toe of the disturbed slope adjacent to Yankee Slough had collapsed and were no longer effective at preventing the discharge of sediment to Yankee Slough (see Photographs 21 through 24). As a result, there was a potential for the discharge of sediment from the disturbed slope areas adjacent to Yankee Slough waterway.

Photograph 20 – Differing vantage point for Photograph 19

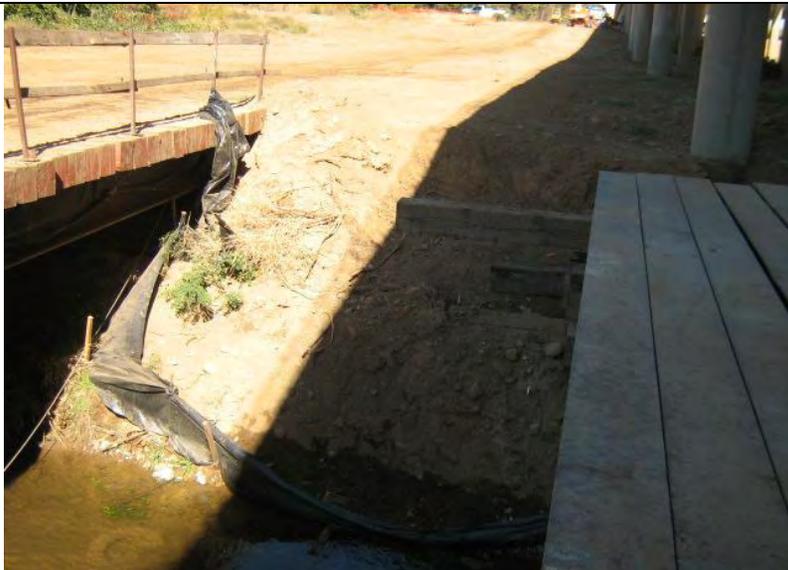
**Photograph 21 – Silt Fence BMP not properly maintained (e.g., collapsed) adjacent to Yankee Slough. Note area of disturbance up-gradient.**

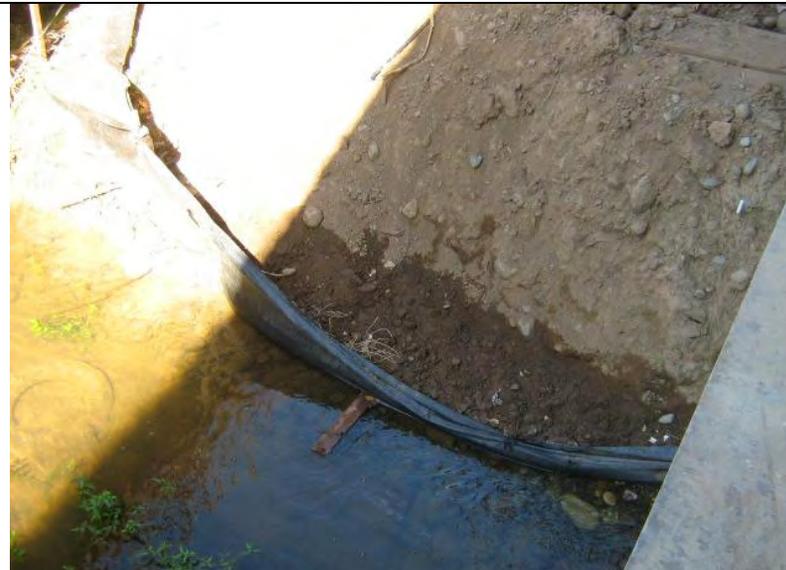
**Photograph 22 – Close-up view of Photograph 21.**
