## **Appendix D**

# **Construction Program Site Visit Reports**

**Site Visit No. 1**

**Thomes Creek Bridge Project**  
**Site Visit Date: 10/13/2009**

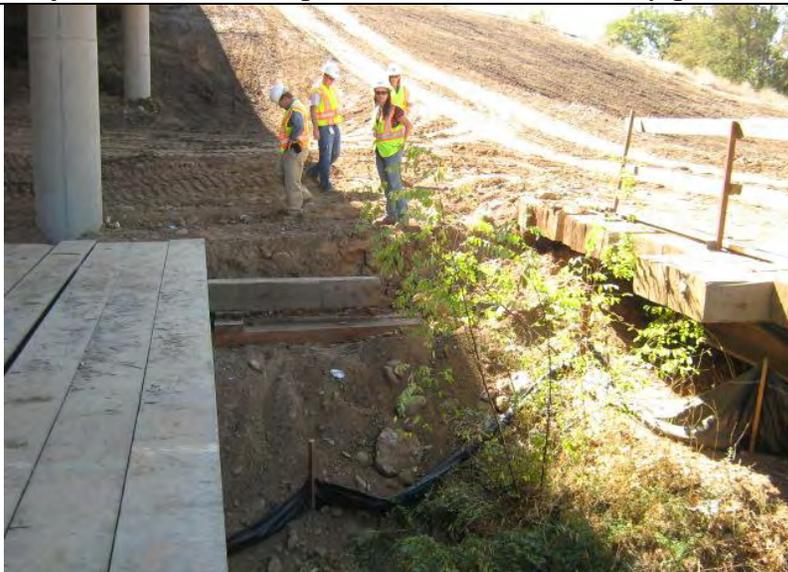
**Photograph 23 – Silt Fence collapsed in areas and not properly maintained. Note large unstabilized slope area upgradient.**

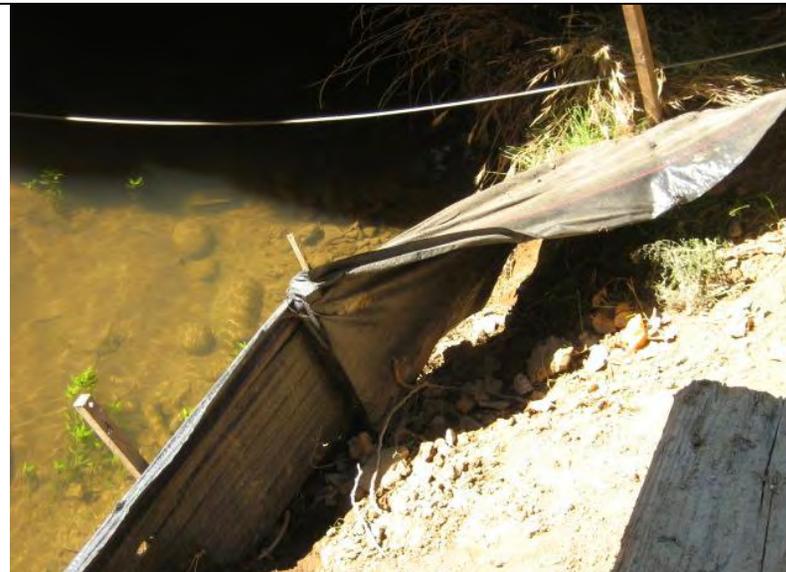
**Photograph 24 – Silt Fence not properly entrenched to retain sediment adjacent to Yankee Slough waterway**

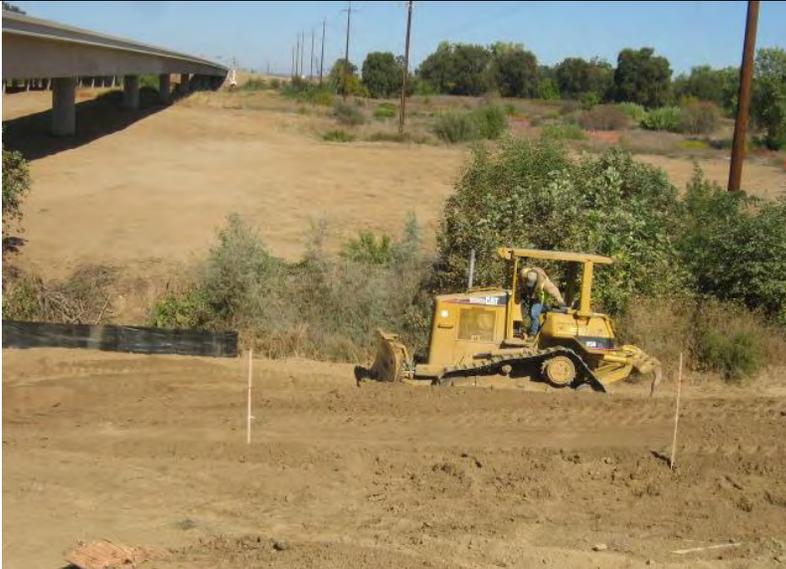
Photograph 25 – SF not adequately implemented for all land disturbing activities to prevent the discharge of sediment to Yankee Slough

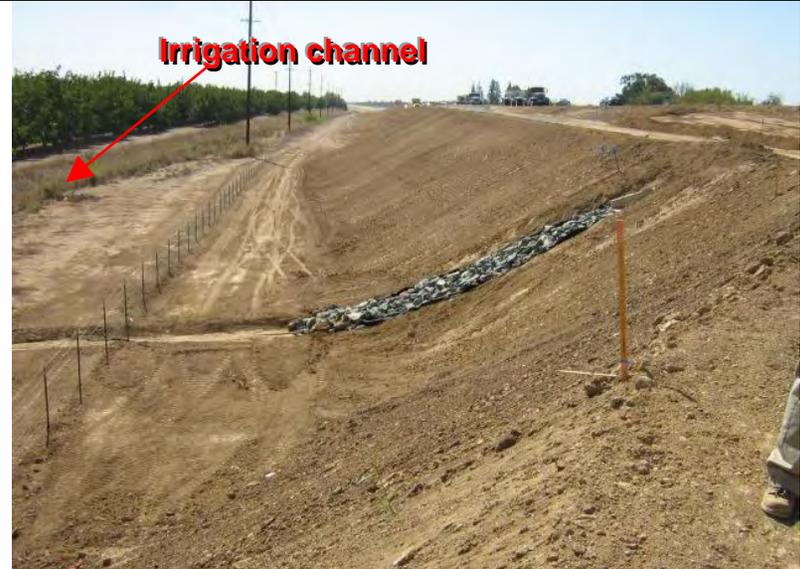
Photograph 26 – Large expanse of disturbed slope area with only rock and no perimeter BMPs.

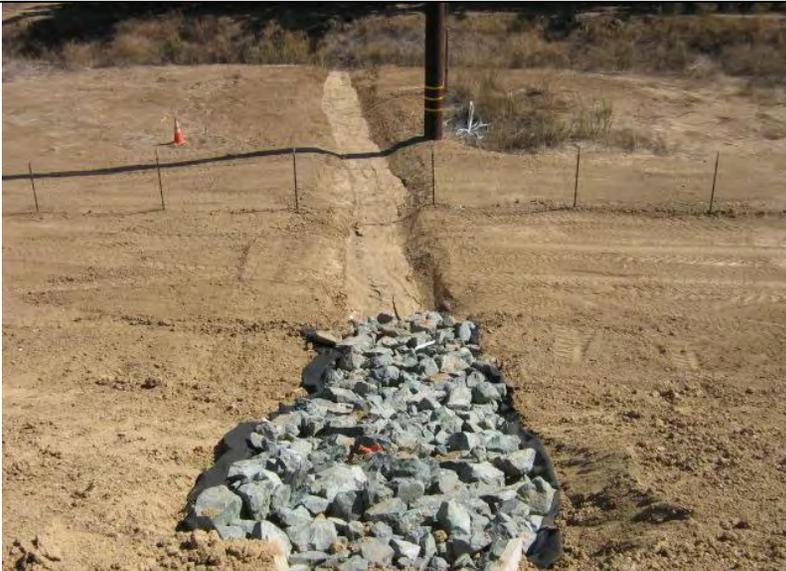
Photograph 27 – Slope drainage channel which drains to irrigation channel

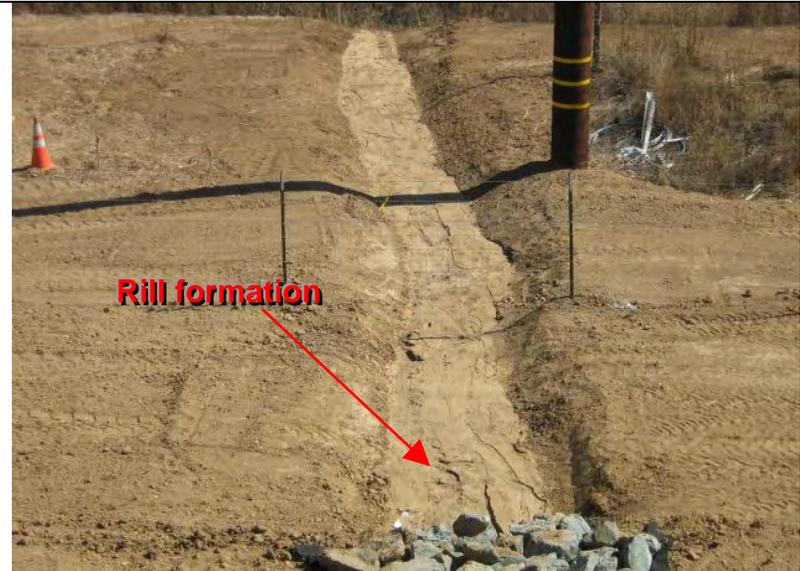
Photograph 28 – Previous erosion and sediment accumulation draining to irrigation channel. Flow dissipators do not extend entire length.

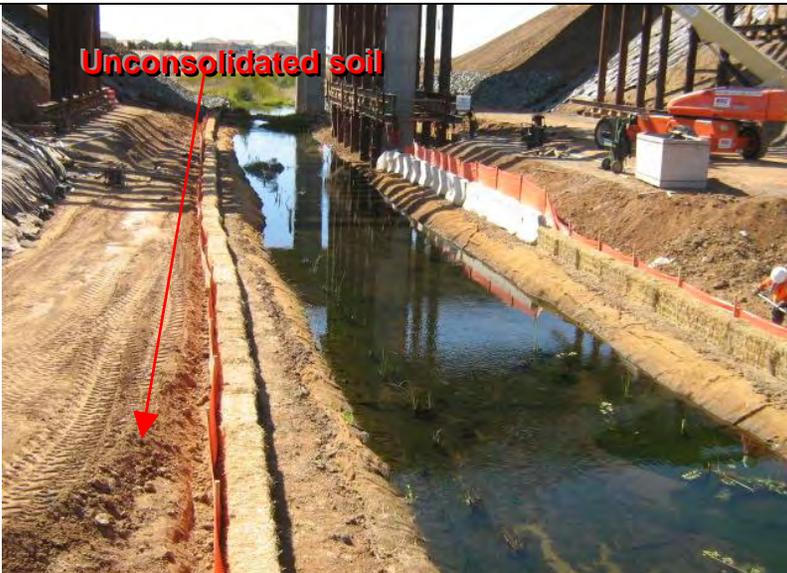
Photograph 3 – Unconsolidated soil placed between the toe of the slope and the perimeter control BMPs along the waterway

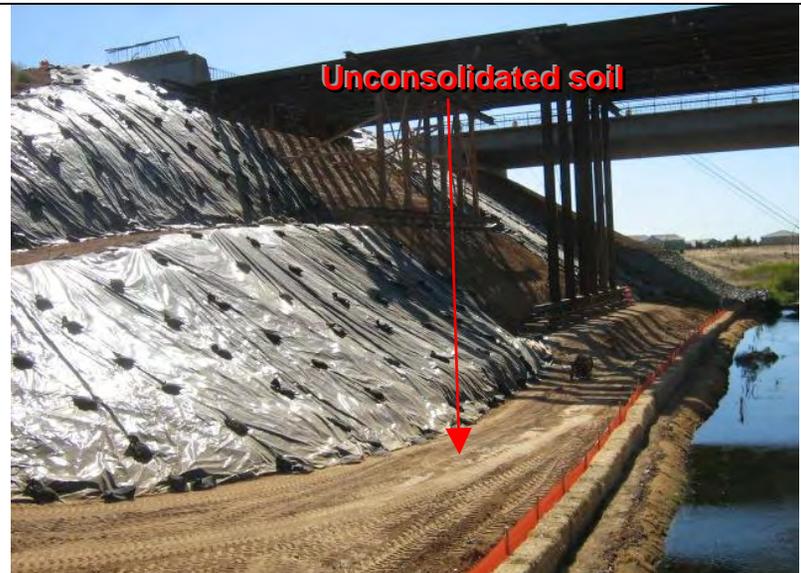
Photograph 4 – No BMPs to control concentrated flow off of the plastic and across the unconsolidated material at the toe of the slope

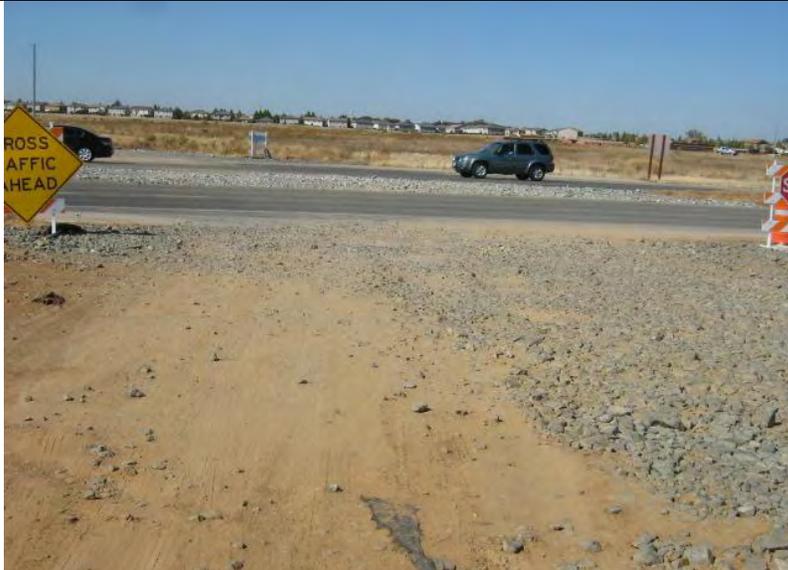
**Photograph 5 – Vehicle tracking pad BMP not adequately maintained (e.g., sediment in pad, and rock thin and sparse in areas)**

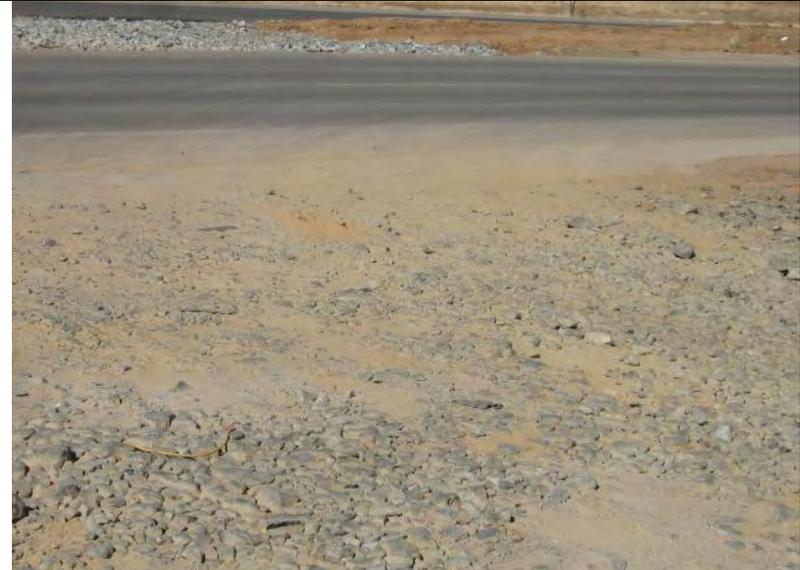
**Photograph 6 – Close-up of Photograph 5 depicting sediment in VTC pad, and rock which was thin, sparse and compacted in areas**

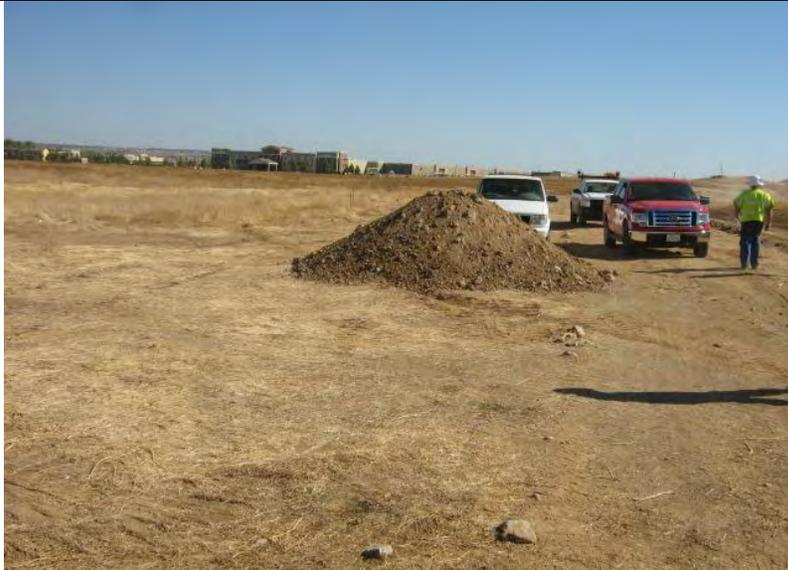
**Photograph 9 – No BMPs implemented for stockpile management near the North Ingram Slough bridge crossing**

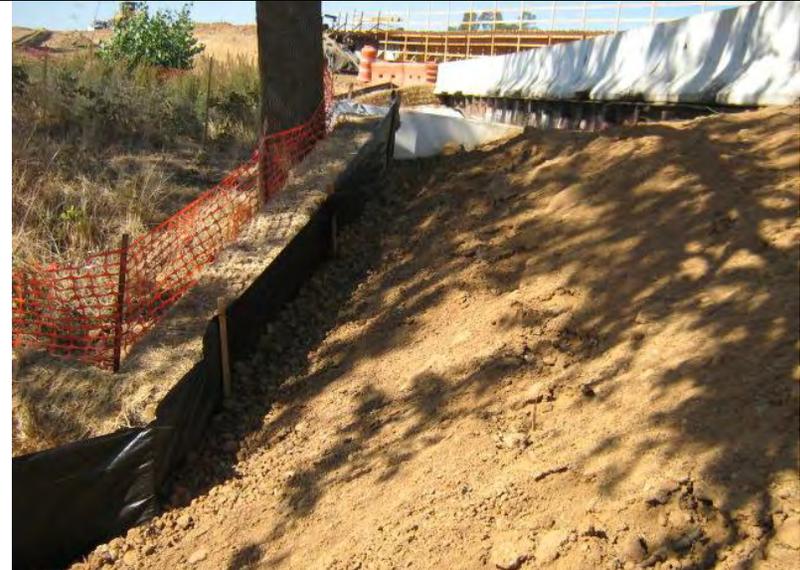
**Photograph 10 – Silt fence BMPs installed backwards (e.g., stakes on the upgradient side of the fabric)**

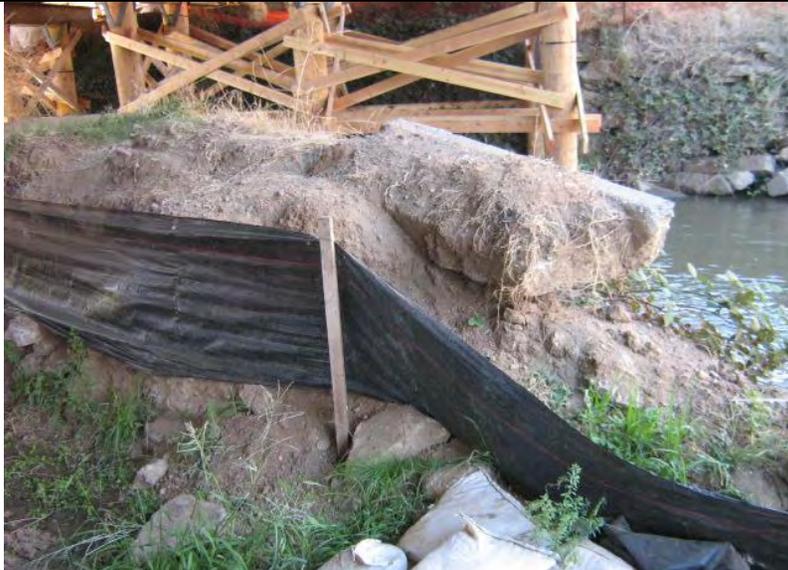
**Photograph 11 – Silt Fence BMPs not properly installed (e.g., not entrenched) or maintained (e.g., collapsed) adjacent to Auburn Ravine**

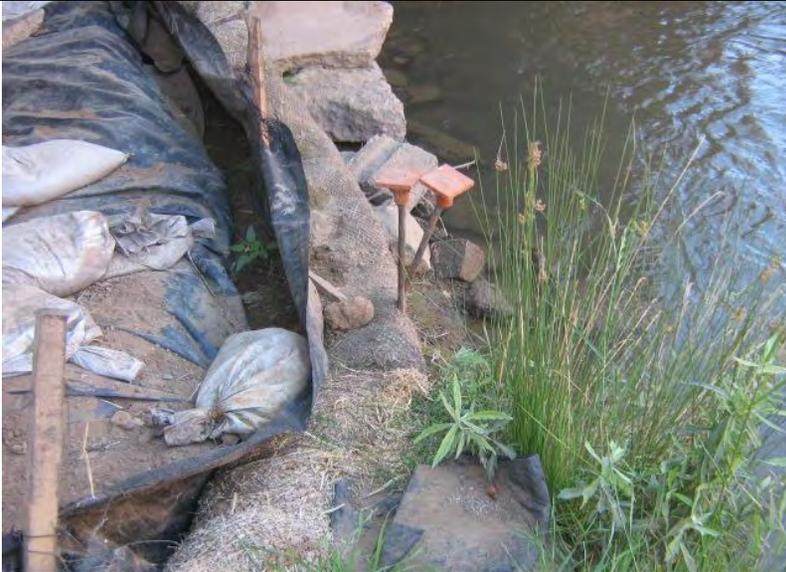
**Photograph 13 – Differing vantage point from Photograph 12 depicting unmaintained Silt Fence BMP adjacent to Auburn Ravine**

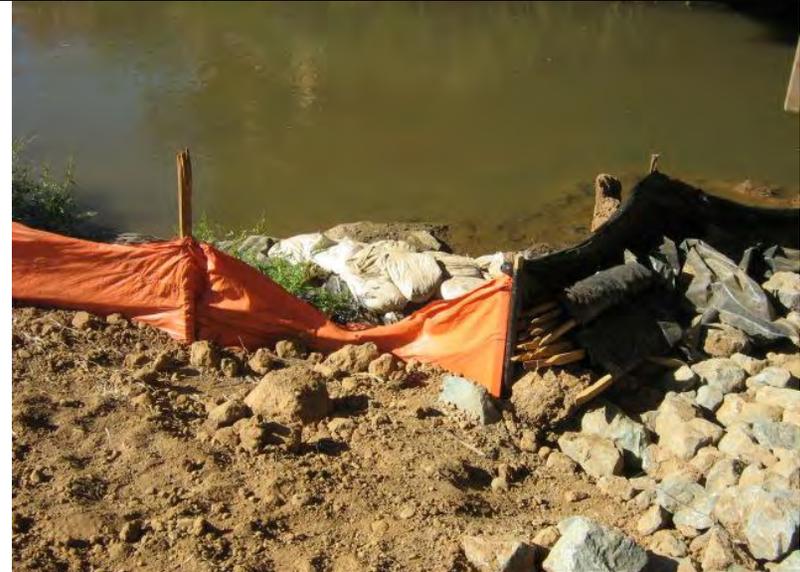
**Photograph 14 – Silt Fence BMP not adequately maintained (e.g., down in areas) adjacent to Auburn Ravine**

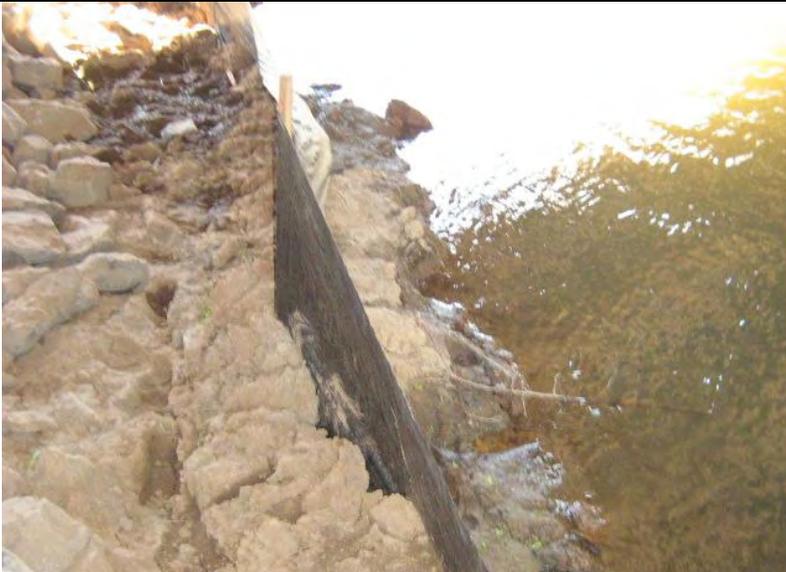
**Photograph 15 – SF BMP not adequately maintained (e.g., sediment placement over ½ the effective height) adjacent to Auburn Ravine**

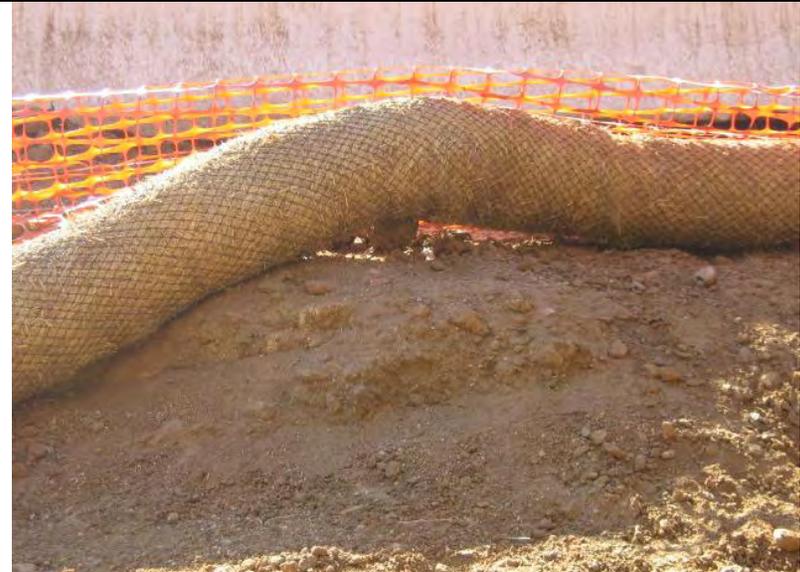
**Photographs 16 – Straw wattle BMP not properly installed (e.g., not entrenched) up-gradient of Auburn Ravine**

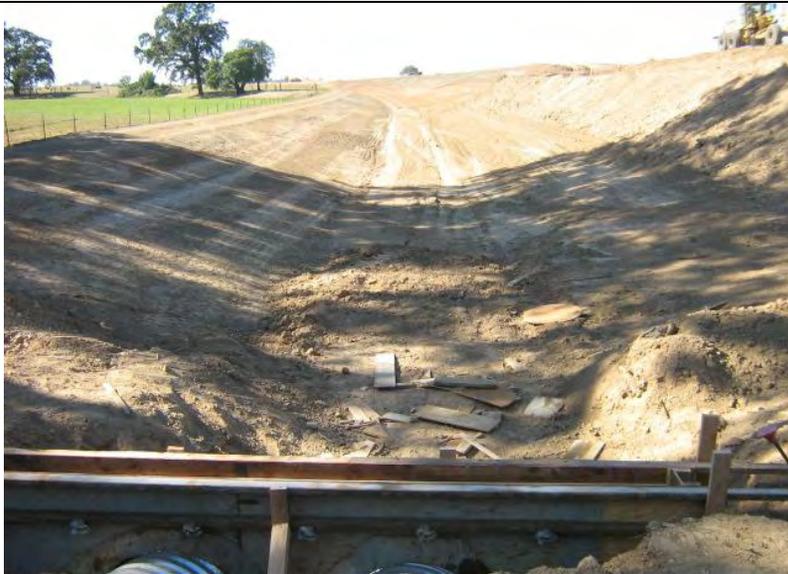
Adequate structural and non-structural BMPs were not implemented in the drainage swale conveyance channels located up-gradient of South Ingram Slough (see [Photograph 8](#)) and Auburn Ravine (see [Photograph 17](#)). BMPs had not been implemented to prevent erosion from run-on to the swale slopes, and concentrated flow along the bottom of the swale. As a result, there was a potential for erosion and subsequent discharge from these drainage swale conveyance channels to South Ingram Slough and Auburn Ravine, respectively.

**Photograph 17 – Upgradient areas of disturbance associated with pollution prevention BMP unstabilized. Drains to Auburn Ravine.**

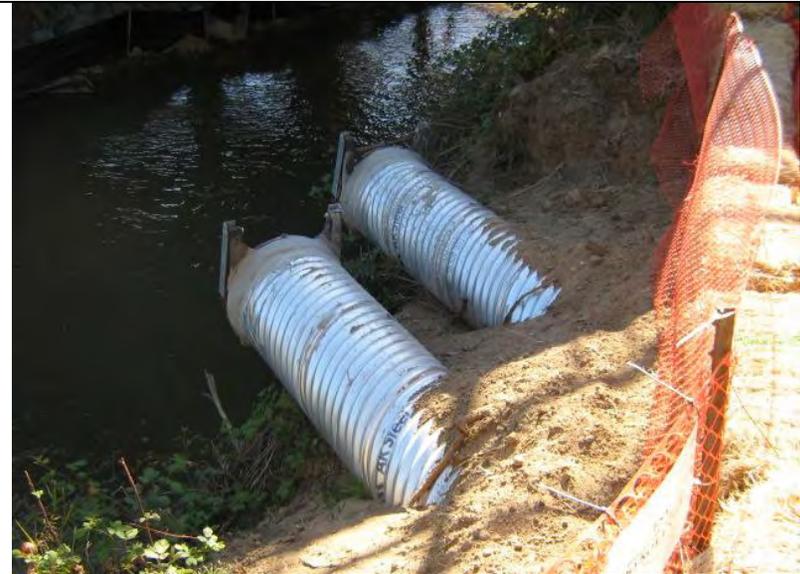
**Photograph 18 – Disturbed slope area adjacent to pollution prevention BMP outlet pipes adjacent to Auburn Ravine.**

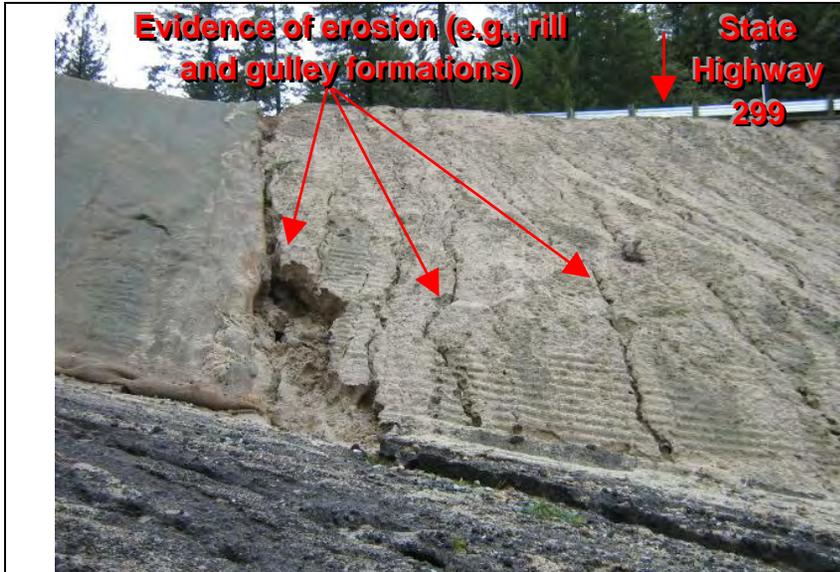
Specifically, adequate BMPs were not implemented to prevent the discharge of sediment from the field constructed sediment basins (see Photograph 9) and from disturbed slope areas adjacent to State Highway 299 (see Photographs 1 and 2). Visible evidence of a runoff event discharging sediment to the field constructed sediment basin No. 2 (see Photographs 2 and 3) and beyond the basin to the unnamed tributary of Crystal Creek (see Photographs 4 through 8) was observed. Visible evidence of a runoff event discharging sediment to the two field constructed sediment basins and sediment accumulation in the basins was observed during the inspection (see Photographs 9 through 12); and within the outlet conveyance channel (see Photographs 4 and 7) which subsequently drains to the unnamed tributary to Crystal Creek (see Photographs 5, 6 and 8).

Photograph 1 – Disturbed slope areas adjacent to State Highway 299 with evidence of erosion (e.g., rill and gully formations)

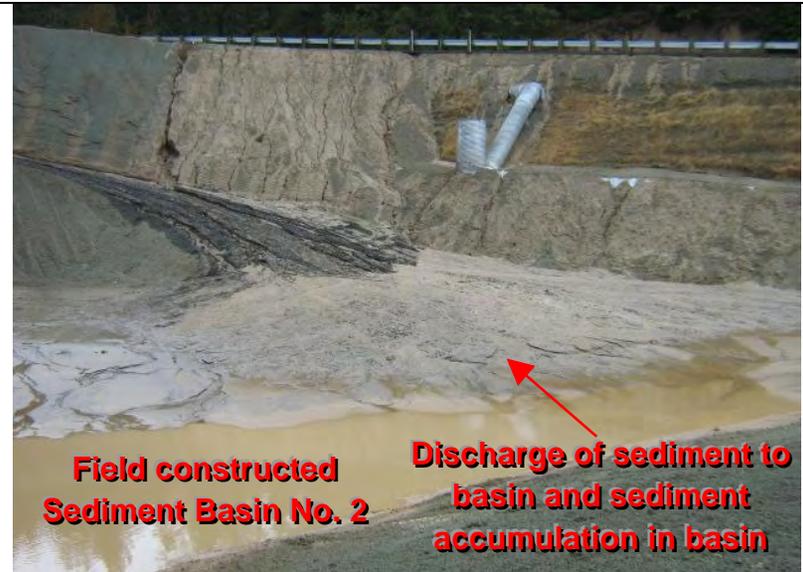
Photograph 2 – Discharge of sediment from disturbed slope area to field constructed sediment basin and sediment accumulation in the basin

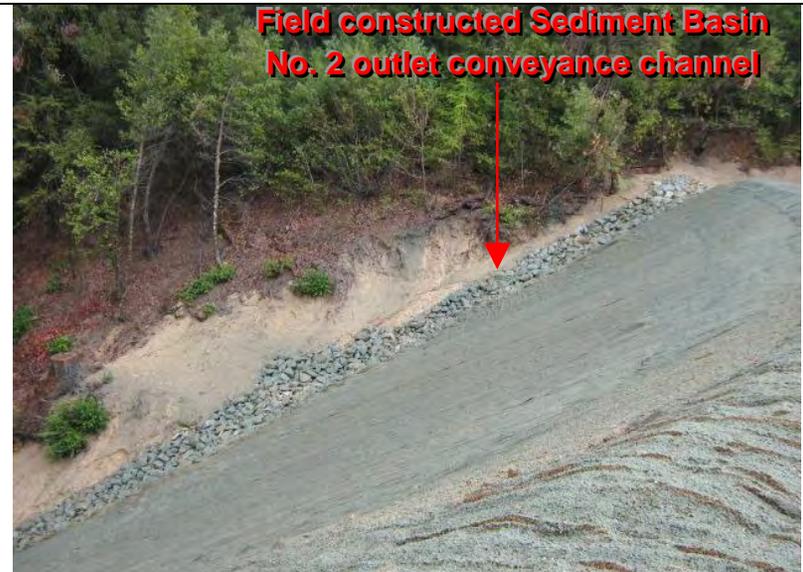
Photograph 4 – Vantage point of the outlet conveyance channel for the field constructed sediment basin No. 2

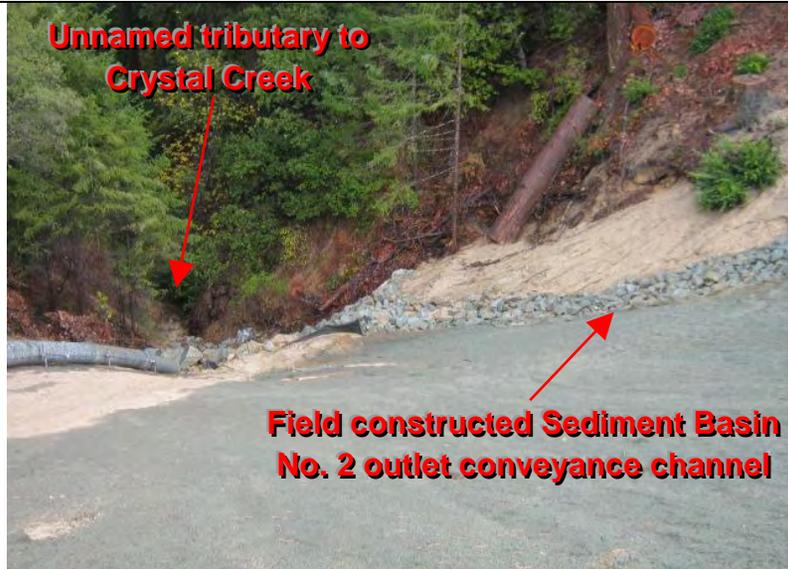
Photograph 5— View of sediment basin No. 2 outlet conveyance channel and confluence with the unnamed tributary to Crystal Creek

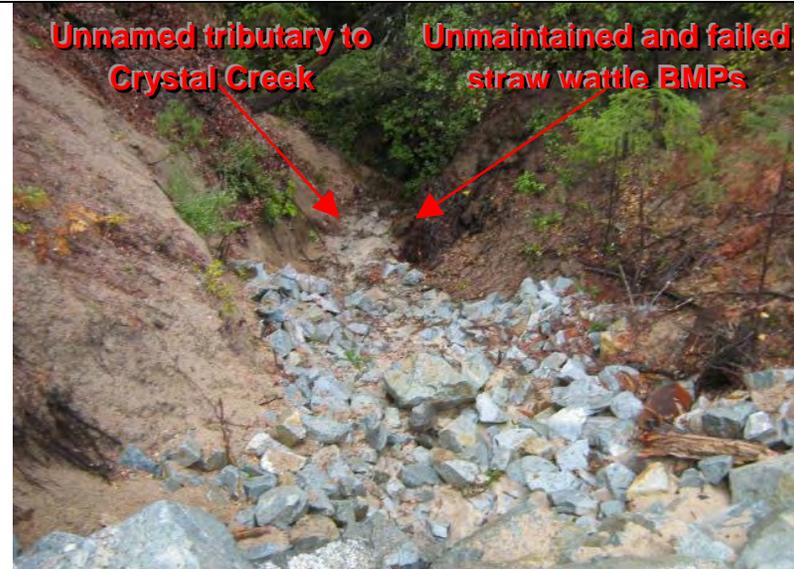
In addition to the up-gradient disturbed areas contributing sediment to and beyond the field constructed basins No. 1 and No. 2, adequate BMPs were not implemented below the basin No. 2 rip-rap outlet conveyance channel (see Photograph 6), at the base of the field constructed sediment basin No. 2 outer embankment slope (see Photographs 13 through 15), below field constructed sediment basin No. 1 culvert outlet pipe (see Photograph 16), and on disturbed slope areas adjacent to the rip-rap outlet conveyance channel. It should be noted that the sediment basins were field constructed, as provided by Caltrans District No. 2 representatives, and it was not known whether the basins were designed and constructed according to the Caltrans Pollution Prevention Design Guide (PPDG).

improper BMPs selection for an area of concentrated flow from the field constructed sediment basin No. 2 outlet conveyance channel (see [Photographs 6 and 8](#)). The silt fence BMPs implemented below the field constructed sediment basin No. 2 embankment slope were placed under a culvert pipe, had collapsed in areas, and evidence of sediment transport beyond the silt fence BMP to the unnamed tributary was observed (see [Photographs 13 through 15](#)). Adequate BMPs had not been implemented for flow dissipation below the field constructed sediment basin No. 1 culvert outlet pipe. Evidence of erosion (e.g., gully formation) and embankment undercutting was observed (see [Photograph 16](#)). Furthermore, BMPs were not implemented for disturbed slope areas adjacent to the rip-rap outlet conveyance channel which drains to the unnamed tributary to Crystal Creek (see [Photograph 17](#)). As a result, there was a discharge of sediment to the unnamed tributary which subsequently drains to Crystal Creek. Prohibition A.1 of the Permit states the “discharge of runoff from construction sites containing pollutants which have not been reduced using BAT for toxic pollutants and BCT for conventional pollutants to waters of the United States is prohibited.”

Photograph 6 – Close-up view of sediment basin No. 2 rip-rap outlet conveyance channel to unnamed tributary to Crystal Creek

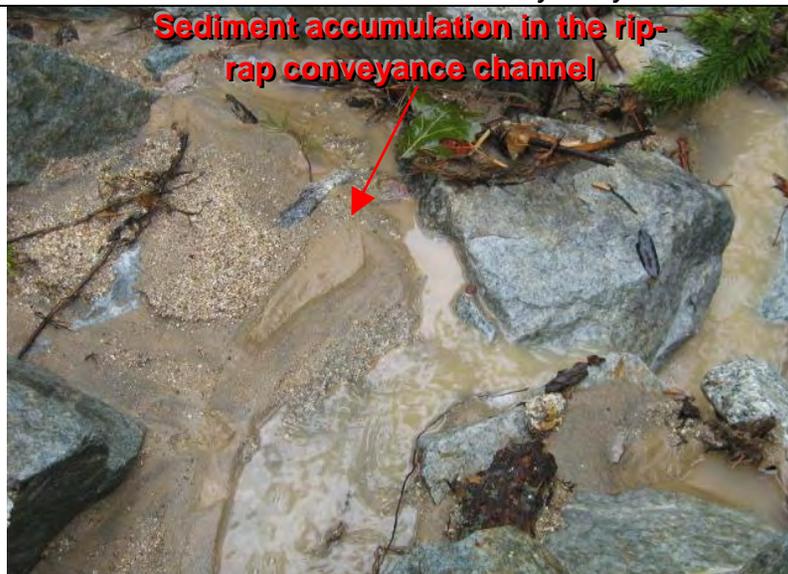
Photograph 7—Visible evidence of sediment accumulation in the rip-rap outlet conveyance channel which drains to the unnamed tributary

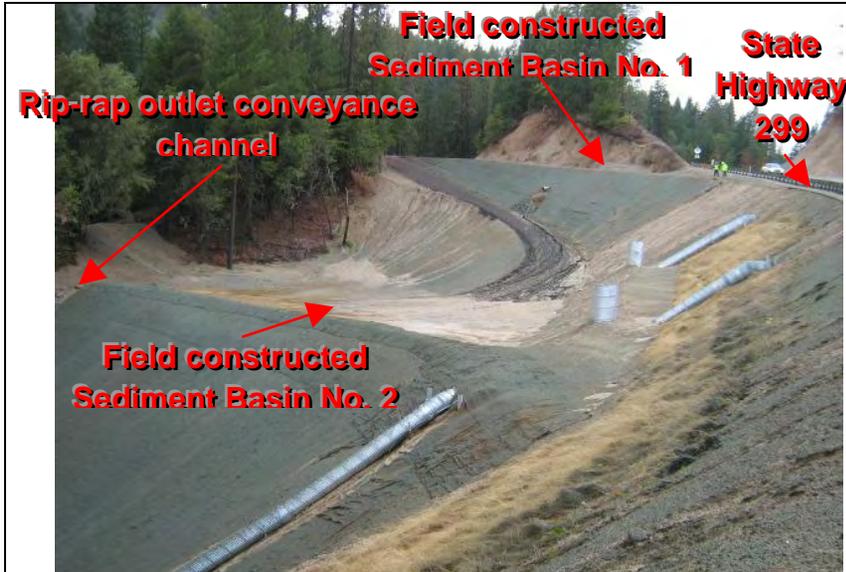
Photograph 9—Vantage point photograph depicting location of field constructed sediment basins No. 1 and No. 2 and their outlet.

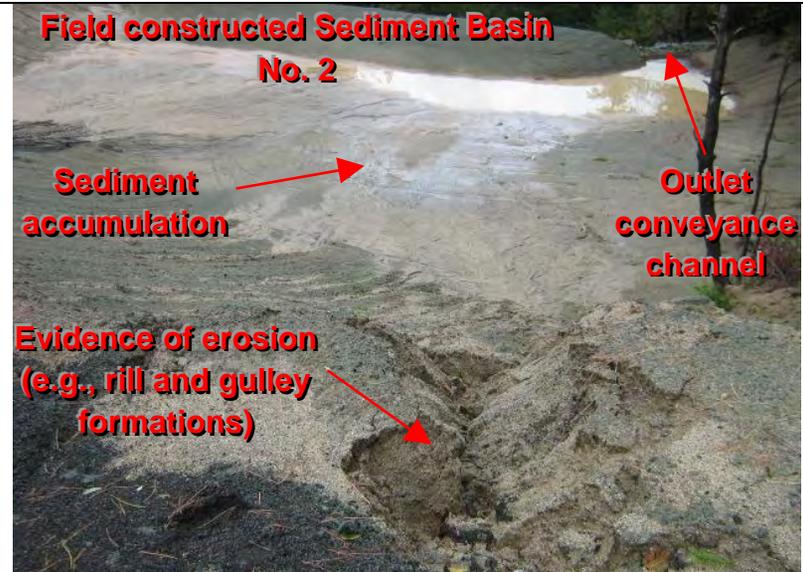
Photograph 10 – Evidence of the discharge of sediment to the basin and sediment accumulation in the basin which drains to unnamed tributary

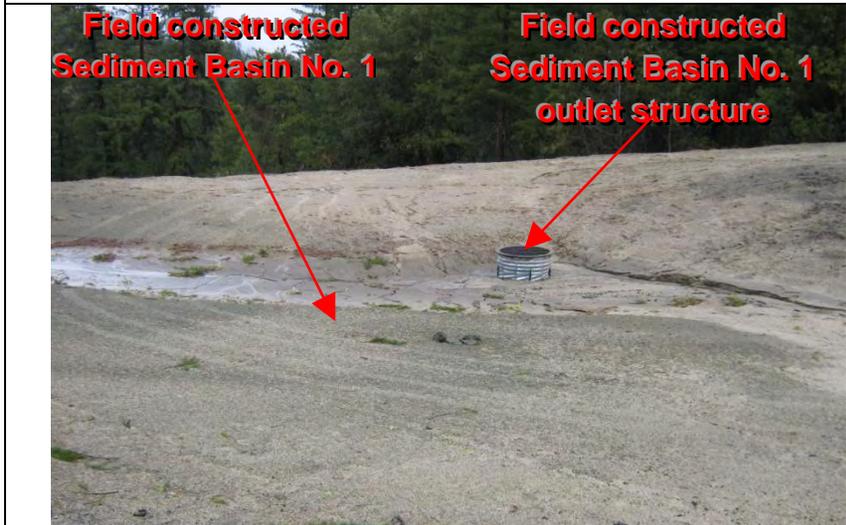
Photograph 11—Evidence of the discharge of sediment to and accumulated in the basin No. 1 which subsequently flows to basin No. 2 and the unnamed tributary to Crystal Creek

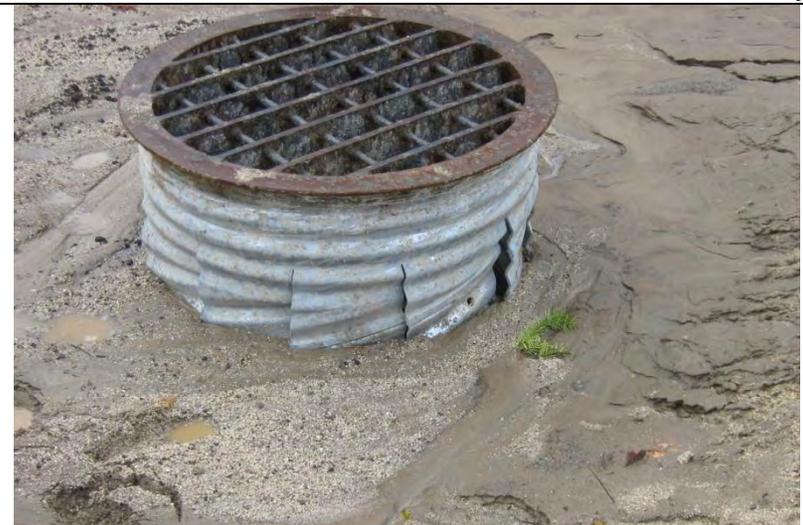
Photograph 12 – Close-up view of sediment basin No. 1 outlet structure with sediment accumulation

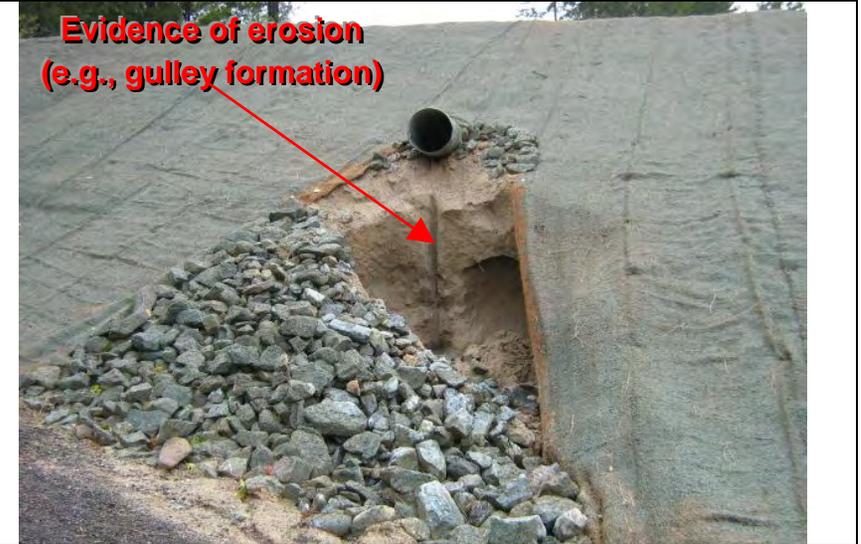
Photographs 16 – Adequate BMPs were not implemented below field constructed sediment basin No. 1 culvert outlet pipe.

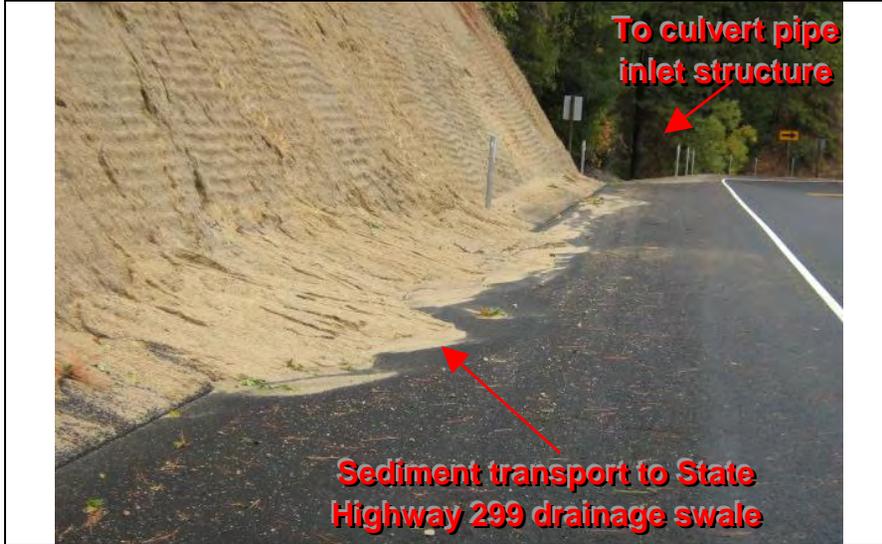
Photograph 19—Evidence of sediment transport to State Highway 299 drainage swale from the adjacent unstabilized disturbed cut slope area.

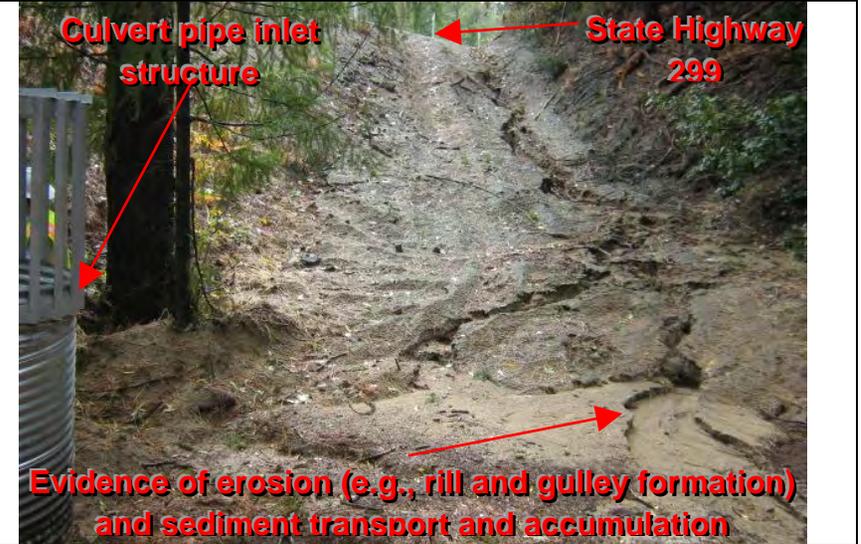
Adequate BMPs were not implemented for disturbed cut slope areas located adjacent to State Highway 299, which ultimately drain offsite via a culvert pipe inlet and drainage pipe leading to unnamed tributary to Crystal Creek. Specifically, adequate structural and non-structural BMPs had not been implemented for the disturbed cut slope areas (see [Photograph 18](#)), and evidence of erosion, cut slope failure and sediment transport were observed (see [Photographs 18 through 20](#)). As a result, there was evidence of sediment transport from the disturbed cut slope area to the adjacent State Highway 299 drainage swale which drains to the culvert pipe inlet area (see [Photograph 20](#)).

Photographs 20 – Evidence of erosion (e.g. rill and gully formation) and sediment transport from upgradient disturbed slope area (see Photo 18+19)

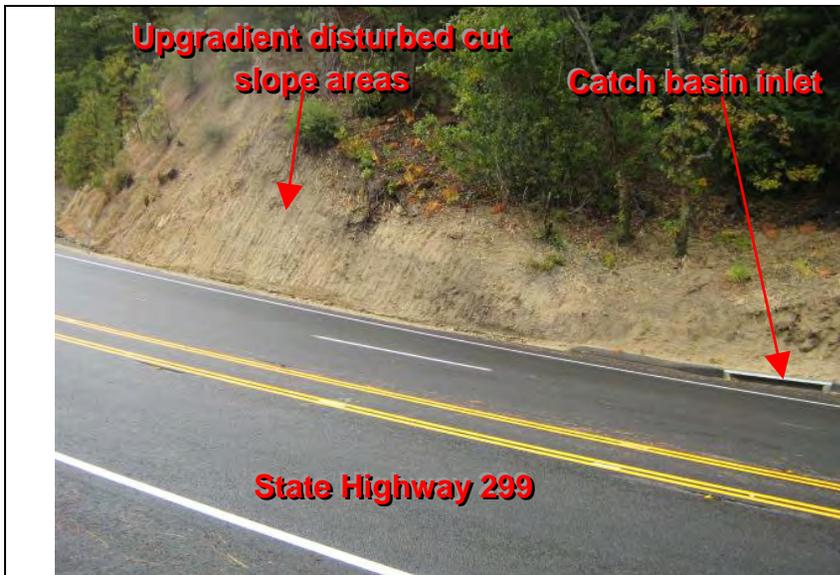
BMPs had not been implemented for catch basin inlets located in the flowline of the drainage swale associated with State Highway 299 roadway. Specifically, BMPs were not implemented to prevent the discharge of sediment to the catch basin inlets from up-gradient disturbed cut slope areas (see [Photographs 21 and 22](#)). As a result, there was a potential for the discharge of sediment to the catch basin inlet and associated culvert drainage pipe which subsequently drains to the unnamed tributary to Crystal Creek.

Photograph 21—BMPs were not implemented to prevent the discharge of sediment from up-gradient disturbed cut slope areas to catch basin inlets.

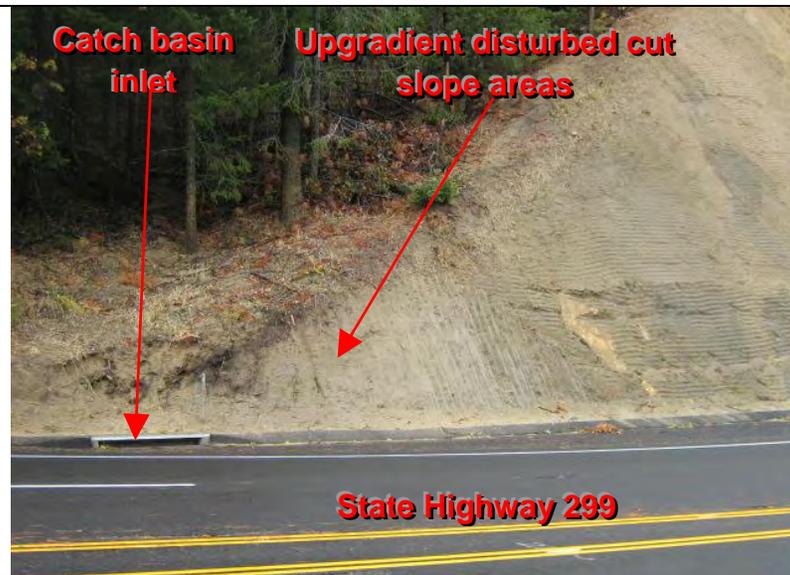
Photographs 22 – BMPs were not implemented to prevent the discharge of sediment from upgradient disturbed cut slope areas to catch basin inlets.

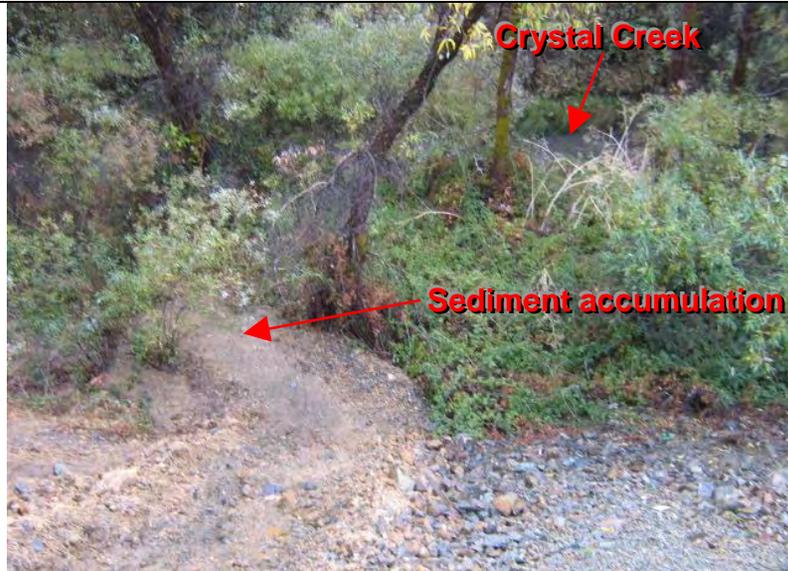
Photograph 5—Discharge of sediment and sediment accumulation in Crystal Creek

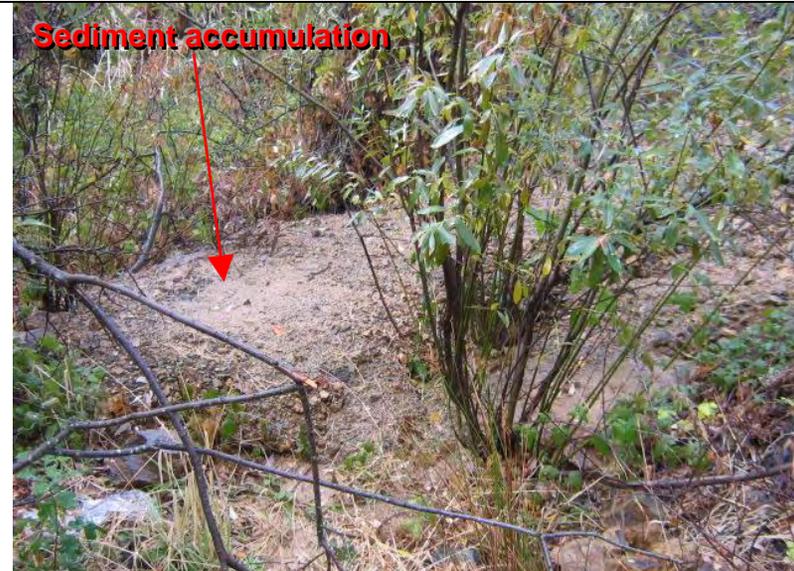
Photograph 6 – Close-up of sediment accumulation shown in Photograph 5

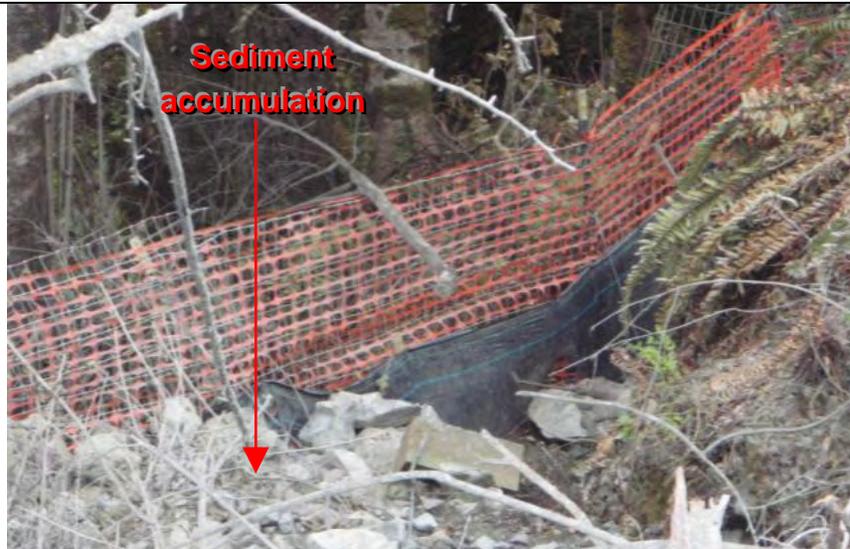
Photograph 3 – Example of sediment accumulation against silt fence BMP

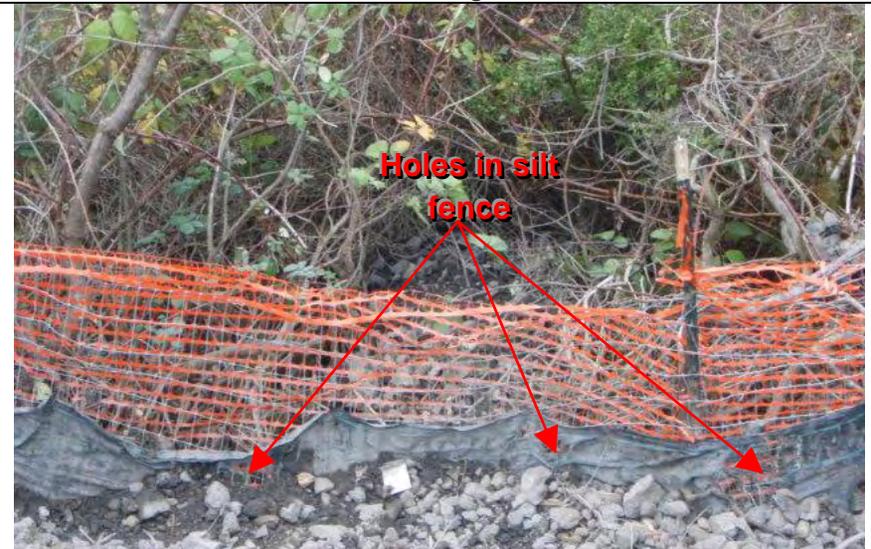
Photograph 4 – Another example of sediment accumulation and unmaintained silt fence

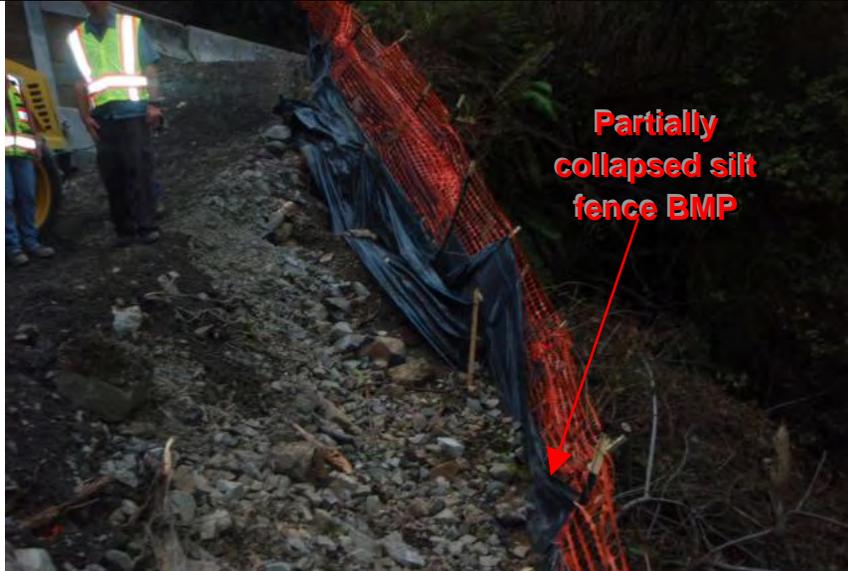
Photograph 5— Another example of sediment accumulation and unmaintained silt fence

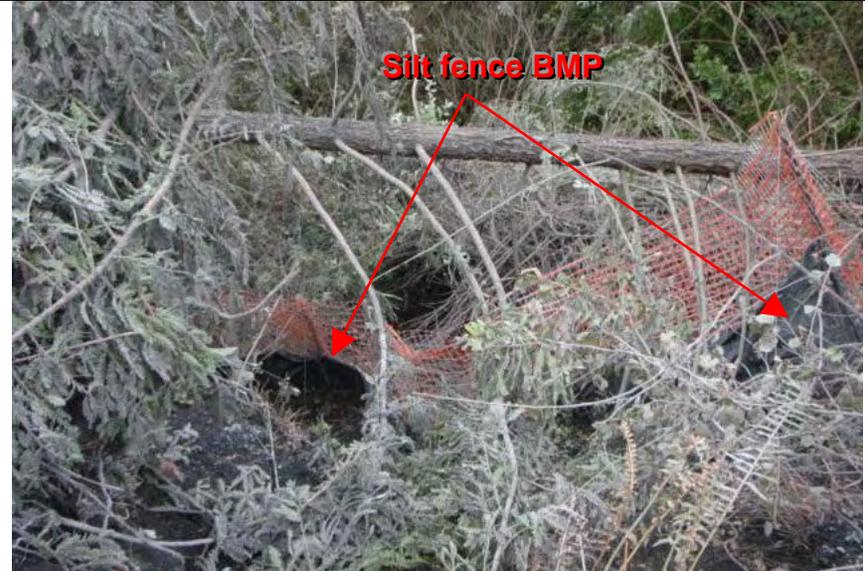
Photograph 6 – Example of silt fence BMP partially covered by collapsed vegetation

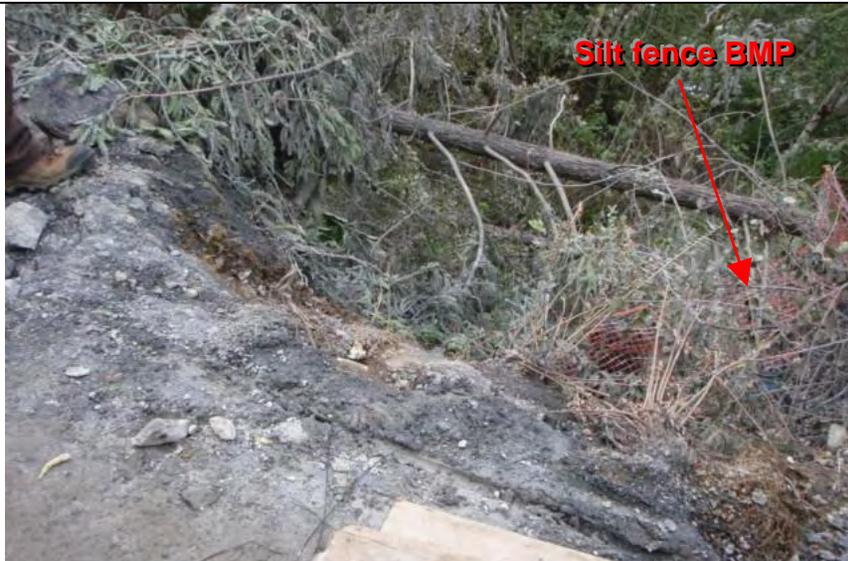
Photograph 7— Another example of silt fence BMP partially covered by collapsed vegetation - view down slope to silt fence BMP

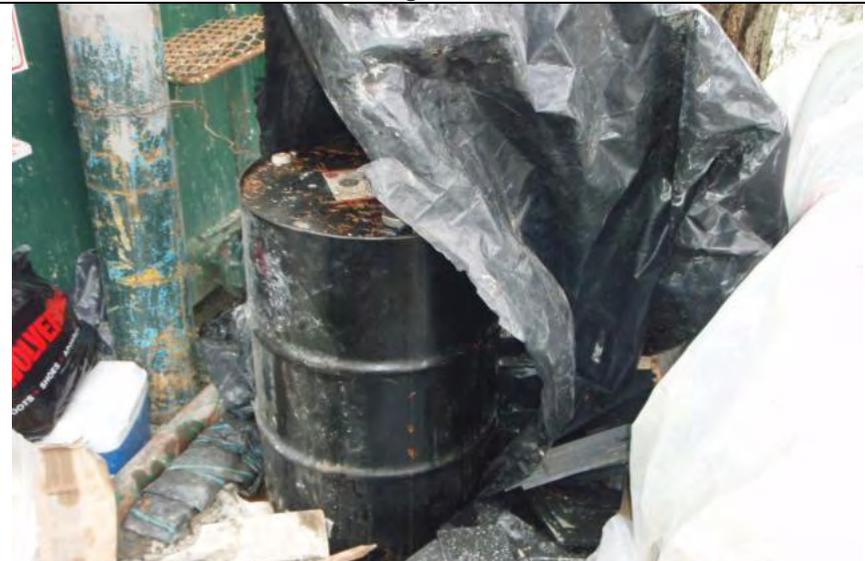
Photograph 8 – 55-gallon drum of “Rock Drill 150” that is partially covered and not within adequate secondary containment

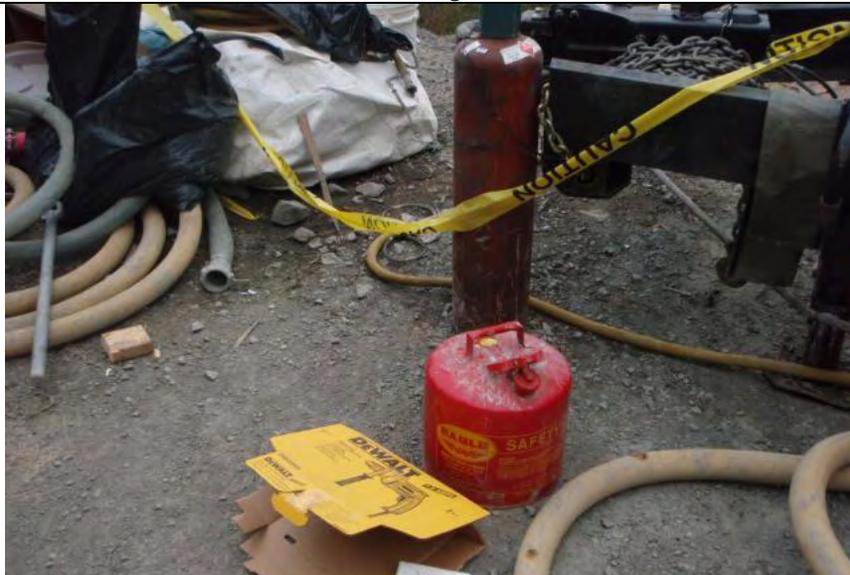
Photograph 11— Example of gas container not stored within secondary containment

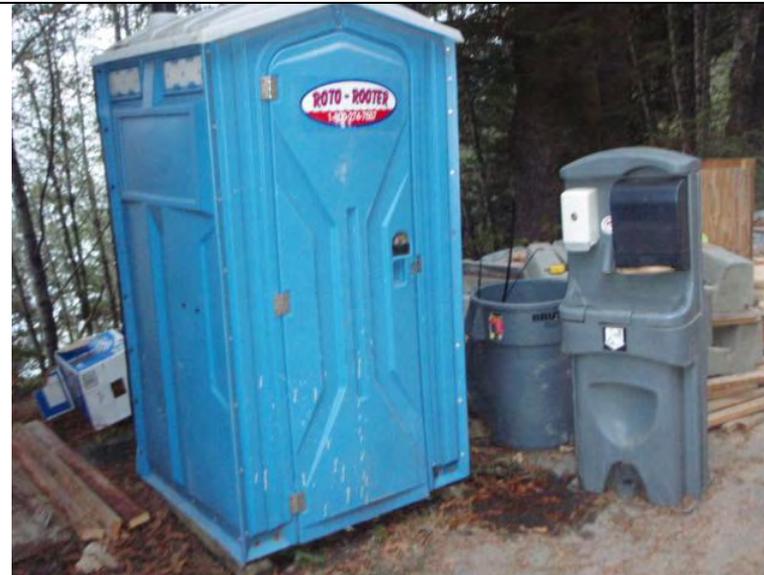
Adequate BMPs were not implemented at the construction site for good housekeeping to properly manage the storage of chemicals and materials on-site. Containers of various chemicals, including a form release agent and petroleum products, were improperly stored without secondary containment or coverage (see Photographs 8, 9, 10 and 11). In addition, a portable toilet was not staked into the ground or otherwise secured and was located adjacent to a steep slope (see Photograph 12).

Photograph 12— Portable toilet adjacent to steep slope
