## **Appendix D**

# **Construction Program Site Visit Reports**

**Site Visit No. 1**

**Thomes Creek Bridge Project**  
**Site Visit Date: 10/13/2009**

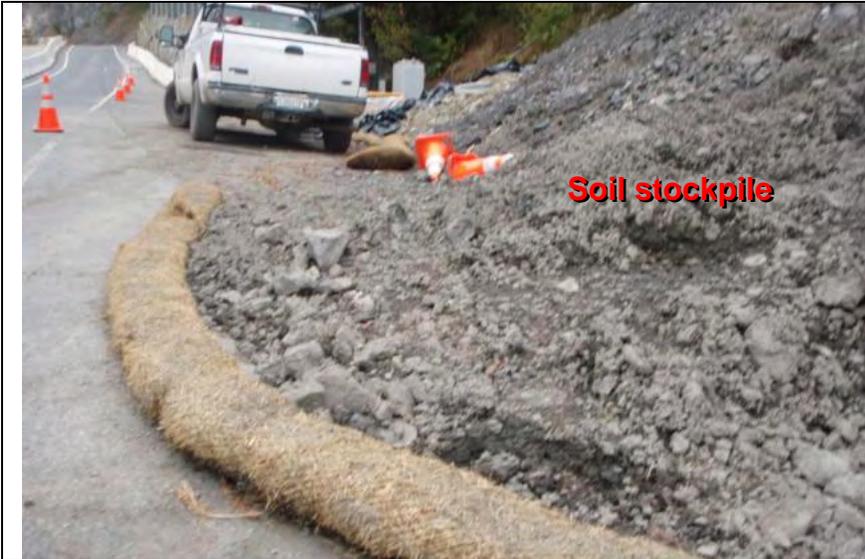
In addition, straw wattle BMPs used for stockpile management were improperly installed on impervious surfaces at the facility, and therefore were not properly entrenched in the ground to retain the stockpiled materials (see Photographs 13 and 14). As a result, there was a potential for the discharge of sediment to the roadway and off-site to the west. The Resident Engineer explained that the SWPPP had been amended to include the use of straw wattle BMPs on impervious surfaces; however, this was not confirmed by the EPA Audit Team.

Photograph 13— Straw wattle not staked or entrenched into ground. Inappropriate application of wattles on impervious surface

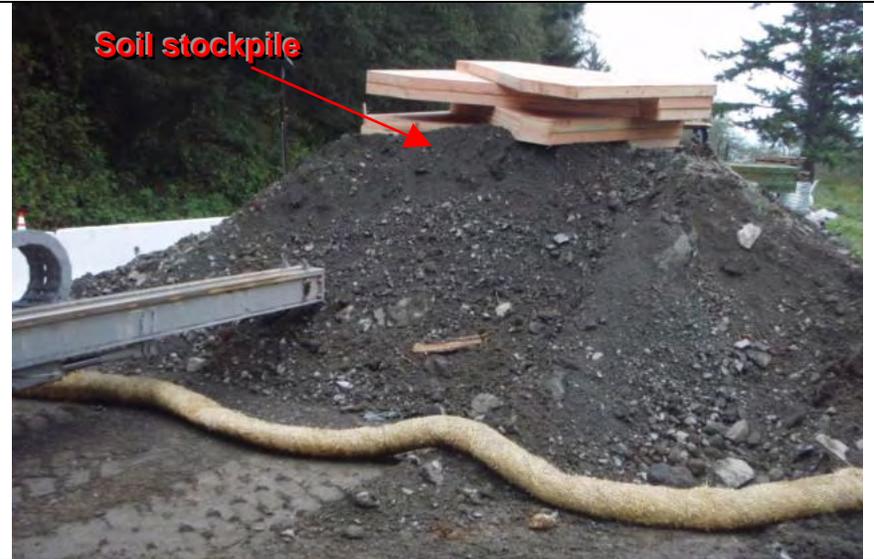
Photograph 14— Another example of straw wattle not staked or entrenched into ground. Inappropriate application of wattles on impervious surface.

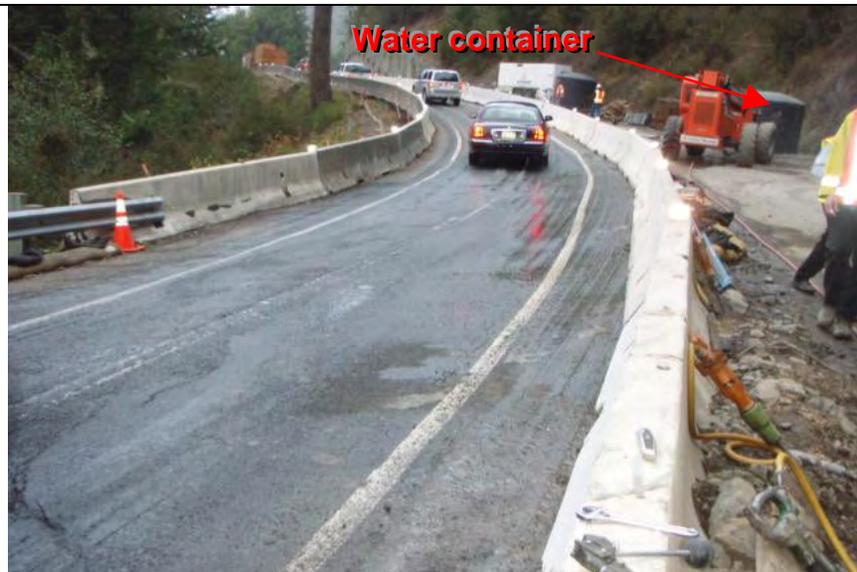
The EPA Audit Team observed that a water storage tank (approximately 1,000-gallon capacity) located up-gradient had been punctured by a forklift and was leaking (see Photographs 15 and 16). Water was observed slowly flowing underneath the straw wattle BMPs that been placed on the impervious roadway surface adjacent to K-rail barriers near the southern end of the construction project (see Photograph 17). The straw wattle BMPs had been installed prior to the puncture incident. Water had flowed underneath the straw wattles and jersey barriers and was observed on the adjacent roadway (see Photograph 18).

Photograph 18— View up-gradient to water container (Note: Wetness on roadway surface down-gradient of water container)

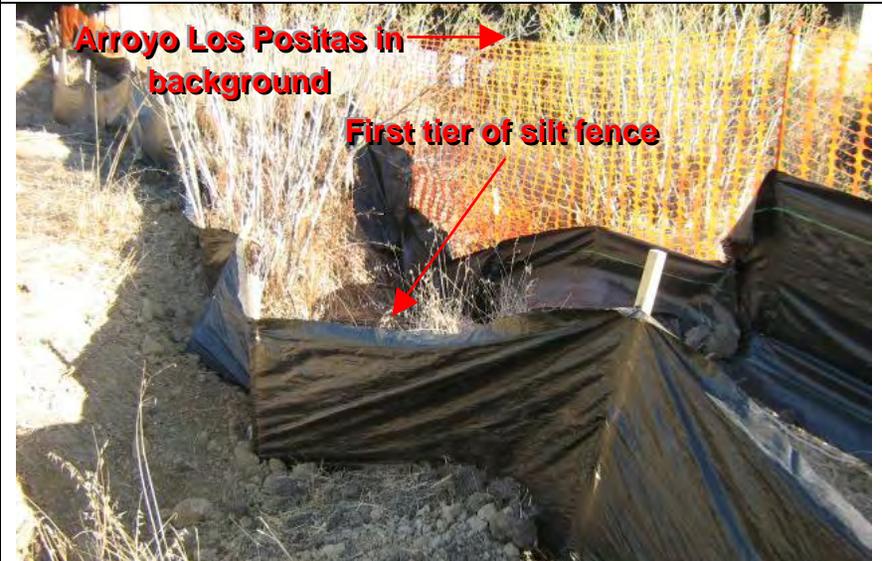
In an area located upstream of the constructed diversion near the entrance to the construction access road, a silt fence BMP was improperly installed in a drainage depression leading to Arroyo Los Positas and had partially collapsed. Although two tiers of silt fence had been installed for BMP redundancy, both tiers were in need of maintenance and the first tier of silt fence had failed (see Photographs 4 and 5). As a result, there was a potential for the discharge of sediment to Arroyo Los Positas.

Photograph 4 – Silt fence BMP installed in a drainage depression

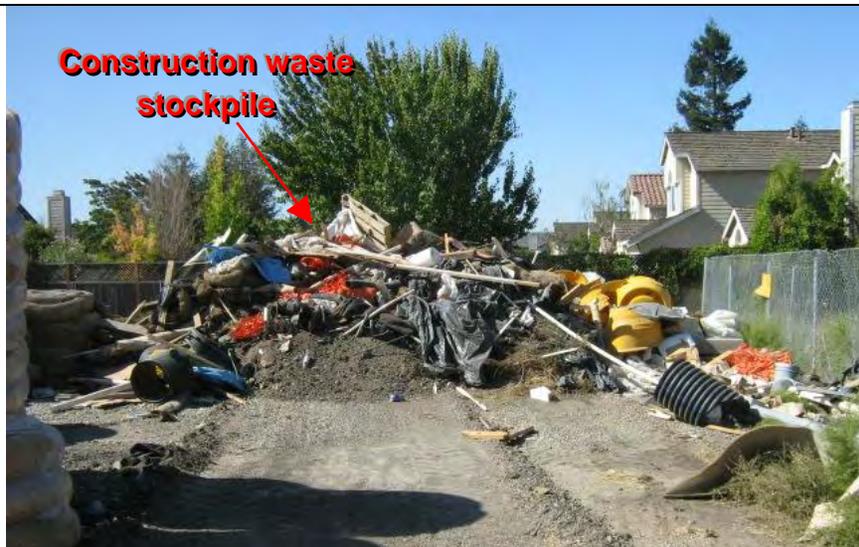
Photograph 5— Uncovered and uncontained construction waste

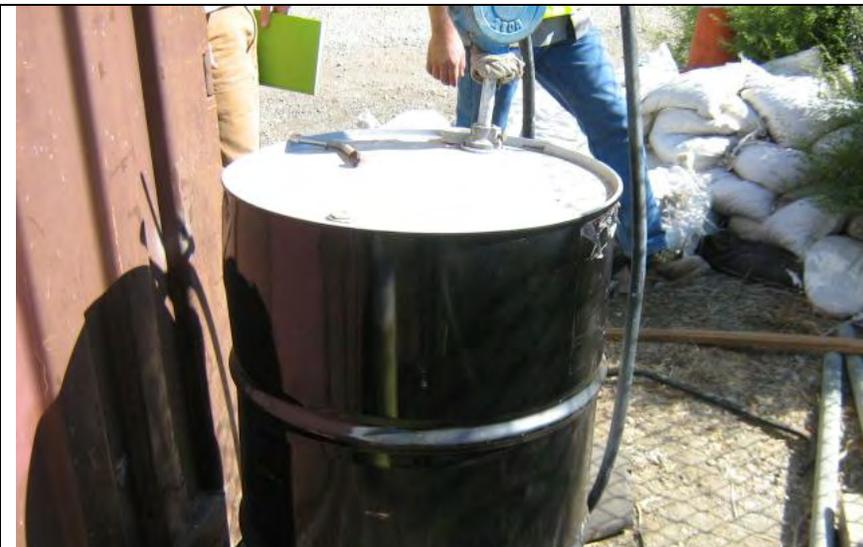
Photograph 6 – Asphalt release agent without secondary containment

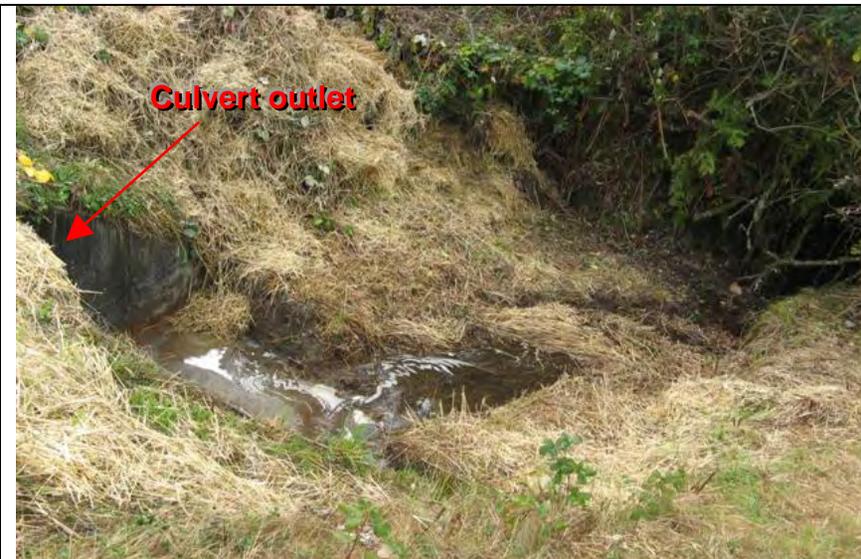
Photograph 6 – West side of culvert outlet (Note: Straw around and within drainage channel)

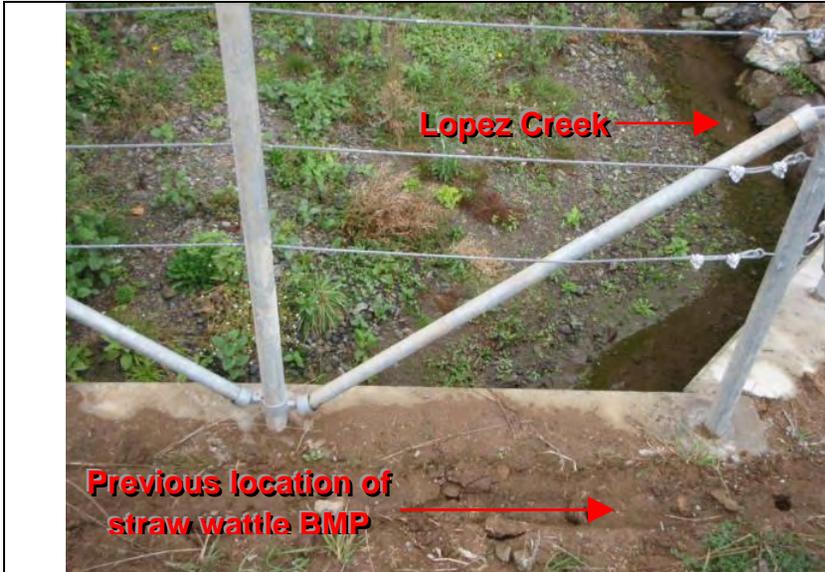
Photograph 9— Another view of the area above the culvert crossing of Lopez Creek

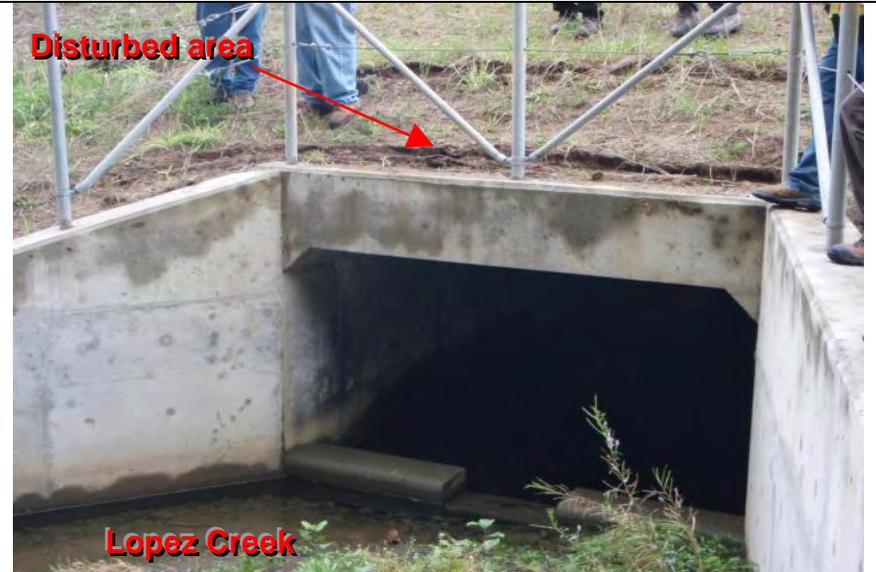
Photograph 10— Culvert crossing of Lopez Creek

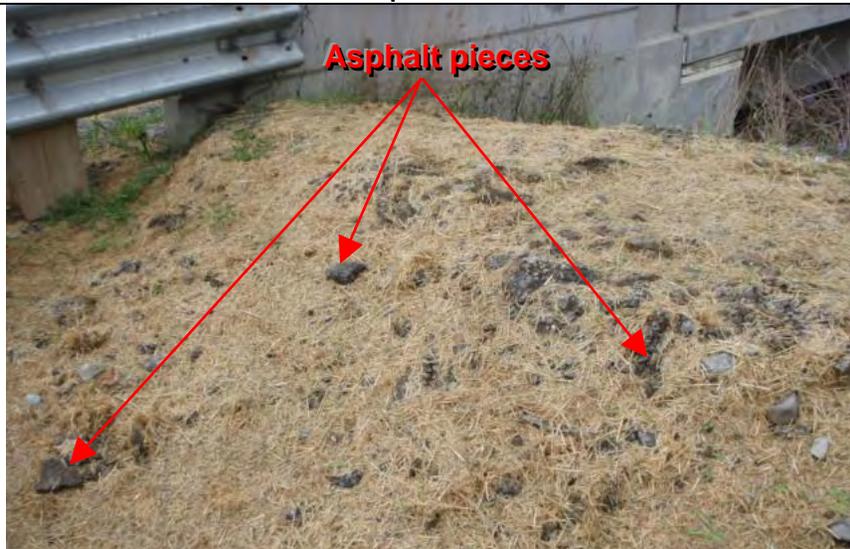
Photograph 11— Sidecast asphalt pieces along side of roadway at northern end of construction project

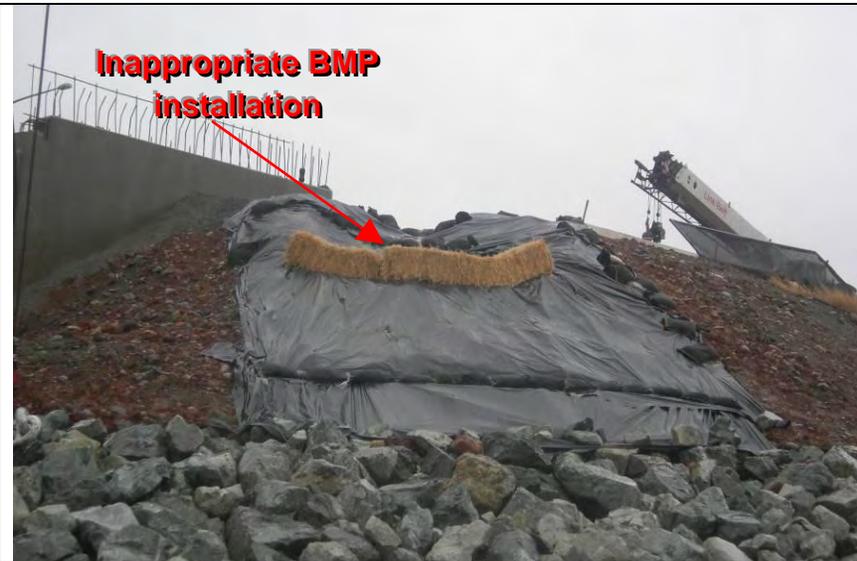
Provision H.1.b of the Permit requires Caltrans to implement a program to control all construction in the rights-of way and states that “program must include requirements of structural and nonstructural BMPs.” Appendix D of the SWMP contains the “Statewide Storm Water Quality Practice Guidelines” which provide a description of each approved BMP for statewide application. Adequate BMPs were not implemented for the disturbed areas associated with the replacement construction of the Sacramento River Bridge (a four span concrete box girder bridge replacement). Specifically, portions of the disturbed slope area along the southeastern side of the bridge had been temporarily stabilized and the hay bale flow dissipation BMPs had been improperly installed on an impervious surface (see Photograph 1).

Photograph 1 – View of disturbed slope at Sacramento River Bridge

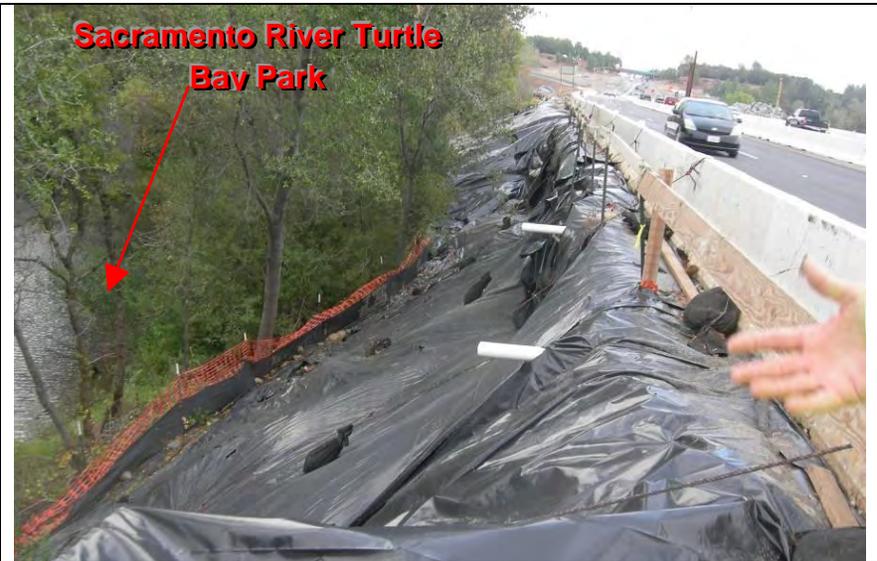
In an area along the northern portion of Interstate 5 and east of the Auditorium Drive Bridge, a perimeter control silt fence located at the toe of the slope had failed (see Photographs 2 and 3). As a result, there was potential for the discharge of sediment offsite into the Sacramento River Turtle Bay Park (see Photograph 3).

Photograph 2 – View of temporary plastic slope stabilization along the north side of I-5, at the terminus of the bike path

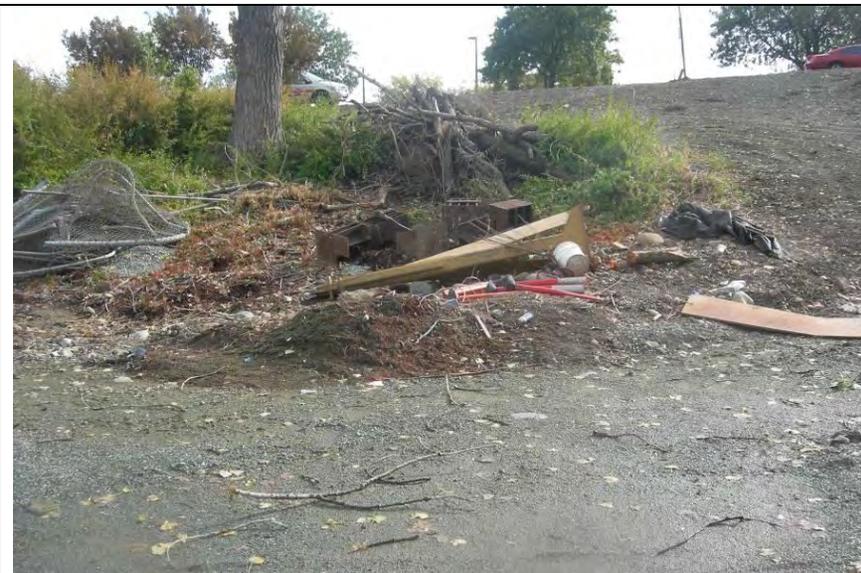
**Photograph 5 – Lack of perimeter control BMPs around a construction material disposal stockpile**

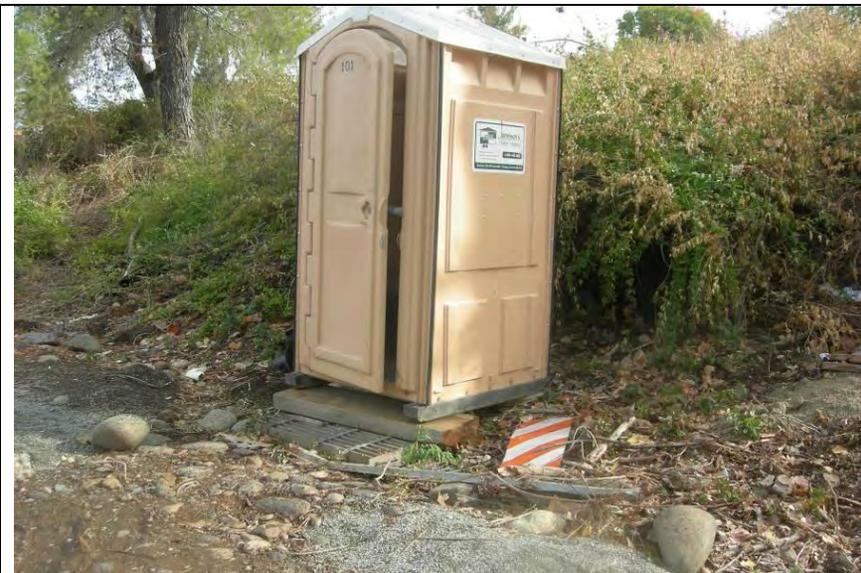
**Photograph 6 – View of unsecured portable toilet**

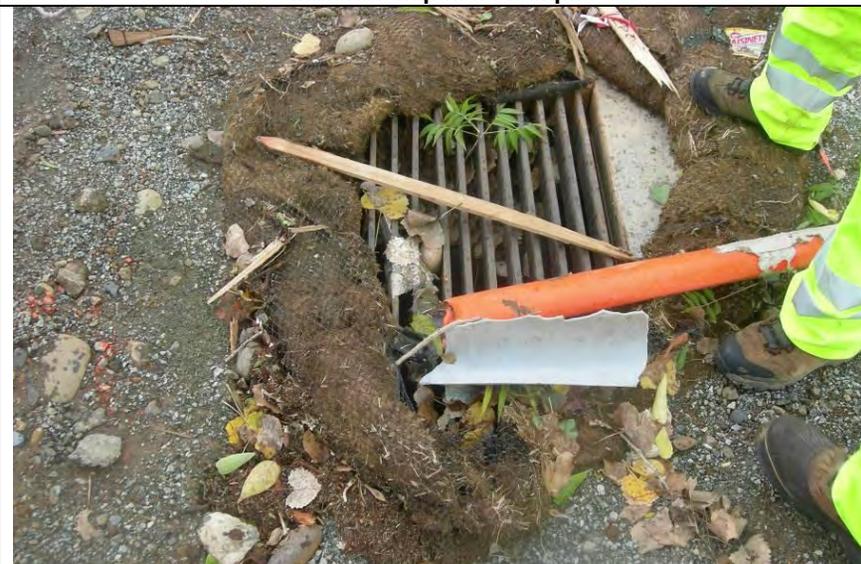
**Photograph 7 – Storm drain inlet at the northwestern portion of the Auditorium Drive Bridge temporary staging area**

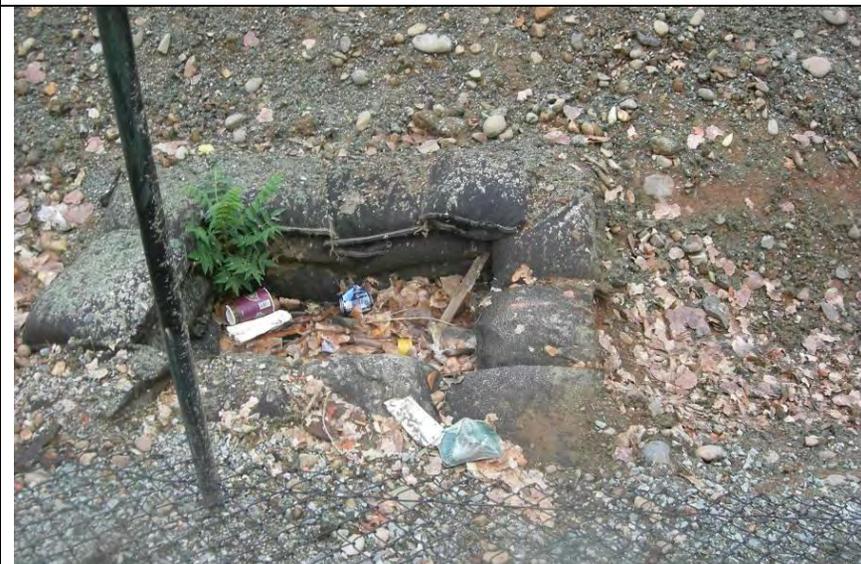
**Photograph 8 – Storm drain inlet located along the bike path adjacent to Interstate 5**

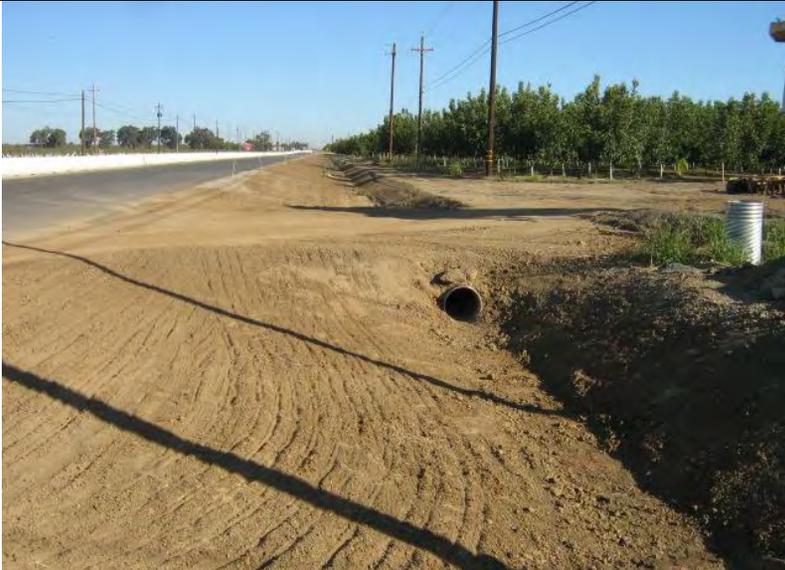
**Photograph 1 – Drainage swale adjacent to roadway without adequate BMPs implemented (Drill seeding only)**

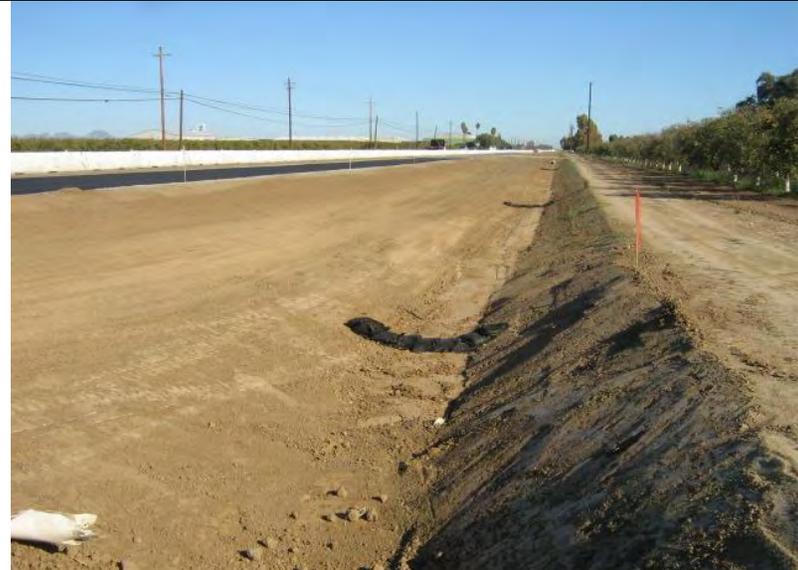
**Photograph 2 – Unstabilized drainage swale and slope adjacent to roadway**

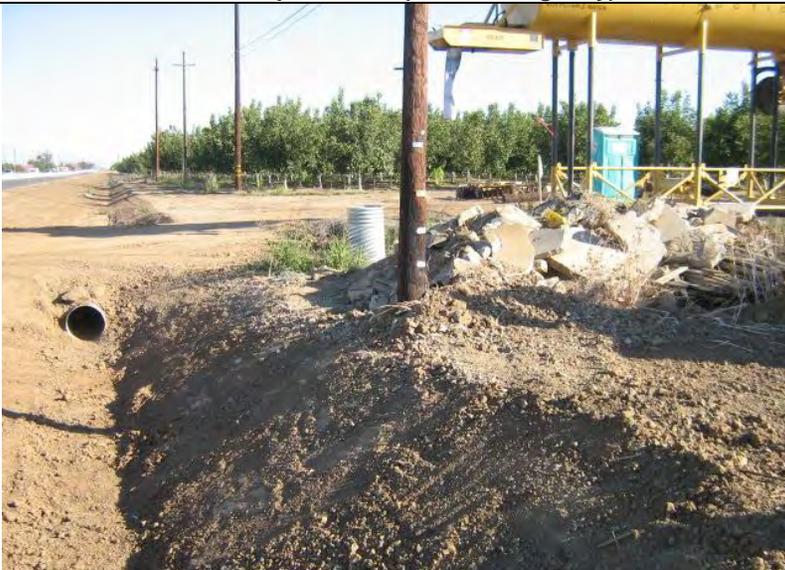
**Photograph 3 – Uncontained concrete waste adjacent to roadway drainage swale**

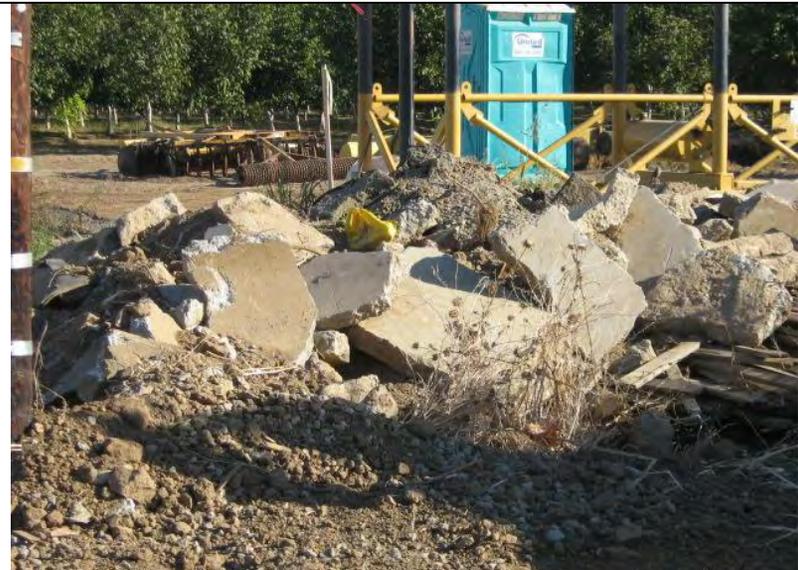
**Photograph 4 – Close-up of Photograph 3 and concrete waste**

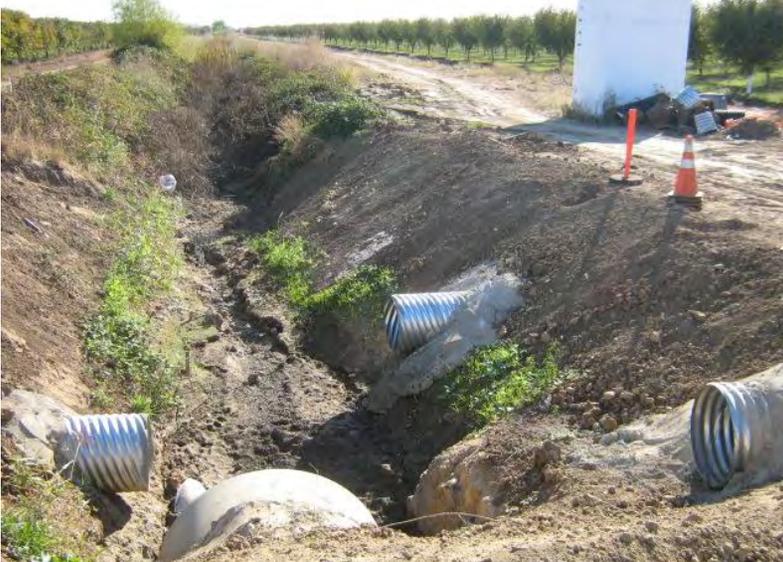
Photograph 5 – View looking upgradient on irrigation channel located adjacent to project. Note unstabilized slopes adj. to irrigation channel.

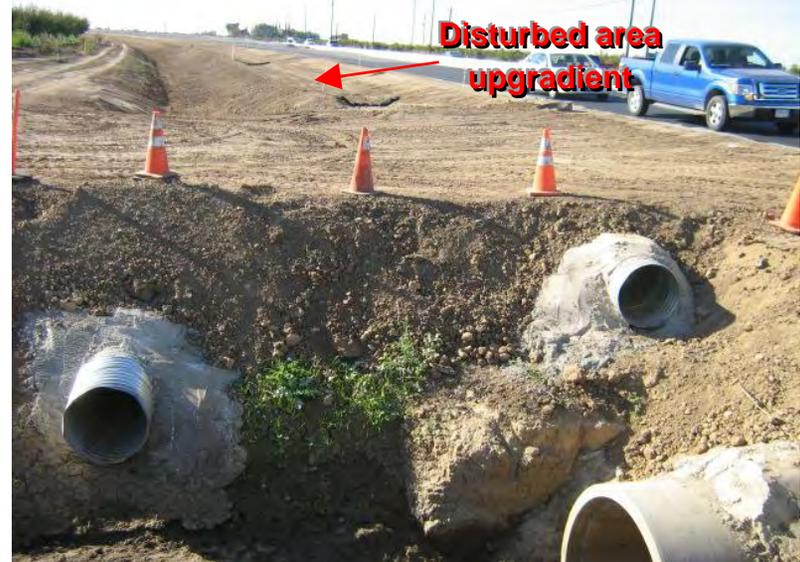
Photograph 6 – Culvert outlet pipes and disturbed embankment slope in irrigation ditch

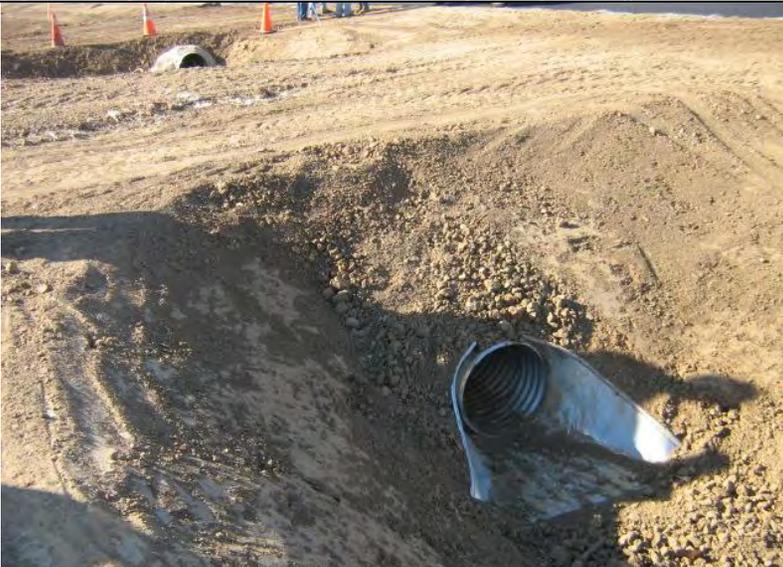
Photograph 7 – Culvert pipe inlet with no BMPs implemented – drains to irrigation ditch.

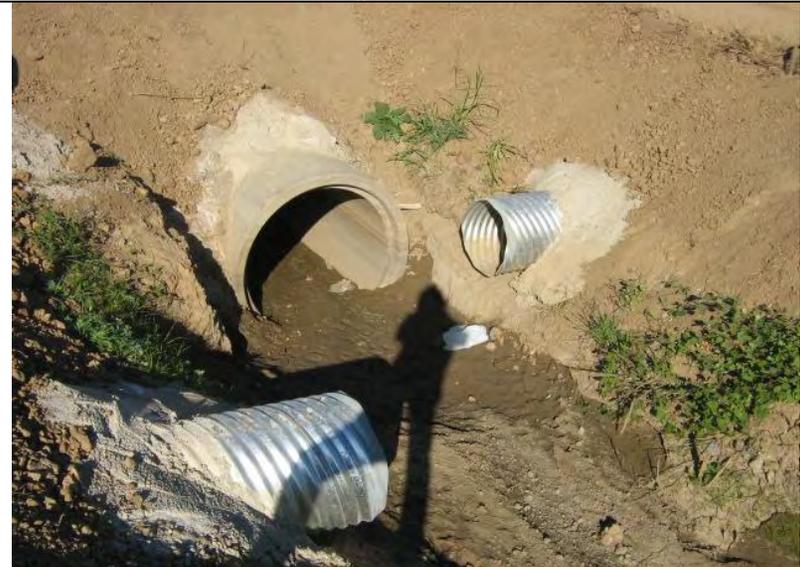
Photograph 8 – Culvert pipe outlet from Photograph 7 to irrigation channel.

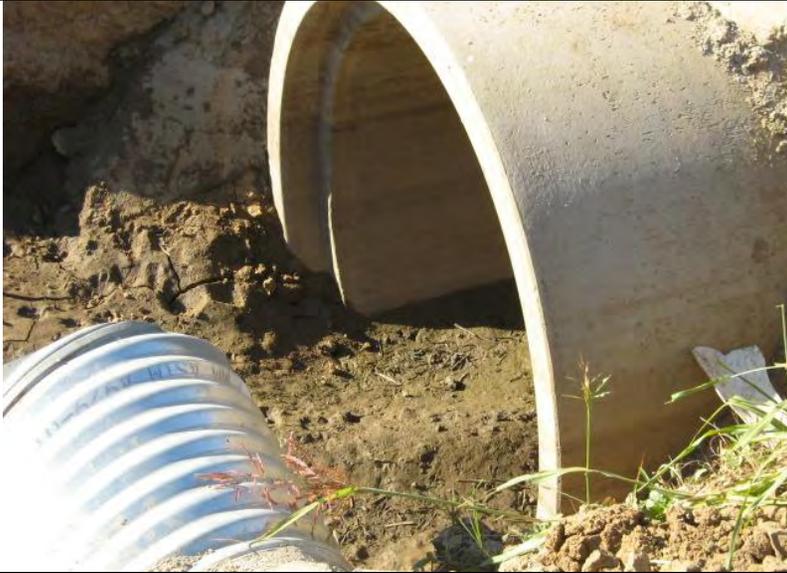
**Photograph 9 – Visible sediment accumulation in the irrigation channel and associated culvert pipe**

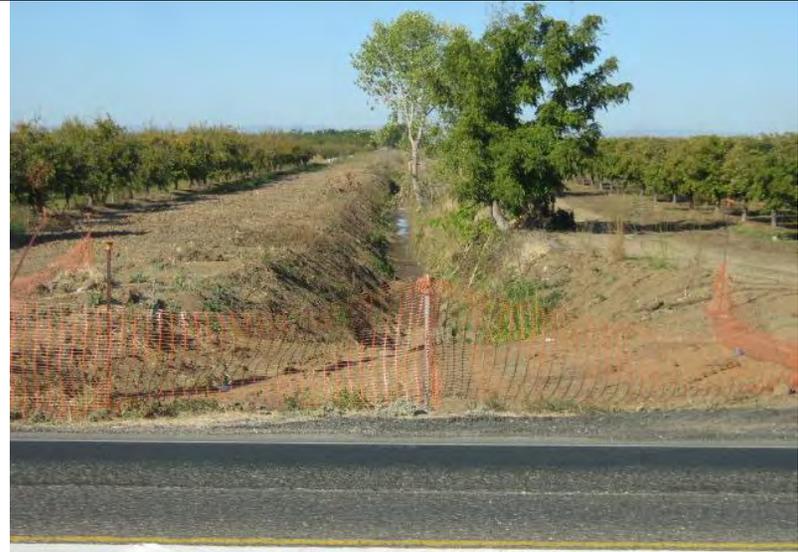
**Photograph 10- View of down-gradient irrigation channel below outlet.  
Note: Inlet to this area is shown in Photograph 9.**

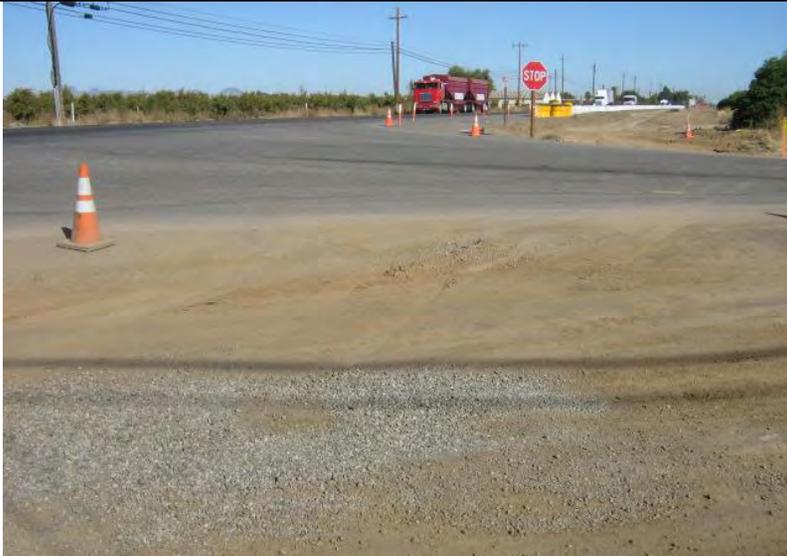
**Photograph 11 –Tracking control BMPs were not implemented near Station 346 + 70.**

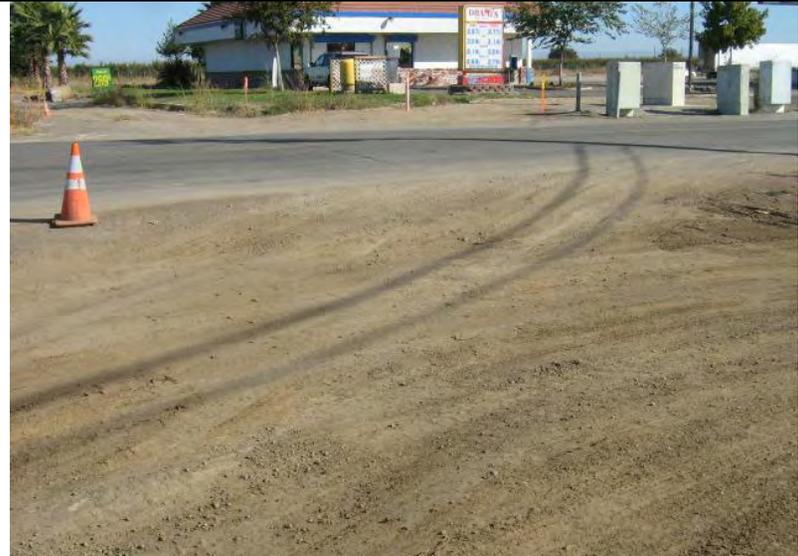
**Photograph 12 – No tracking control BMPs implemented at Sta. 346 + 70.**

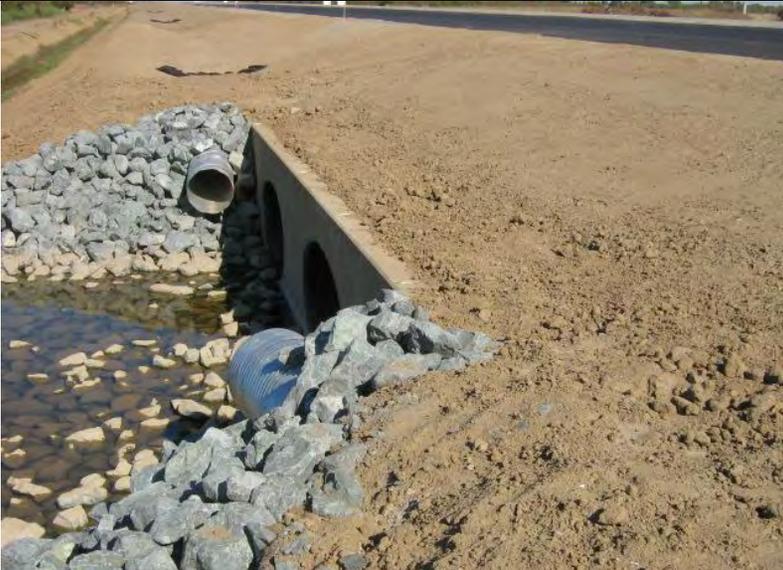
Adequate structural and non-structural BMPs had not been implemented for up-gradient areas of disturbance located directly adjacent to an irrigation channel located at Station 300 + 00 (see Photographs 13 through 16). Specifically, erosion and sediment controls had not been implemented for disturbed slope areas and no inlet protection BMPs had been implemented. As a result, there was a potential for the discharge of sediment from the up-gradient areas of disturbance to the irrigation channel which subsequently drains to levees at Sutter Bypass and ultimately to the Sacramento River.

**Photograph 13 – Adequate E&S controls were not implemented for areas of disturbance up-gradient of irrigation channel (East side)**

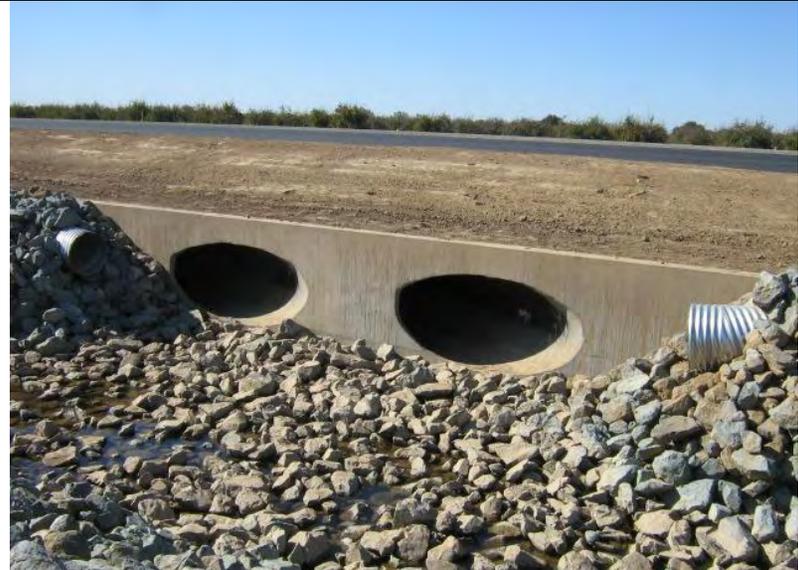
**Photograph 14 - Adequate E&S controls were not implemented for areas of disturbance up-gradient of irrigation channel (West side)**

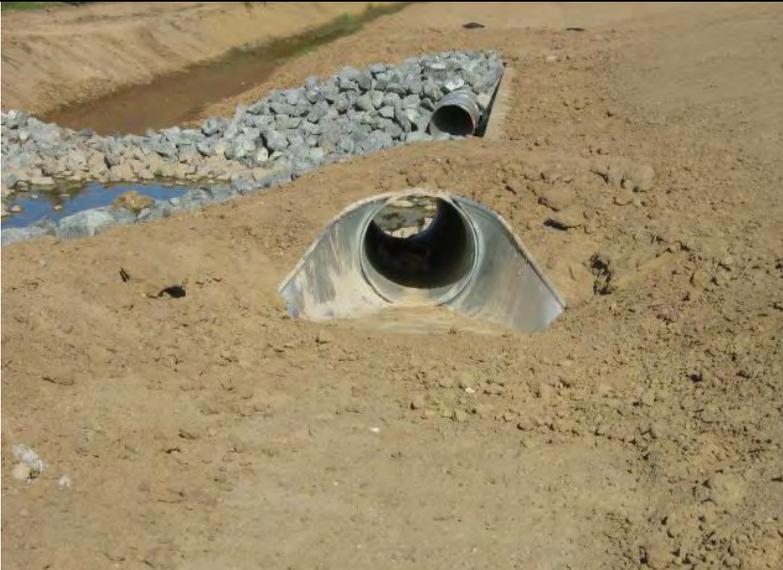
**Photograph 15 – Inlet protection BMPs were not implemented for a culvert inlet draining to the irrigation channel.**

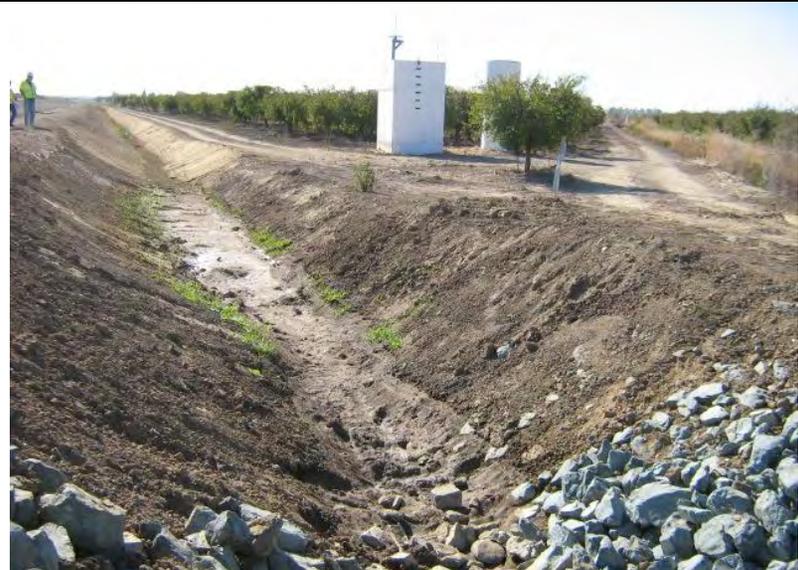
**Photographs 16 – BMPs were not implemented for the entire disturbed slope areas of the adjacent roadway drainage swale (East side).**

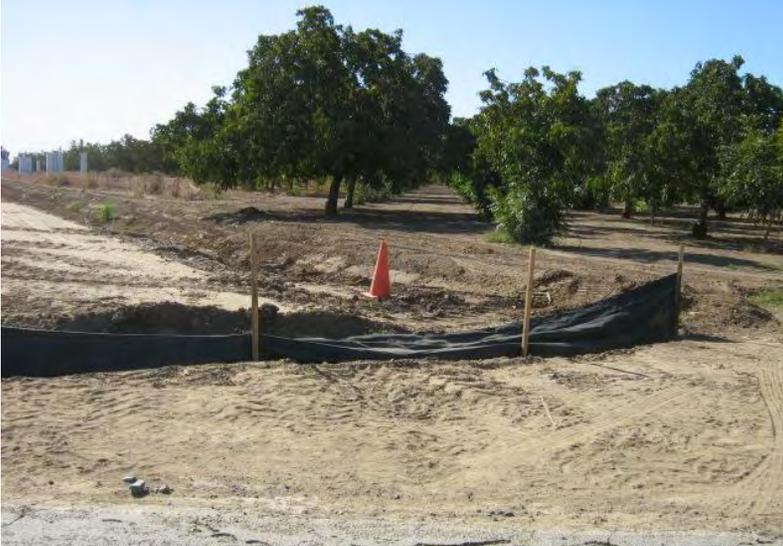
**Photograph 19 – Silt fence not adequately maintained (e.g., collapsed in areas) near the new Hwy 99 and Wilson Road intersection.**

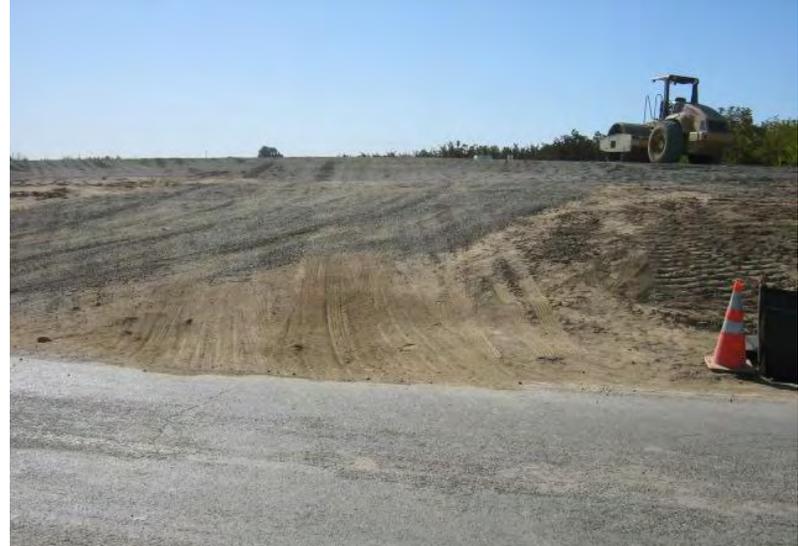
**Photograph 20 – Adequate tracking control BMPs had not been implemented at the Wilson Road intersection.**

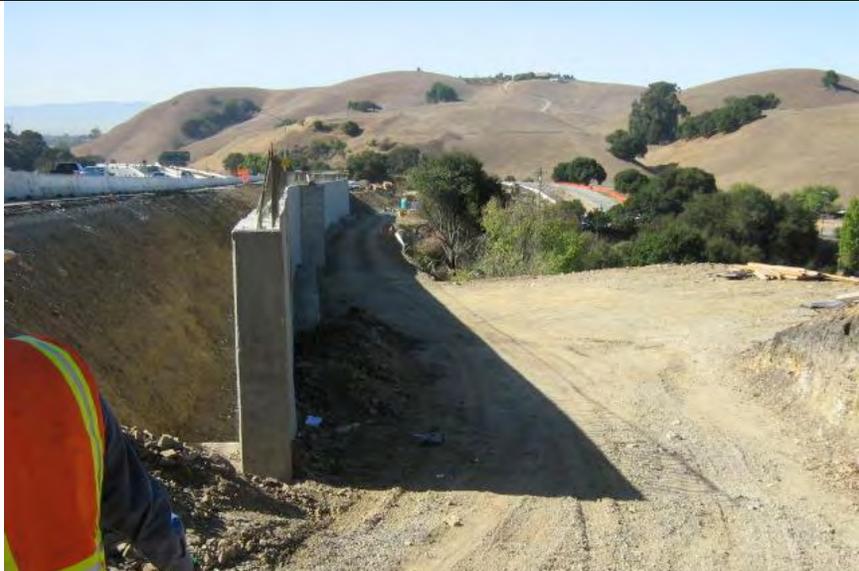
Photograph 1 – View down-gradient along access road
