Appendix E

Maintenance Program Site Visit Reports

Site Visit No. 16

**Willow Creek Highway Maintenance Facility
Site Visit Date: 10/22/2009**

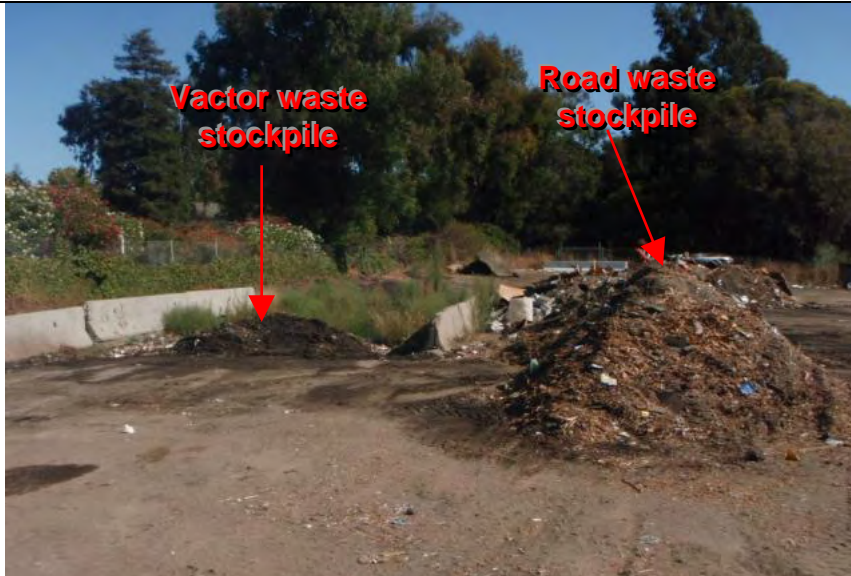
Photograph 1 –Waste stockpiles at the facility

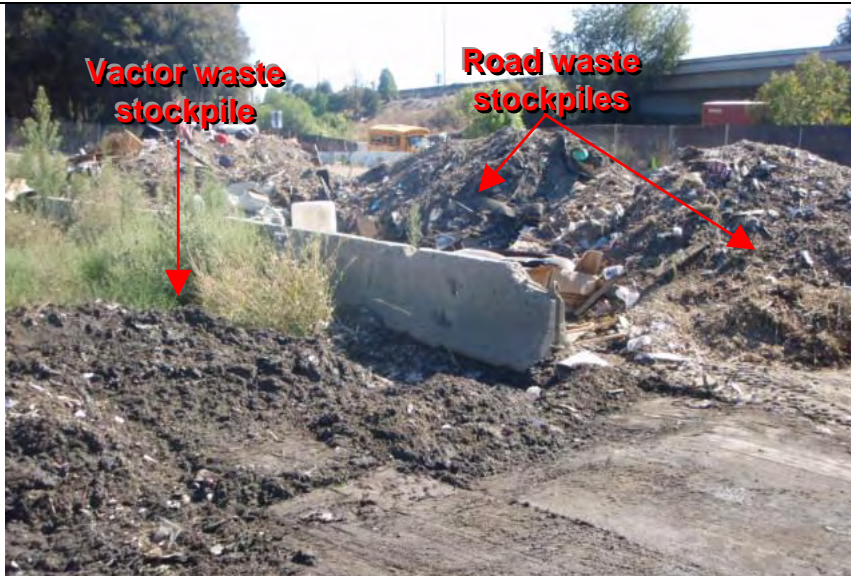
Photograph 3 – Lack of BMPs for containment or coverage of road waste stockpiles

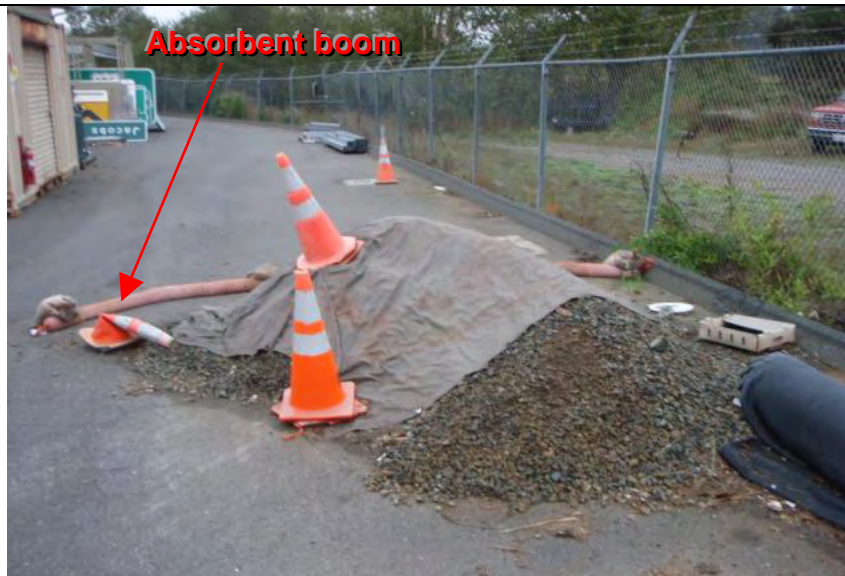
In a separate location along the eastern edge of the facility, a stockpile of gravel and sediment did not have properly selected and implemented BMPs for stockpile management (see [Photograph 10](#)). Specifically, the stockpile was only partially covered and perimeter controls had only been implemented around a portion of the stockpile. Furthermore, absorbent booms are not intended to be used on impervious surfaces as sediment control.

Photograph 10 – Partially covered and contained stockpile along eastern edge of facility

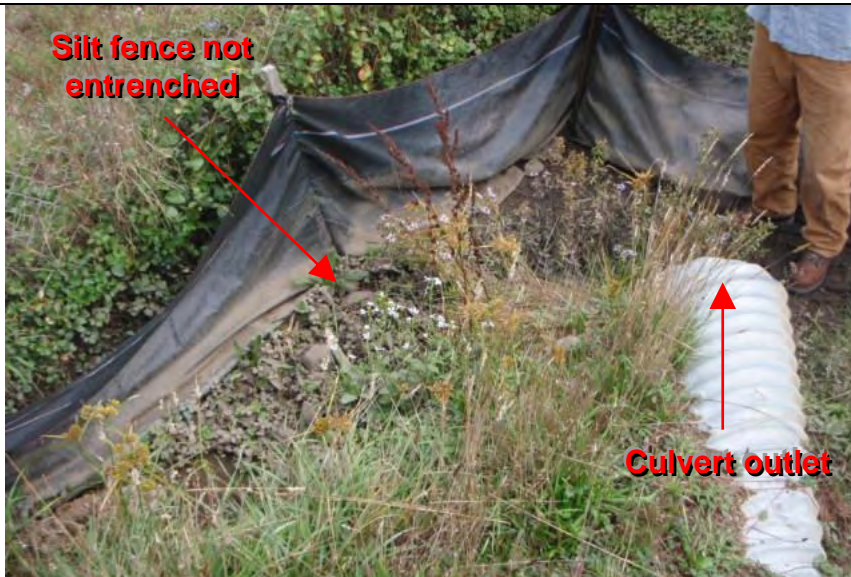
Provision I.3.b of the Permit requires Caltrans to provide appropriate site-specific BMPs for all maintenance facilities. A significant amount of sediment accumulation was observed within a storm drain inlet at the facility that did not appear to have been recently cleaned (see [Photographs 1 and 2](#)). As explained by the Highway Maintenance Supervisor, storm drain inlets at the facility flow to the drainage ditch in the southeast corner of the facility (see [Photograph 3](#)). He added that storm water runoff does not generally discharge off-site from this location but rather ponds and remains as standing water until it infiltrates into the ground. Nonetheless, evidence of sediment discharged to the drainage ditch as well as sediment accumulation within the culvert pipe that discharges to the southeast corner of the facility was observed (see [Photograph 5](#)). Furthermore, a silt fence BMP had been installed in the flow pathway of the culvert outlet and was not entrenched into the ground to retain sediment and prevent failure (see [Photograph 3](#)).

Photograph 3 – Storm drain outlet to drainage ditch in southeast corner of facility

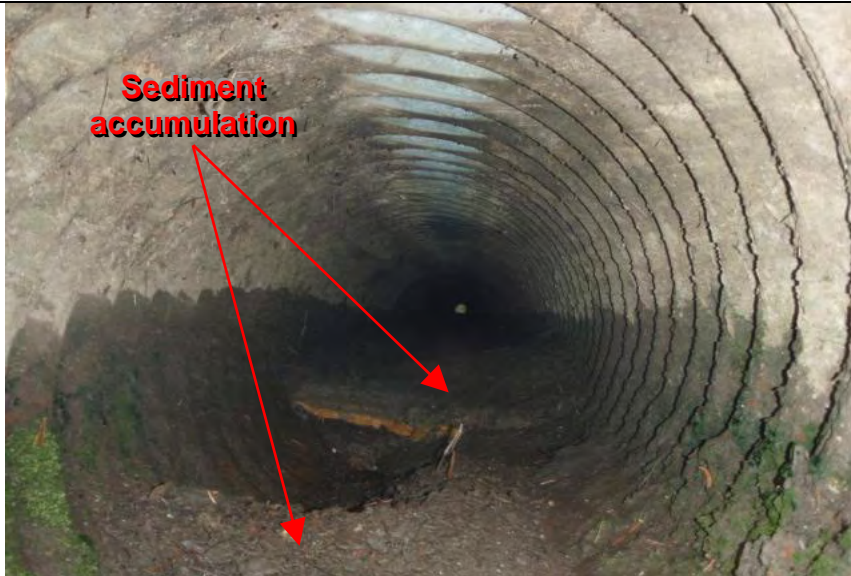
**Sediment
accumulation**

Photograph 5— View into storm drain pipe from outlet

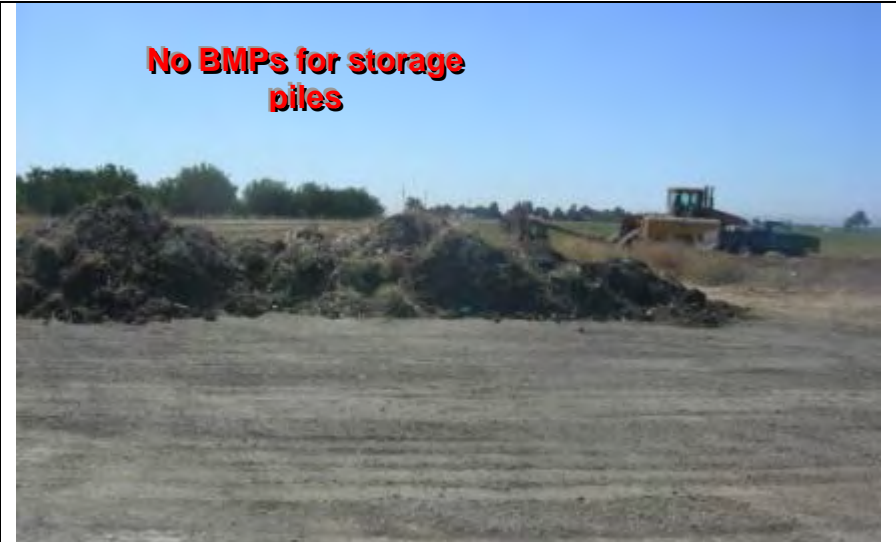
Photograph 2 – Lack of BMPs to contain stockpiled soils from tree removal

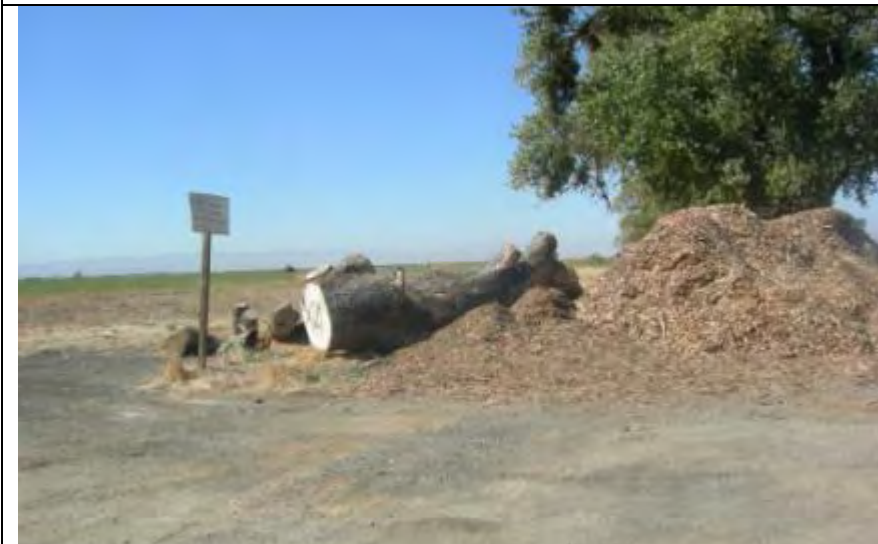
Photograph 3 – View of tree trimming debris
