**Appendix A**  
**Storm Water Management Plan: Comments from NDEP and Co-Permittee Response**

## Storm Water Management Plan: Comments from NDEP and Co-Permittee Response

**Appendix B**  
**Clark County**

**Appendix B.1**  
**Documentation of Findings**

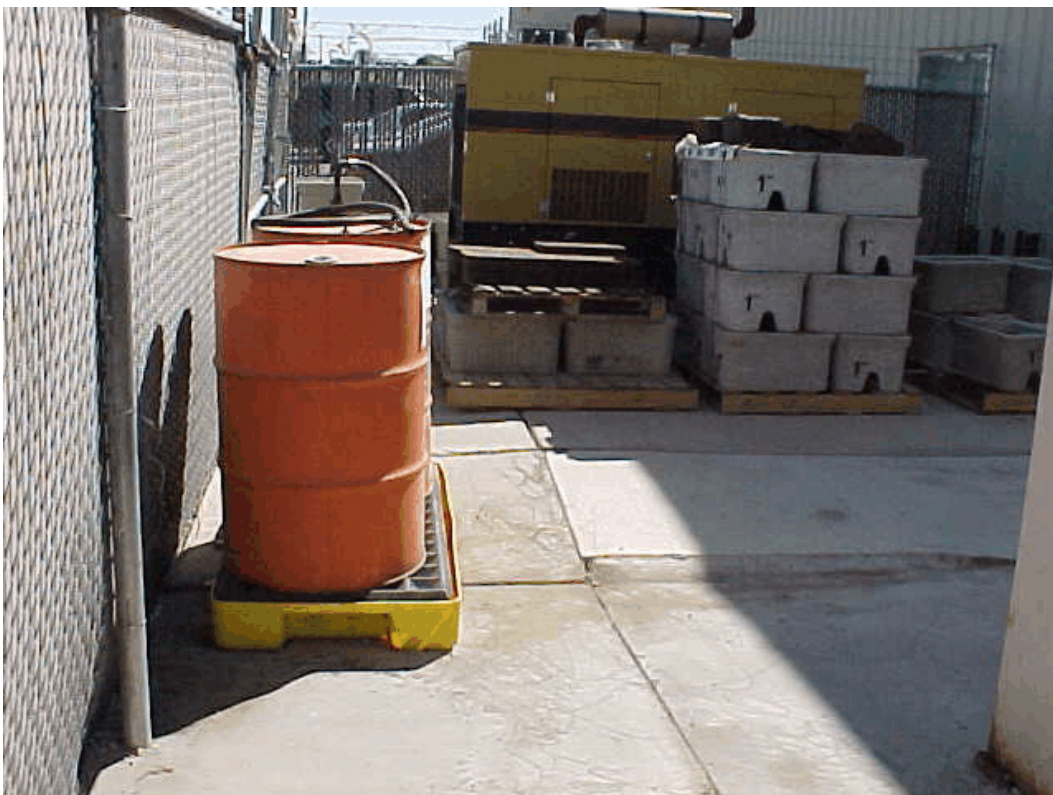
**Photo 2.** Fleet (primary) facility: Two uncovered 55-gallon drums of solvent.

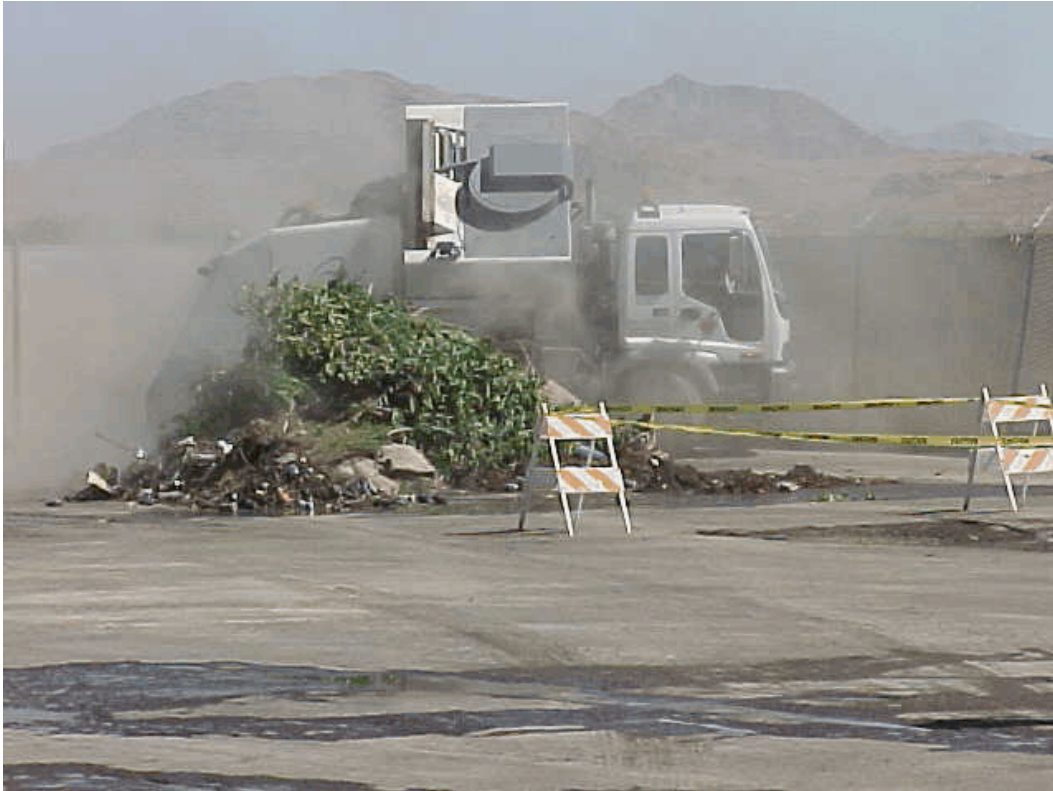
**Photo 1.** Street sweeper unloading and sweeping facility area.

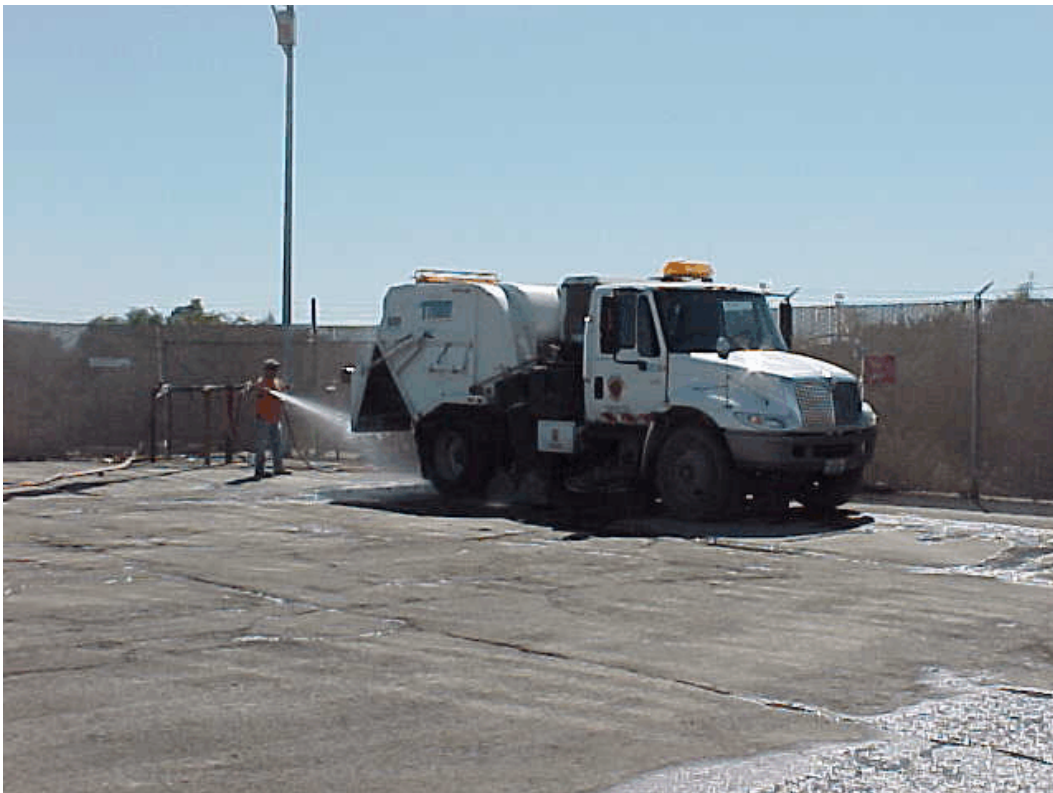
**Photo 2.** Street sweeper being washed out.

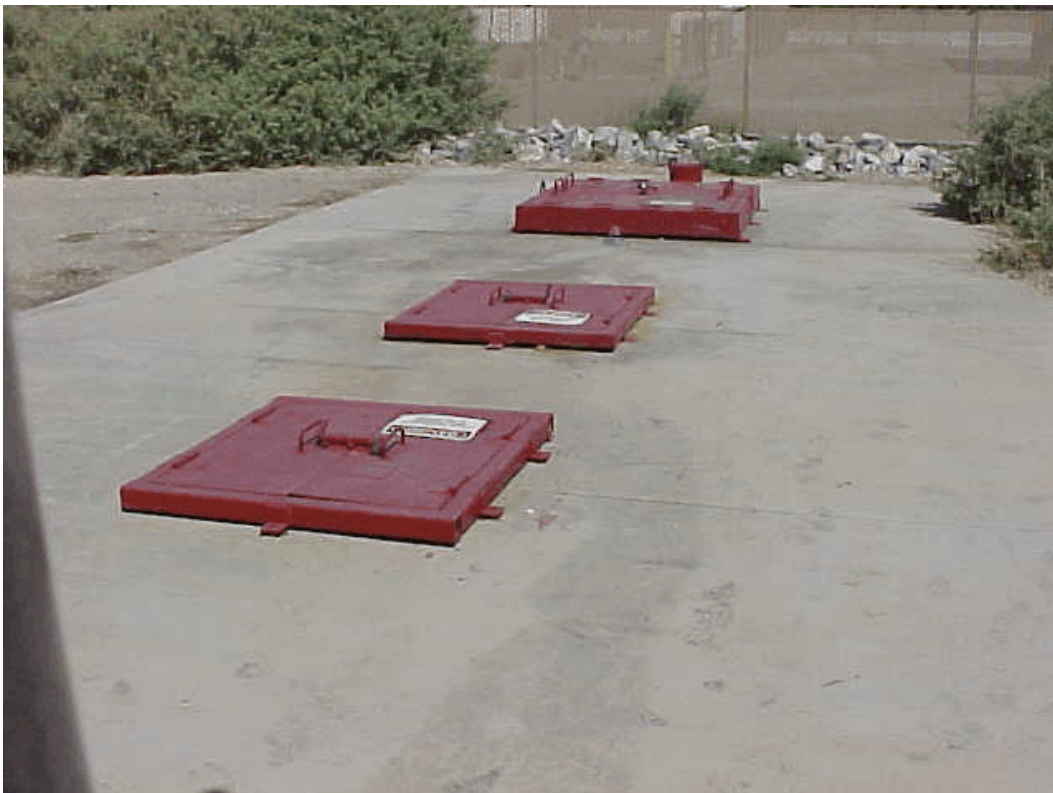
**Photo 4.** Treatment basin for materials escaping the sediment traps.

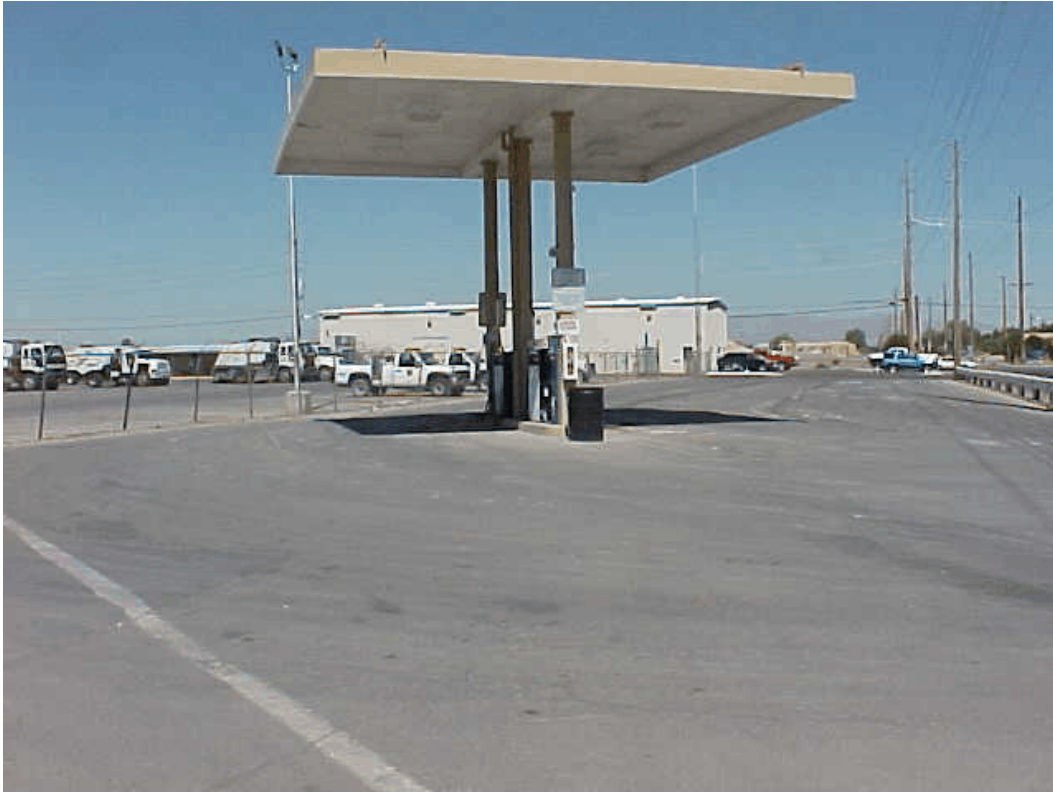
**Photo 5.** View of fuel island.

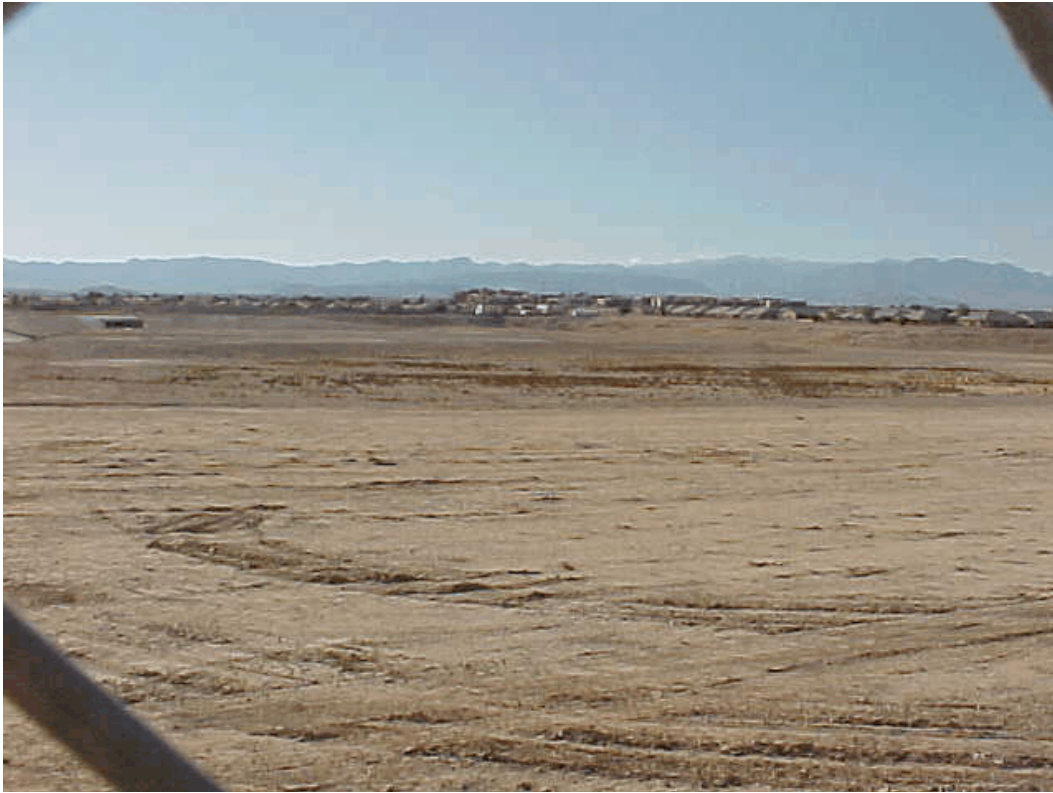
**Photo 3.** West view of the detention basin from the east fence.

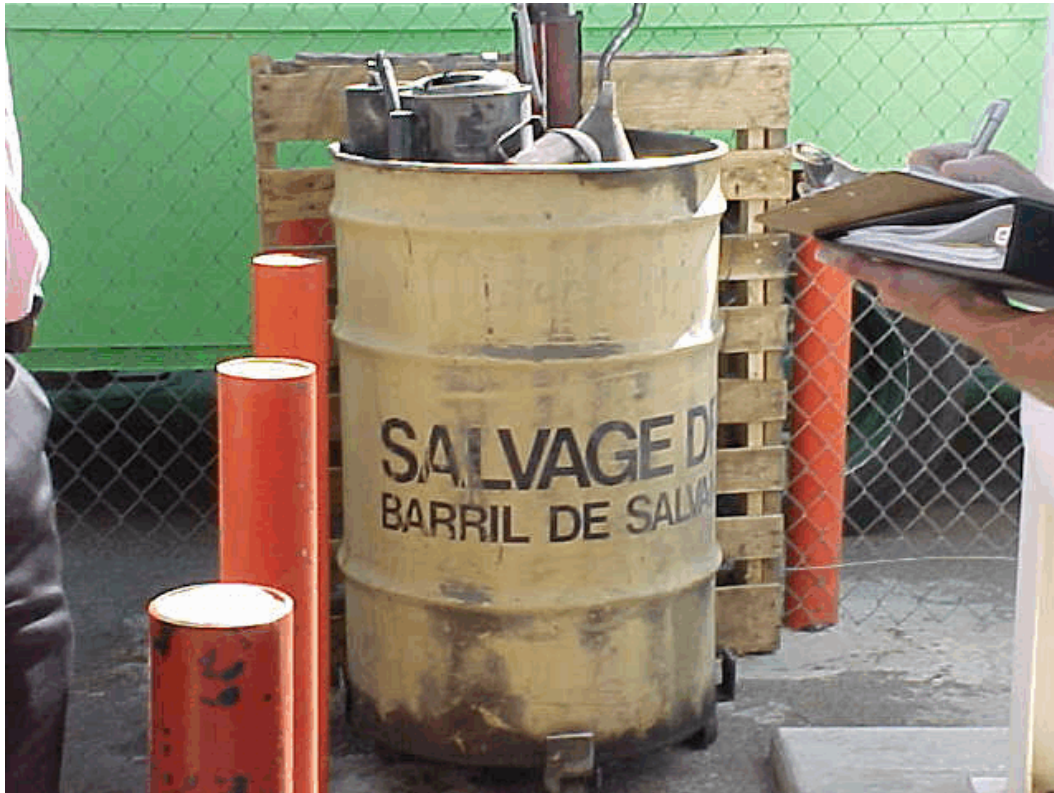
**Photo 5.** Salvage material drum at propane fueling point.

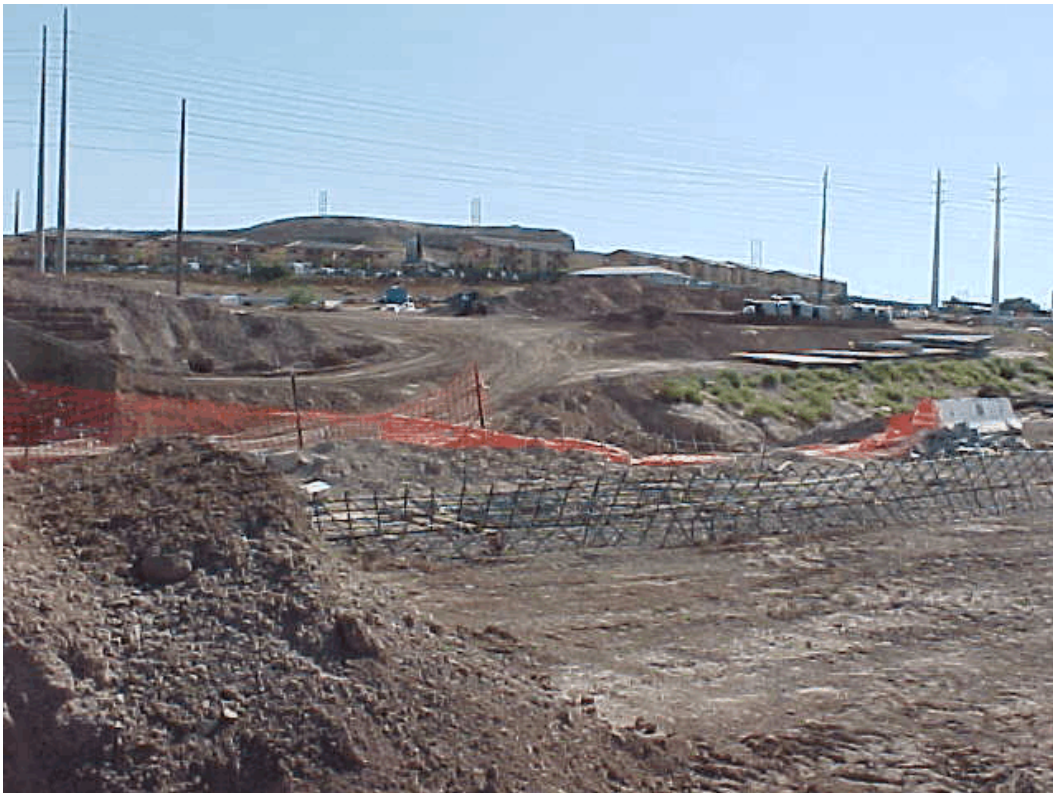
**Photo 6.** Staging area. Note the soil disturbance and no BMPs.

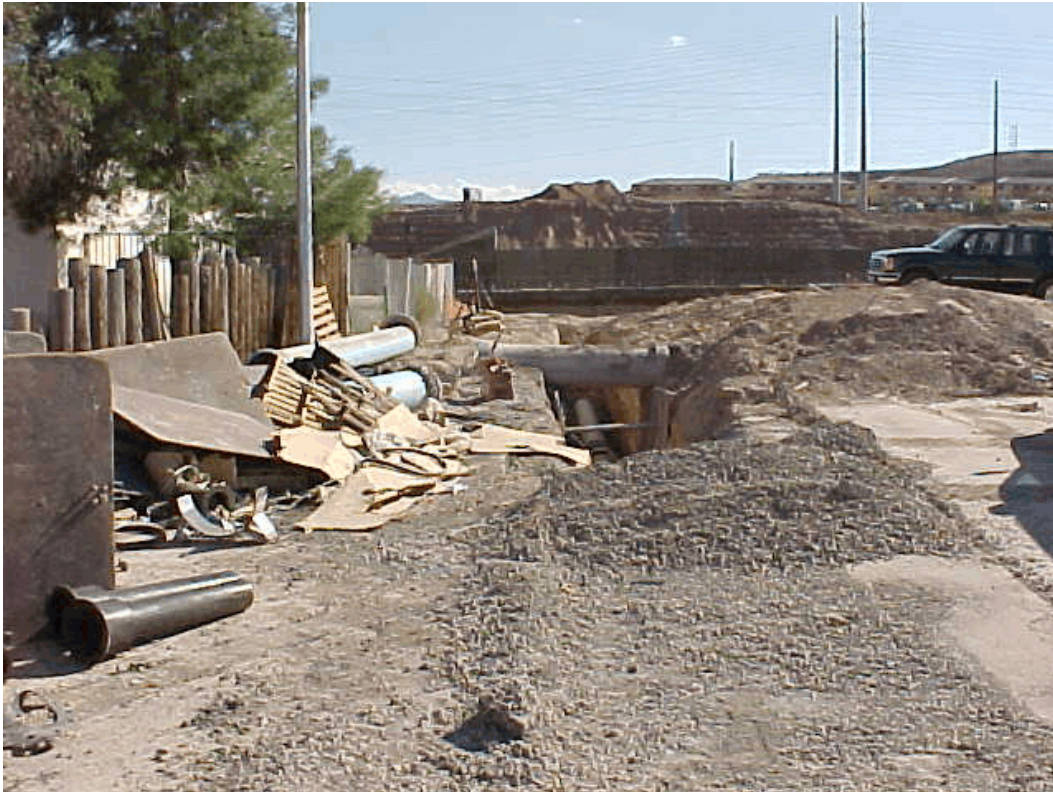
**Photo 7.** Additional staging area. Note uncontained five-gallon gas can (photo center).

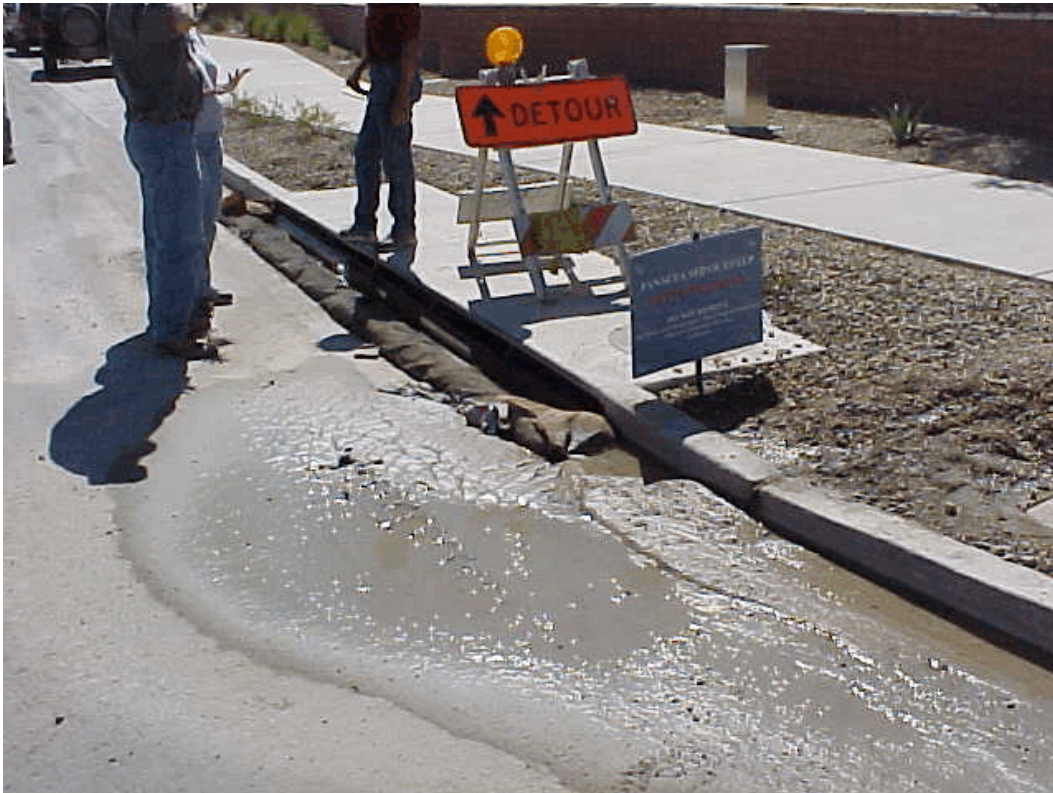
**Photo 1.** Street inlet protection that is poorly maintained by Landtec LLC.

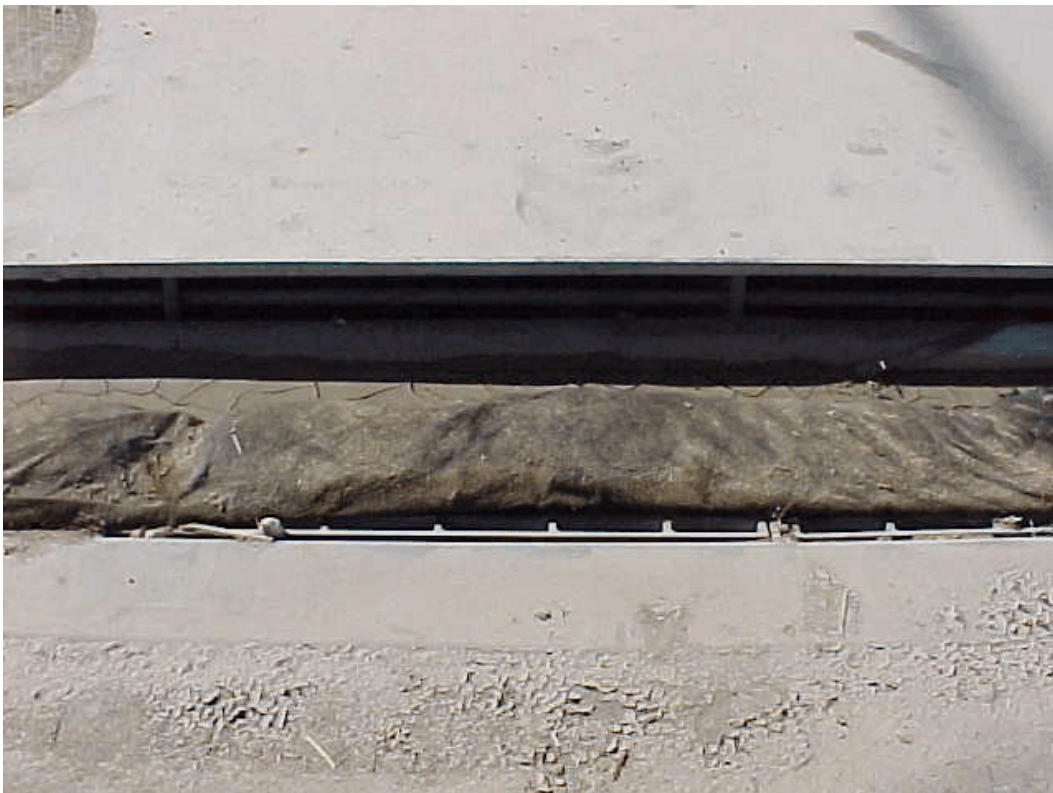
**Photo 2.** Street inlet protection that is poorly maintained by Landtec LLC.

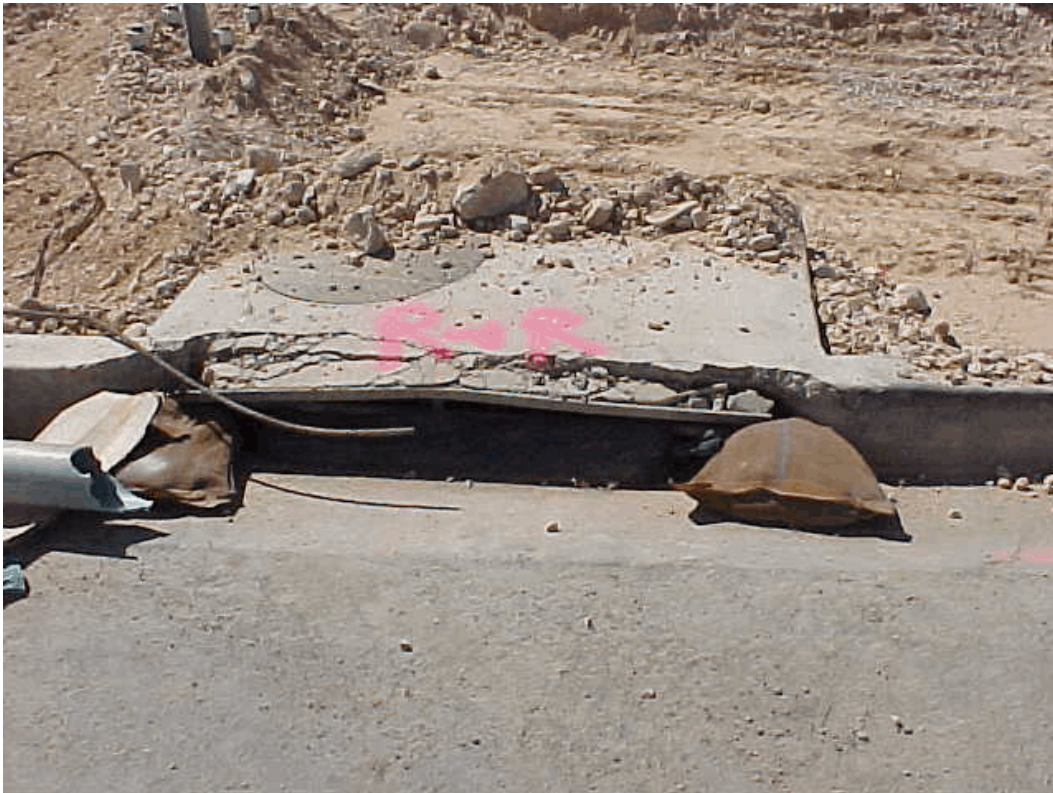
**Photo 3.** Street inlet protection that is poorly maintained by Landtec LLC.

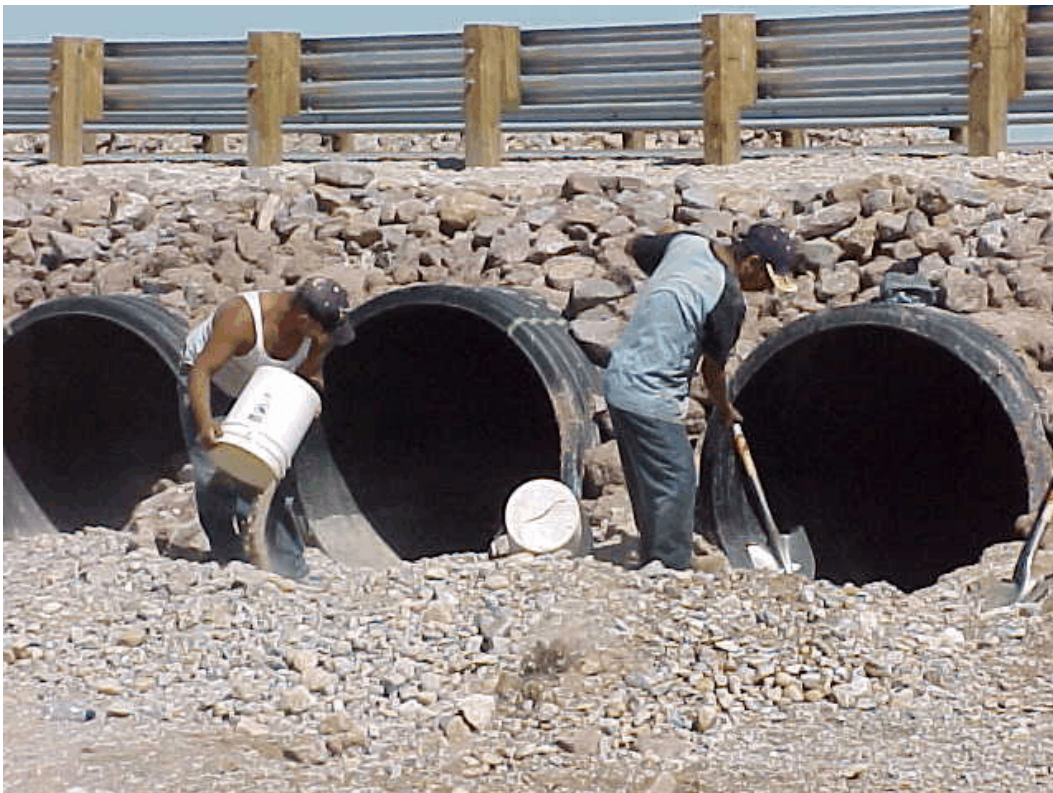
**Photo 4.** KB Home hand cleaning of culverts in wash.

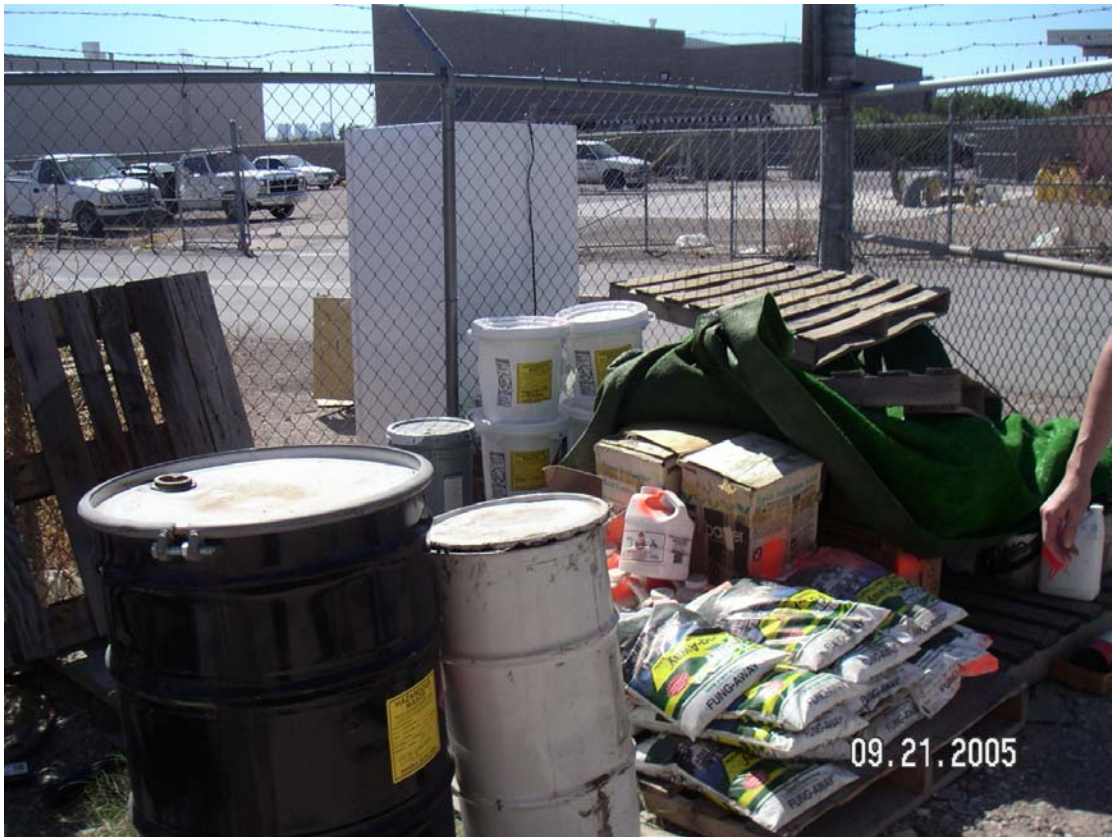
**Photo 3.** Waste materials abandoned by Parks Department.

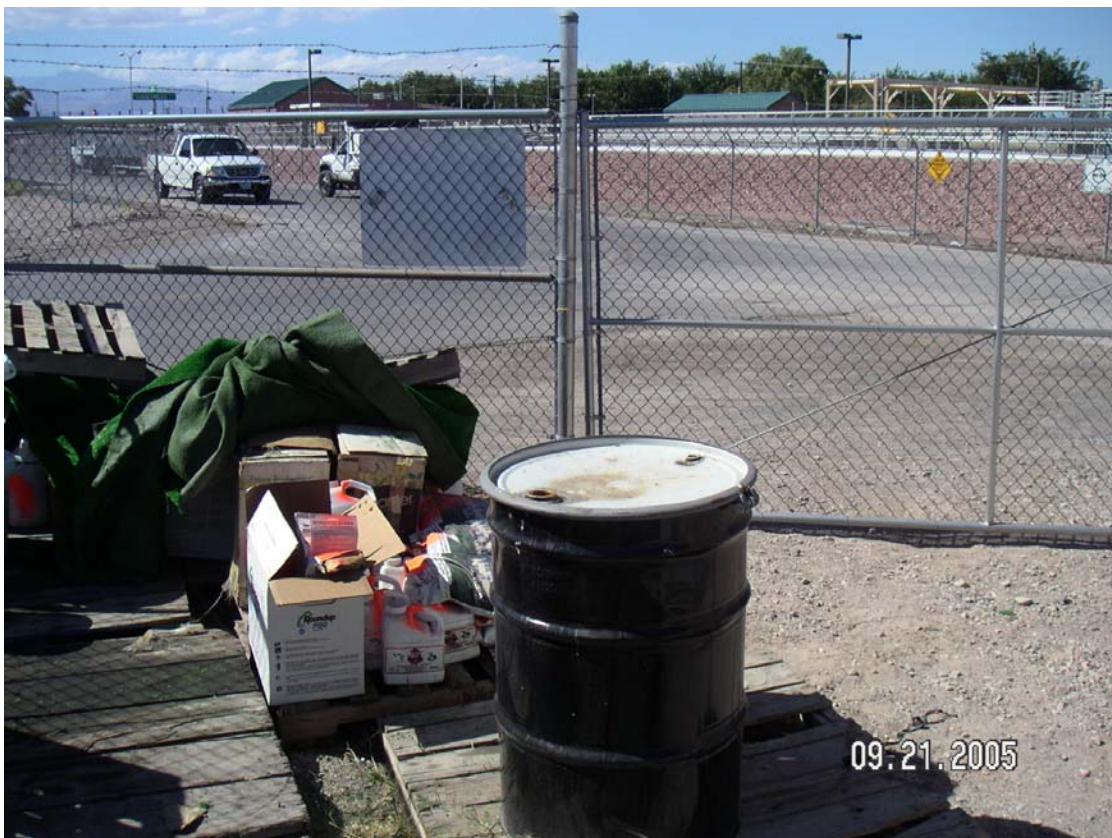
**Photo 4.** Waste materials abandoned by Parks Department.

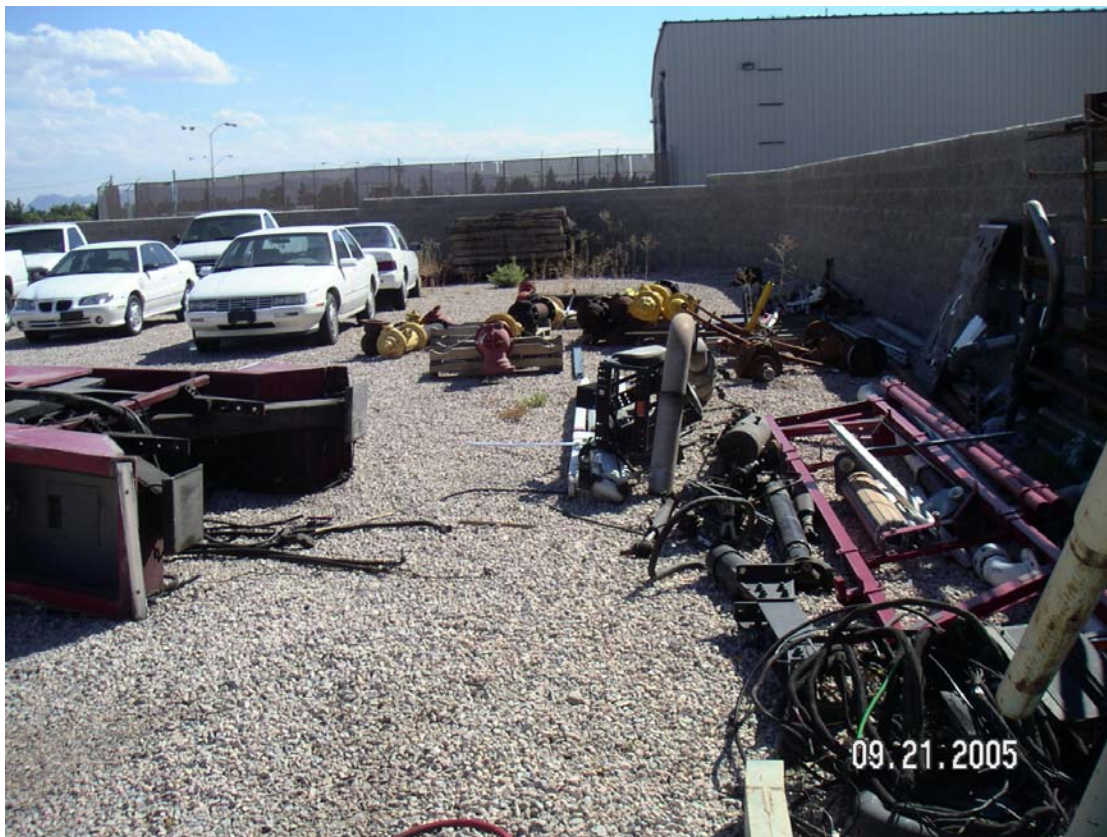
**Photo 7.** Materials stored on gravel pad.

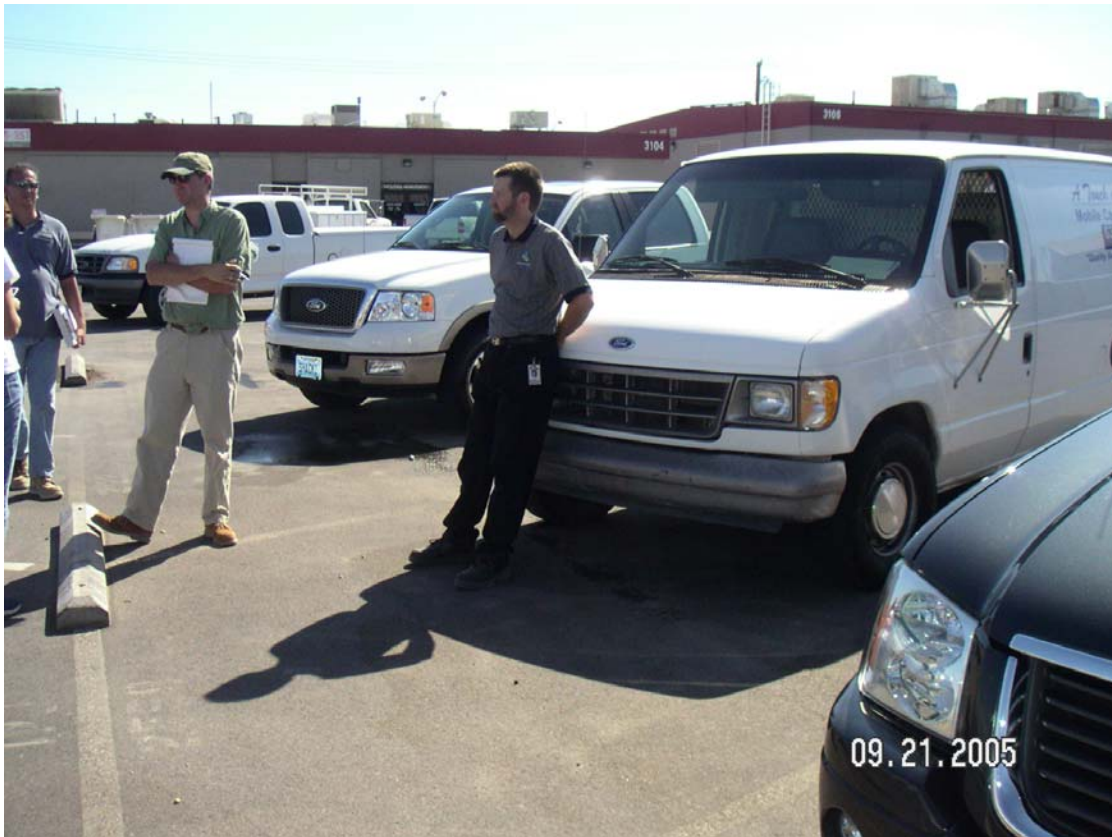
**Photo 9.** Mobile car wash in parking lot of East Yard.

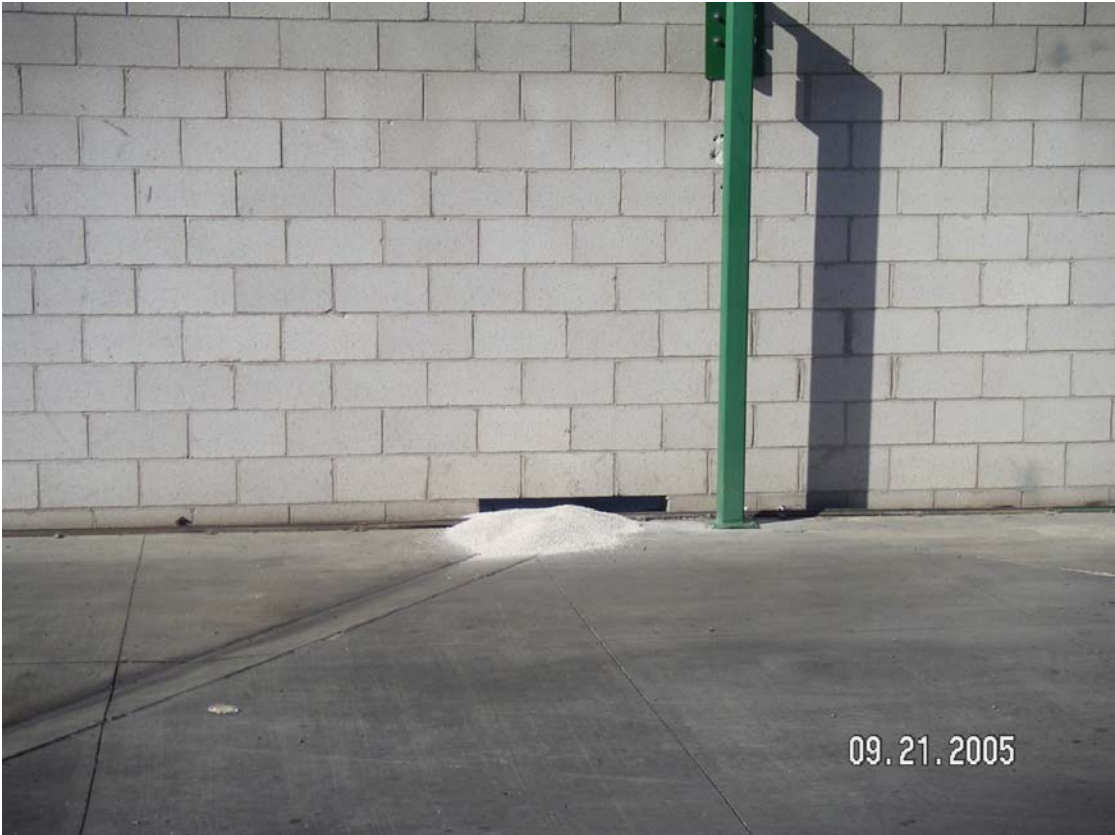
Photo 5. Absorbent material at point of outflow from yard.

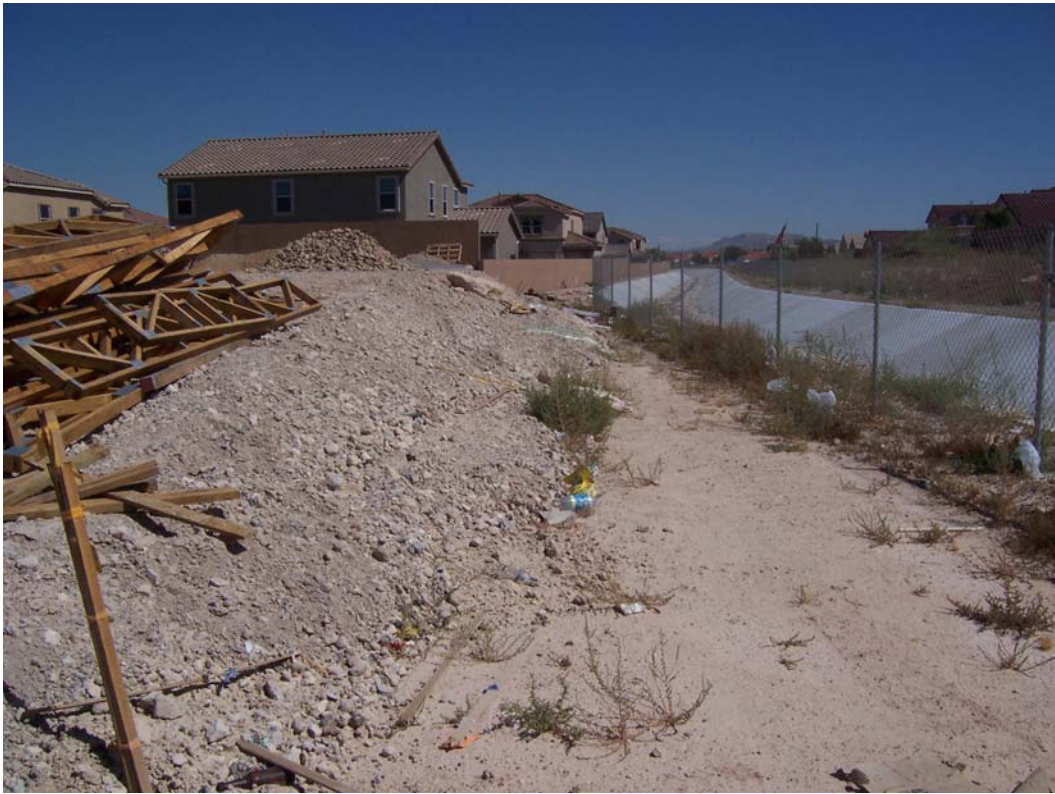
**Photo 1.** Dirt and debris piled adjacent to wash at the construction site.

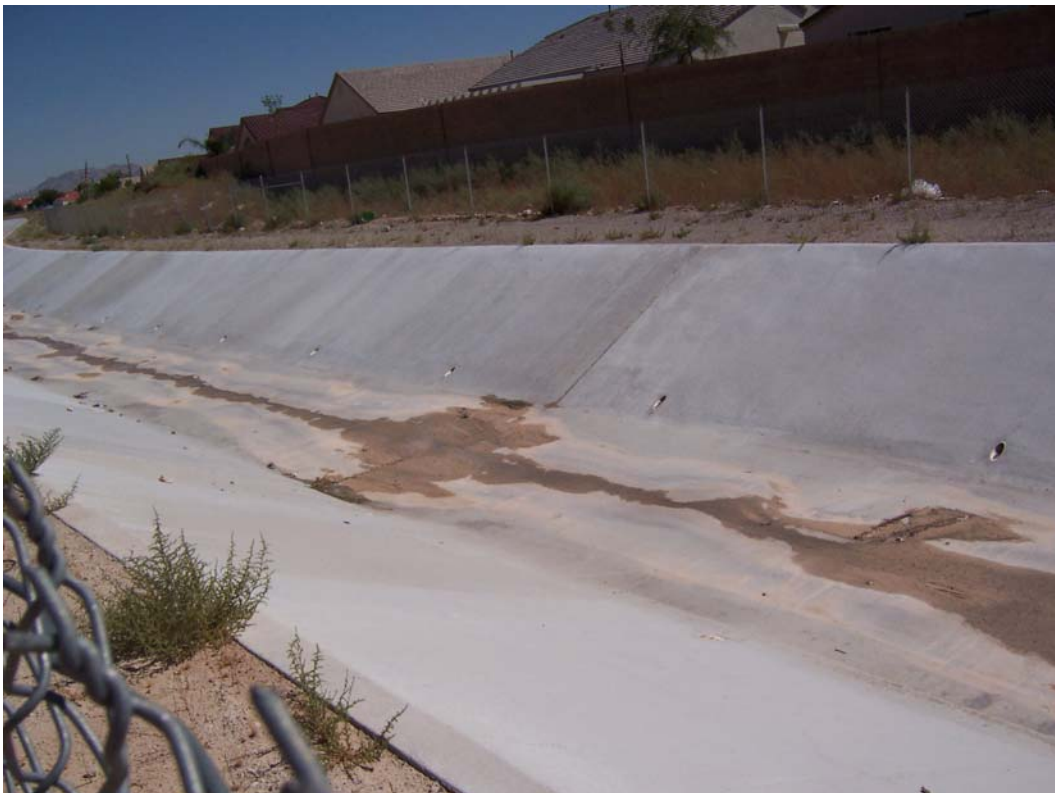
1. Mr. Melo did not comment on the presence of sediment in the wash next to the construction site.
2. Mr. Melo did not comment on the placement of a portable toilet next to a paved roadway. If knocked over by a construction vehicle, it would flow directly to a storm inlet.
3. The inspection form used asks if BMPs are in place. It is Mr. Melo's practice to check the "yes" box if any BMPs are in place, even if they are incomplete or do not cover all areas. Thus, he appears to be answering the question: Are any BMPs in place?
4. Mr. Melo indicated that he had received four hours of training in storm water control and that the subject had come up in at least two inspector meetings.
5. The audit team reviewed the SWPPP prepared for the site. It appeared complete, current, and well organized.

**Photo 2.** Wash adjacent to the construction site. Wash appears to contain sediment that may have come from the site.

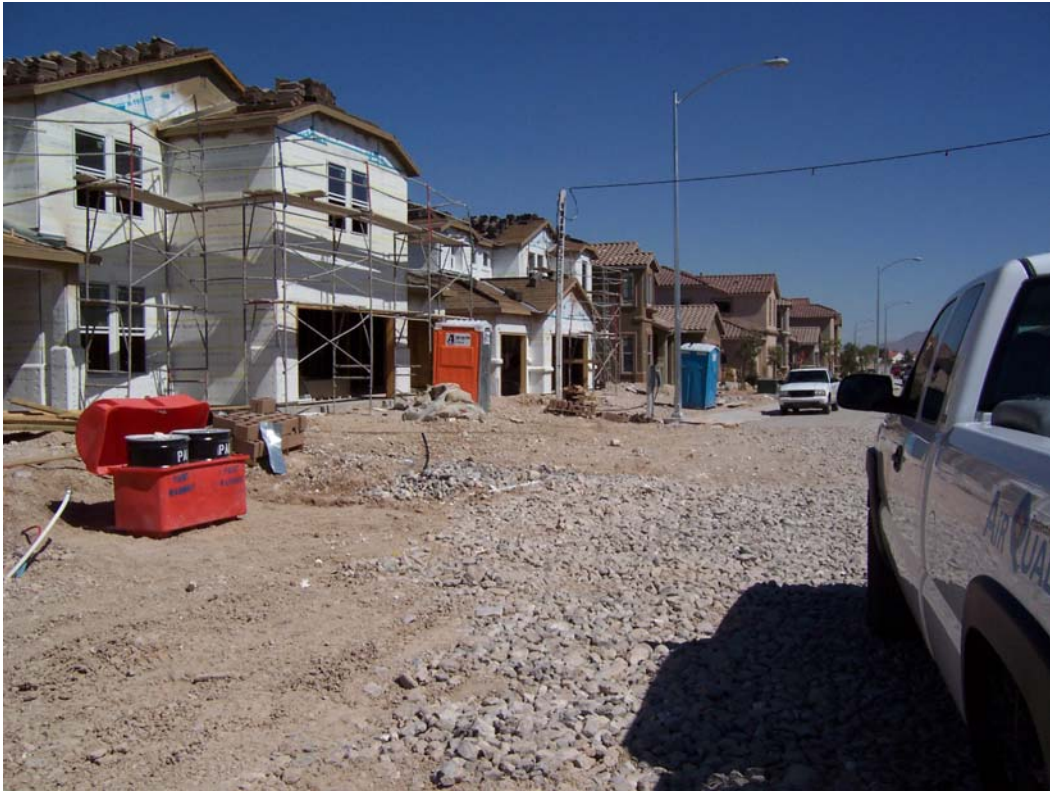
**Photo 3.** Note portable toilet (blue) in photo right center located immediately adjacent to the paved road upslope of inlets. Note also crush rock for trackout control located in front of pickup truck at photo right.

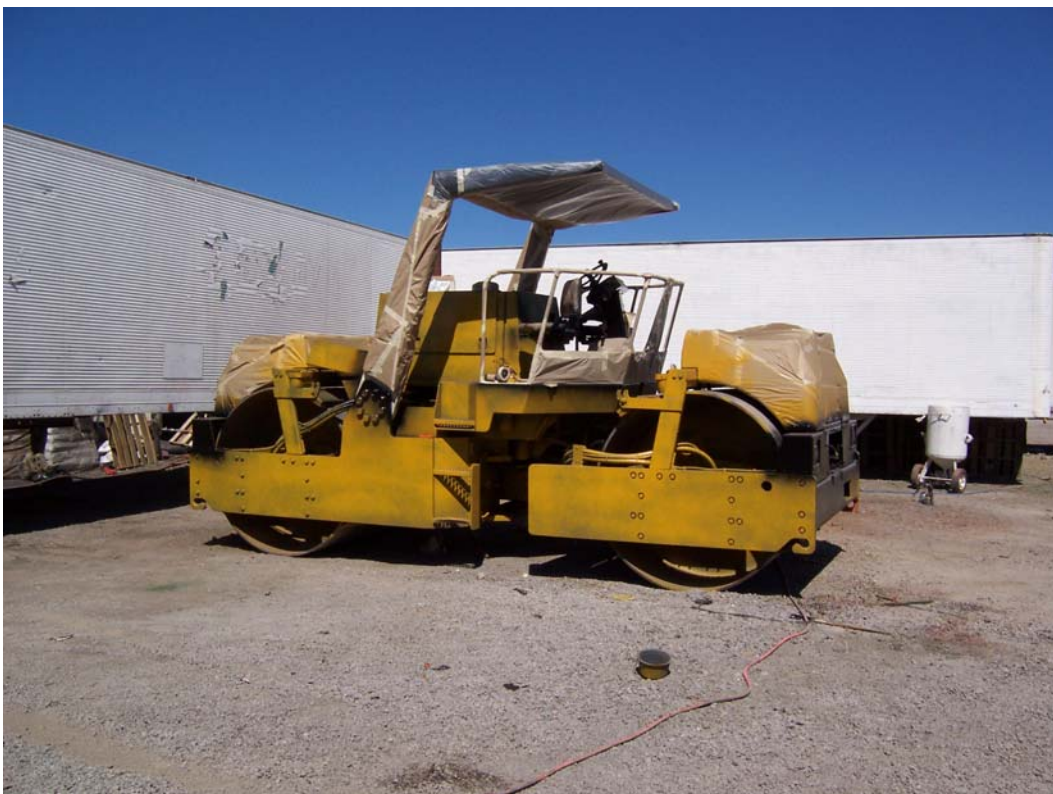
**Photo 2.** Roller masked for open air spray painting operation.

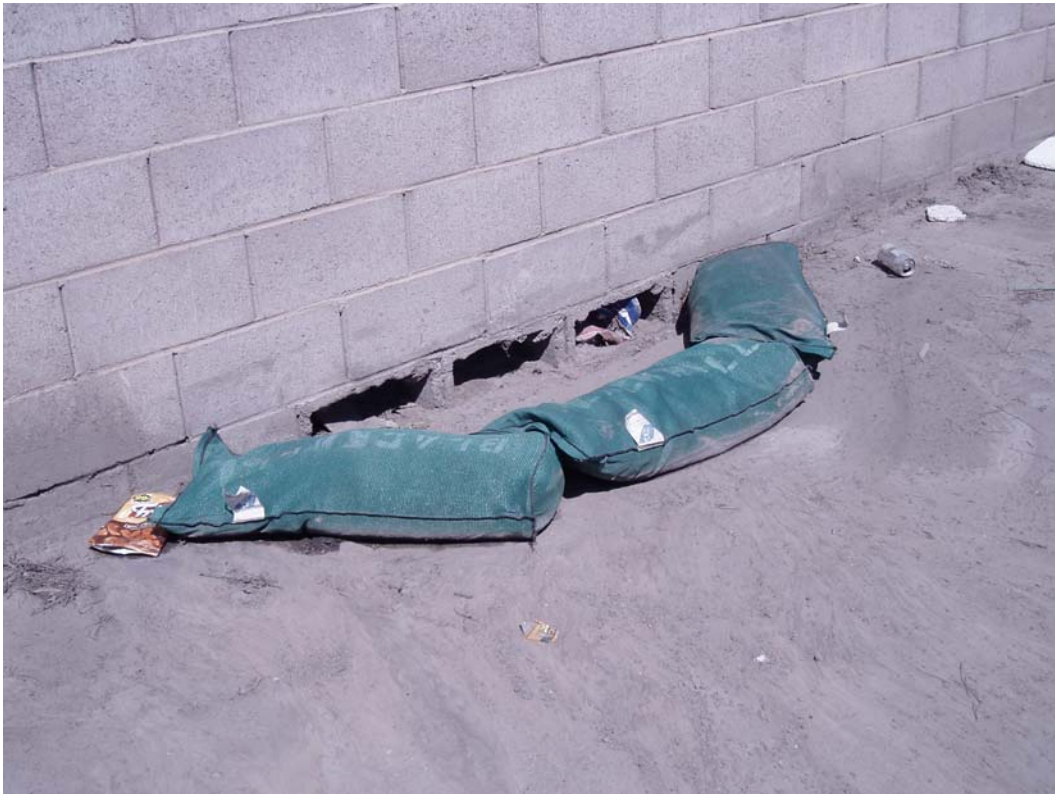
**Photo 3.** Drain to street in corner of parking lot.

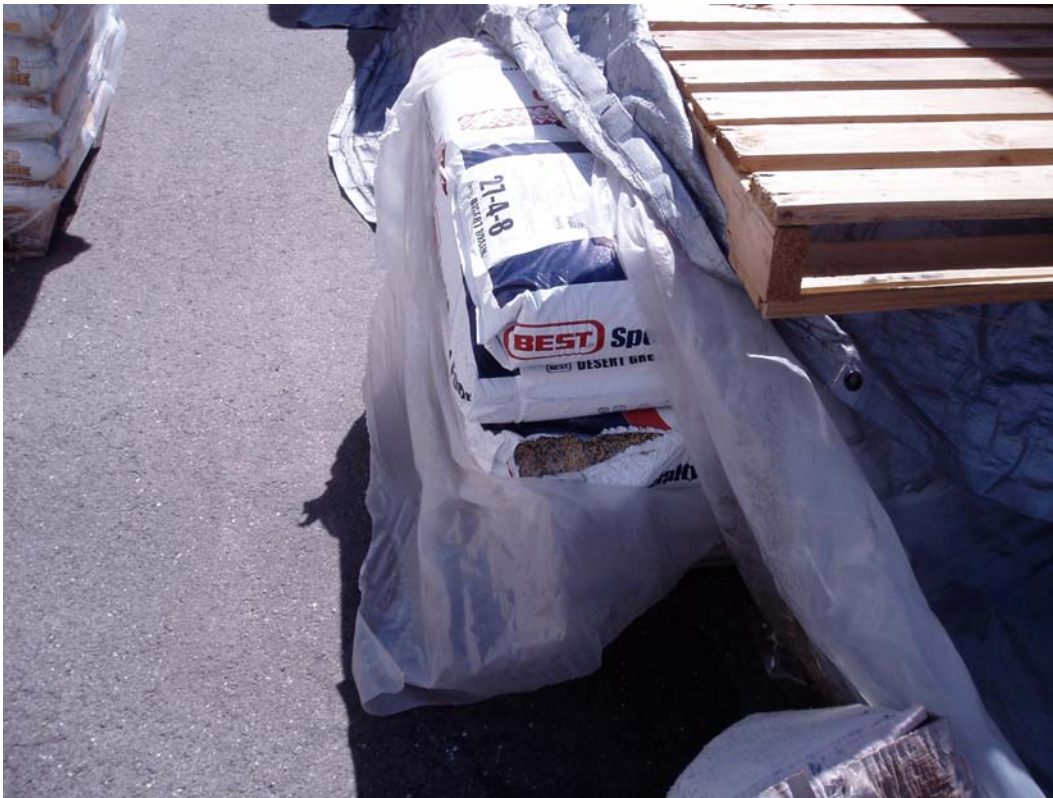
**Photo 1.** Fertilizer, note tear in package.

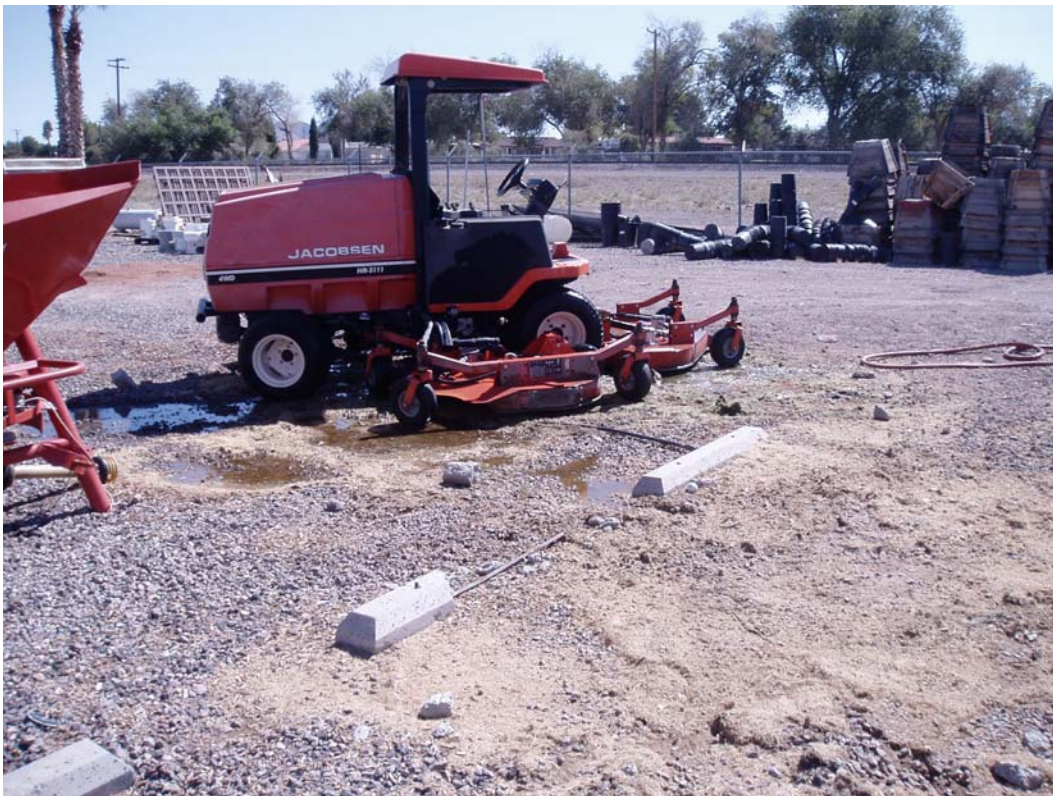
**Photo 3.** Vehicle that was being rinsed during the site visit. Note puddles of water.

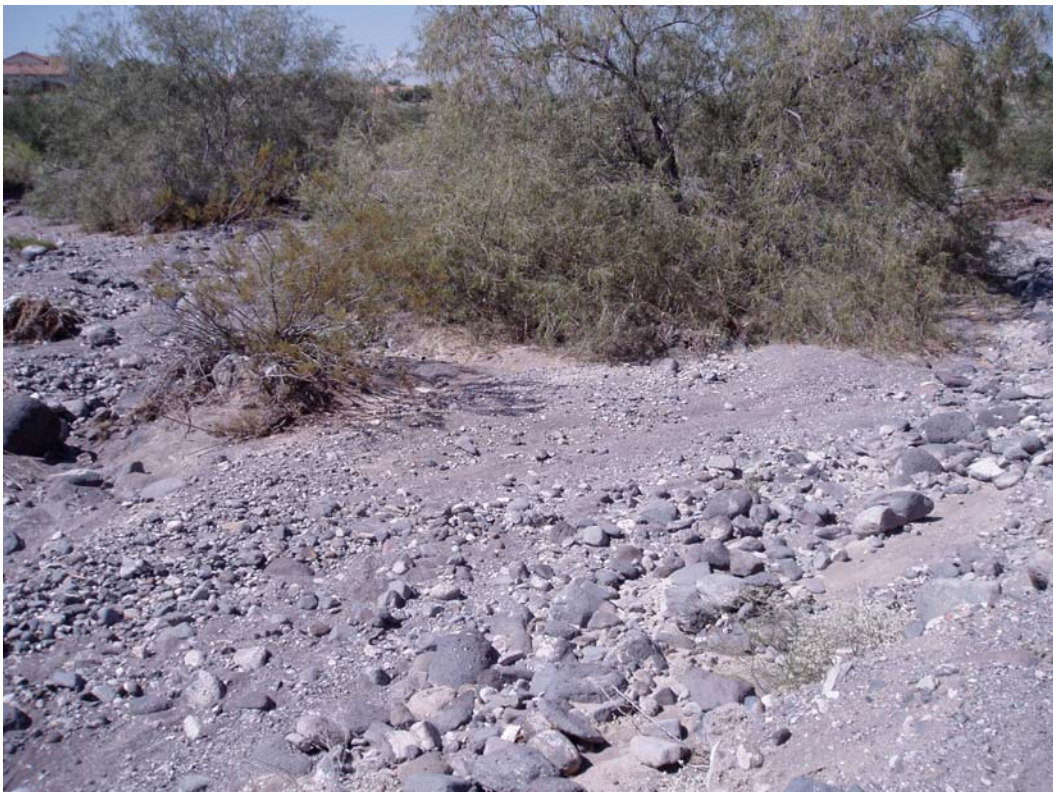
**Photo 4.** Invasive tamarisk.
