**Appendix A**  
**Storm Water Management Plan: Comments from NDEP and Co-Permittee Response**

## Storm Water Management Plan: Comments from NDEP and Co-Permittee Response

**Appendix B**  
**Clark County**

**Appendix B.1**  
**Documentation of Findings**

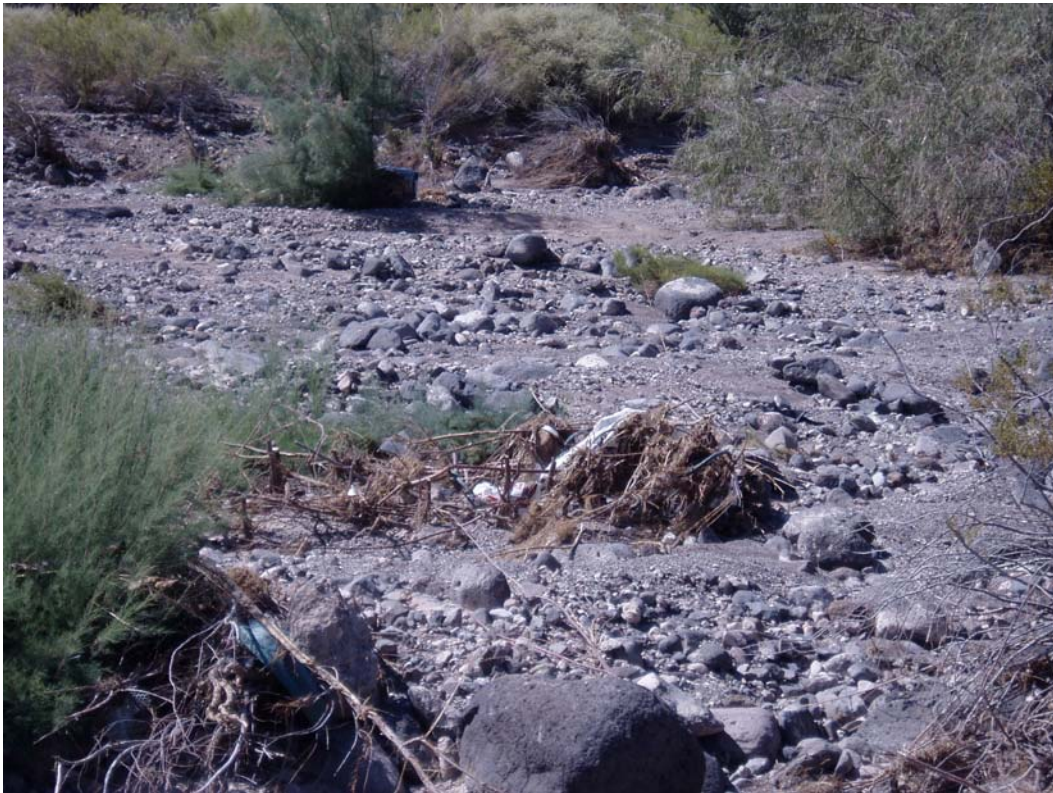
**Photo 5.** Tamarisk and debris in Project Green area of Pittman Wash.

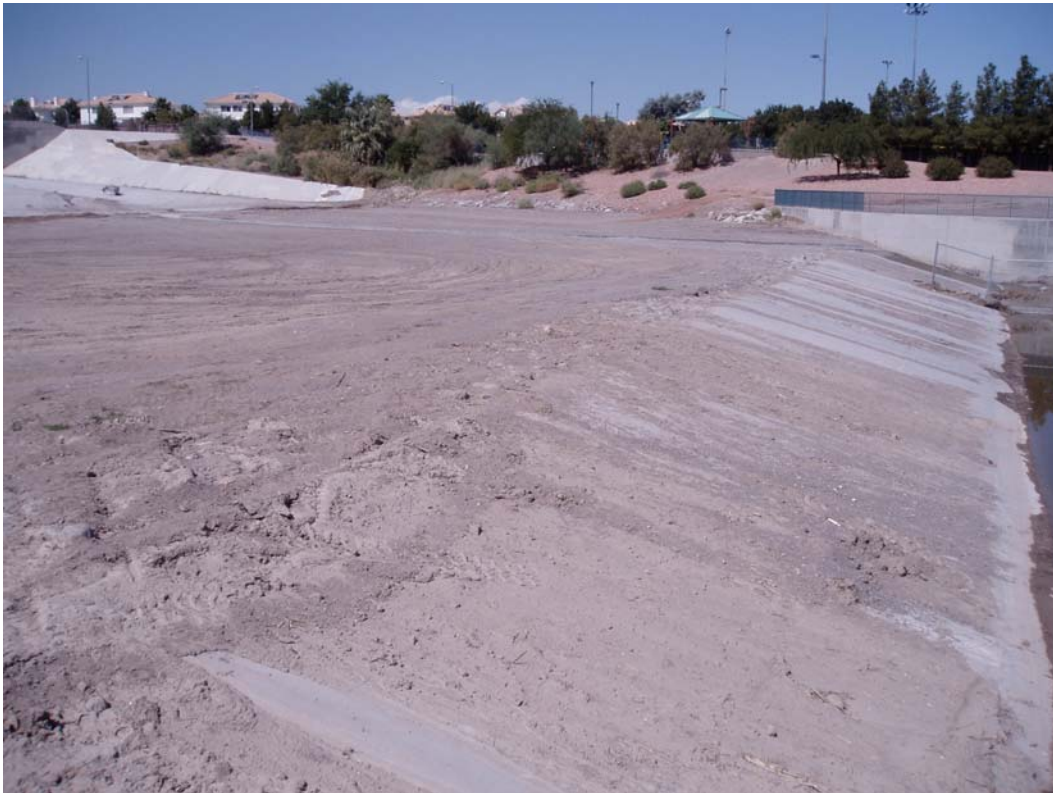
**Photo 15.** Location of first sediment deposit.

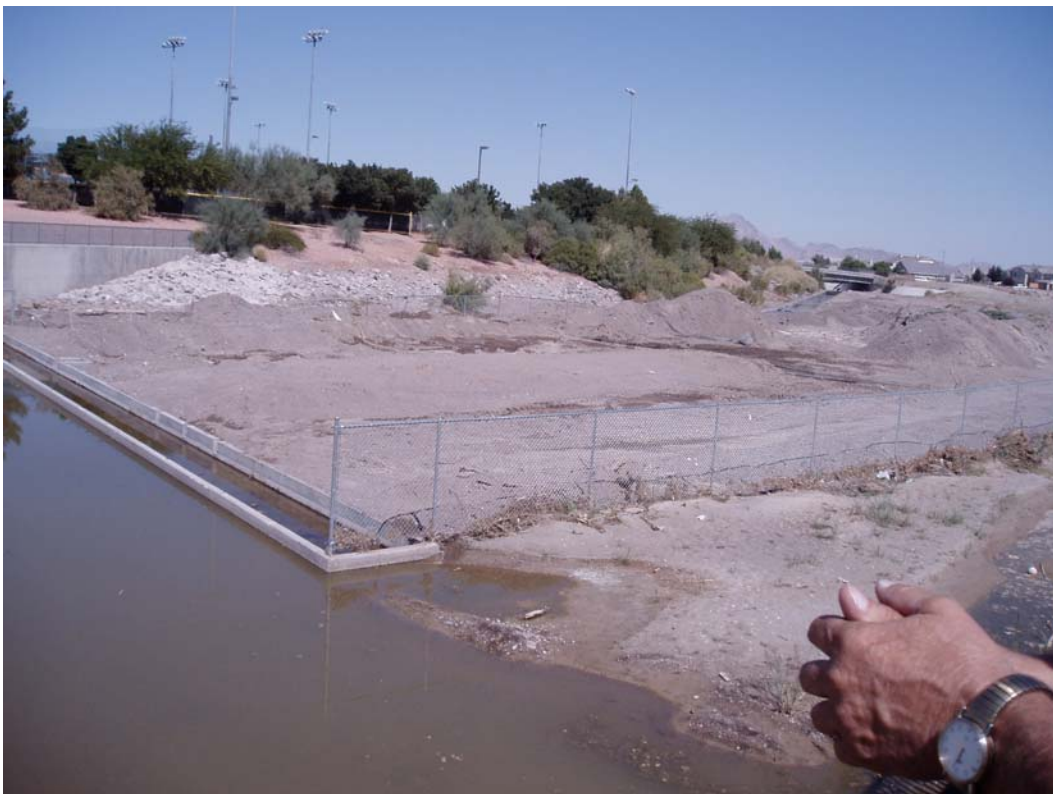
**Photo 16.** Location of second sediment deposit.

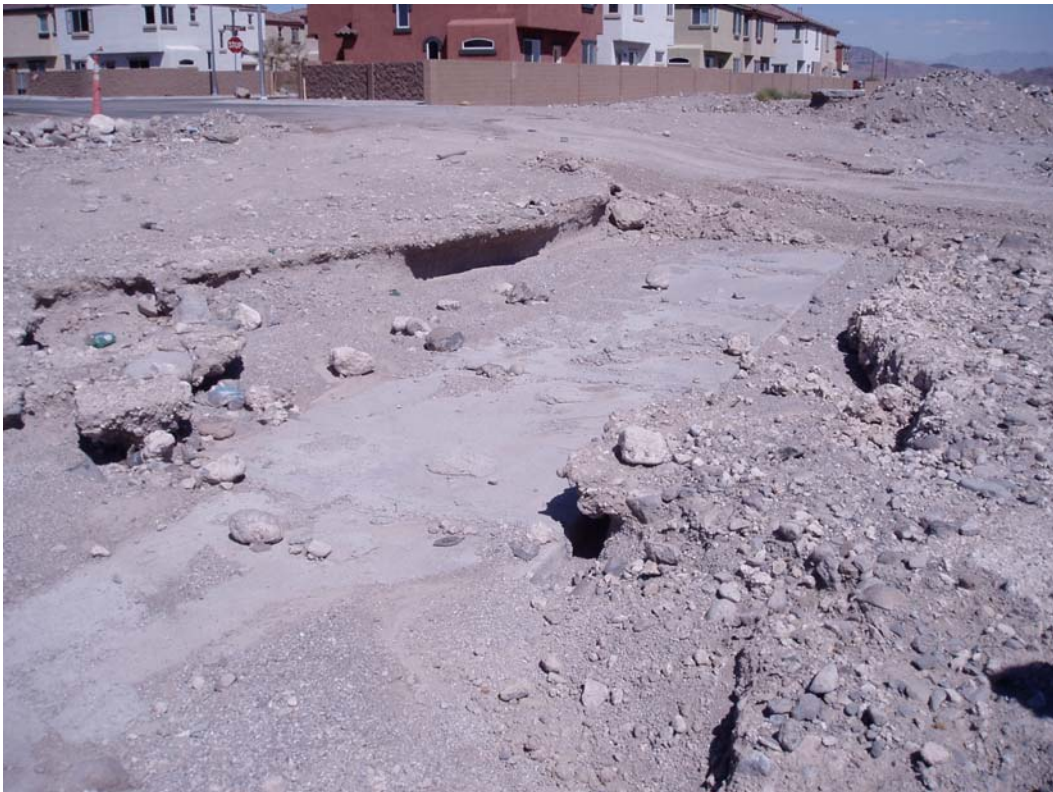
**Photo 24.** Exposed box.

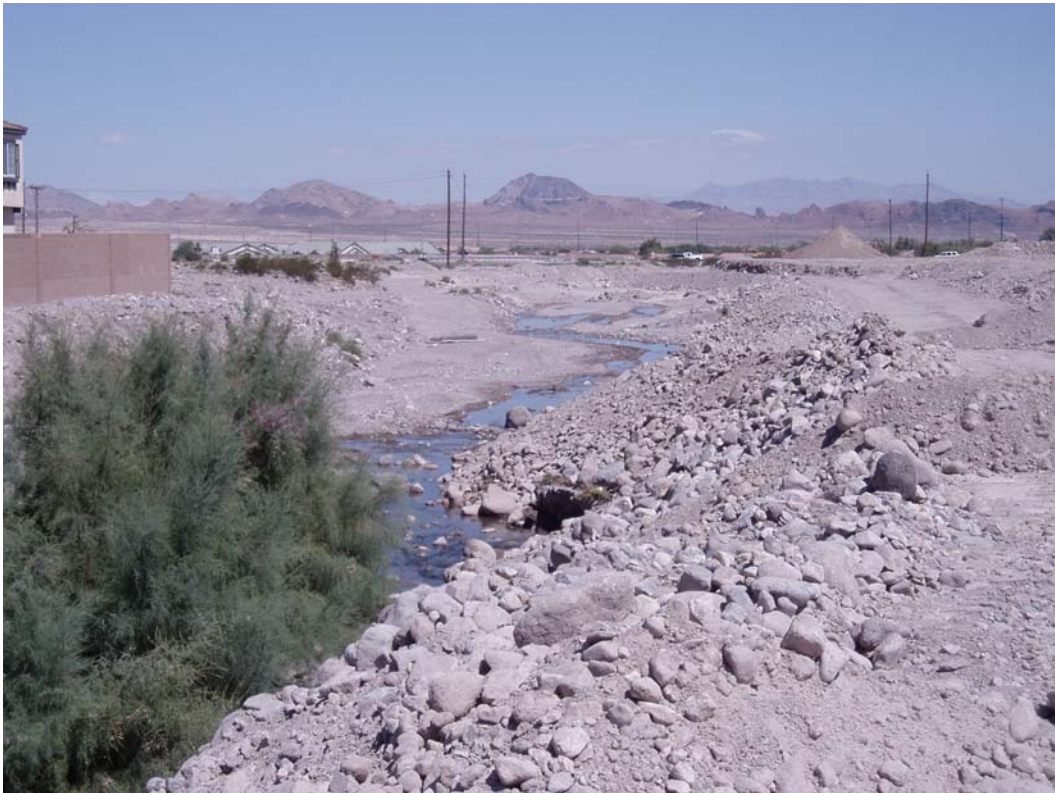
**Photo 27.** Flow from outfall in Photo 25.

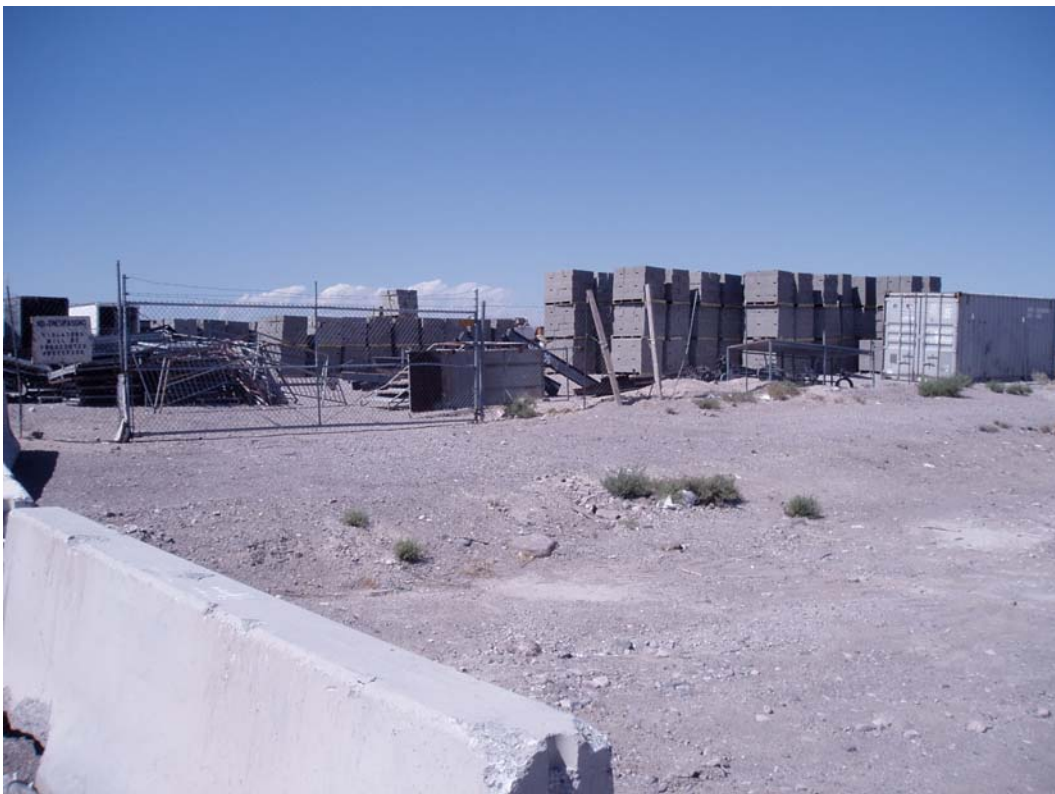
**Photo 28.** Storage along Gibson Channel.

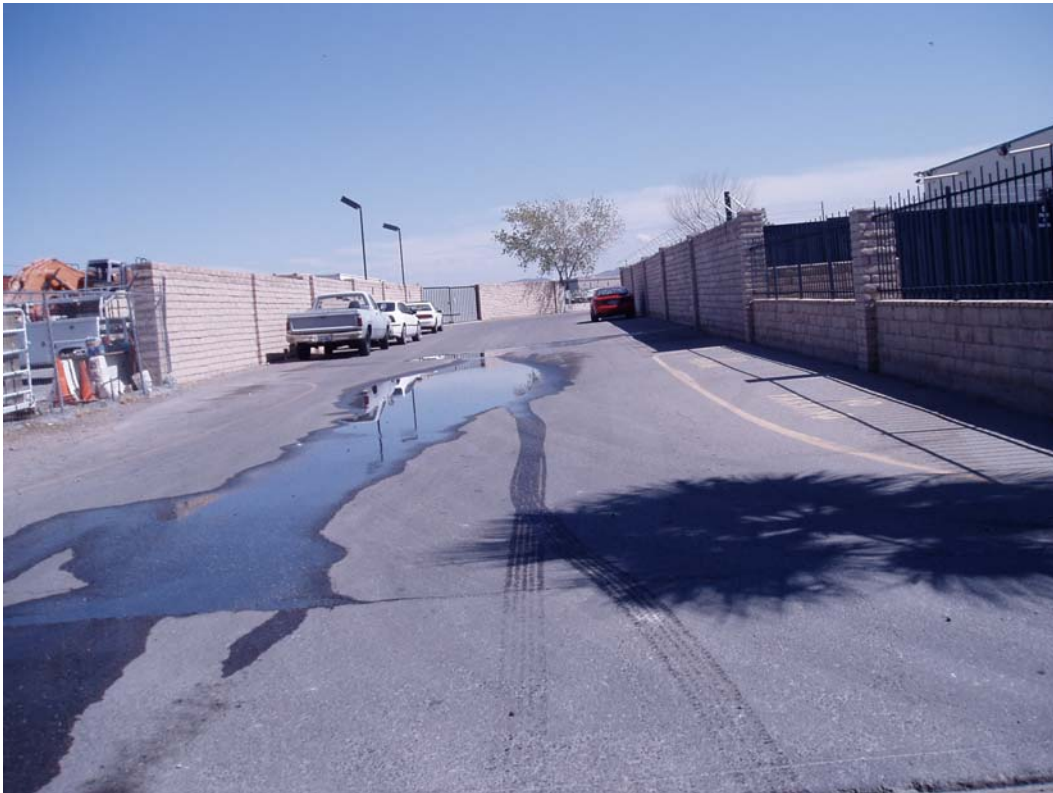
**Photo 29.** Discharge coming from B.Witt parking lot.

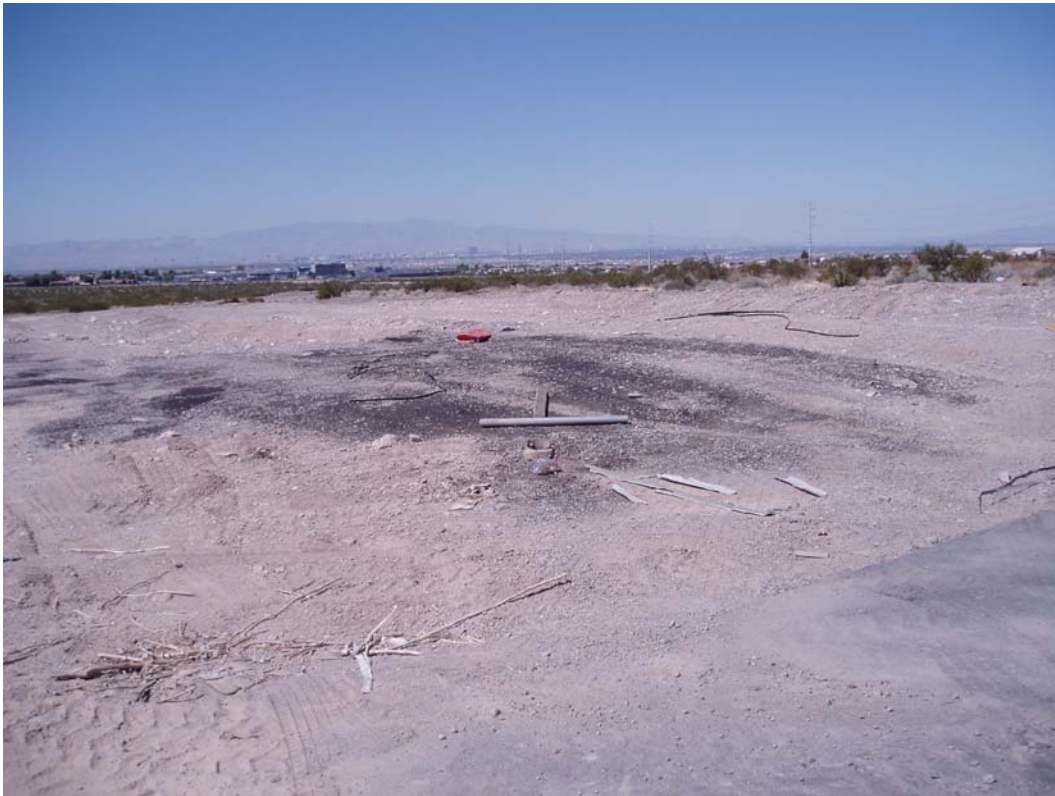
**Photo 3.** Construction debris.
